# ST PETER'S

## Barton-upon-Humber, Lincolnshire

*A Parish Church and its Community*

HISTORY, ARCHAEOLOGY AND ARCHITECTURE

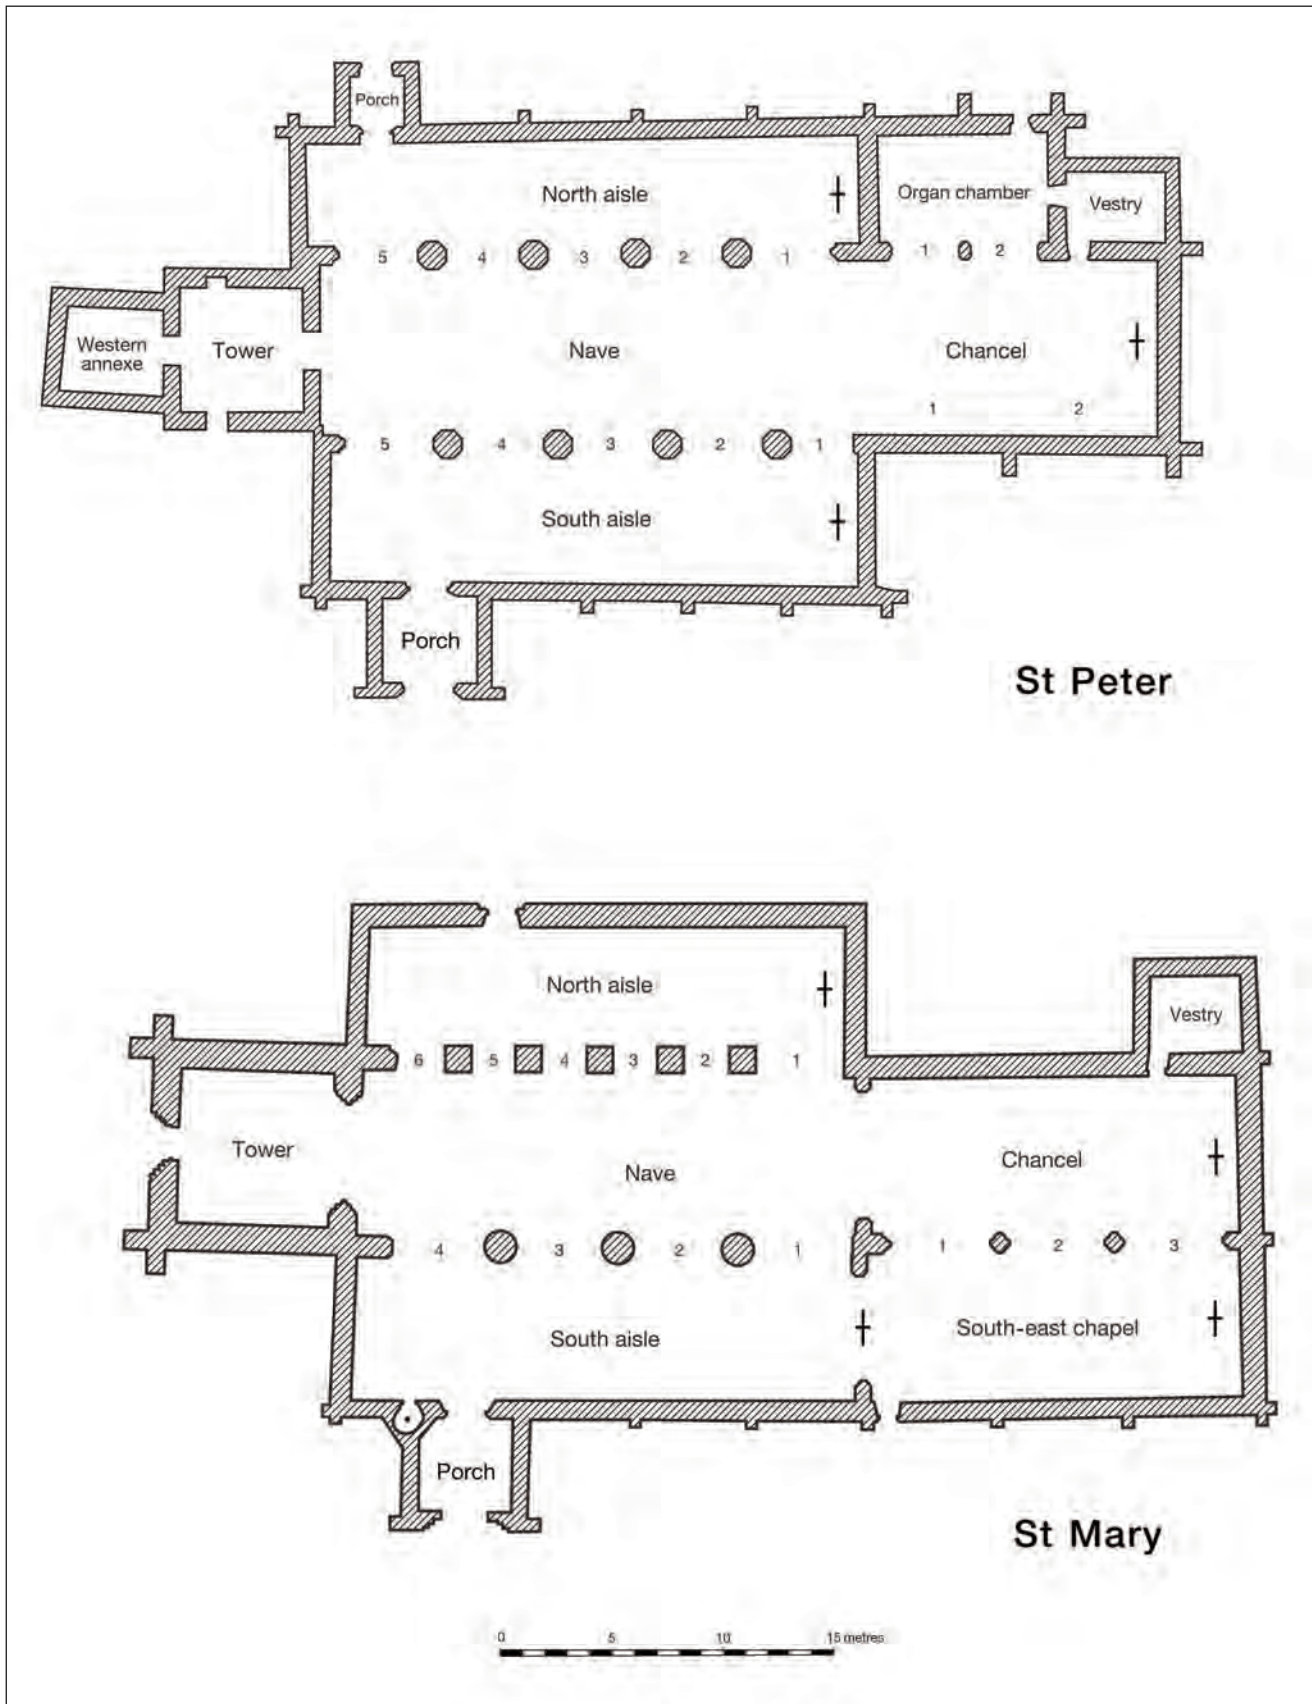
Fig. 7: Comparative floor plans of St Peter's and St Mary's churches in their fully developed form. The nomenclature and bay-numbering system adopted in this report is indicated. Drawing: Simon Hayfield

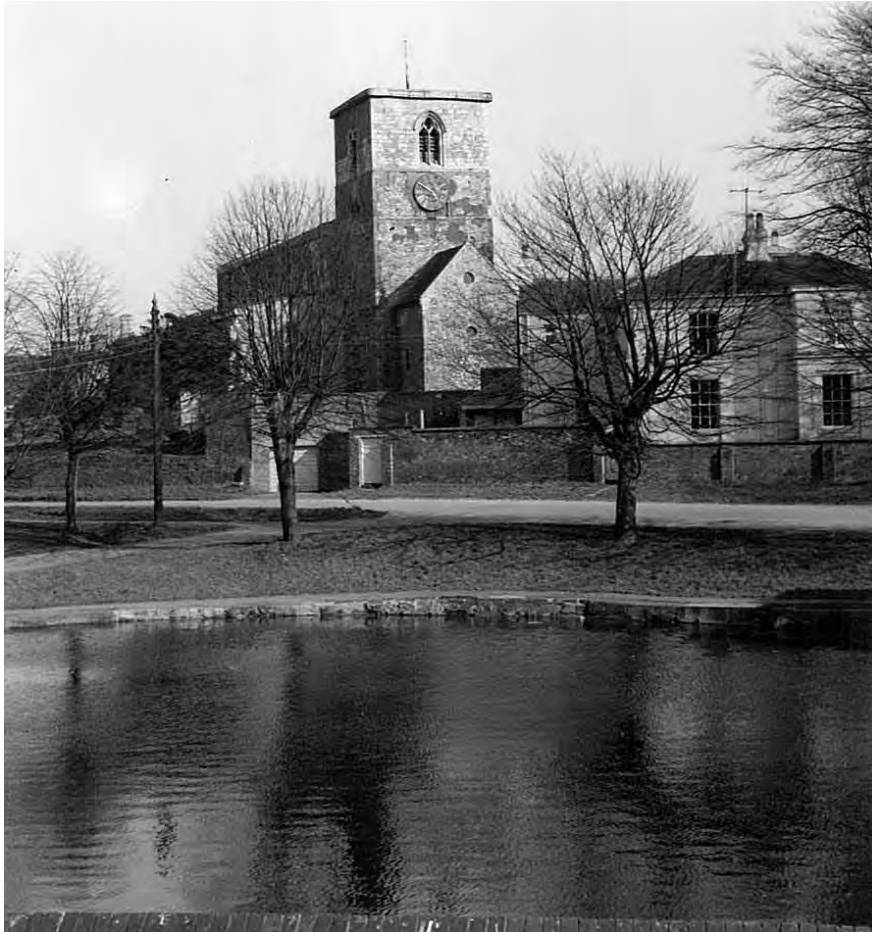
*Fig. 9: St Peter's church. Tower and western annexe from the west, 1965. View from St Mary's churchyard, with the Beck in the foreground and the vicarage to the right. For the same view in 1823, see Pl. 9, and in 2006, see Pl. 4. Photo: David Lee Photography*

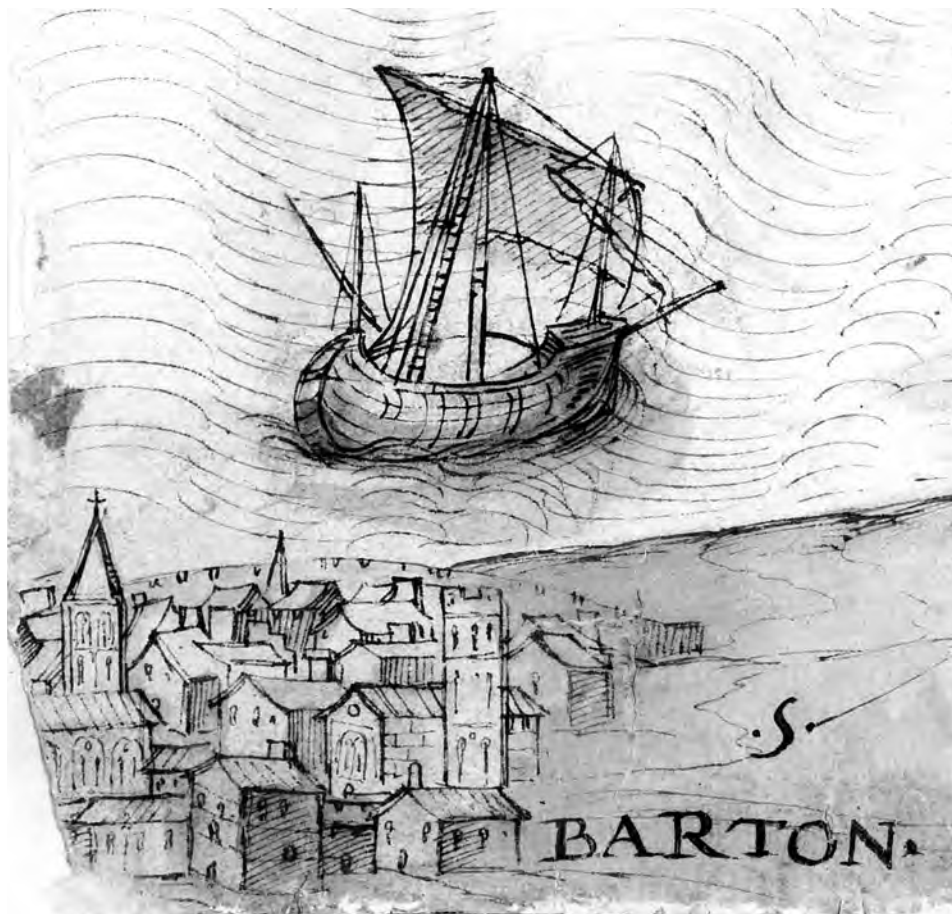
*Fig. 16: Bird's-eye view of Barton, c. 1538–39, showing St Mary's church (left), St Peter's church and a Tudor riverside fortification, above which rises a possible signalling mast. Photo: British Library. Cotton Ms Aug. I.i, f. 83*

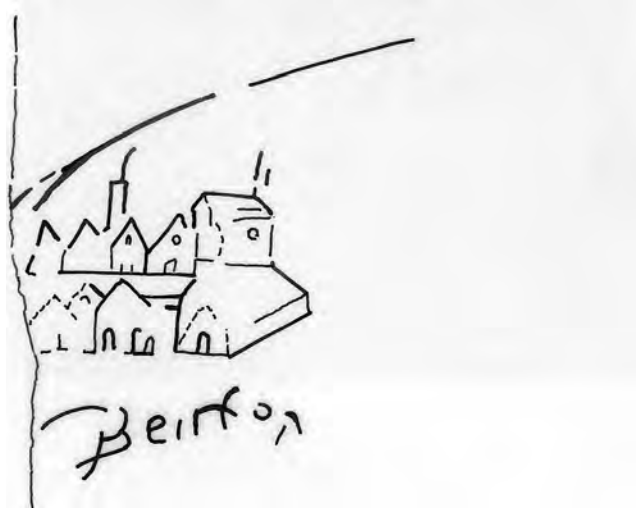
Fig. 17: Plan of Barton, c. 1540–41, showing buildings in rudimentary form, including the two church towers. Photo: British Library. Cotton Ms Aug. I.i. f. 86

The second map, which dates from 1541–42, is much cruder and depicts the entire Humber mouth.<sup>64</sup> Consequently, the scale is much smaller, and little attention is paid to the detail of buildings. Again Barton is included and labelled. The view seems to include two churches with towers, and a series of gable-ends which could be interpreted as aisles and other parts of the churches, but are more likely to represent buildings on a street frontage (Fig. 17). A wood

is shown immediately east of the town. The canopies of the trees are dappled with white paint, and a thick, crude line in the same paint separates the town from the wood.<sup>65</sup> This plan is very schematic and no conclusions can safely be drawn from what is depicted.<sup>66</sup>

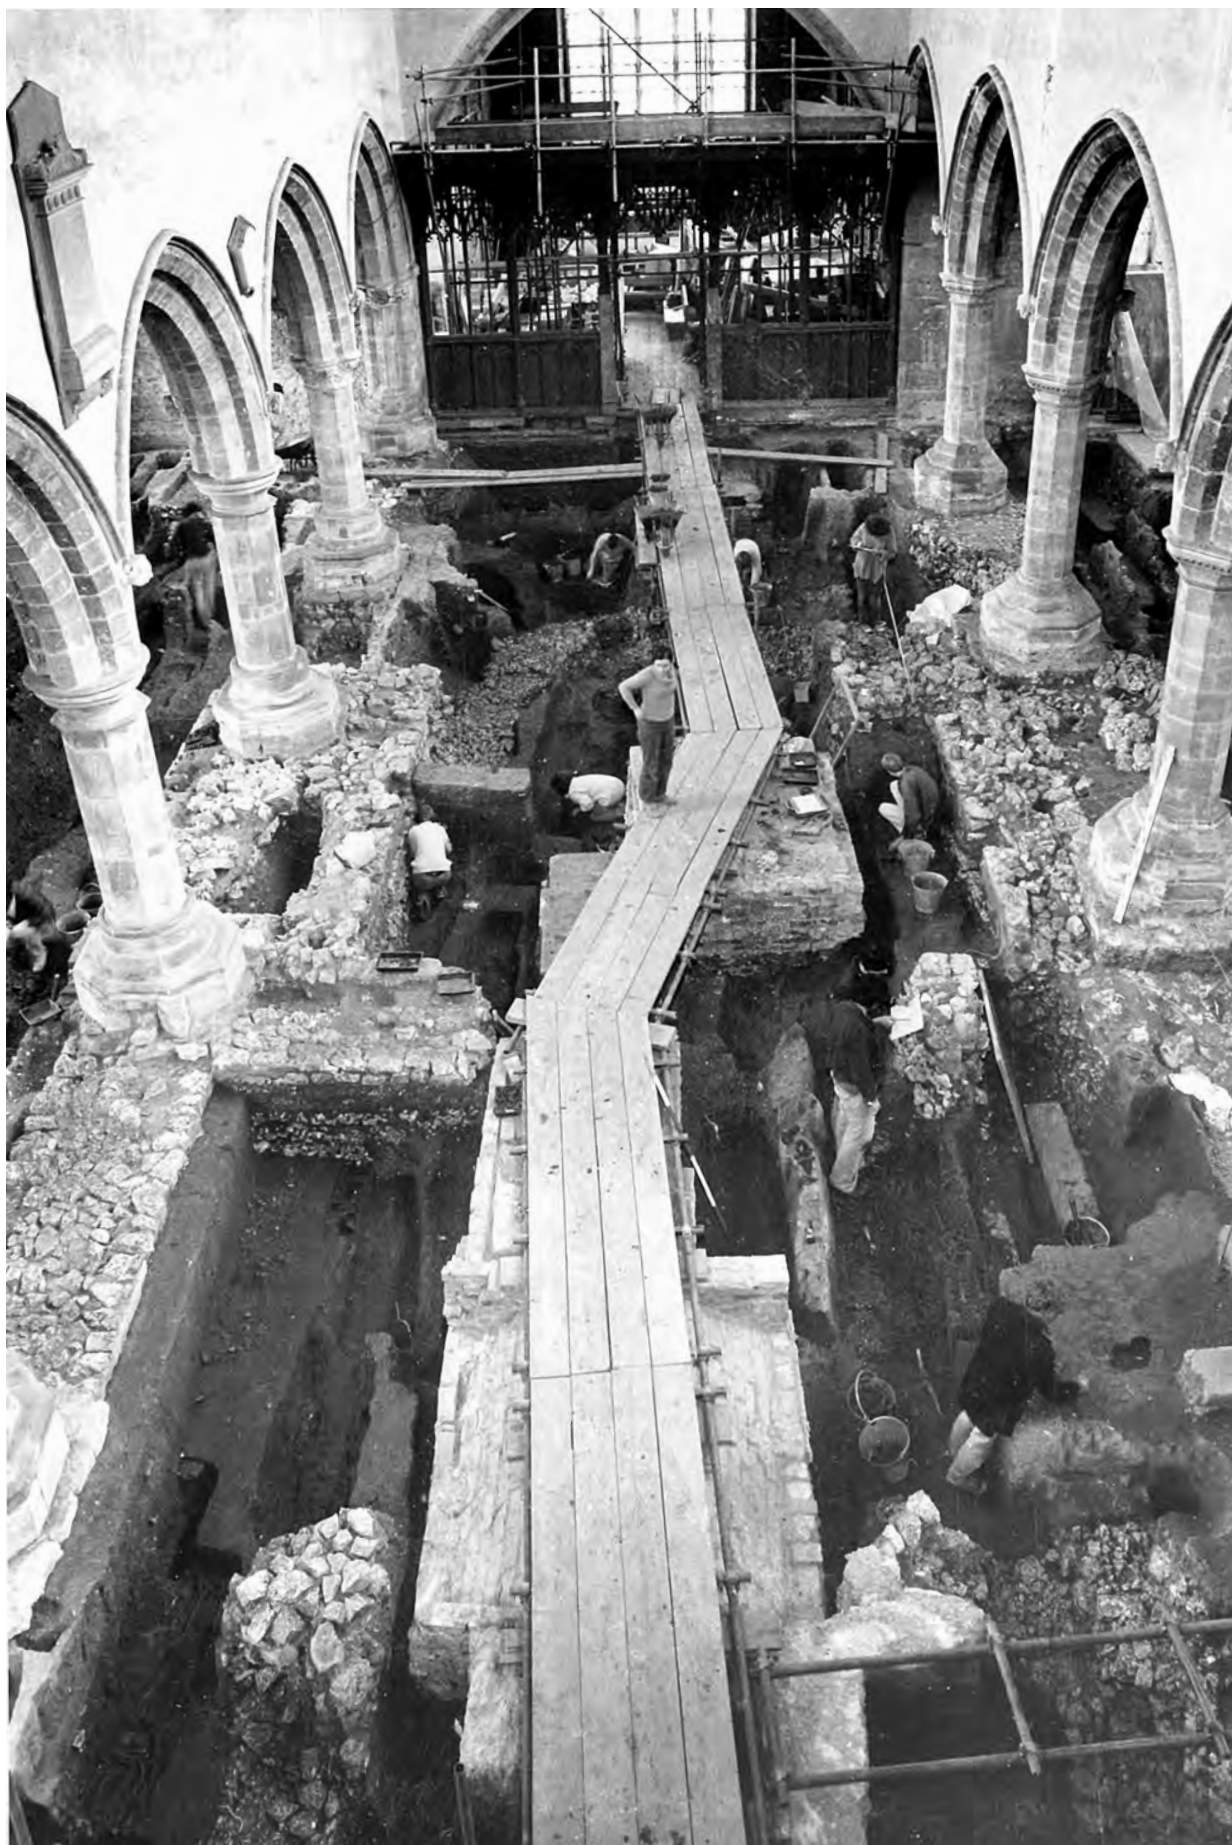
*Fig. 22: St Peter's church: excavation in progress in the nave, 1980. View east. Photo: Warwick Rodwell*

Between 1978 and 1984 seven seasons of excavation were conducted within and immediately around St Peter's church, accompanied by campaigns of structural recording and investigation of the above-ground fabric of all parts of the building (Figs. 22, 23, 24, 260 and 390). The latter continued until 1985 and was supplemented by further campaigns of architectural study in 1988–89, 2000 and 2005. An interim report on the first four seasons' work was published while investigations were still in progress (Rodwell and Rodwell 1982), and a preliminary guide booklet to the church was issued (Rodwell 1983). Subsequently, the restoration of the fabric has continued intermittently, and the building was opened to the public in 1985. Aspects of the archaeological and architectural investigations have also been used to illustrate other published works (*e.g.* Rodwell 1981; 1986; 1989; 1990; 2005a). Similarly, the prolonged study of the human remains, since excavation, has resulted in many references to Barton material in published papers (for a bibliography of these, see Vol. 2).

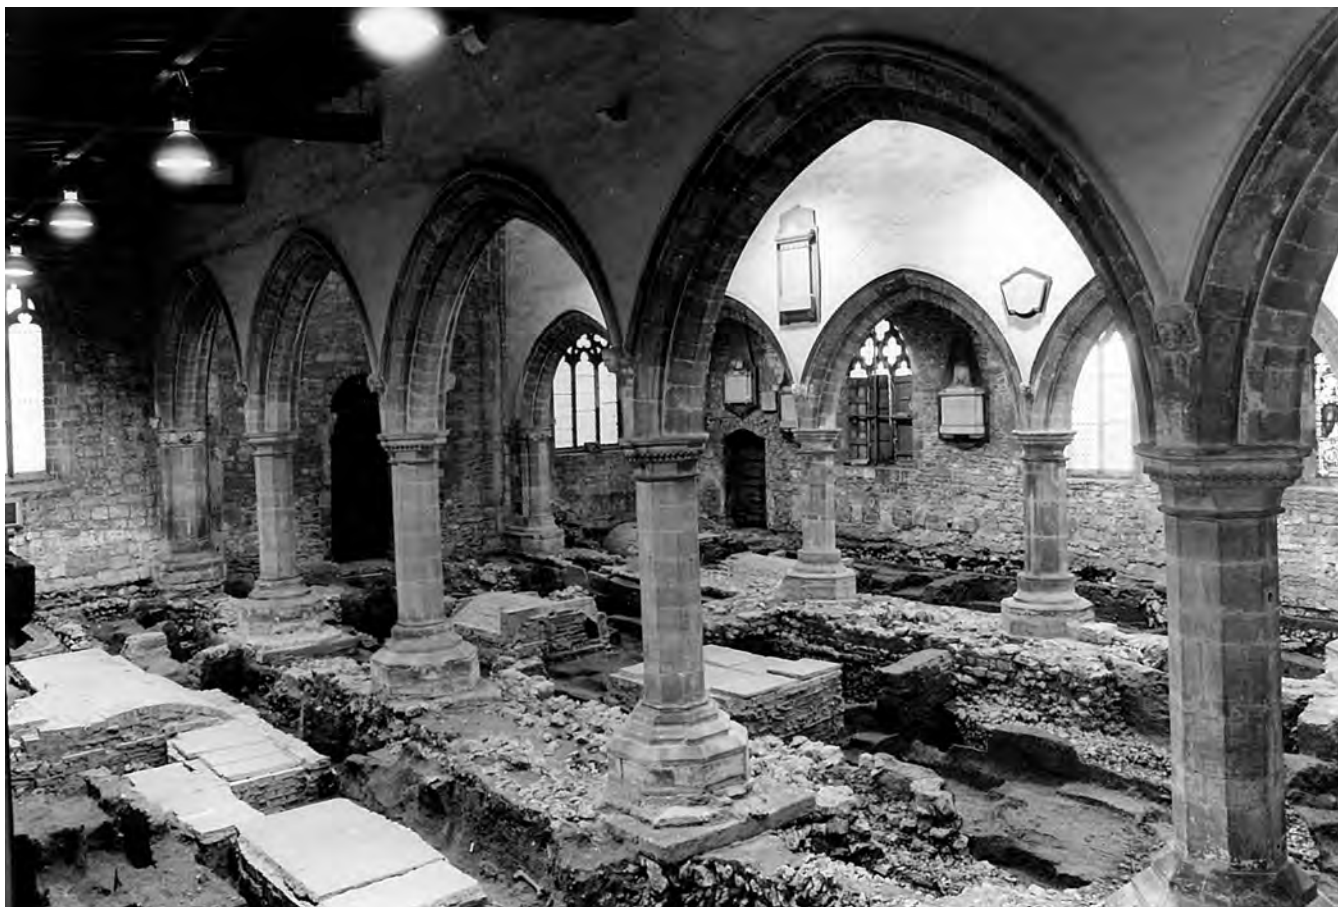
Fig. 23: St Peter's church: excavation in the nave and aisles, 1980. View north-west, from the east end of the south aisle. Photo: Warwick Rodwell

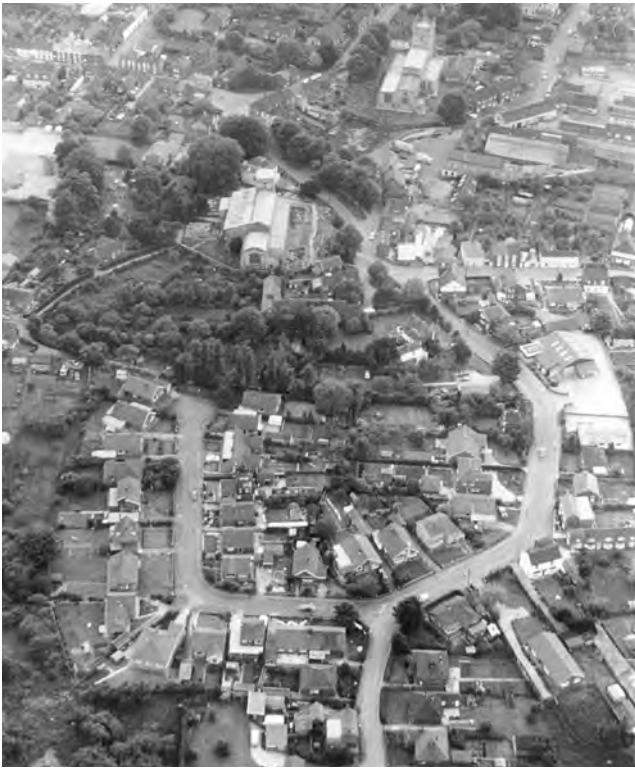
Fig. 26: The sub-circular enclosure in relation to the modern topography of Barton; view from the east, 1983. The bungalow estate in the foreground occupies the site of the enclosure, its northern boundary being marked by the angular course of the road (East Acridge) on the right. In the middle ground is Tyrwhitt Hall garden and St Peter's church beyond: the footpath running away from the south-east angle of the churchyard marks part of the southern side of the enclosure. In the distance is St Mary's church and Burgate (to the left), the town's main street, which aims directly for the enclosure. Photo: Geoffrey Bryant

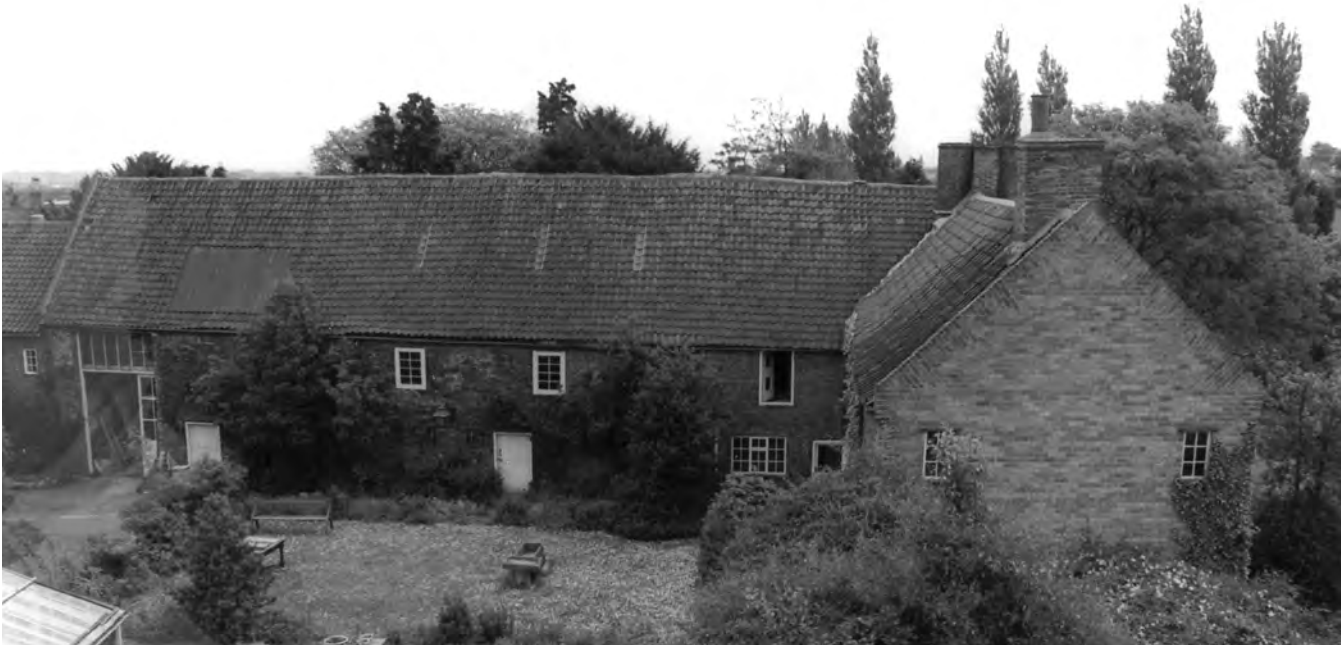
*Fig. 32: Tyrwhitt Hall, Barton. View east into the courtyard, towards the brick-encased medieval hall; the south range is on the right. Photo: Warwick Rodwell*

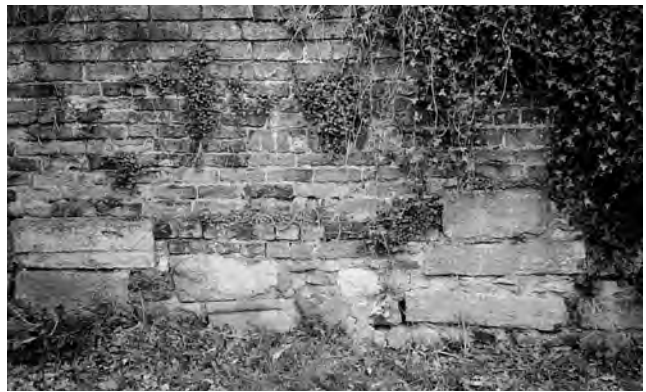
*Fig. 42: St Mary's: eastern churchyard wall (c), adjoining the Beck, showing reused moulded stones and flat limestone slabs. Photo: Warwick Rodwell*

prepared for this purpose, or were salvaged from a previous use, is unknown. Reused materials are certainly present in the later work, including flat slabs (medieval grave-covers?) and mouldings (Fig. 42). The stone wall stood at least 2 m high before the brick capping was installed in the nineteenth century and, as noted above, was probably in the region of 3 m. Additionally, it must have been founded on a solid base, rather than on unstable silt around the rim of the Beck, otherwise the lateral pressure exerted by the raised churchyard would have overturned the wall bodily. It was probably in the late seventeenth century that the process of replacing decayed masonry with brick began, and may be related to several references in the churchwardens' accounts (particularly in the 1690s) to hauling quantities of bricks to the churchyard (p. 126). In 1862 the whole wall was heightened – or the upper courses were removed and rebuilt – and given a bevelled capping.

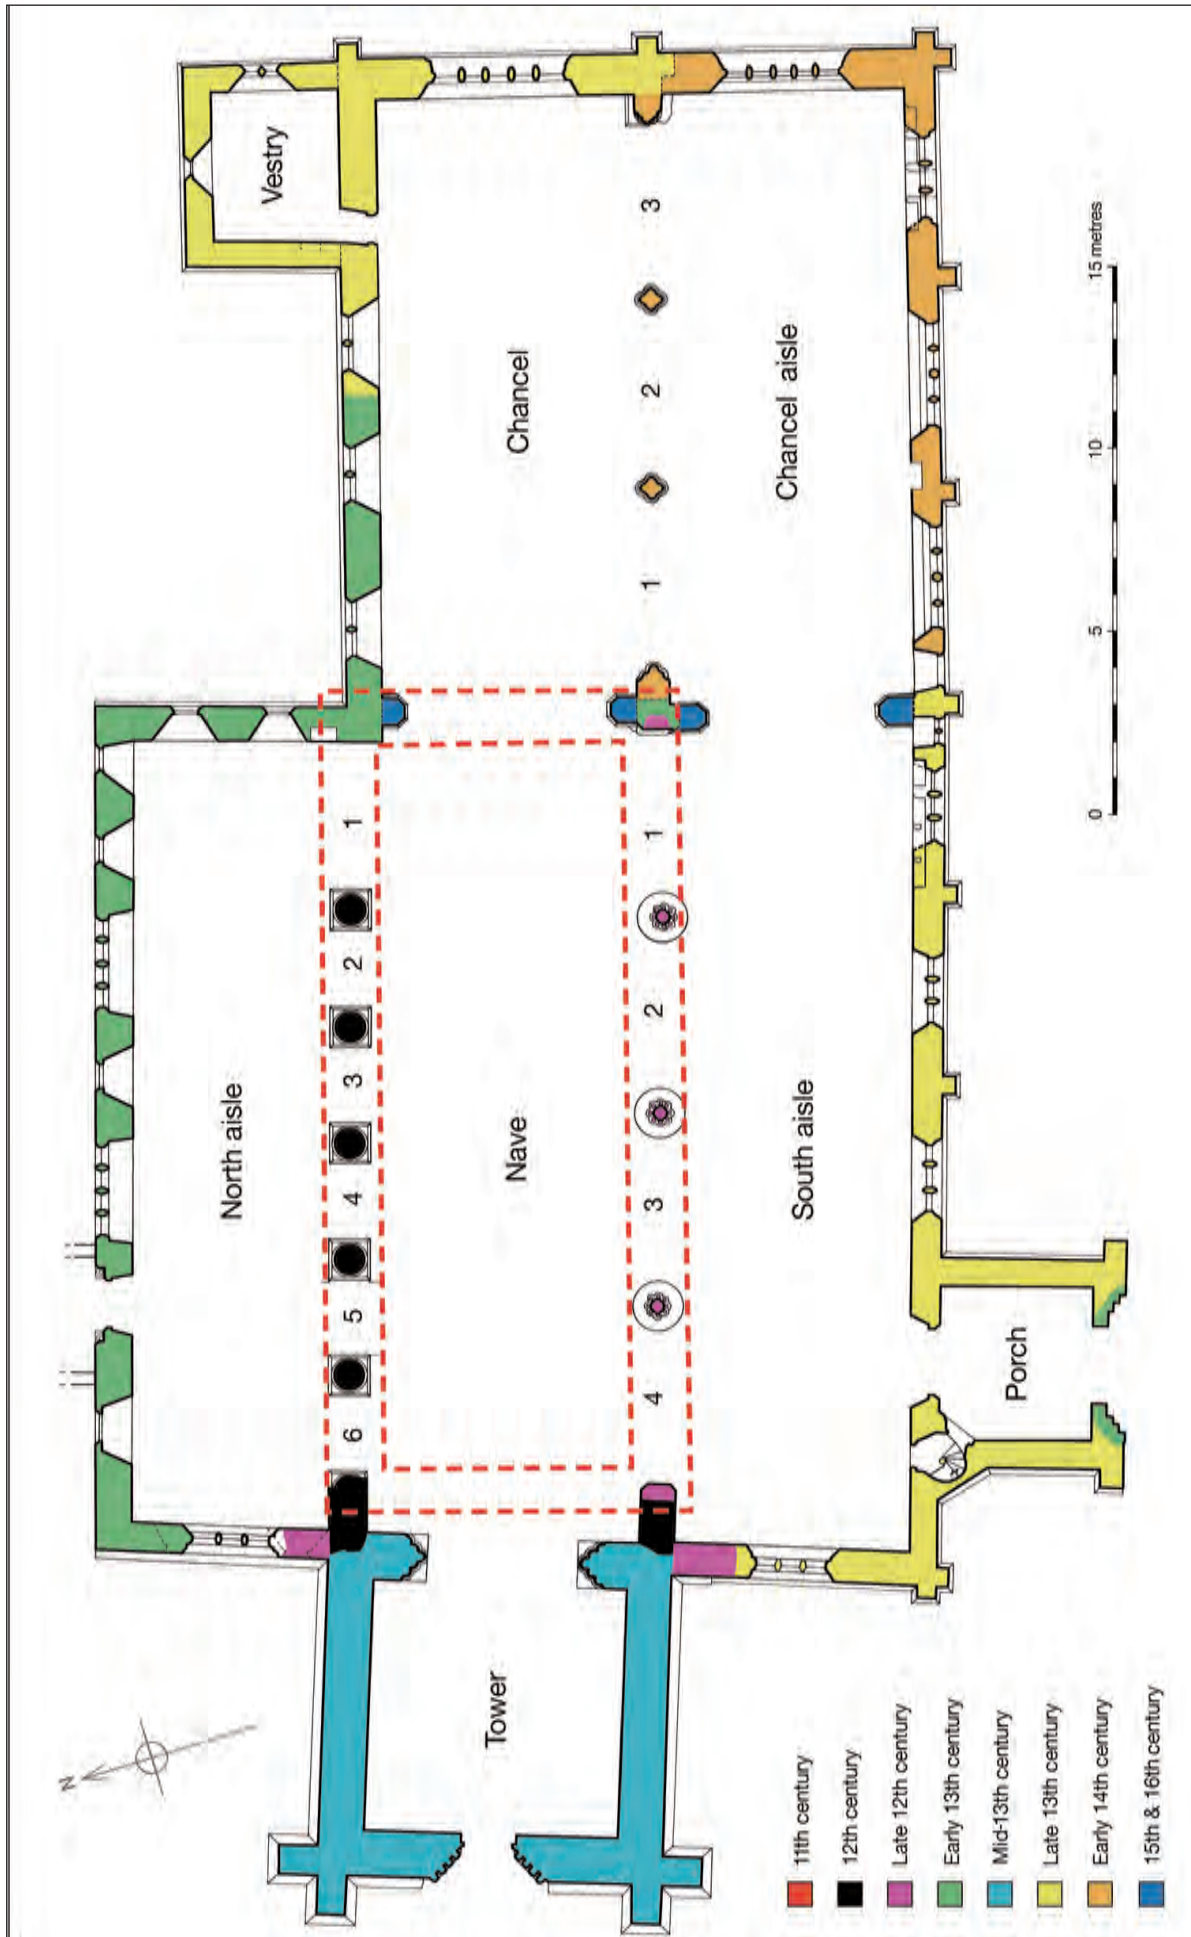
Fig. 46: St Mary's church: phased plan of the upstanding walls. The approximate positions of the earlier (Anglo-Saxon?) nave are also shown. Drawing: Caroline Atkins and Simon Hayfield

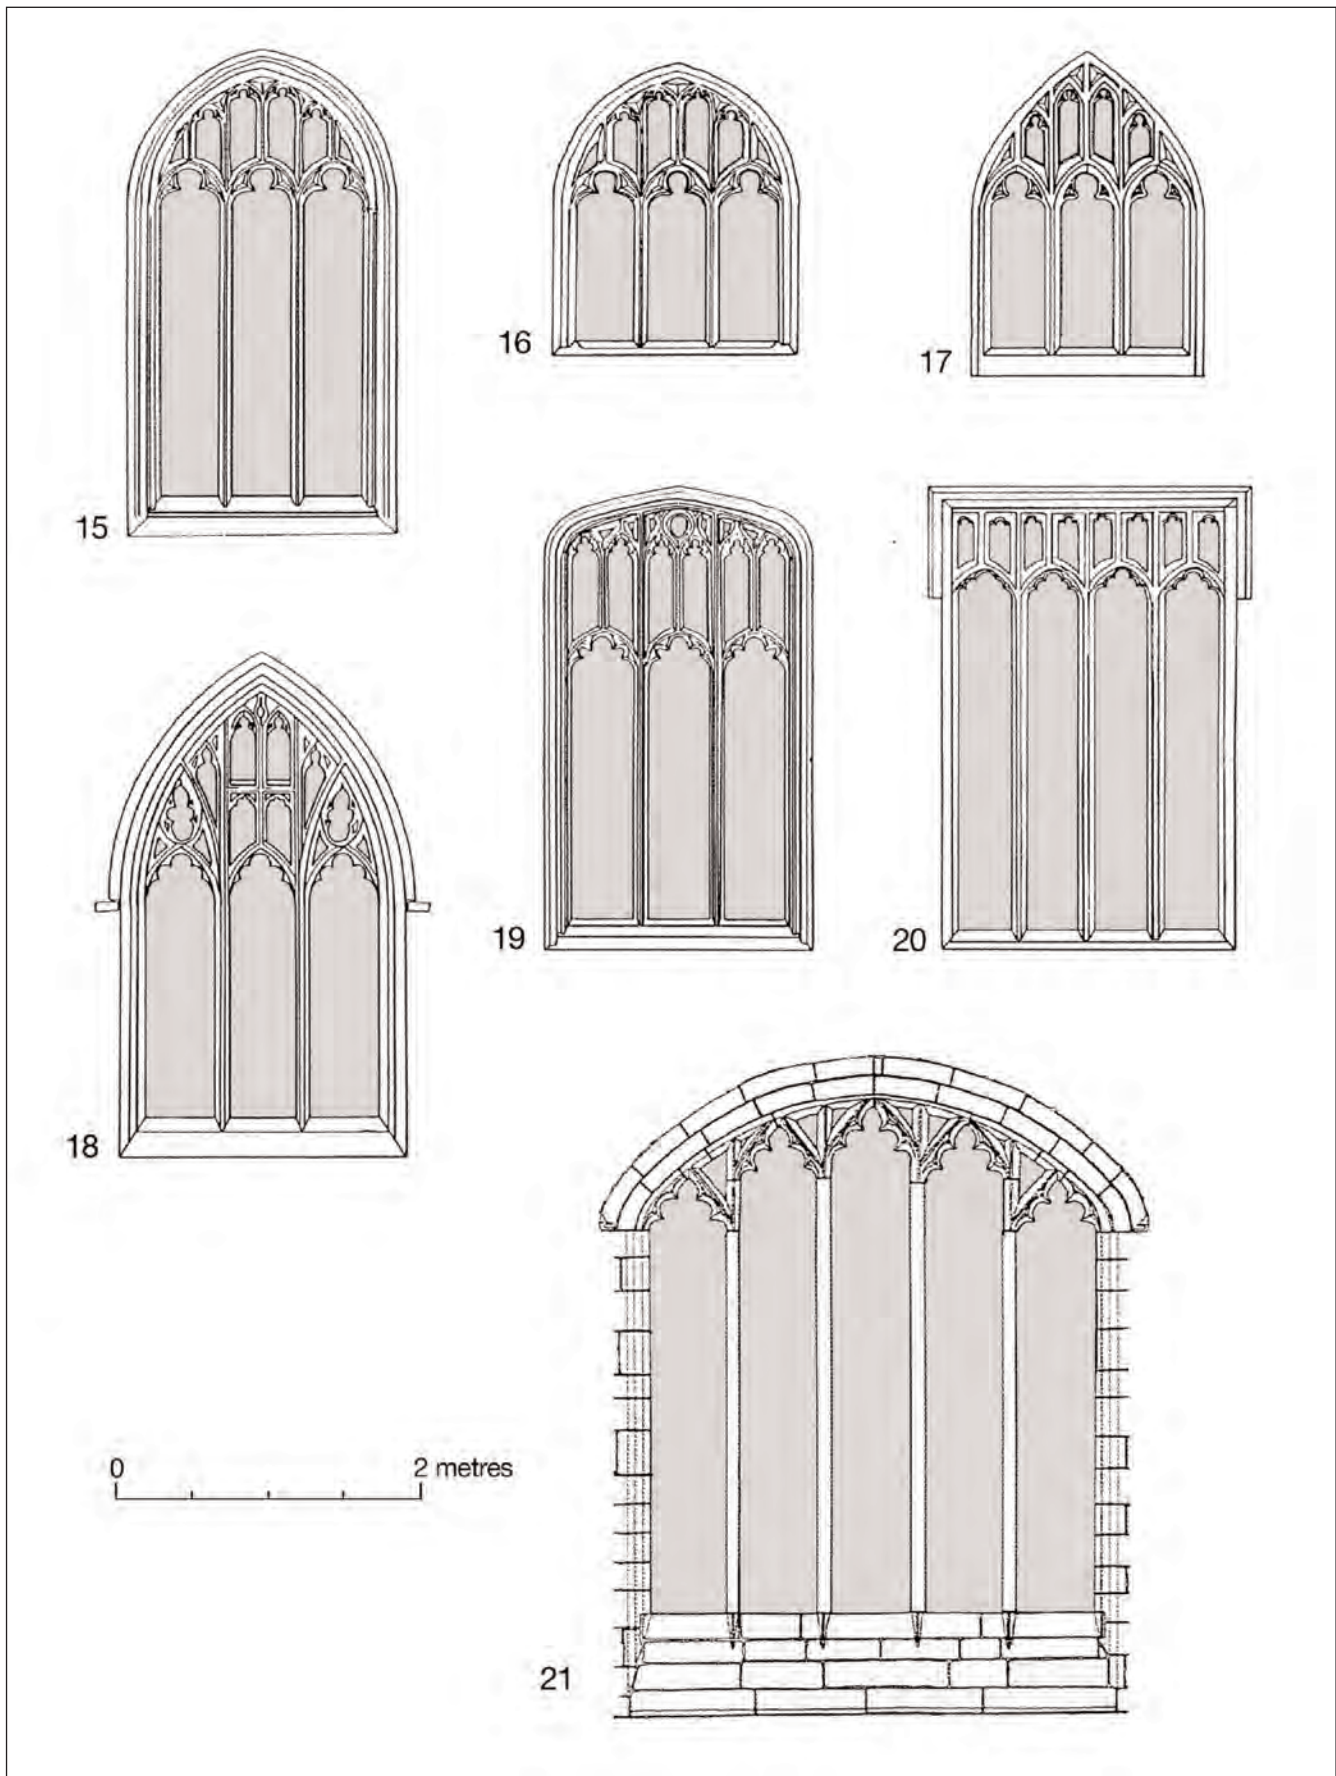
Fig. 50: Typology of the medieval windows in St Peter's and St Mary's churches. 15 St P., south aisle, west wall; 16 St P., clerestory; 17 St M., clerestory; 18 St M., north aisle, west wall; 19 St P., south aisle, east wall; 20 St M., north aisle; 21 St P., chancel, east wall. Scale 1:50. After Bryant 2003 (except 21)

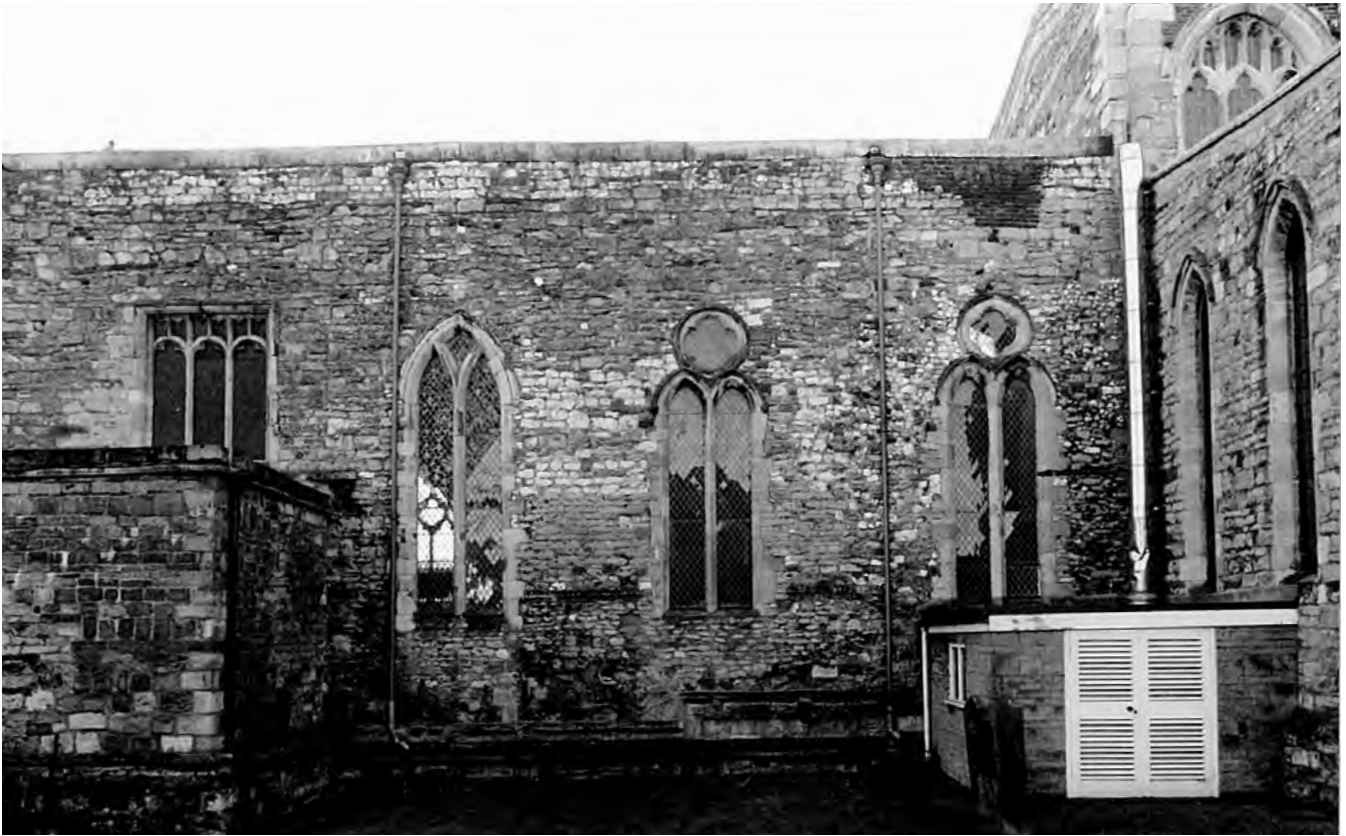
*Fig. 51: St Mary's: north elevation of the chancel, showing also the vestry (left) and boiler-house (right). Photo: Warwick Rodwell*

Externally, there is a marked difference on the north side between the masonry of bays 1–3, and that of the easternmost bay and the vestry; this indicates two periods of construction (Fig. 51). The east elevation is united by a moulded plinth and a string-course at window sill level; the masonry is predominantly squared limestone rubble laid to neat courses. The north and west sides of the vestry are less well finished and lack the string-course (Fig. 54). The masonry of bays 1–3 is much less regular and contains a greater mixture of rubble, with clear banding present, representing the arrival on site of different loads of stone. Thus, up to sill level the rubble is mixed, there is then a band of flattish pieces of limestone, followed by a band which is primarily chalk. This wall also contains the remnants of a string-course which is a little above sill level and the mid-thirteenth-century windows have clearly been cut through it. Internally, traces of former (Norman?) windows can be detected in the wallplaster above the present window heads in bays 1 and 2. The primary masonry of the north wall is similar to that in the same location at Barrow church.

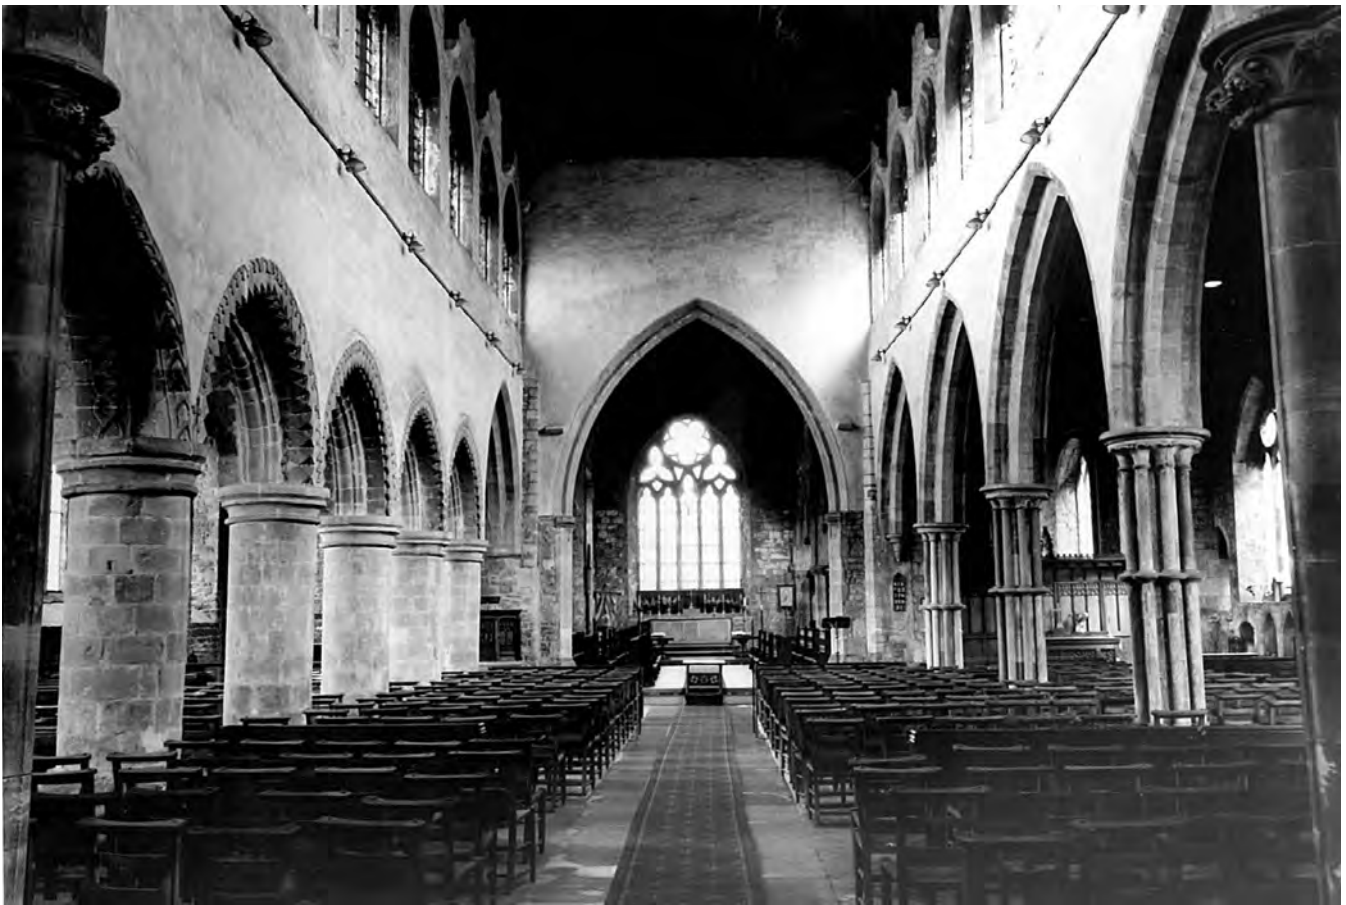
*Fig. 52: St Mary's: interior of the nave and chancel, looking east, c. 1965. The transverse screen in the south aisle was later removed to the tower, and the organ from St Peter's installed here: cf. Pl. 14. Photo: David Lee Photography*

This is of four wide, uniform bays, and has a short nib at the west end; the arches are of two plain-chamfered orders without label-mouldings on either face (Fig. 52). The east and west responds are flat and plain-chamfered. The eastern stands on a roughly formed square plinth which was probably not meant to be visible; it incorporates a reused fragment of incised grave-slab (Fig. 709, no. 2). The arcade springs from waterleaf corbels with beast-heads below: the eastern corbel is a Victorian replacement. The chamfers on the west respond have brooch-stops, and the waterleaf corbel is embellished with upright crosses (Fig. 66).<sup>63</sup> The beast-head has pointed ears, large dishd eyes, prominent eyebrows, and rows of bared ferocious teeth; the muzzle is damaged. Built into the face of the respond, as secondary patching, are two pieces of alabaster, one of which is defaced and carries remnants of a moulding:

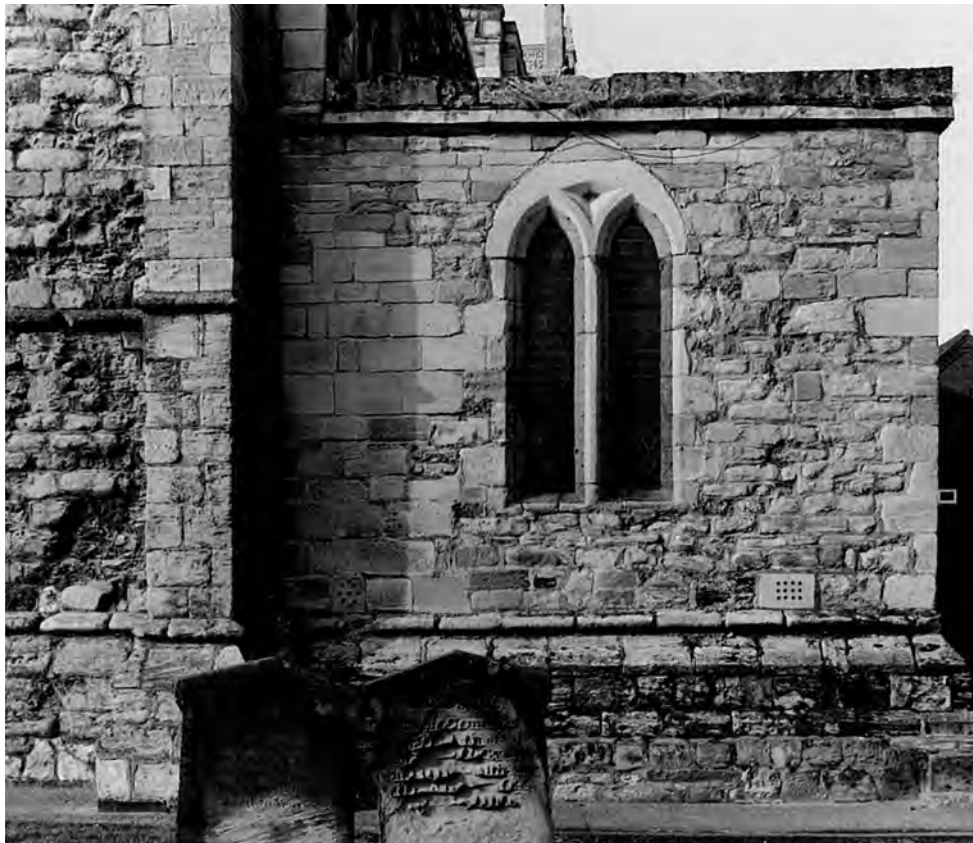
Fig. 54: St Mary's: east face of the vestry. Photo: Warwick Rodwell

north has a single lancet, and that on the east has two lights with Y-tracery; no hood-mouldings (Fig. 54). The internal reveals are widely splayed.

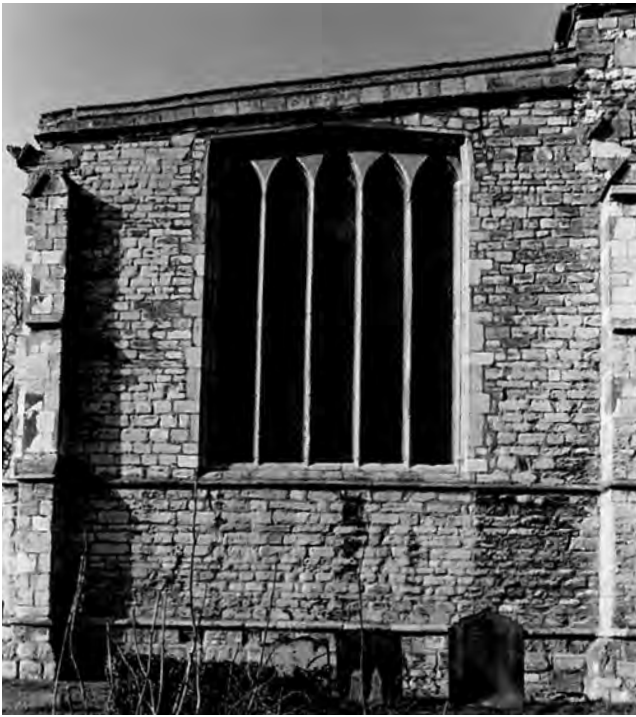
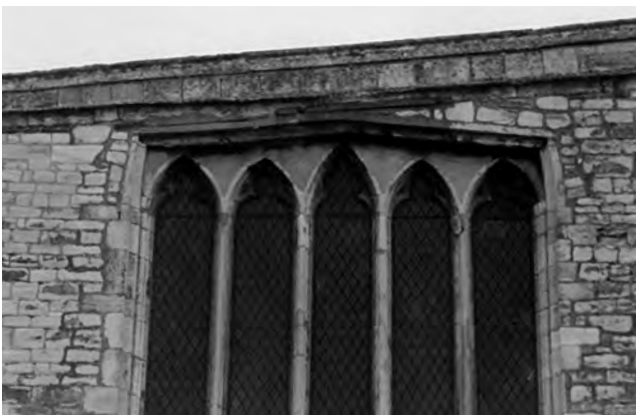
Fig. 56: St Mary's: south chancel aisle. Upper, east end, with its truncated window. Lower, detail of the window tracery and substitute cambered head. Photos: Warwick Rodwell

The five-light east window was once much taller and more elaborate (Fig. 56). It has been truncated at the apex of the main lights and all the traceries have gone: it now has a cambered head externally and a timber lintel internally. The springing of the two-centred head

survives outside, together with the scars where the hood-moulding and label-stops have been removed. The springing of the head can also be seen inside, together with the lower ends of the hollow-moulded hood and the two human heads that formed its label-stops (Fig. 117, sculpture nos. 9 and 10). They are *en suite* with the stops on the chancel arcade. The reveals are unmoulded. The main lights have trefoil heads, with the exception of the central one which stands slightly taller and has an elongated cinquefoiled head, similar to the windows in the south nave aisle.<sup>57</sup> This suggests that the tracery of the east window was Geometrical and was not contemporaneous with the fourteenth-century aisle: almost certainly, this was a repositioned window, fitted with a pair of label-stops to match those on the new arcade. The window is likely to have originated in the east end of the late thirteenth-century south nave aisle and to have contained one or more foiled circles in the tracery.

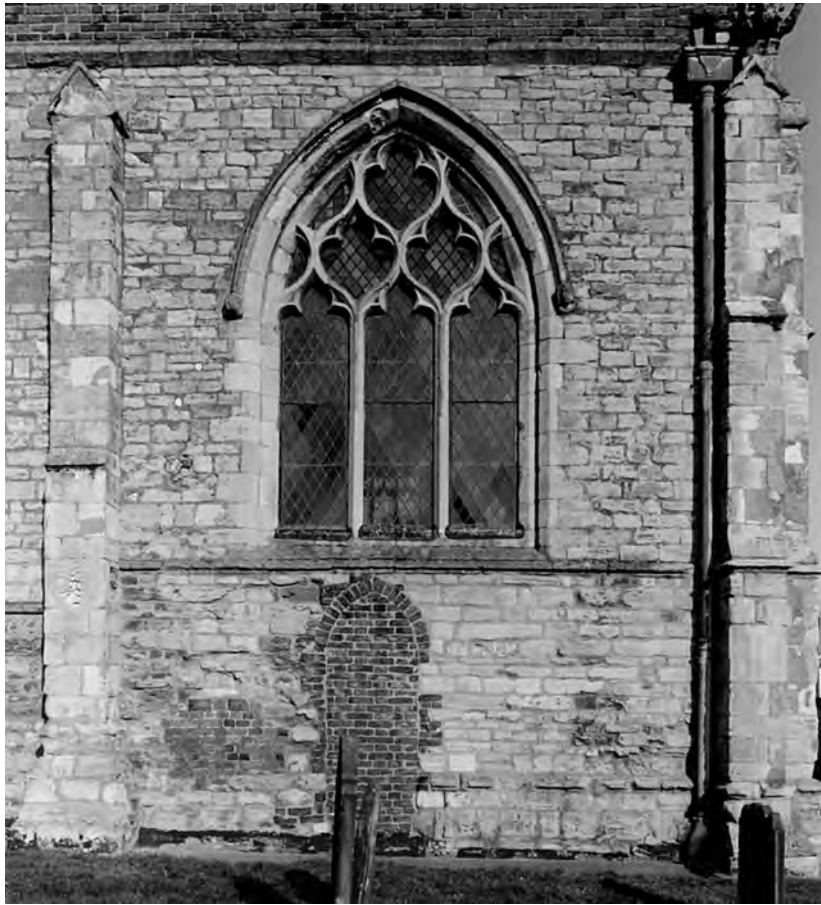
*Fig. 58: St Mary's: south chancel aisle. Reticulated window tracery and blocked post-medieval doorway in bay 3. Photo: Warwick Rodwell*

The three-light reticulated window with a two-centred head in the south wall of bay 3 is almost identical to those in the north aisle of St Peter's: only the cusping is slightly different (Figs. 49, 9 and 11 and 58). The rear-arch is chamfered, the splays plain. The window is contemporary with the triple sedilia in the wall below (Fig. 59).<sup>59</sup> The openings are pointed and have continuous chamfered arrises. The divisions between the seats were originally mullion-like and freestanding (*cf.* sedilia in the south nave aisle), but the lateral openings have been infilled with brick. There is a hood-moulding of crude, angular section (not hollowed), cut on the same blocks as the voussoirs of the arch; this is similar to the hood over the vestry doorway in St Peter's (p. 456). The associated piscina originally had a broad, trefoil-shaped head with a continuous plain chamfer (cut from a single block), but the cusping has been hacked away to form a square-topped cupboard. The basin has gone and a plain stone slab substituted as a sill. The piscina and sedilia are thirteenth century in style and were probably once in the south wall of the chancel, being repositioned when the aisle was added.

Probably in the eighteenth century, the masonry in and beneath the central sedilium was broken out to create a small pointed doorway; this was the external entrance to the schoolroom that, from an unrecorded date, occupied the easternmost bay of the aisle (Fig. 58). A fireplace was installed in the south-east corner of the room, and a chimney erected on top of the angle buttresses. The doorway was infilled, probably in 1883, and the fireplace later removed.

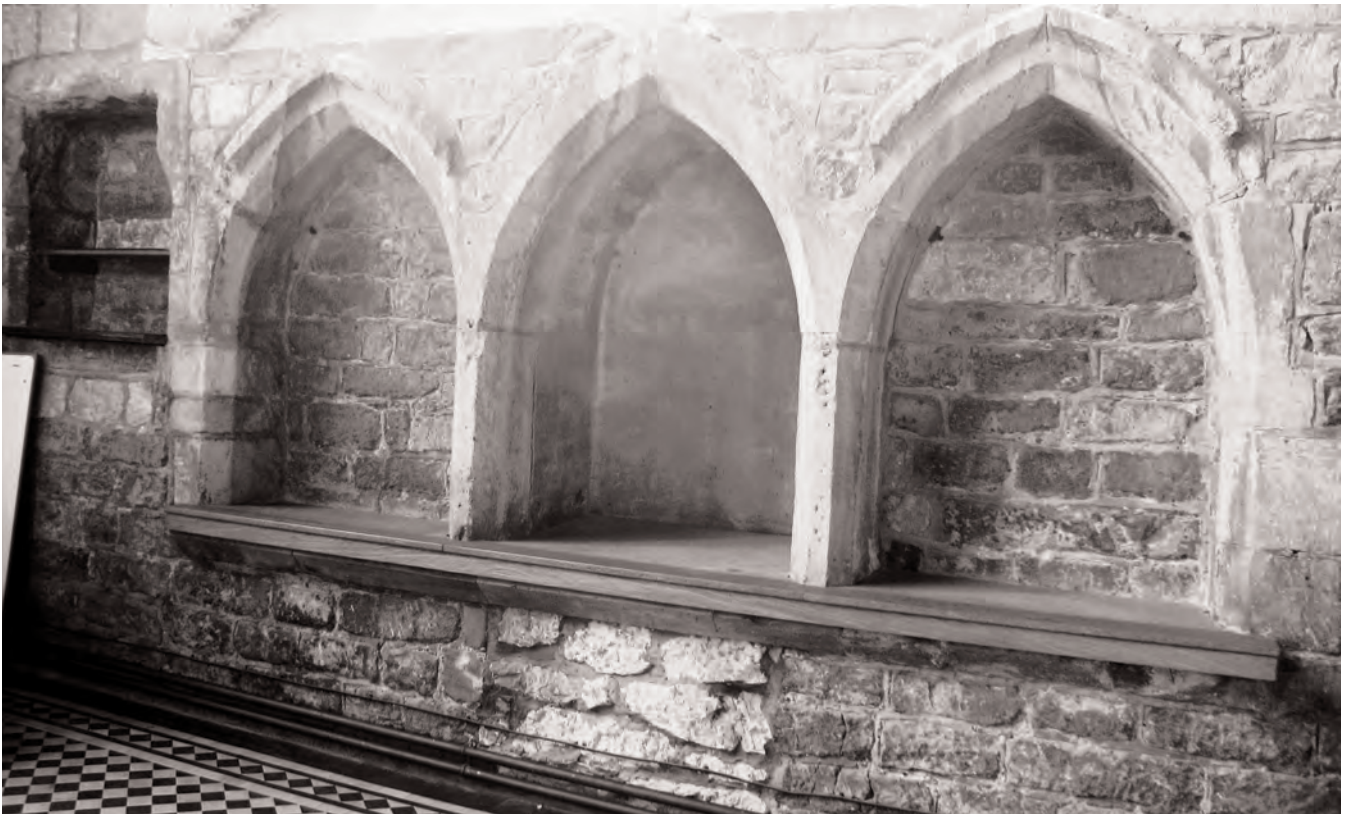
*Fig. 59: St Mary's: south chancel aisle. Piscina and sedilia in south wall, the central seat restored after being converted into a doorway. Photo: Warwick Rodwell*

The writer continued by describing two of the sedilia in the south wall of the chancel aisle (the third had been opened up to form a doorway; Figs. 58 and 59). The piscina with the 'very perfect' drain must be a reference to that in the north aisle, with the 'recess' being the aumbry in the same wall.
