# ST PETER'S

## Barton-upon-Humber, Lincolnshire

*A Parish Church and its Community*

HISTORY, ARCHAEOLOGY AND ARCHITECTURE

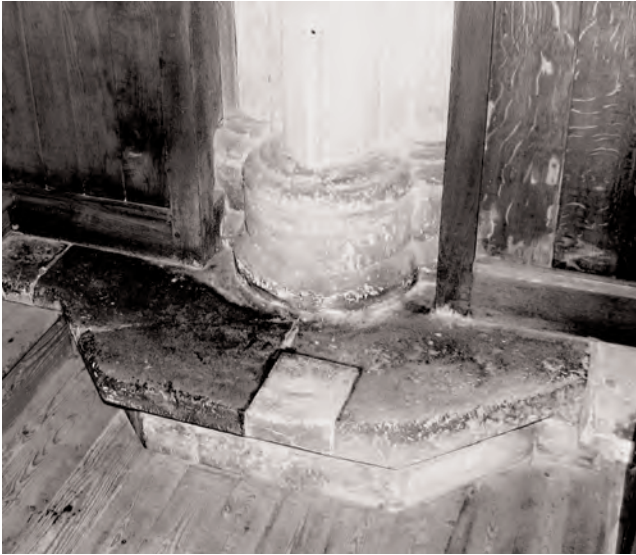
Fig. 63: *St Mary's: chancel arcade. Stone bench angled around the base of the pier between bays 1 and 2, as seen from the aisle. Photo: Warwick Rodwell*

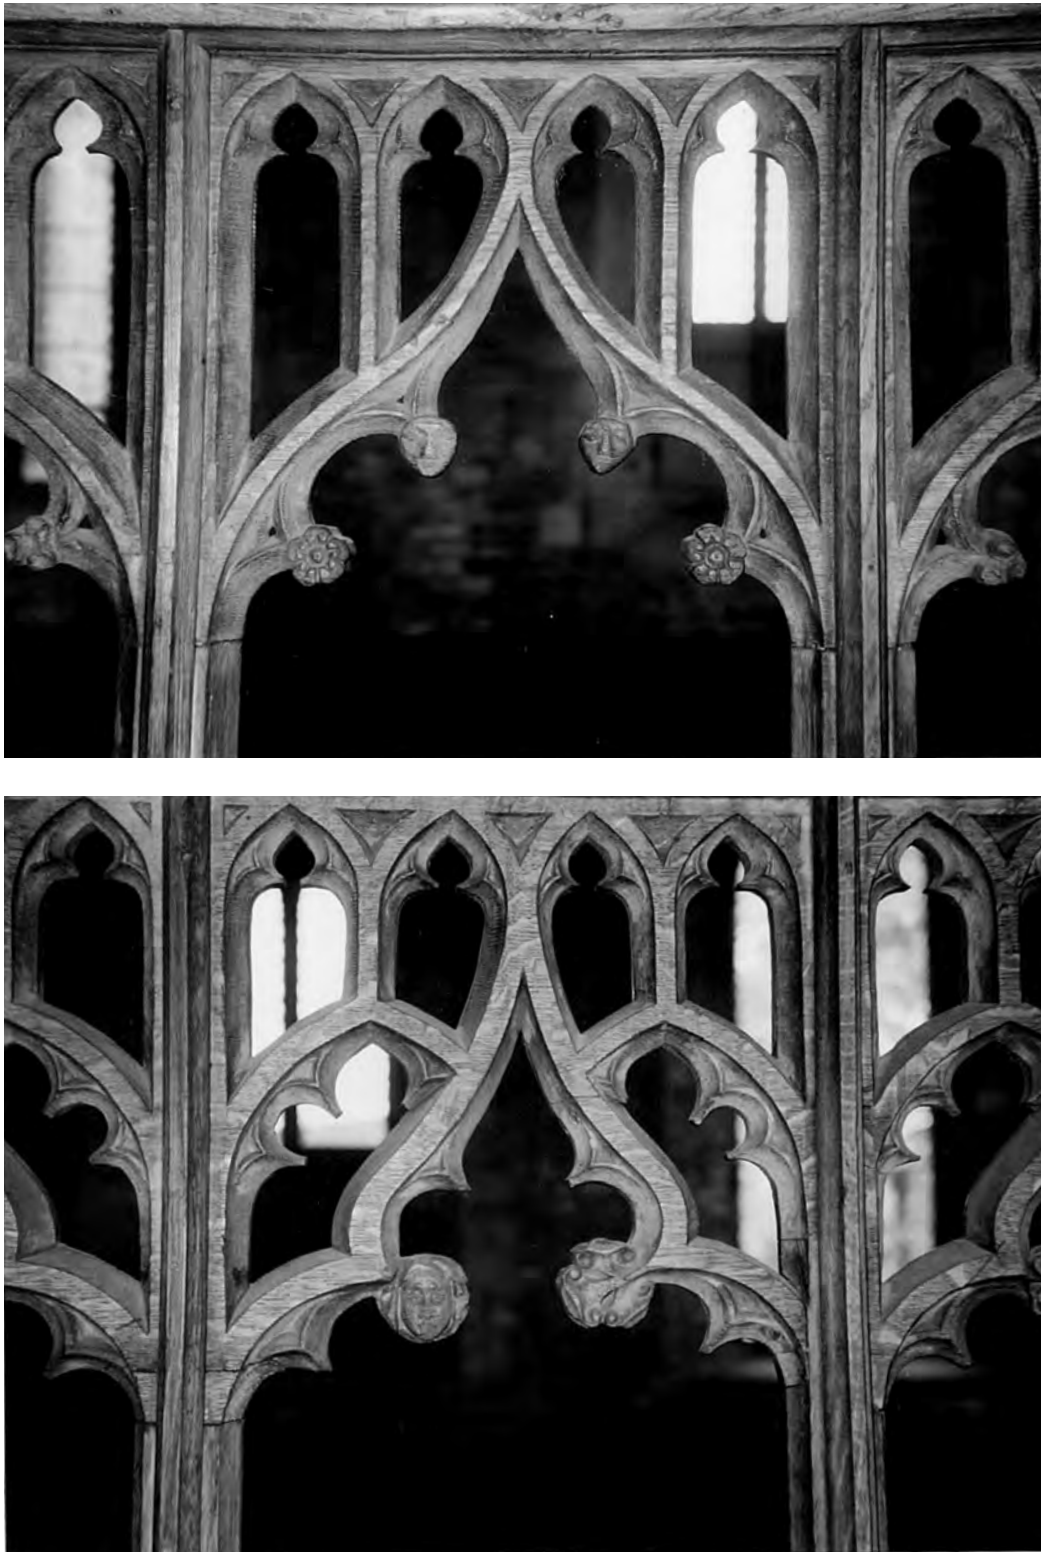
*Fig. 64: St Mary's: chancel arcade. Details of the tracery heads of the timber screens. Upper, bay 1. Lower, bay 2. Photos: Warwick Rodwell*

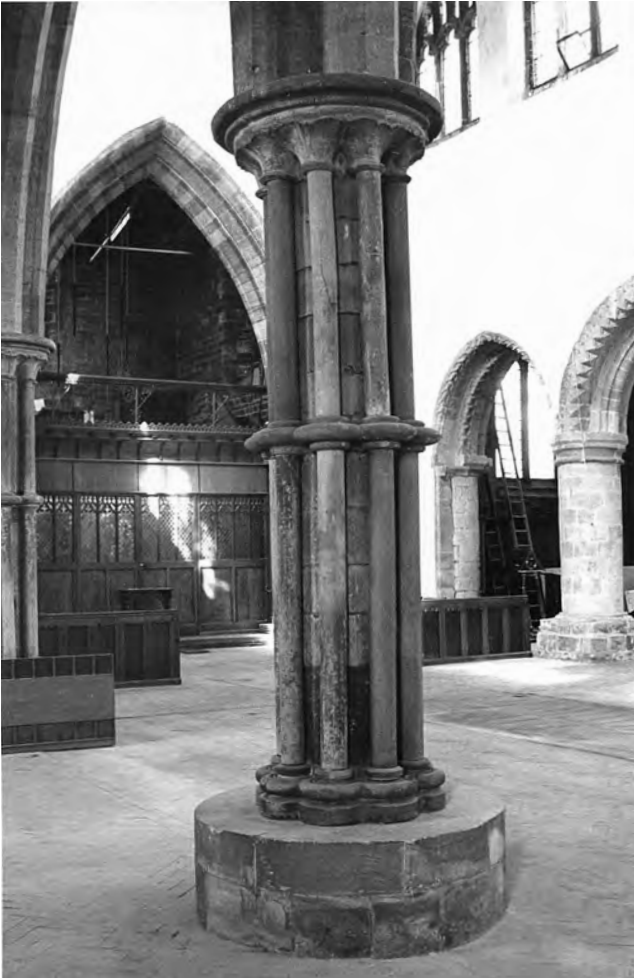
*Fig. 68: St Mary's: south nave arcade, 1984. Clustered pier with basal seat in bay 2/3; view from the south-east. This pier was rebuilt in 1892. Photo: Geoffrey Bryant*

The three piers are all similar, comprising an octagonal core with eight detached circular shafts with rings at mid-height (Fig. 68). The capitals are decorated with waterleaf and the circular, cavetto-moulded abacus

The pier of bay 2/3 was completely dismantled and rebuilt in 1892 (Fig. 71) because it had leaned southwards: the cause of this movement is not recorded, but it was very likely induced by an underlying archaeological feature. Set one above the other (300 mm apart), in the upper section of the north-east shaft of the pier in bay 1/2, is a pair of wrought iron pins with round shanks and large, flat heads; the shanks are horizontal (Fig. 72).<sup>65</sup> The shaft was drilled and the pins set horizontally in lead. The caulking is so neatly executed as to indicate the likelihood that the fixings were inserted before the shaft was mounted in the pier: that being so, the pins must date from the late twelfth century. It has been suggested that these were the fixings for an hour-glass (or sand-glass), a preaching aid which became popular in the reign of Elizabeth I (Moor 1892, 26; Cox 1923, 184–8). The suggestion was doubtless prompted by the fact that 'one sand glass 8d.' is recorded in the accounts for 1662.<sup>66</sup> However, the two substantial and very rigid fixings are not only medieval but also unsuited for such an insubstantial item.

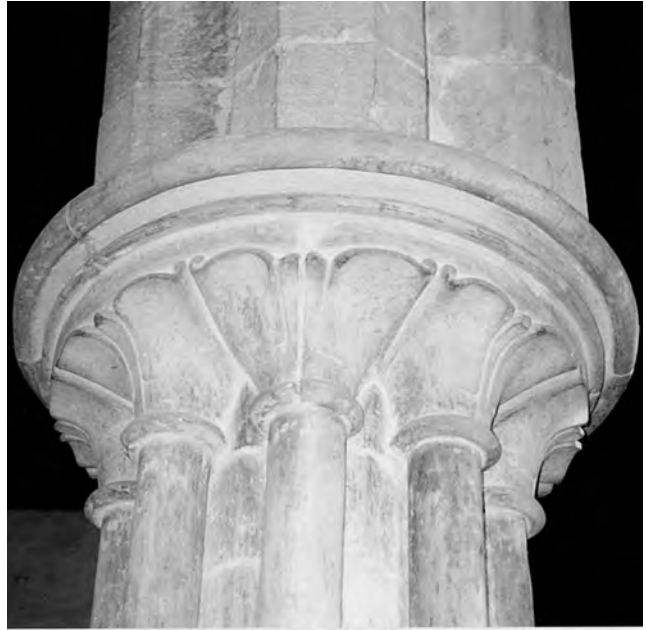
*Fig. 69: St Mary's: south nave arcade. Waterleaf capital on the pier of bay 1/2; view from the east. Photo: Warwick Rodwell*

is separate (Fig. 69); the bases are water-holding with a quirk, and stand on plain circular plinths which served also as seats (Fig. 70). The latter comprise a series of wedge-shaped segments, some of which are chalk. Lead was used for jointing the shafts.<sup>64</sup> and the masonry is a mixture of cream limestone and Lower Magnesian Limestone. A good deal of dark red paint

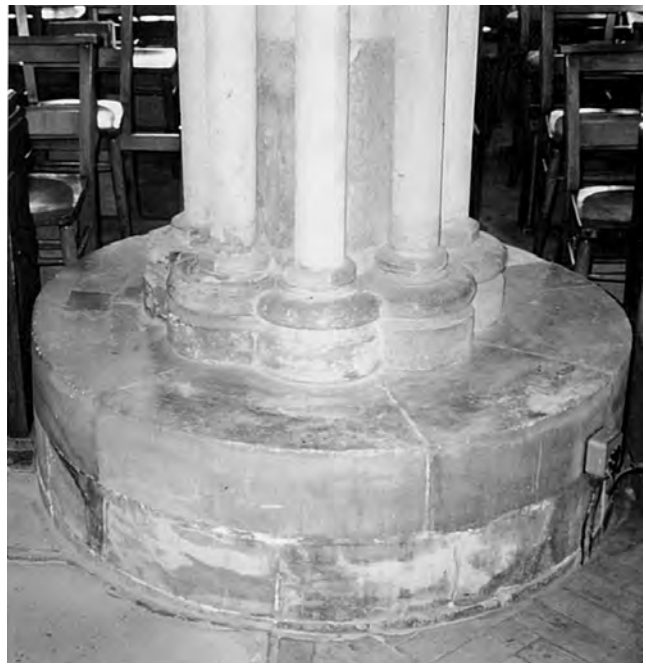
*Fig. 70: St Mary's: south nave arcade. Base of the pier in bay 1/2, with circular bench around; view from the east. Photo: Warwick Rodwell*

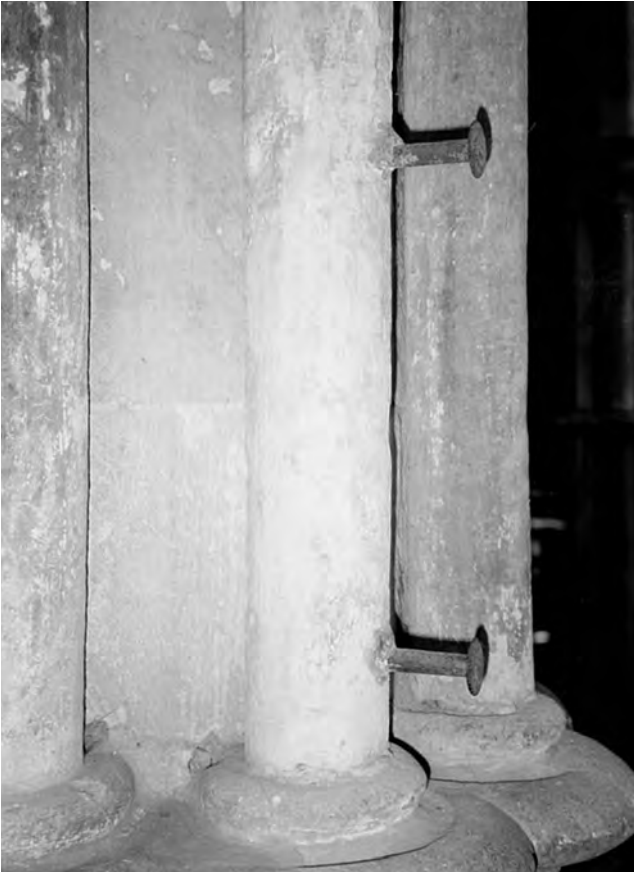
*Fig. 72: St Mary's: south nave arcade. Two iron pins set in lead in one of the shafts of the pier between bays 1 and 2. The pins were probably for securing the rope that operated the medieval rood veil. Photo: Warwick Rodwell*

These large-headed pins are more appropriate for hitching the ropes that operated the pulleys for raising and lowering a cloth veil, and as such they constitute a rare and interesting survival (Bond 1916, 101–5). There are two possibilities to consider here. First, this could have been the medieval Lenten veil, which would have hung in front of the principal altar during Lent. If so, this would be important evidence for demonstrating that the body of the church was single-celled in the

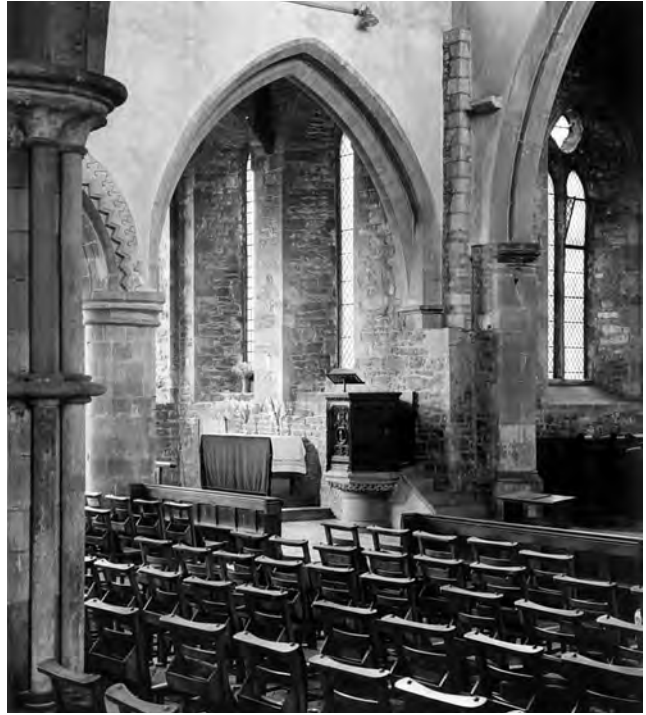
*Fig. 73: St Mary's: nave. View north-east across the nave, showing bay 1 of the north arcade, and the chapel beyond, c. 1965. Photo: David Lee Photography*

This has generated a great deal of antiquarian interest on account of the irregularities in its construction.<sup>67</sup> It comprises six unequal bays, and a short nib at the west end. Bay 1 is the widest and highest, with an early thirteenth-century two-centred and stilted arch of two chamfered orders and no label-moulding. There is no respond on the east, and the arch simply springs from a short length of string-course (not original) set into the rubble masonry of the north aisle wall (Fig. 73).

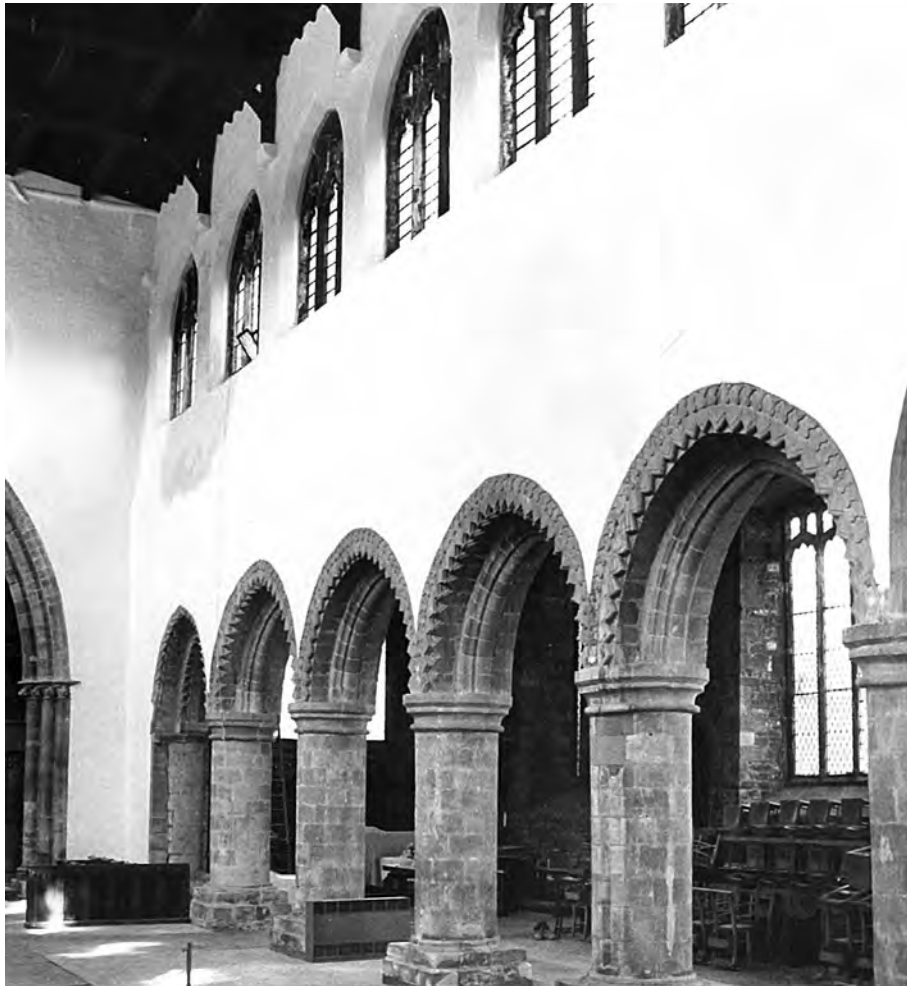
Fig. 74: St Mary's: north arcade and clerestory. View north-west, 1984. Photo: Geoffrey Bryant

The nave is tall and crowned by an elegant clerestory of eight bays; this was a late addition and its north and south walls are slightly thinner than those of the arcades below (Figs. 38, 52 and 74; Pl. 14). Consequently, there is a clearly evidenced 'shoulder' in the wallplaster just above the top of the south arcade, and at a similar level on the north (where the arcade is not as tall). A good deal of medieval wallplaster survives above the arches on all four sides of the nave, and when contractors scrubbed the walls prior to redecoration in 1984, extensive traces of polychromy were observed.<sup>61</sup> Nothing is now visible.

The arcade is carried on five circular piers, with a corresponding half-pier forming the respond at the west end: this is all late Romanesque work (Fig. 74). The shafts are made of medium-sized ashlar of several different stone types, and much dark red paint survives on them, which is almost certainly medieval.<sup>68</sup> The capitals have hollow mouldings and separate basally chamfered abaci (Fig. 75; *cf.* the north arcade in St Peter's). Both the capitals and the abaci are constructed segmentally. The moulded bases are square and mounted on chamfered plinths of various heights: bay 1/2 stands the highest. Each base is composed of about six separate blocks, mostly limestone. However, pier 5/6 differs from the previous four in several respects: the presence of sandstone in the shaft;<sup>69</sup> the

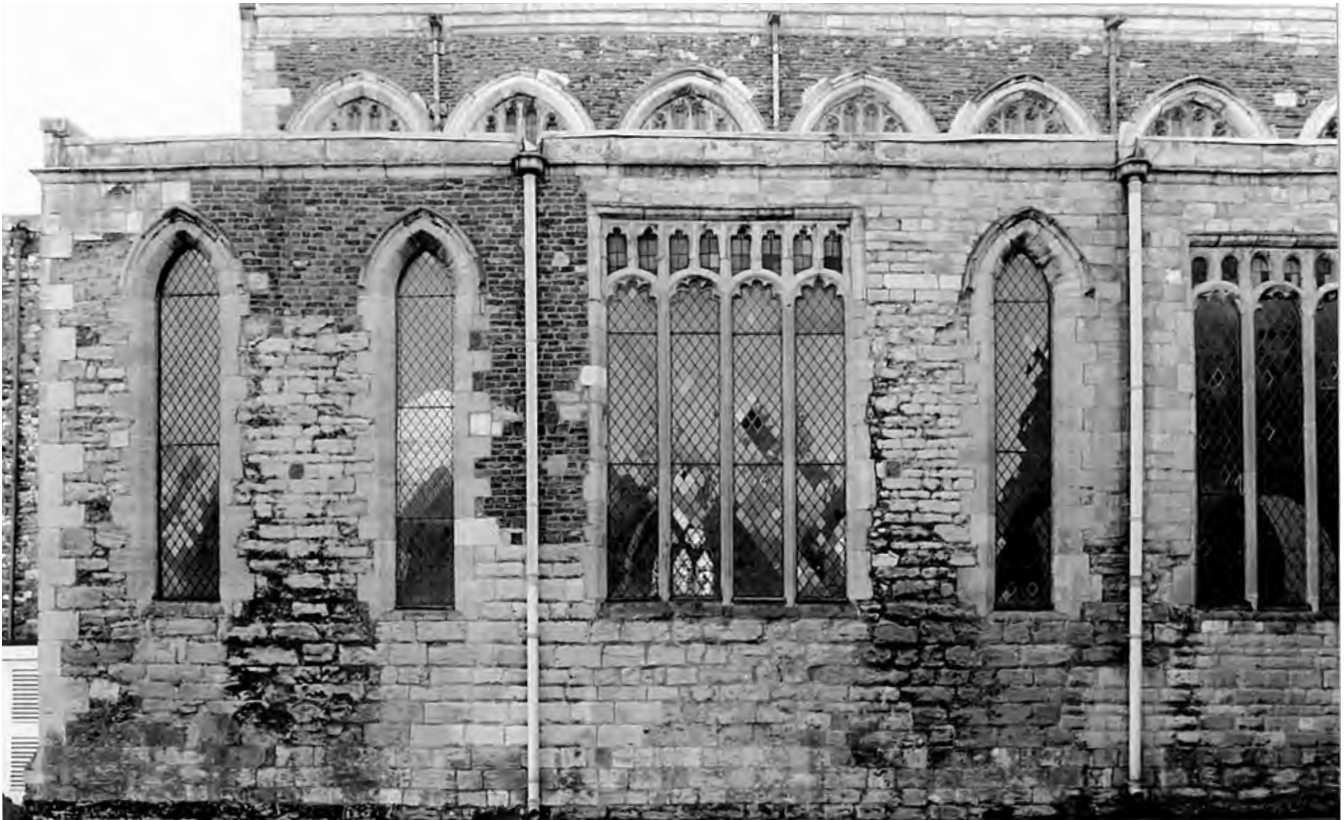
*Fig. 78: St Mary's: north aisle. Exterior, bays 1 to 3. Photo: Warwick Rodwell*

The north wall contains a mixture of windows, three of which are primary (bays 1, 3 and 6), and it is likely that two more have been destroyed by later openings (bays 2 and 4) (Fig. 78). These are plain, tall lancets with hood-mouldings and externally chamfered apertures. Internally, the heads are shouldered, matching the windows in the east wall. Another tall lancet was

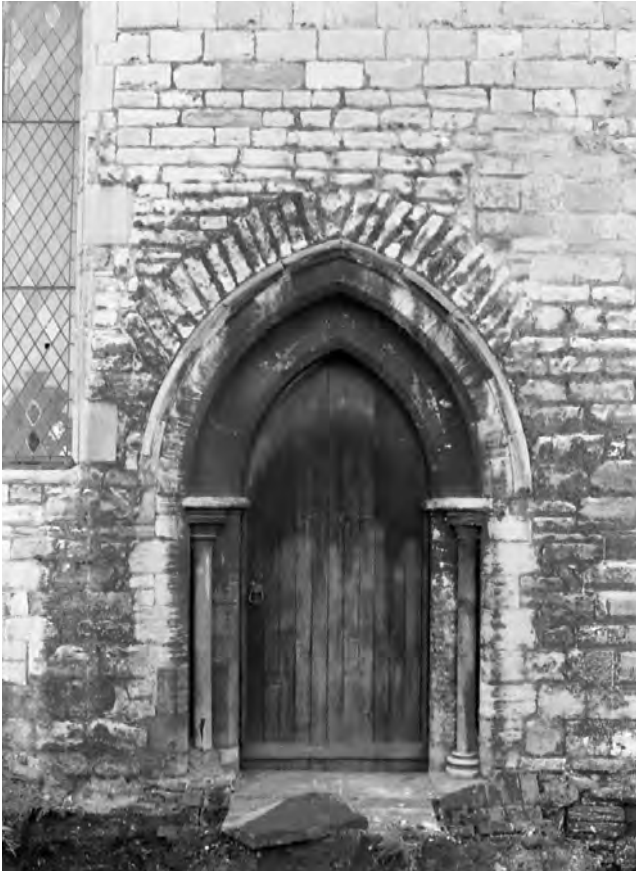
*Fig. 81: St Mary's: north doorway, 1980. Photo: Warwick Rodwell*

The north doorway (bay 5) has a rather plain, two-centred head of two modestly chamfered orders and a hood-moulding (Fig. 81). The arch has an outer ring of roughly cut voussoirs. The opening is flanked by detached shafts (secured with lead dowels), with plain bell capitals and renewed bases; the abaci are separate from the capitals and do not support anything. This odd arrangement gives the impression that there ought to be a moulding between the two chamfered orders, but there clearly never was one. Although original, the shafted reveals were not designed to carry such a basic arch. The rear-arch is unmoulded, has a pointed head and the splays are ashlar-dressed; there is an outer ring of roughly cut voussoirs; infilled draw-bar sockets are visible in the reveals. The doorway was blocked and obscured by pews until 1891.

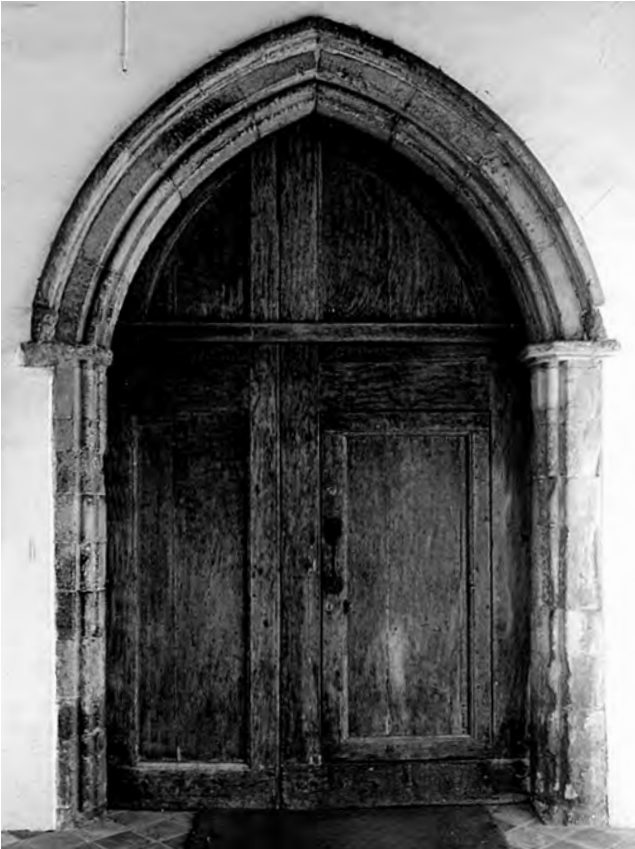
*Fig. 83: St Mary's: south doorway. Photo: Warwick Rodwell*

The doorway is in bay 4 and is remarkably plain: it has a two-centred arch and moulded jambs of the same profile (Fig. 83). The moulding comprises a roll with a deep hollow to either flank. The imposts are unusually thin and flat, and are also moulded;<sup>76</sup> there are no capitals or bases (Fig. 84). The hood-moulding does not have complementary stops, but two pieces of stone have been roughly built-in at the ends: that on the east is a shapeless lump of limestone which does not appear ever to have been carved. In contrast, on the west, a reused head has been incorporated: it has an elongated face with a flattened nose, almond-shaped eyes, a high

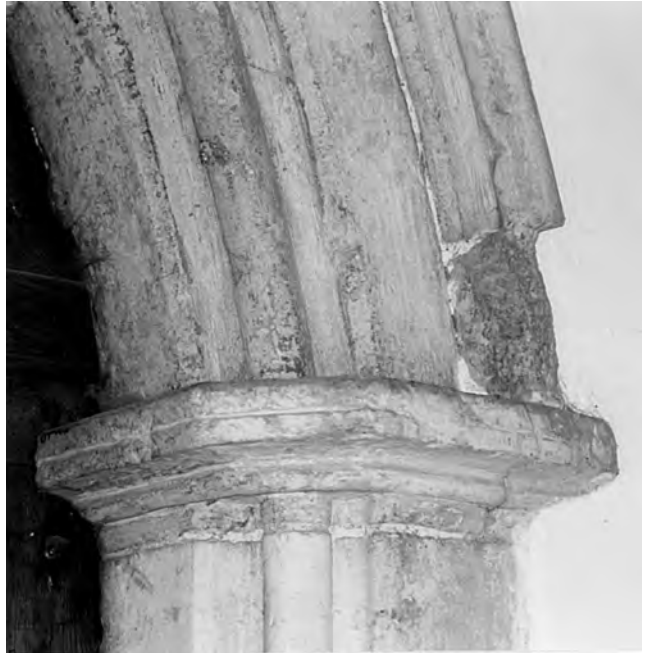
*Fig. 84: St Mary's: eastern impost of the south doorway. A shapeless piece of stone occupies the place of the missing label-stop. Photo: Warwick Rodwell*

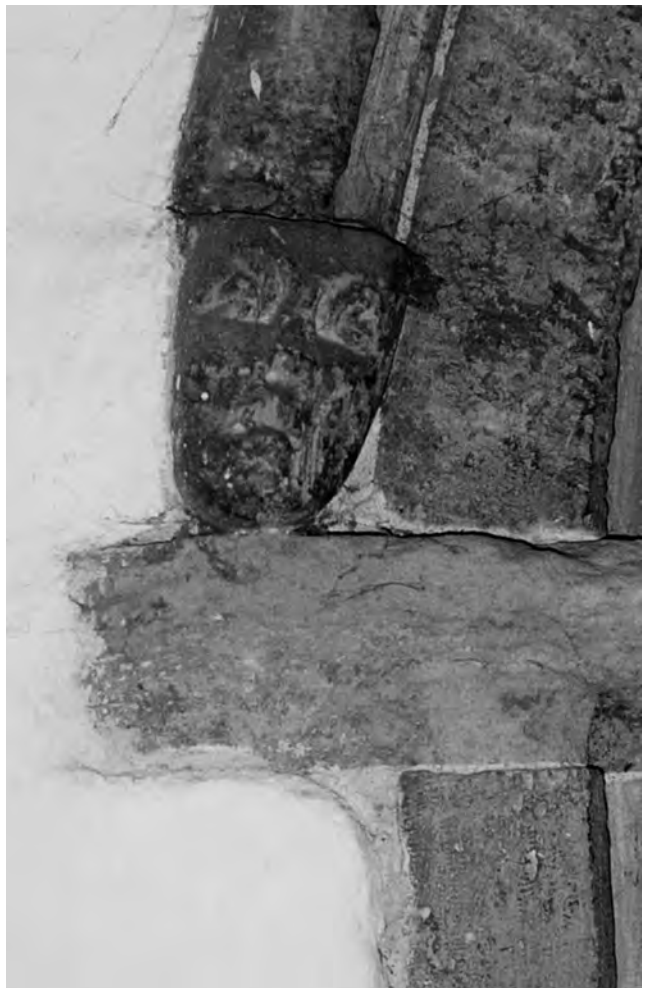
*Fig. 85: St Mary's: decayed western impost of the south doorway, with a reused Romanesque head as the label-stop (sculpture no. 18). Photo: Warwick Rodwell*

brow and a small mouth (sculpture no. 18; Fig. 85). The face is clean-shaven and has no hair descending on to the forehead. The head is Romanesque in style and has clearly been broken from a sculpture, perhaps another label moulding or a small corbel: it has merely been set here in a bed of mortar.

18. Male head reused as west label-stop (Fig. 85).

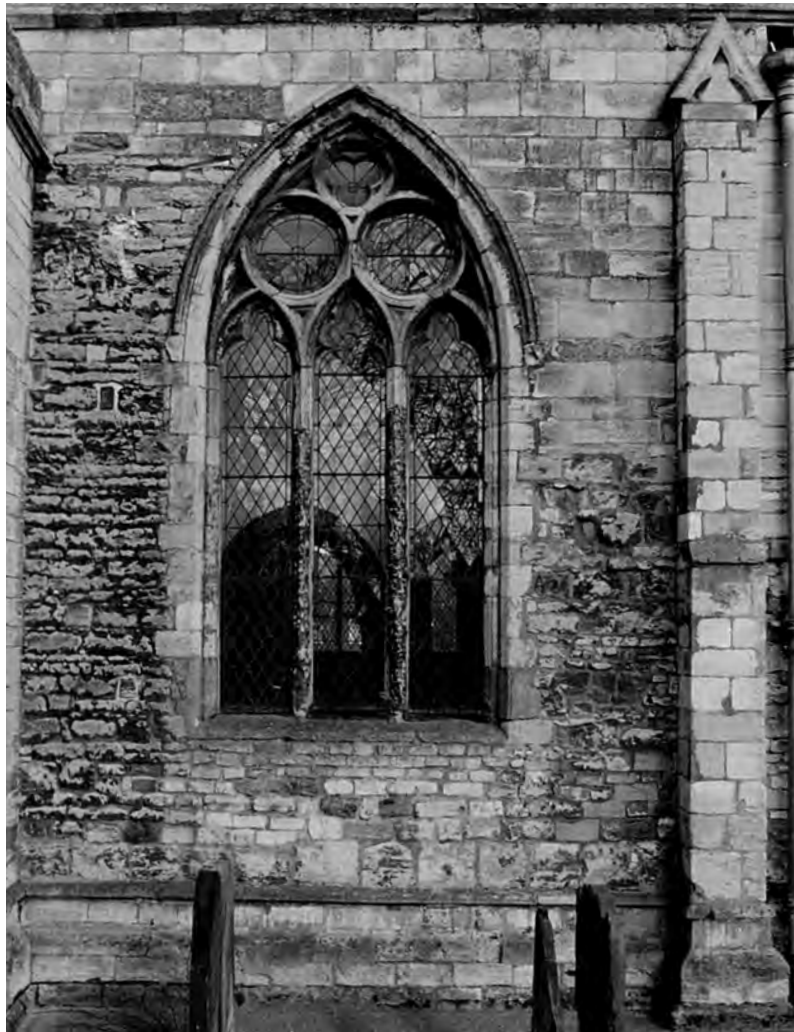
*Fig. 86: St Mary's: south nave aisle. Unrestored window in bay 3. Photo: Warwick Rodwell*

The windows in bays 1–3, and in the west wall, are each of three lights under a pointed head (Fig. 86). The rear-arches of these windows are dressed with limestone ashlar and have chamfered arrises; the splays are of rubble. The central light in each is cinquefoiled, the others trefoiled. The tracery lights comprise three

circles: a small one at the top containing a trefoil, and two larger ones which are uncusped, except in the case of bay 2. There, the larger circles are cinquefoiled, although the originality of this detail is dubious.<sup>77</sup> Similar windows with uncusped circles in the traceries are found in other Lincolnshire churches (*e.g.* Sutterton, south transept; see also the transept at Castor, Cambs). The south wall of the chancel at Barrow had a two-light version of the Barton windows, with a small trefoiled circle in the apex; it is evidently from the same workshop (Fig. 87). At Winterton there is another two-light example which is entirely devoid of cusping (Fig. 88). The tracery design at St Mary's is remarkably close to that on the back of the Coronation Chair at Westminster Abbey, commissioned by Edward I in 1297 (RCHME 1924, pl. 23).

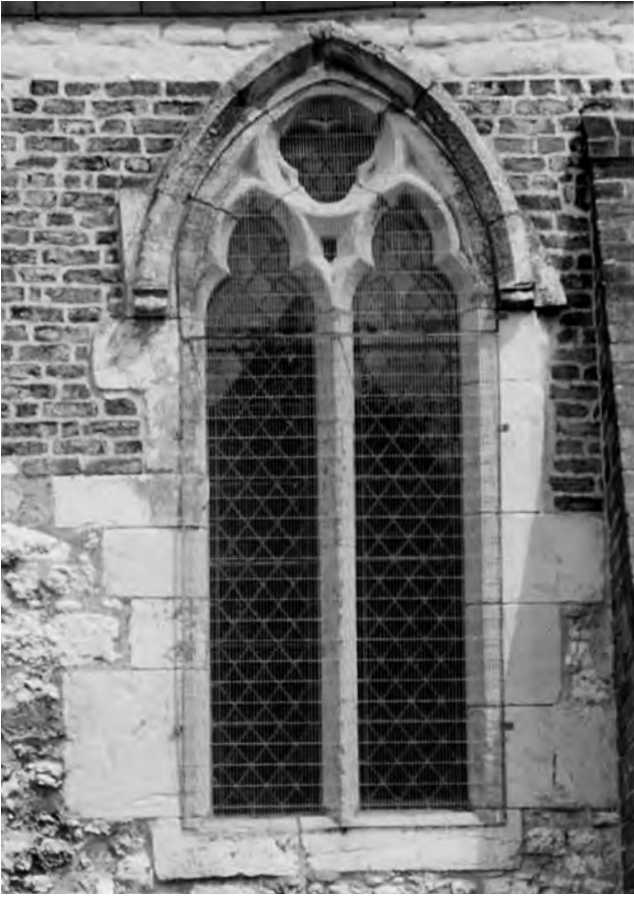
*Fig. 87: Holy Trinity, Barrow-upon-Humber (Lincs.): south wall of chancel. A two-light version of the window seen in Fig. 86. Photo: Warwick Rodwell*

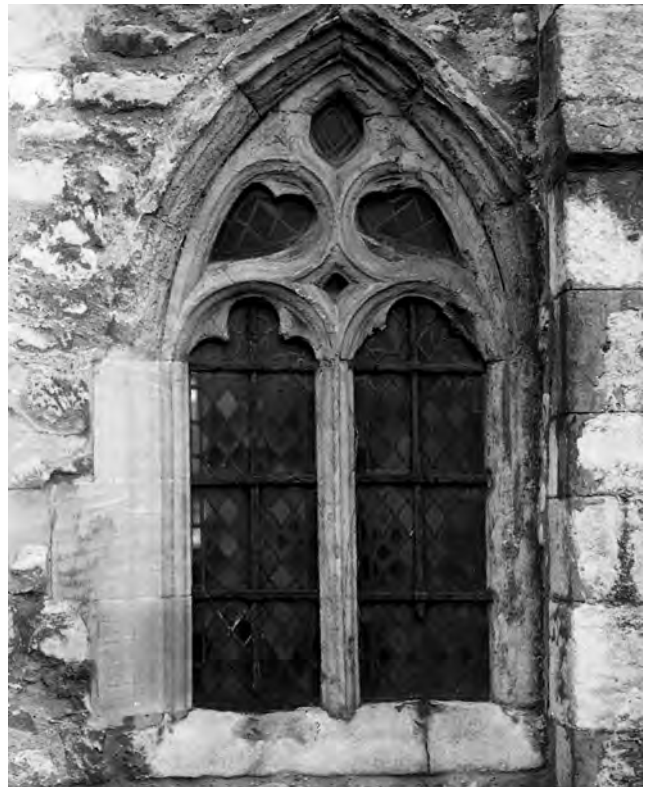
*Fig. 89: St Mary's: south nave aisle. 'Low-side window' in bay 1. Photo: Warwick Rodwell*

At the east end of the wall, a small two-light window with a pointed head and curvilinear tracery was inserted in the early fourteenth century (Figs. 49, 14, 82 and 89). The traceried head appears to be cut from a single block of stone, the rear-arch is crudely chamfered and the soffit is formed in brick.

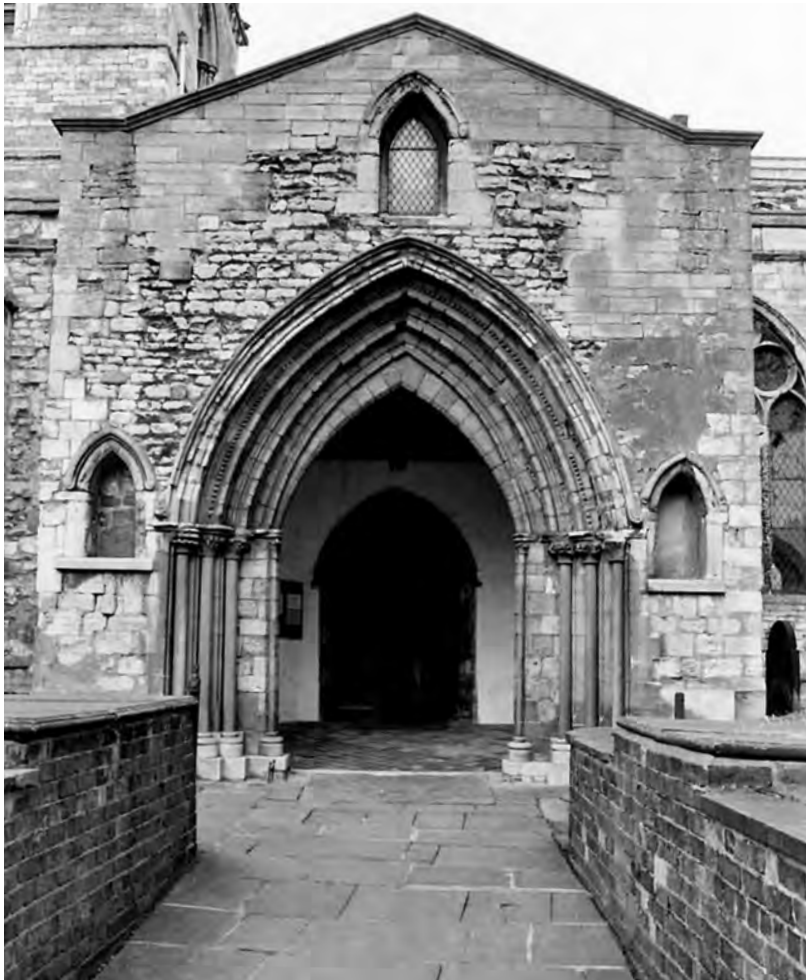
*Fig. 91: St Mary's: south porch and entrance from Burgate. The brick walls form a revetment to the elevated churchyard. Photo: Warwick Rodwell*

Externally, to either side of the opening is a flat-backed niche with a lancet head and hood-moulding, all made from small blocks of stone; the sills are modern slabs (Figs. 91 and 93). These niches are of uncertain age and even function: they could have been fabricated from the heads of small lancet windows taken from the earlier aisle. A third, generally similar, feature in the wall above the entrance is now a window, lighting the upper chamber, but it too was potentially once a niche.<sup>82</sup> The remains of one label-stop survive. If these were niches, they presumably all once held

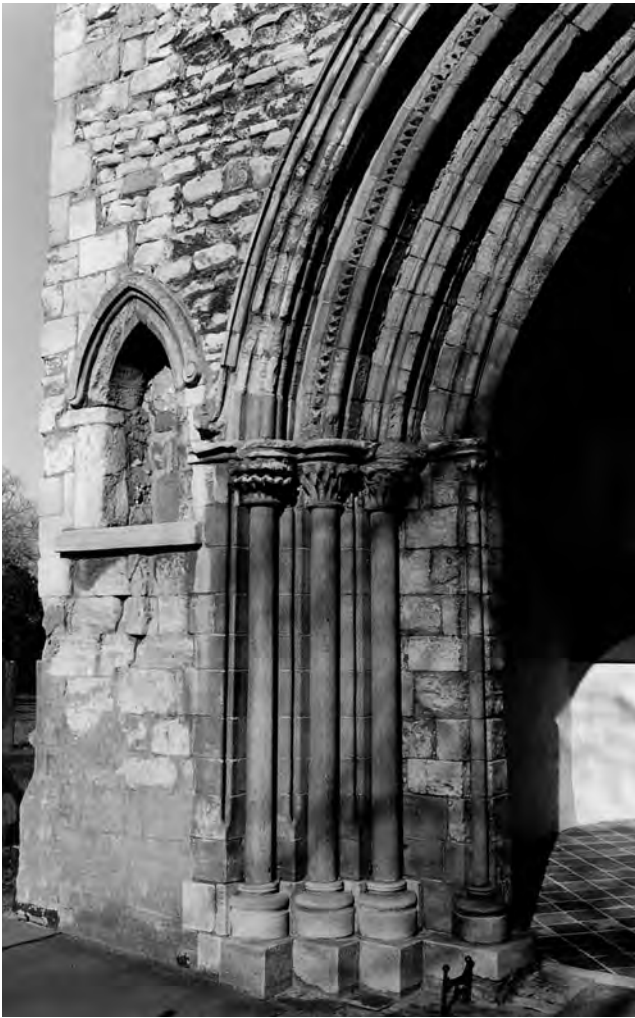
*Fig. 93: St Mary's: south porch. West respond of outer entrance, with adjacent niche. Photo: Warwick Rodwell*

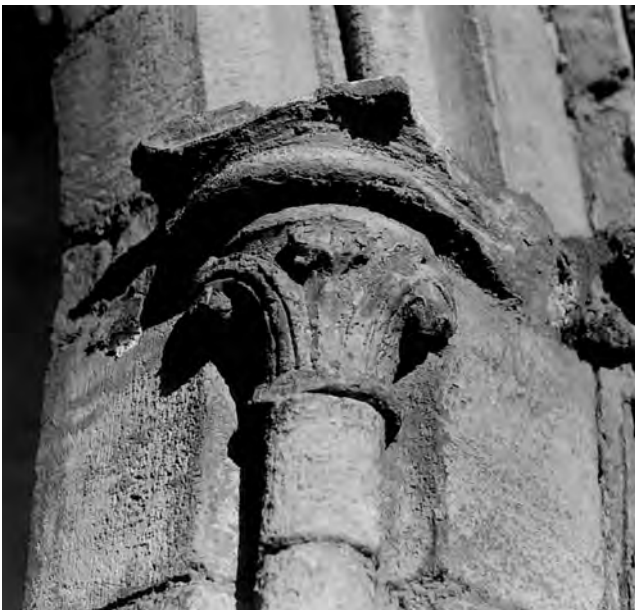
*Fig. 94: St Mary's: south porch. Decayed stiff-leaf capital and abacus on the east respond of the innermost order of the arch. Photo: Warwick Rodwell*

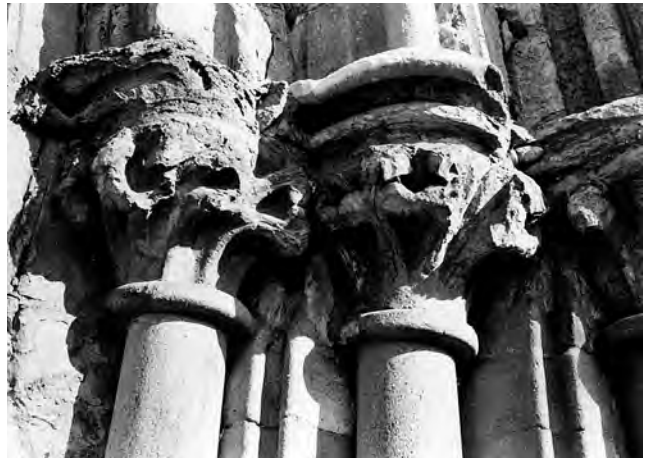
*Fig. 95: St Mary's: south porch. Decayed stiff-leaf capitals and abaci on the outer order of the east respond of the arch. Photo: Warwick Rodwell*

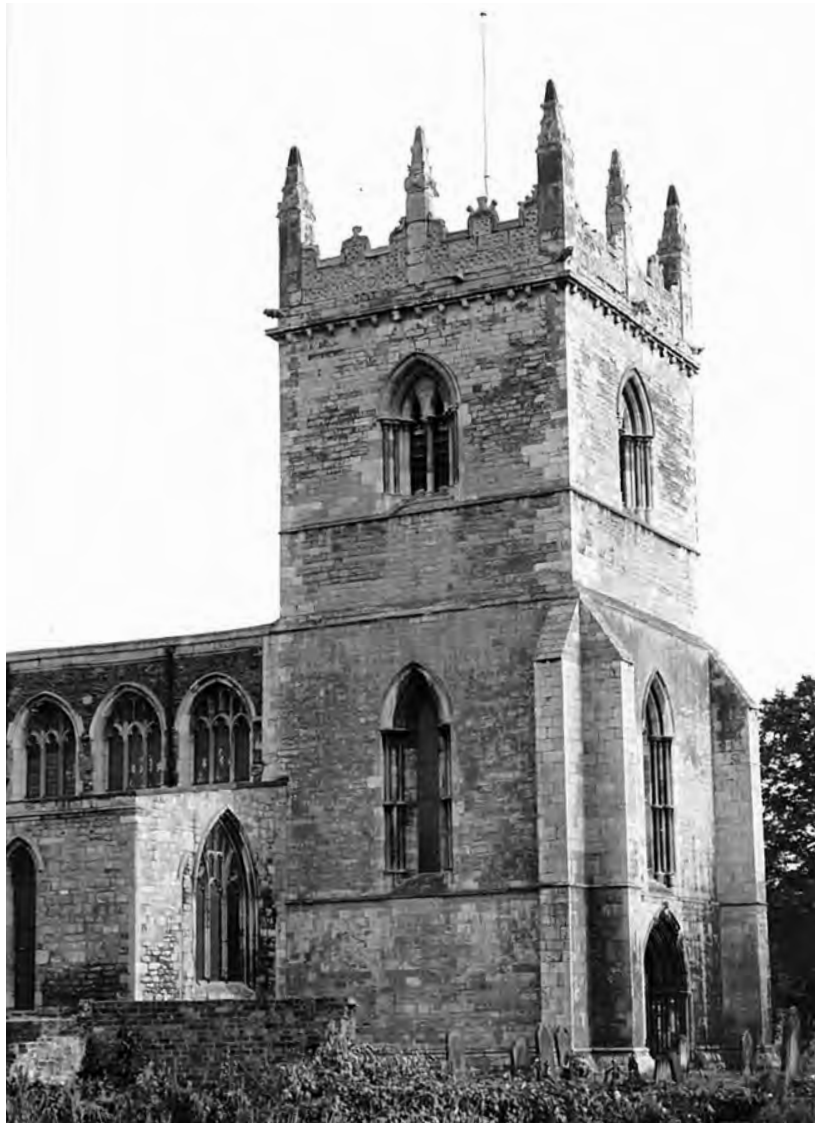
*Fig. 97: St Mary's: the tower from the north-west in the 1960s, before the church hall was erected. In the foreground is the site of the Chantry House, now built upon. Photo: David Lee Photography*

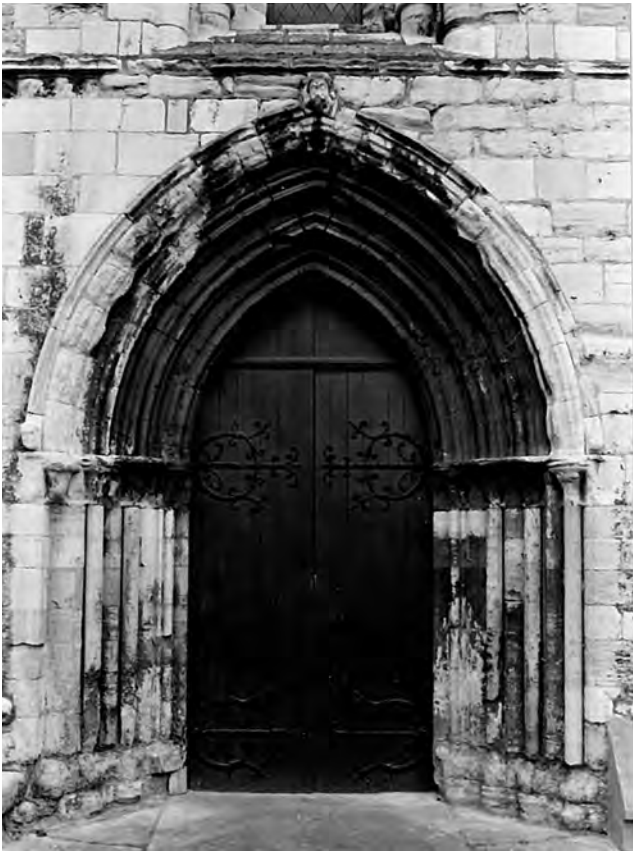
*Fig. 98: St Mary's: tower, west doorway. Note the small head-sculpture incorporated in the apex of the arch (sculpture no. 19). Photo: Warwick Rodwell*

The ground stage stands on a substantial moulded plinth and has clasping buttresses on the western angles (Fig. 41); they have no set-backs. In the west face is a fine doorway with a well-moulded arch of four orders with fillets (Fig. 98). The responds have four linked stiff-leaf capitals: the innermost order comprises an attached triplet roll, which is flanked by three detached shafts and capitals, all now heavily eroded. The abaci are integral with the capitals, and the entire set on each side appears to be carved on a single block; the shafts are secured with poured lead. All detail to the bases of the responds has been lost. The hood-moulding terminates with a pair of head-stops, now weathered beyond recognition, and also has a third original head fitted at the apex of the arch; this is male, boldly projecting, and integral with the moulding (sculpture no. 19). The arch and capitals are of yellow Magnesian Limestone, while the hood-moulding, reveals and bases are in white limestone. Internally, the doorway has plain, squarely-cut reveals and an unmoulded, pointed arch composed of two rings of ashlar voussoirs; there is a draw-bar socket.

19. Male head set centrally in the external hood-moulding (Fig. 98).

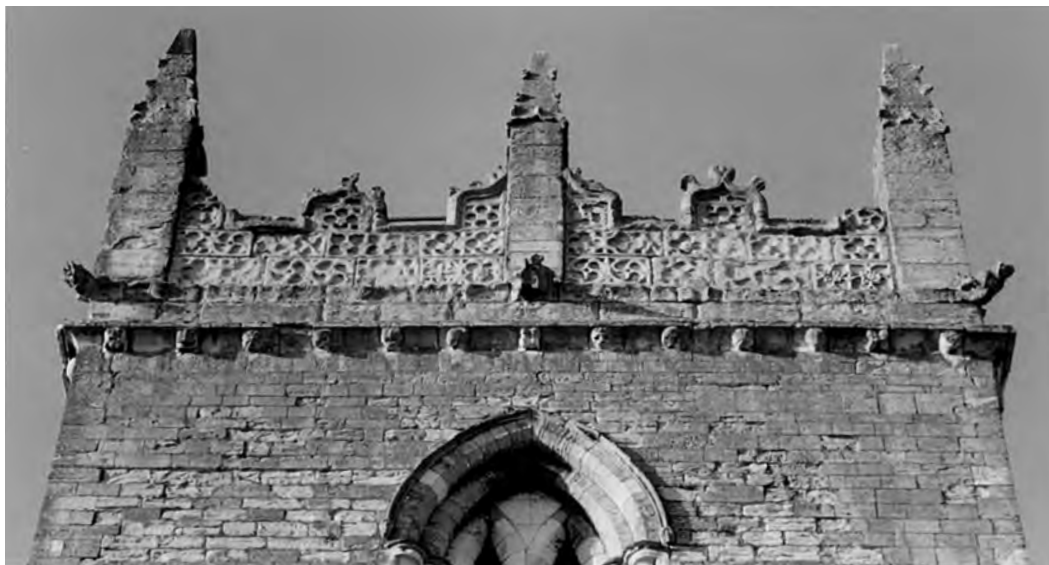
*Fig. 100: St Mary's: tower. Corbel-table and decorated parapet on the south side. Photo: Warwick Rodwell*

The upper stage is crowned by a corbel-table with thirteen heads on each face of the tower. The original roof – which almost certainly took the form of a timber and lead spire – would have rested directly on the eaves-course, without a parapet (Fig. 100). Internally,

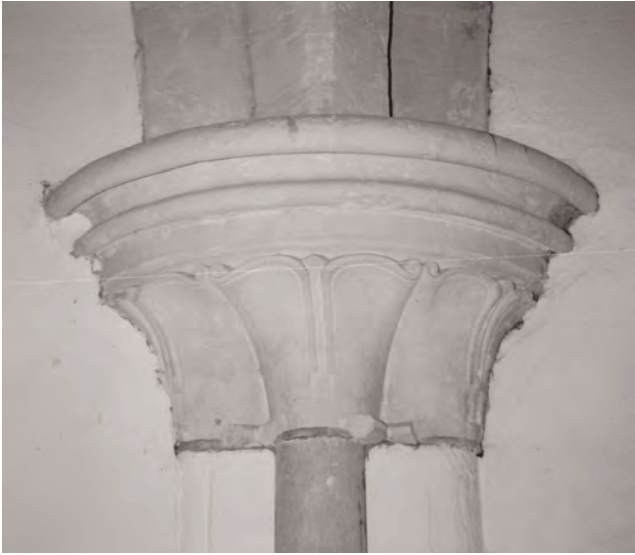
*Fig. 103: SS Peter and Paul, Reepham (Lincs.): south arcade (blocked). Waterleaf capital and octagonal clustered shaft. Photo: Warwick Rodwell*

A close analogue for the St Mary's waterleaf occurs on one of the capitals of the blocked south arcade at Reepham, which is only 5 km east of Lincoln (Fig. 103). The work is of similarly high quality, but there the octagonal piers have attached shafts. The capitals at Barton could be by the same sculptor, but the pier design represents a further stage in the development. However, there are other Transitional churches in the vicinity of Lincoln which have detached shafts around an angular core, such as Waddington (Sharpe 1871, pl. 23). Bryant has therefore questioned the design source for the St Mary's arcade and, by implication, the primacy of Lincoln in the development of the multi-shafted pier.<sup>101</sup> Also at Reepham is a related springer-corbelt with lotus leaves (Fig. 104).

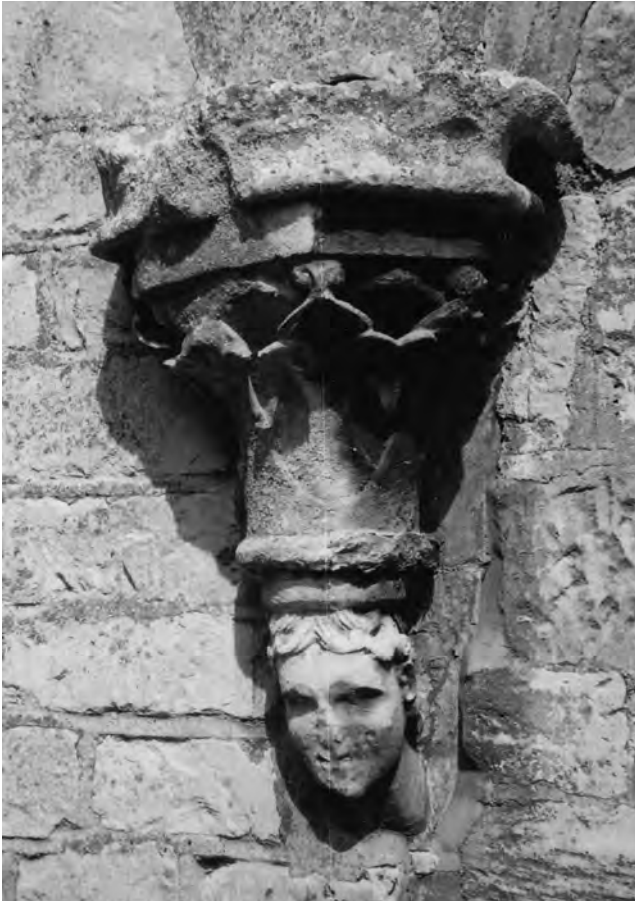
*Fig. 104: SS Peter and Paul, Reepham (Lincs.): south arcade. Springer corbel with lotus leaves and separate abacus. Now external (aisle demolished). Photo: Warwick Rodwell*

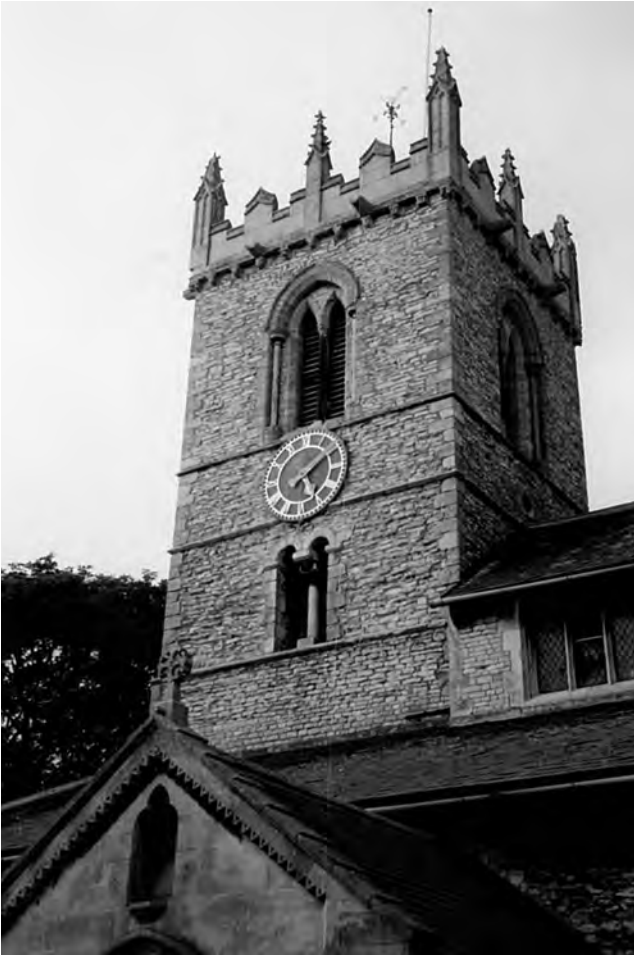
Fig. 106: *All Saints, Winterton (Lincs.): west tower. Upper stages, from the south-east. Photo: Warwick Rodwell*

at Thornton Curtis, which may be the work of the same masons (Fig. 105). Thornton has two-light belfry openings, separated by octagonal shafts, and flanked by circular shafts with plain capitals and shaft-rings; the tower is topped by a corbel-table (as is the chancel too). There is no west door, but the lancet window with its flanking shafts is a reduced version of those in the ground stage at Barton. The added upper belfry on the tower at Winterton is another product of the same workshop (Fig. 106).

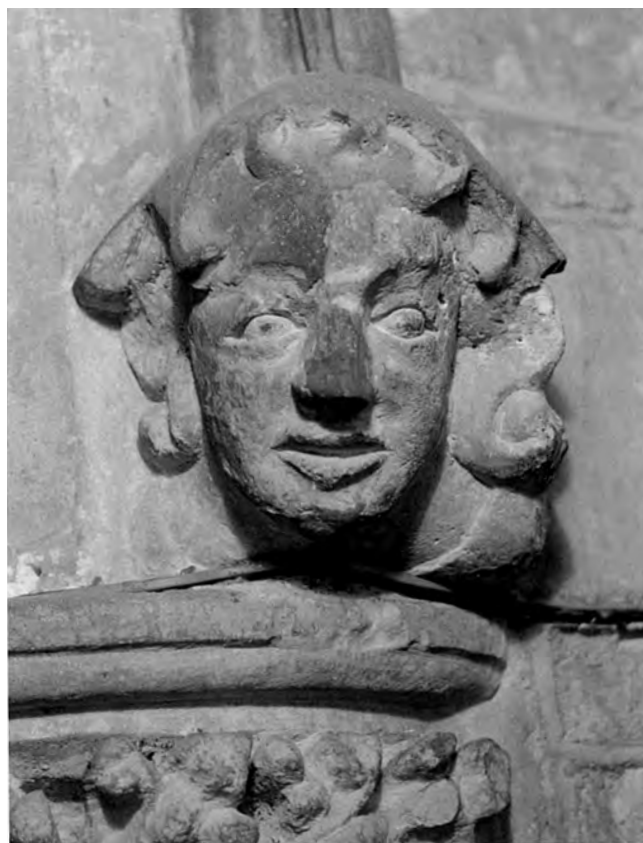
*Fig. 109: St Mary's: chancel arcade. Label-stop no. 1. Photo: Warwick Rodwell*

1. Young man with long curly hair and no beard. Angled into the chancel (Fig. 109). Head and brow much repaired with Roman cement.
2. Bearded man (Fig. 110).
3. Bearded man (Fig. 111).
4. Young man with a beard and long, curly hair. The beard has suffered damage (Fig. 112).

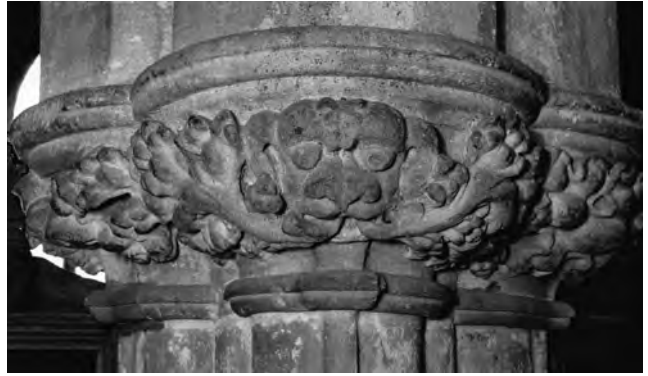
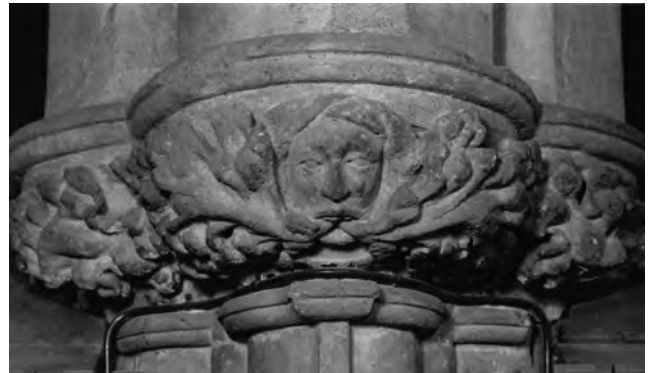
*Fig. 120: St Mary's: chancel arcade. Capital bay 1/2 (sculpture no. 15). Upper, north face. Lower, south face. Photos: Warwick Rodwell*

14. West respond. Knobbly foliage (Fig. 119).
15. Capital to pier, bay 1/2. Knobbly foliage and four human/grotesque heads (Fig. 120).
16. Capital to pier, bay 2/3. Knobbly foliage and two human/grotesque heads (Fig. 121).
17. East respond. Knobbly foliage (Fig. 122).

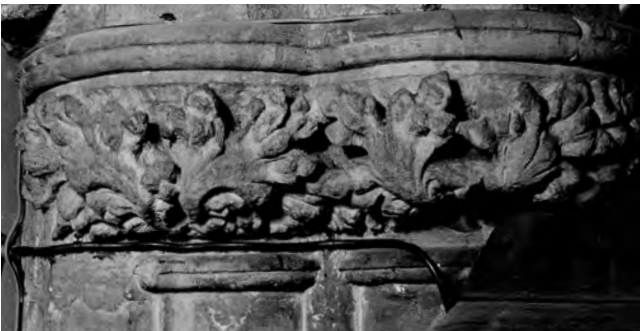
*Fig. 119: St Mary's: chancel arcade. West respond (sculpture no. 14). Upper, south-east view. Lower, north-east view. Photos: Warwick Rodwell*

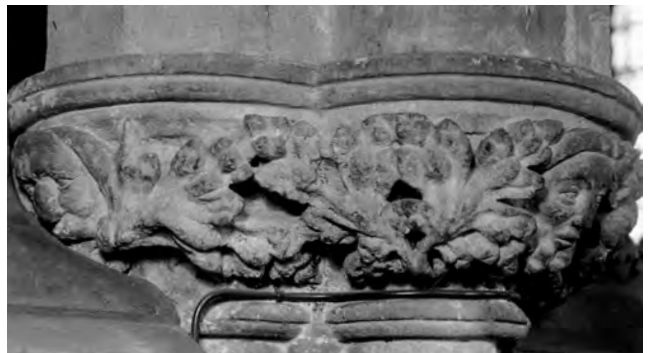
*Fig. 121: St Mary's: chancel arcade. Capital bay 2/3 (sculpture no. 16). Upper, south-west view. Lower, south face. Photos: Warwick Rodwell*

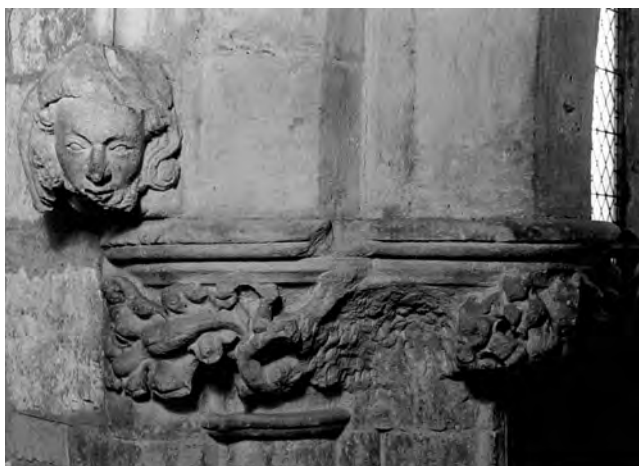
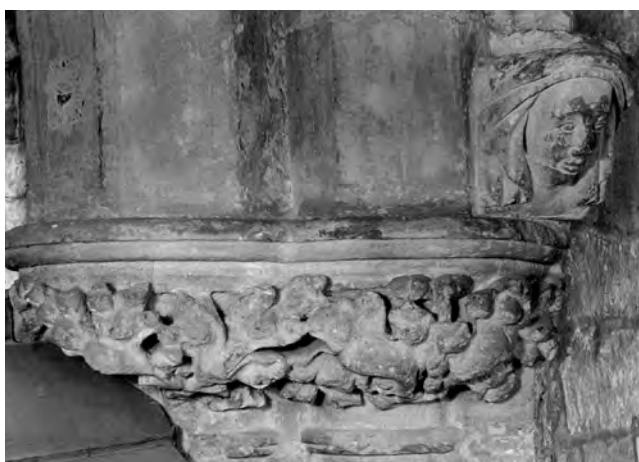
Fig. 122: *St Mary's: chancel arcade. East respond (sculpture no. 17; label-stops nos. 4 and 5). Upper, north-west view. Lower, south-west view. Photos: Warwick Rodwell*
