# ST PETER'S

## Barton-upon-Humber, Lincolnshire

*A Parish Church and its Community*

HISTORY, ARCHAEOLOGY AND ARCHITECTURE

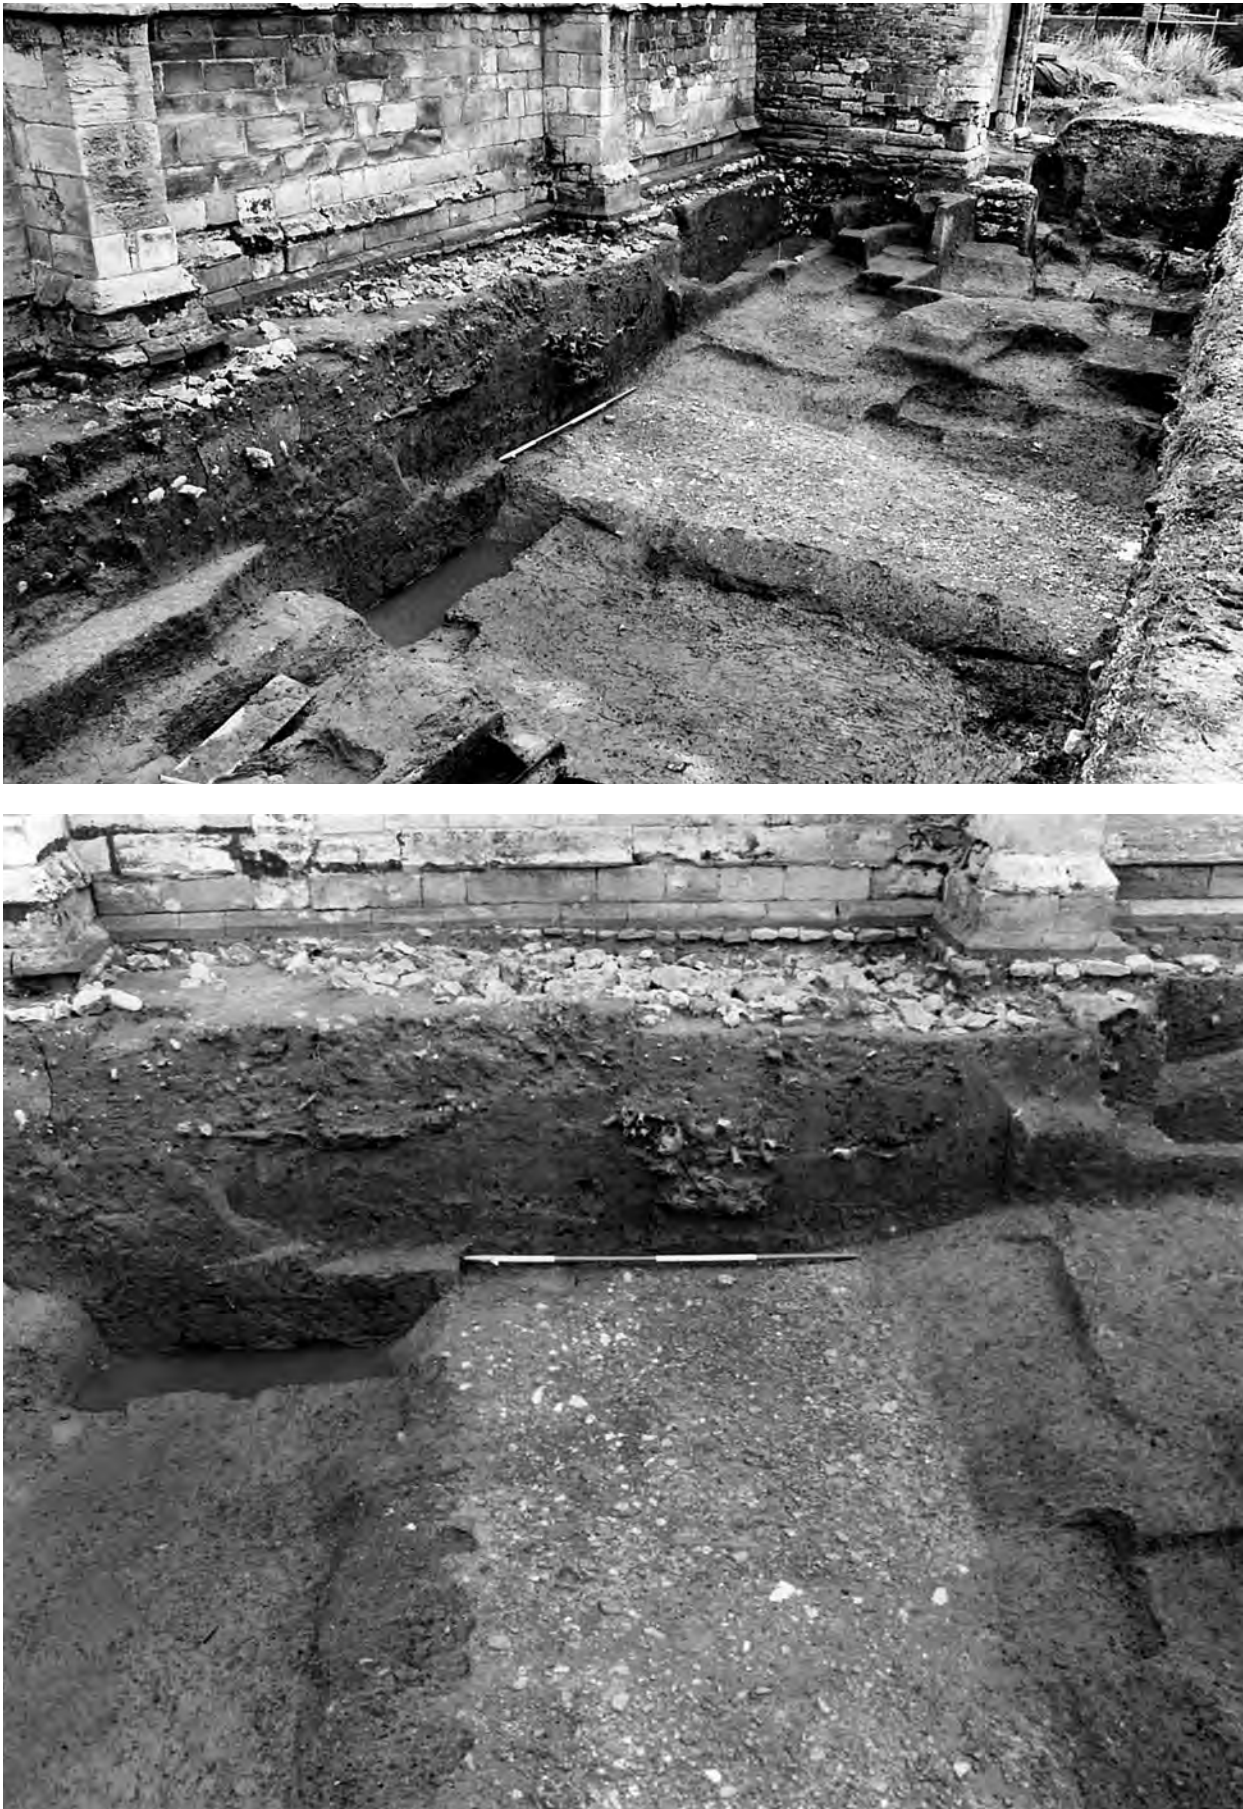
*Fig. 149: Band of gravel metalling (F5057) running north–south in Area 11. Upper, view south–west. Lower, detail looking south. Scale of 2 m. Photo: Warwick Rodwell*

- v) A little further west, in Area 11, a clearly defined band of metalling (F5057) was preserved, 2 m wide, running north–south across the full width of the excavation (Fig. 149). It comprised a thin, very compact layer of rounded pebbles and small pieces of chalk and flint, laid in a flat-bottomed

hollow or terrace that had been cut into the natural clay. Superficially, this feature had the appearance of being a path, but once again the smooth, level and polished surface of the metallurgy argues strongly against such an interpretation. Indeed, the western edge of the metallurgy was so sharply defined that there must have been a delimiting feature, such as a turf or timber wall. The eastern edge was more diffuse and it seems likely that the surface once continued further in this direction, but had been scoured away by later activity. The most plausible interpretation is that we have part of the western edge of a large, gravel-floored building which was slightly terraced into the knoll that forms this site. The metallurgy recorded within the north aisle (above, Area 5) was part of the same structure. Small pieces of animal bone and teeth were again the principal finds on the surface.

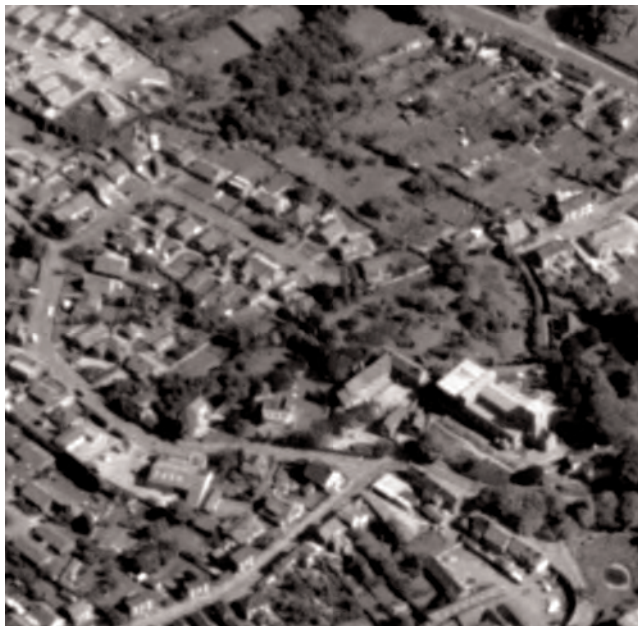
*Fig. 150: Aerial view, looking south-east, of the sub-circular enclosure, as defined by features in the modern landscape in 1985. St Peter's church is middle right and Tyrwhitt Hall is the L-shaped building to its left. Photo: David Lee Photography*

The sub-circular enclosure surrounding Tyrwhitt Hall has already been described (pp. 29–30; Figs. 150, 151 and 152). Although not a massive fortification, it seems likely that the earthwork was constructed to enclose and give limited protection to a settlement nucleus of middle Saxon date, which was in turn successor to Romano-British and early Anglo-Saxon

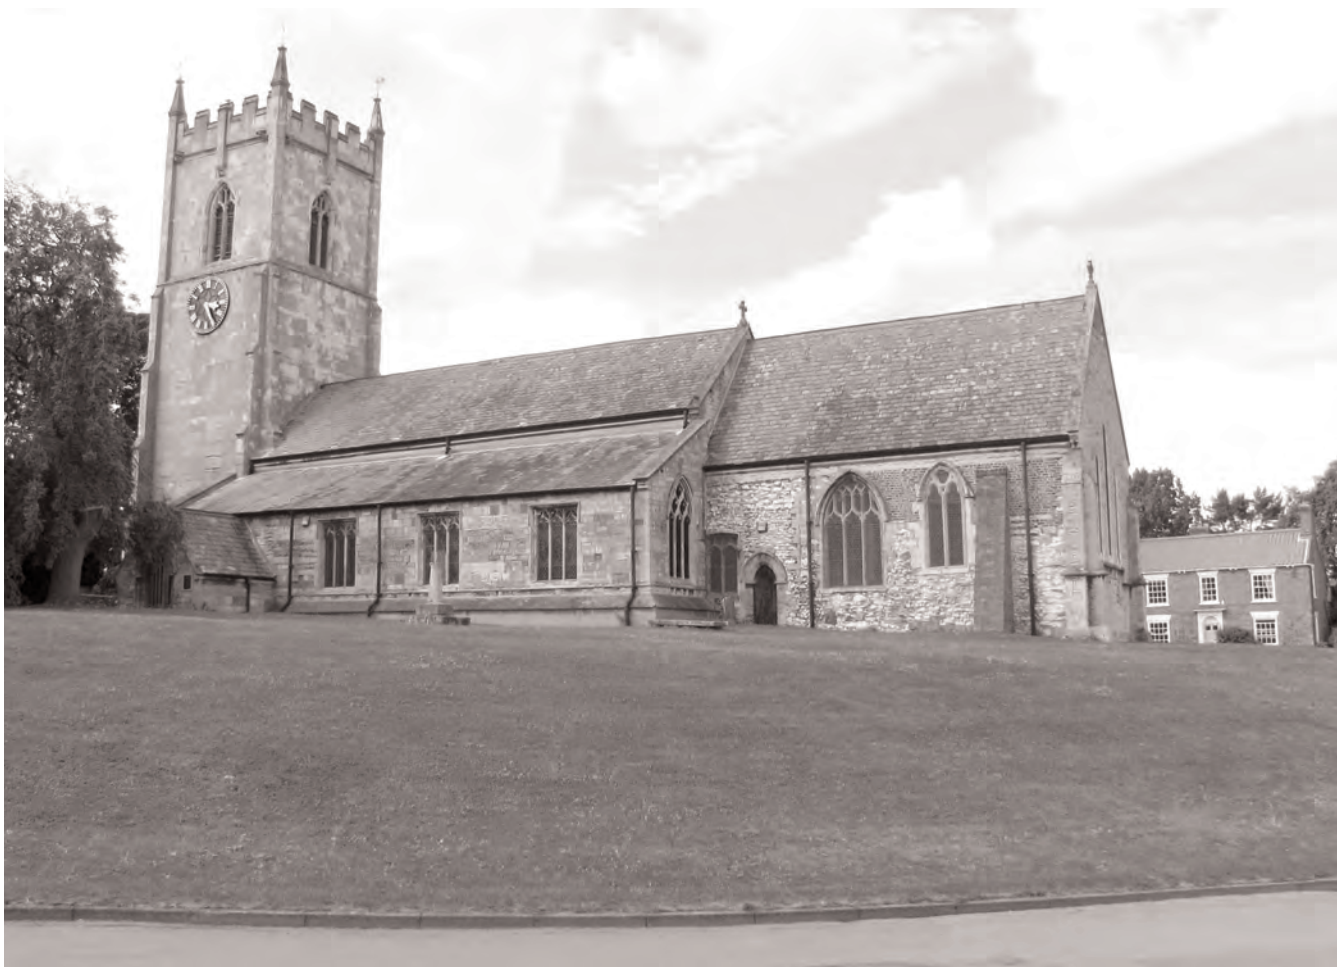
Fig. 159: Holy Trinity, Barrow-upon-Humber. View from the south-east. Photo: Warwick Rodwell

Holy Trinity church has been neglected by scholars, and a detailed appraisal of its history and architecture is long overdue.<sup>57</sup> Today, the building comprises an aisled nave and a rectangular chancel; there is a substantial west tower and a south porch (Figs. 159 and 160).<sup>58</sup> The church is significantly smaller than those at Barton, the nave being 16 m long (St Mary's is 22 m, and St Peter's was originally nearly 24 m). There is no clerestory. The chancel is of the same width as the nave and appears to have been built in the early thirteenth century, succeeding an earlier and narrower structure: similarities with Barton St Mary's are apparent.

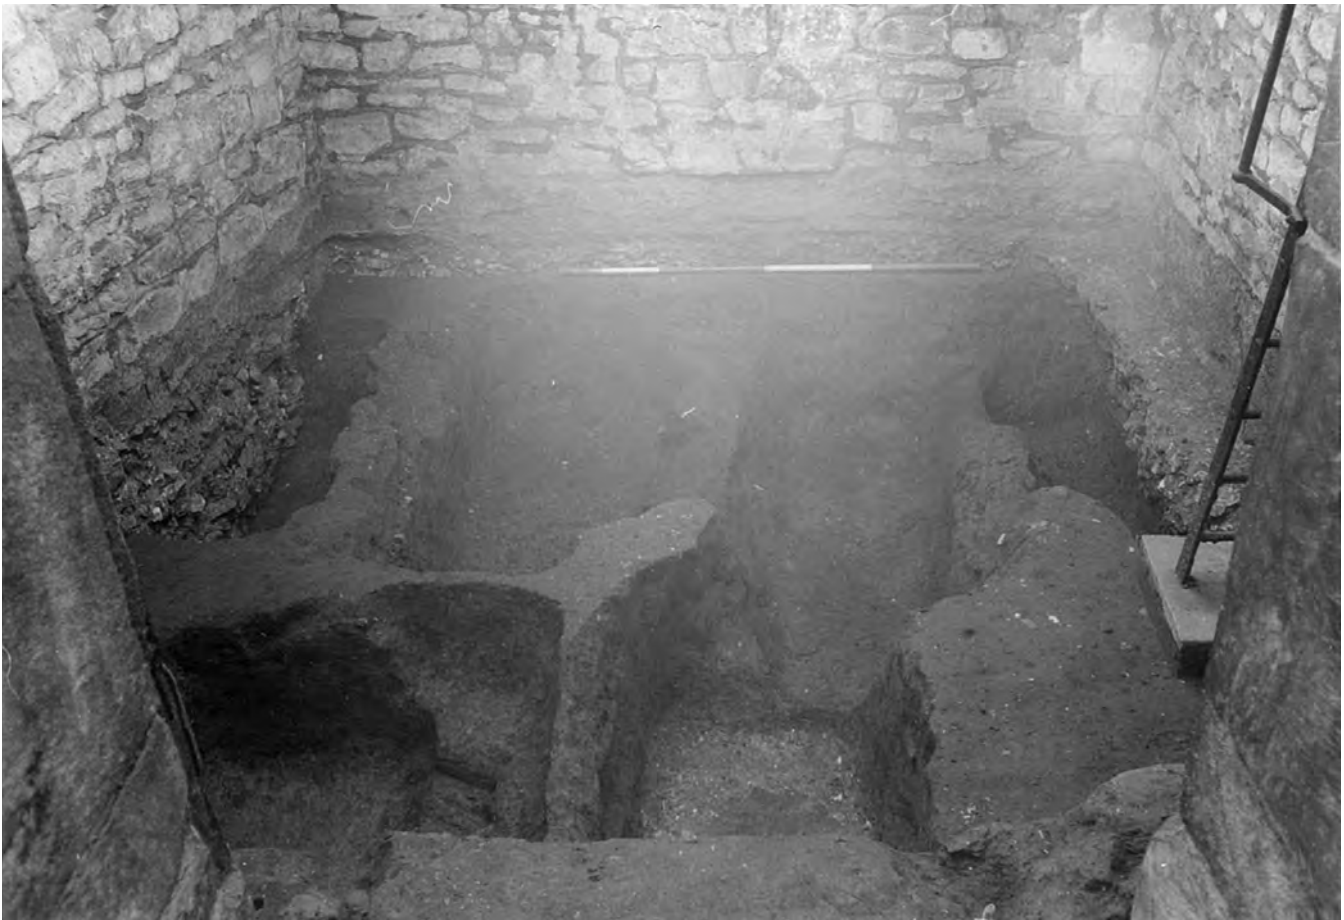
*Fig. 165: Exhumed pre-church graves excavated within the western annexe. View west. Scale of 2 m. Photo: Warwick Rodwell*

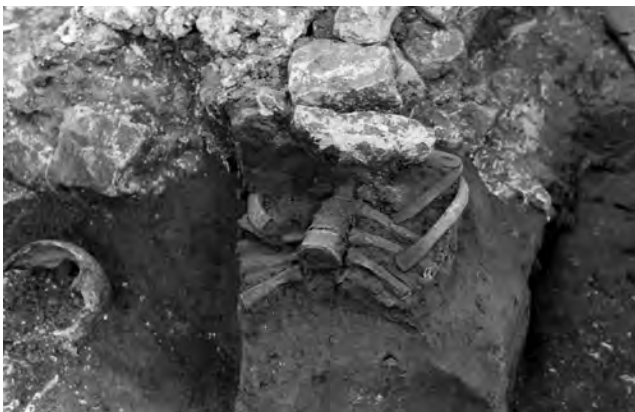
Fig. 166: Remains of the torso of a pre-church burial (F1364), the lower part cut away by the chancel foundations (the skull was removed by a later disturbance in the foreground). View west. Photo: Warwick Rodwell

As part of the programme of scientific dating, attempts were made to identify intact burials that might have belonged to one of the pre-church cemetery phases, but with little success. However, the failure to remove all burials from the intended footprint of the chancel meant that human bone from F1364 was available for radiocarbon dating. This sample, taken from an adult male, yielded a posterior density estimate of *cal. AD 985–1035 (95% probability; OxA-12374)* and comparable posterior density estimates (*i.e. falling within the date-range 985–1045*) were yielded by samples of human bone collected from a further eleven intact burials selected from disparate parts of the excavated area. Although all of the twelve dated samples *could* be from pre-church burials, it is likely that at least some were derived from graves associated with the first churchyard phase, since they were not sealed by building construction deposits.

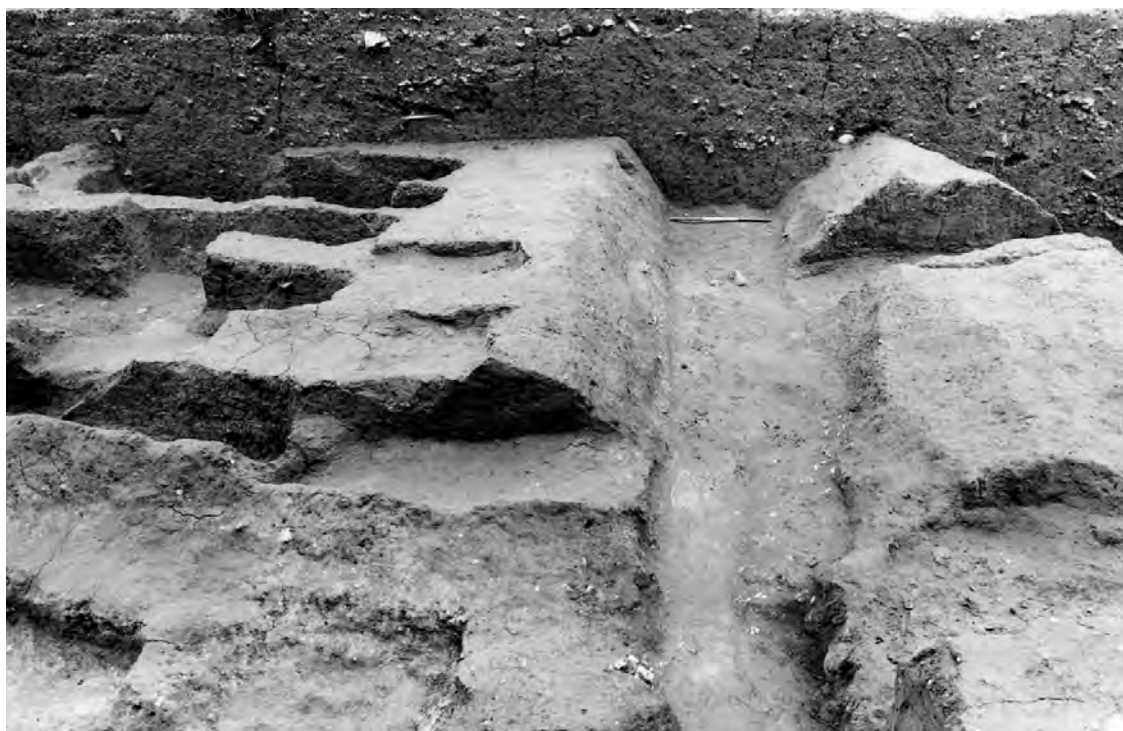
Fig. 168: Eastern boundary ditch of the late Saxon churchyard (F5384). View north. Scale of 75 cm. Photo: Warwick Rodwell

flanked on its western side by a bank and hedge. Although none of the burials in the easternmost row has been scientifically dated, it is probable that they were the first to be made in the churchyard extension. Not only did these six graves lie at right-angles to the new boundary, but they also shared an alignment with the earliest dated burial in the extension (F5475; winter 1103/04), suggesting that they were part of the primary ordering of the extended cemetery.<sup>7</sup>

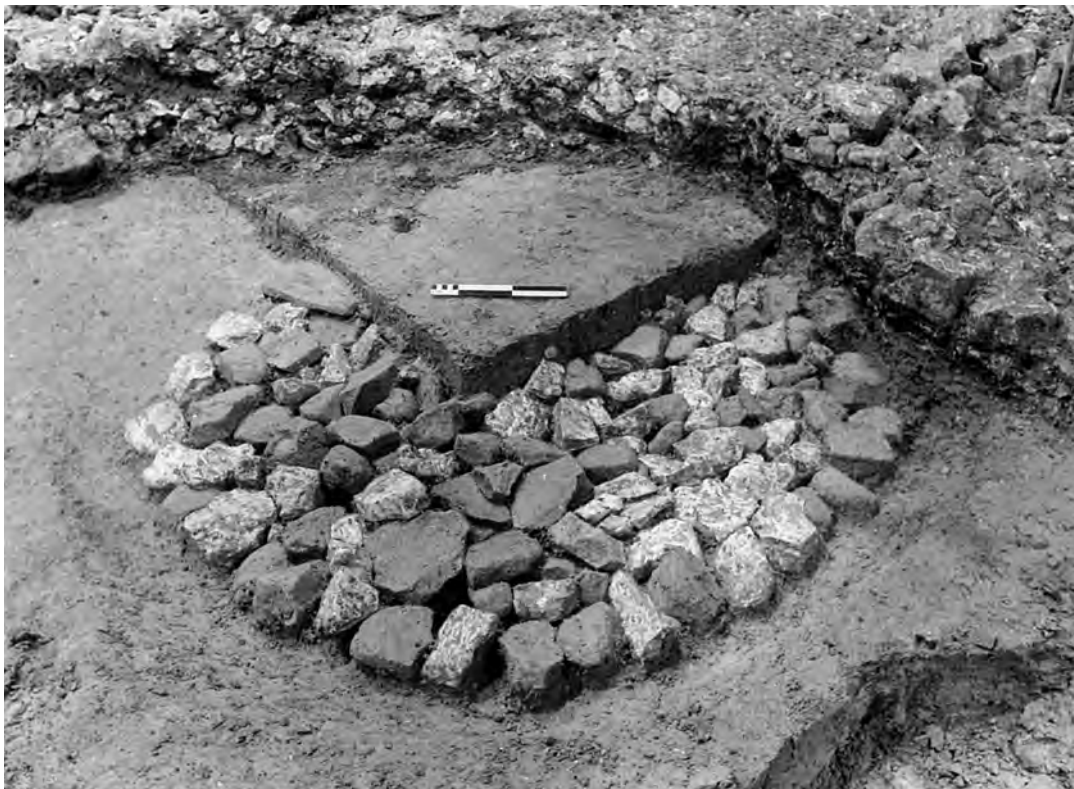
Fig. 170: Stone foundation of kiln (F1727). View south-east. Scale of 25 cm. Photo: Warwick Rodwell

Sealed beneath, and partly destroyed by, the foundation of the apse of the Saxo-Norman church was a kiln or oven (F1727) which had been constructed in a sub-circular pit (F1757). The kiln chamber, which was circular and composed of fired clay, went through four phases (Pl. 38; Fig. 169). The initial structure had an internal diameter of 1.05 m, and had been formed on a carefully prepared circular base of cobbles and small pieces of limestone (Fig. 170). At the time of the first reconstruction the kiln was enlarged to have an internal diameter of 1.2 m (4 ft). The flue faced north-east, and the stokepit (F1725) contained nothing but fine black ash and some charcoal. Several small postholes in the base of the pit, close to the edge, were evidently associated.

In the absence of any slag or other readily identifiable residues, it was initially concluded that the feature was an oven that performed a function such as baking bread, which would leave no diagnostic evidence. However, the structure is too large for a domestic oven and its situation in the corner of a sizeable stokepit rather implies its association with an industrial process that involved considerable time and labour. It is commensurate with a pottery kiln, but the lack of wasters must cast doubt on such an interpretation. That said, the extent to which later activity had removed the contemporary ground surface from around the pit, and all but a tiny amount of stratification within it, the absence of ceramic evidence cannot be considered definitive.

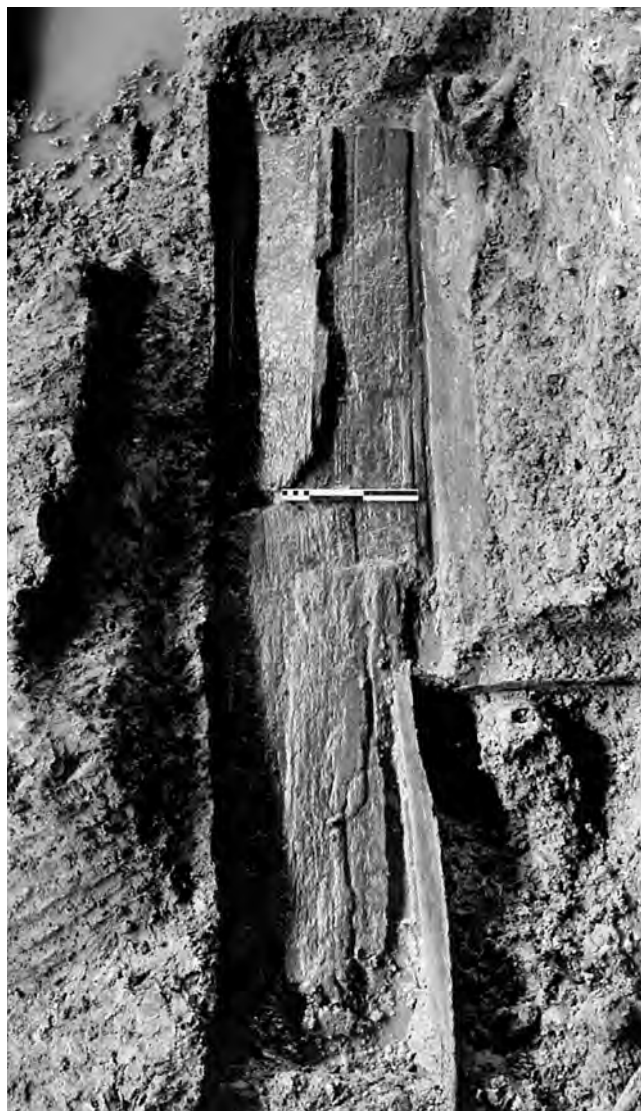
Fig. 173: Loose planks forming the base and sides of grave F3547. View west. Scale of 25 cm. Photo: Warwick Rodwell

two long planks had been stood on edge against the sides of the grave and four short pieces of board laid in the bottom to form a makeshift base (Fig. 173). These had not been cut to fit, and were partly overlapped. Both ends of the grave were destroyed, but they too were presumably lined with loose pieces of timber, wedged between the two sides. Traces of a cover-board were also noted, but this projected above the water-table and had consequently decayed.

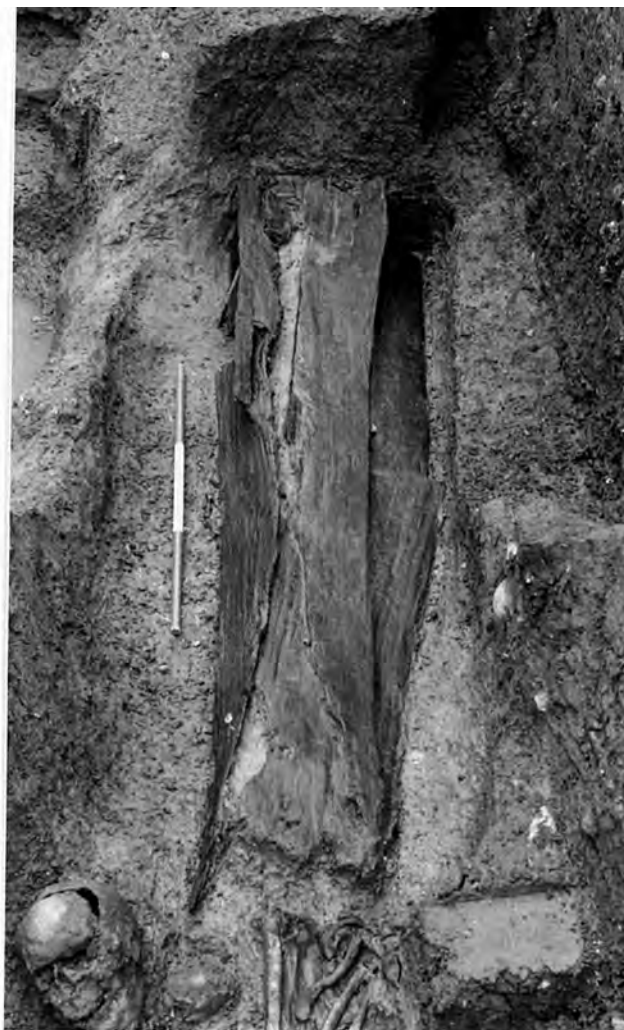
Fig. 174: Planks laid over an uncoffined burial (F5002). The corpse beneath was encapsulated in liquid mud. View west. Scale of 75 cm. Photo: Warwick Rodwell

burials, was encountered on numerous occasions, and its function was presumably to contain disease (p. 194). Several boards had been laid over the body before the grave was backfilled (Fig. 174). At least one plank had had a previous use, since there was a rectangular cut-out in it. There was also a short piece of board wedged across the west end of the grave: its dimensions and the presence of three nail-holes (but no nails) along one edge suggest that it had been, or was intended to be, the end-board of a jointed coffin. One of the covering timbers from this grave gave a tree-ring date of 1049–85, from which a posterior density estimate of 1047–75 (95% probability) was calculated.

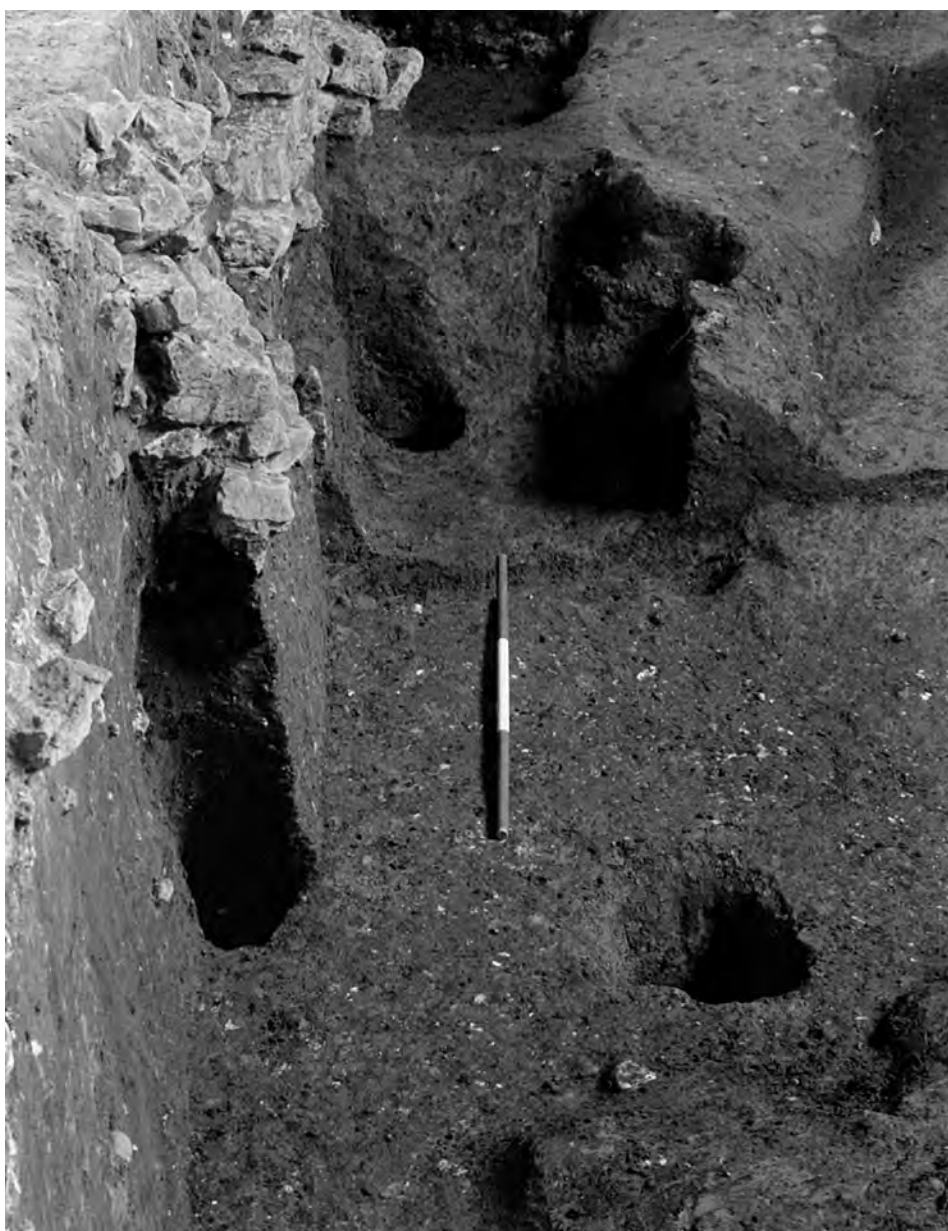
*Fig. 178: Exhumed grave F1680, marked at the corners by four postholes. The backfilling was covered by a layer of rough limestone rubble, F384 (left, in section). View west. Scale of 75 cm. Photo: Warwick Rodwell*

almost certainly been coffined, but was subsequently exhumed, leaving only the grave-pit with its squarely cut edges (F1680), the modest size of which suggests that the occupant was an older child or sub-adult. The corners of the grave had been marked by four timber posts, for which pits had been excavated (Fig. 178). The length was 1.7 m, to the centres of the posts, and the width *c.* 0.8 m at the east end, by *c.* 0.7 m at the west end. No other feature of this kind was encountered in the cemetery, and the singular treatment accorded to the burial points to a timber canopy or shrine structure having been erected over the grave.

After exhumation – and presumably translation of the corporeal remains to a new location – the grave-pit was backfilled with soil, the upstanding timber structure was removed, and a raft of chalk rubble laid down (F388). The rubble, being set in a matrix of sand, was

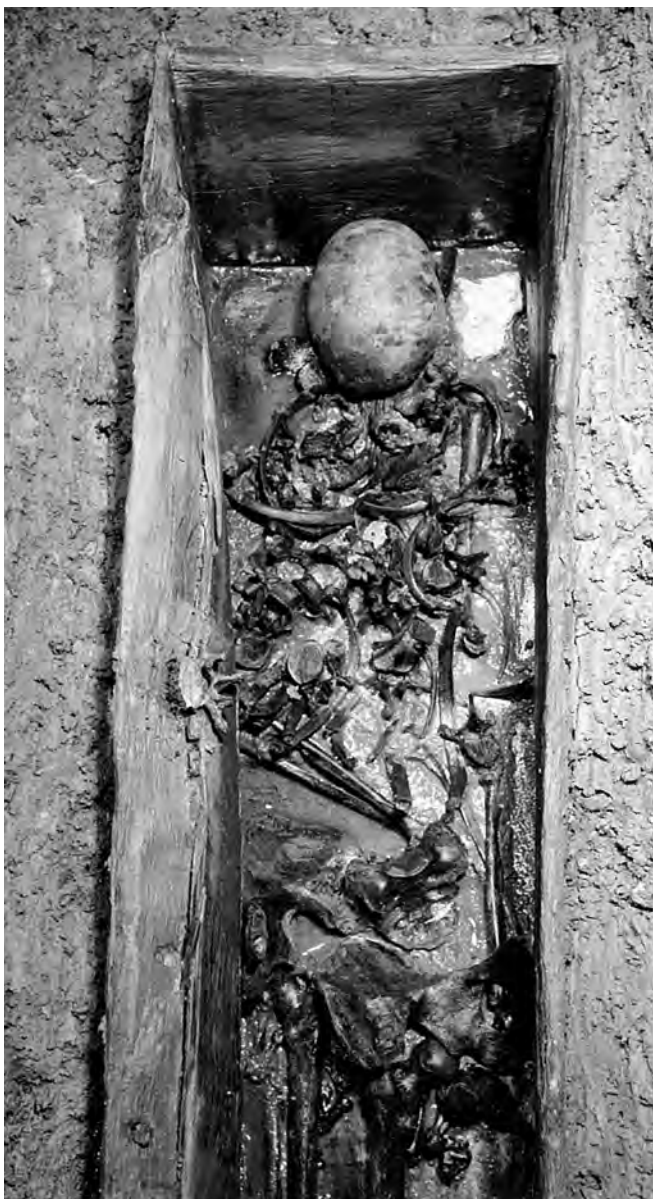
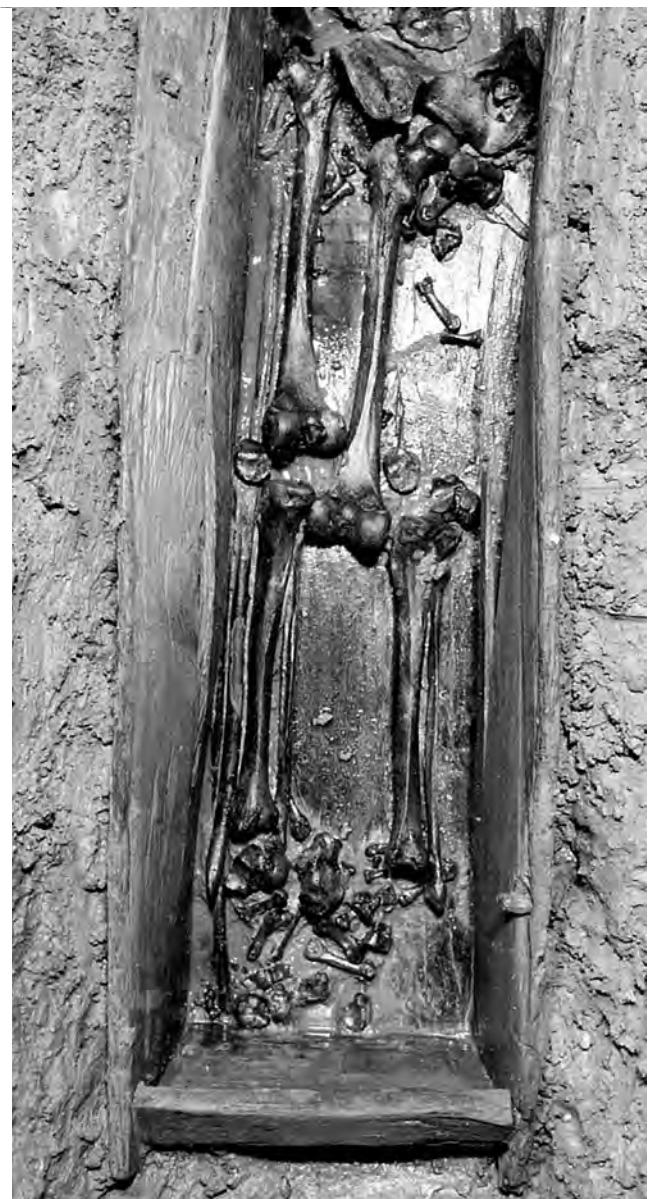
*Fig. 181: Coffin, grave F1790 (upper and lower parts of grave). Skeleton with rotated leg bones and dispersed vertebrae and rib cage. Note the single vertebra perched on top of the distorted upper part of the left-hand (south) side, trapped by the lid as the coffin became compressed. Photo: Warwick Rodwell*

It was not uncommon to find considerable displacement of bones within the torso, particularly the rib-cage, as though the body had 'exploded' during decomposition (*e.g.* F3968). There were also instances where not only the ribs but also the vertebrae were found in complete disarray (*e.g.* F1790); this could only have occurred after full decomposition, when there were no longer ligaments tying the vertebrae together. The possibility that ground-water alone was responsible for moving bones was considered and rejected for three reasons. First, some of the graves exhibiting 'bone tumble' lay in areas where waterlogging is unlikely. Second, variations in the local water-table would have occurred slowly, so that seepage into

did float to the top of a water-filled coffin. In one instance a single vertebra had become trapped in the joint between the lid and side of a coffin, as the former bowed and collapsed under the weight of the overlying soil. It is difficult to see how a vertebra could have risen to such a level other than by floating in water. In F1753 vertebrae were scattered all over the west end of the coffin, seemingly having settled at random when the water level subsided (or when the bone became fully waterlogged and sank; Fig. 183). The low bone-density of vertebrae, especially of the centrum, gives them greater buoyancy in water than other bones: their movement through this means is thus feasible.

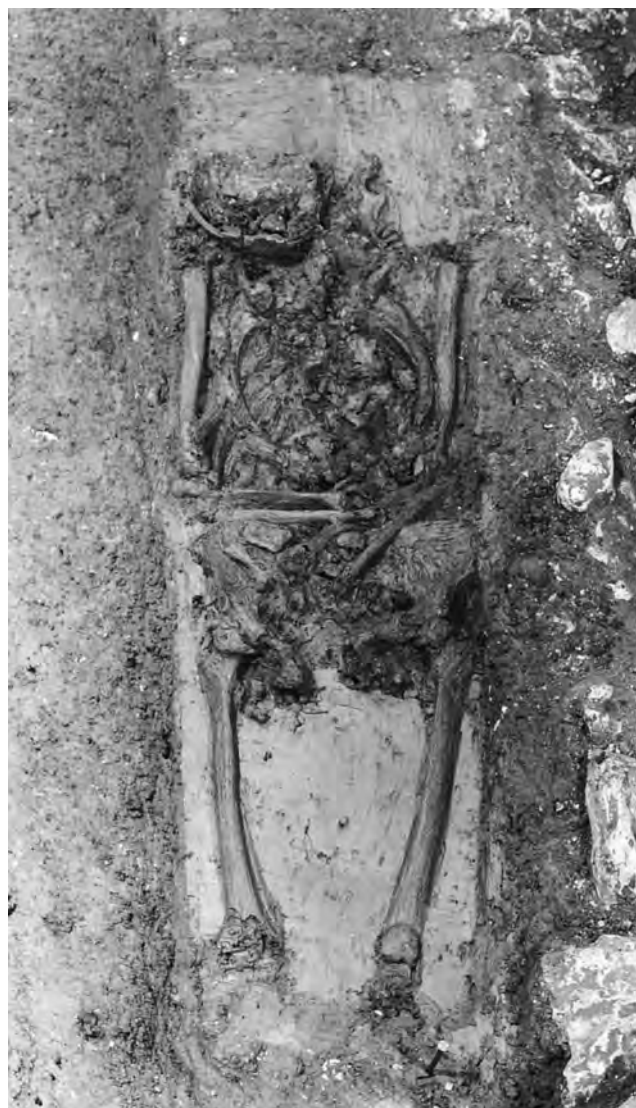
*Fig. 184: Grave F4019. Mud burial, excavated to reveal the outline of the coffin, not the grave-cut. The legs have been truncated by a later feature. View west. Photo: Warwick Rodwell*

Six mud burials were encountered beneath the nave and south aisle of the present church, giving rise to the recognition of this distinctive class of interment (F4019, F4040, F4064, F4067, F4100 and F4152) (Pl. 113; Fig. 184). Two of the mud burials were included in the scientific dating programme: F4019 gave a posterior density estimate of *cal. AD 1035–1145* (81% probability; UB-4662) and F4040 a posterior density estimate of *cal. AD 1015–1050* (40% probability), or *cal. AD 1085–1125* (30% probability), or *cal. AD 1135–1160* (25% probability; UB-4663). These dates confirm, first, that the mud burials are assignable to Phase E and, second, that they are not consequent upon a single event, but were deposited over the course of a century or so.

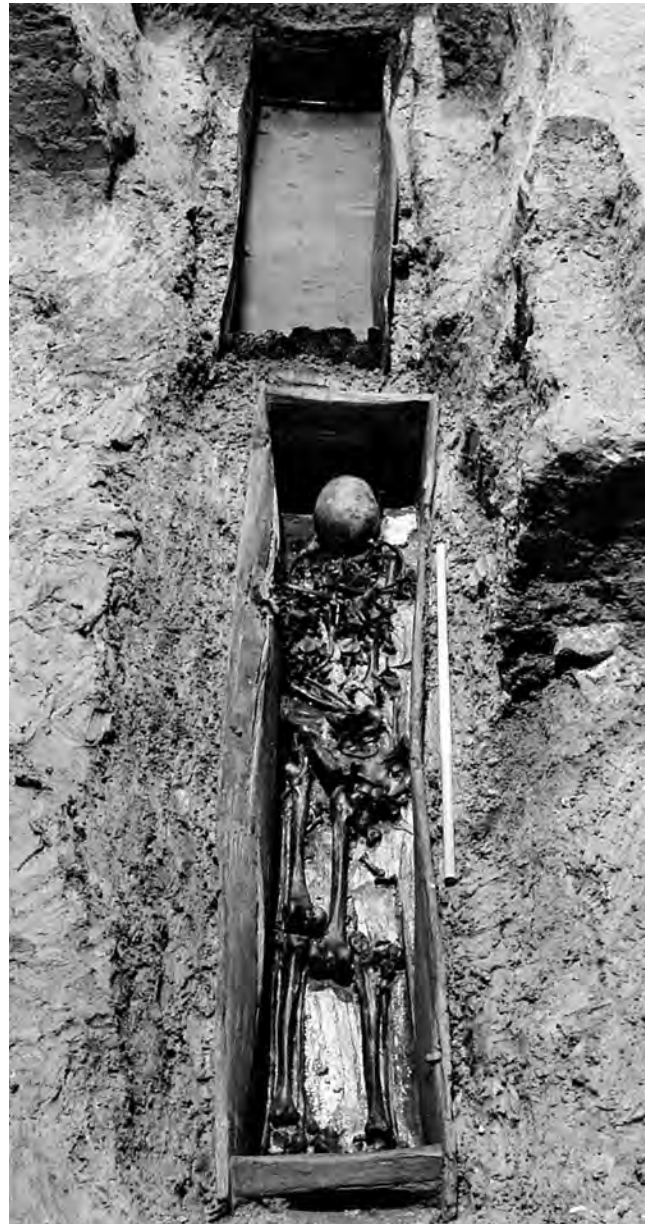
*Fig. 186: Two oak coffins under excavation: F1790 with the skeleton in situ, and F1753 after removal of the contents. View west. Scale of 75 cm. Photo: Warwick Rodwell*

In 1981–83 a large body of data – unparalleled elsewhere in Britain at the time – was recovered concerning the construction of timber coffins, many of which were subsequently dated by dendrochronology (Figs. 185 and 186). A representative selection of the material is discussed here. With the sole exception of a child's coffin, made entirely of pine, the identifiable timber was all locally grown oak (Tyers 2001a).

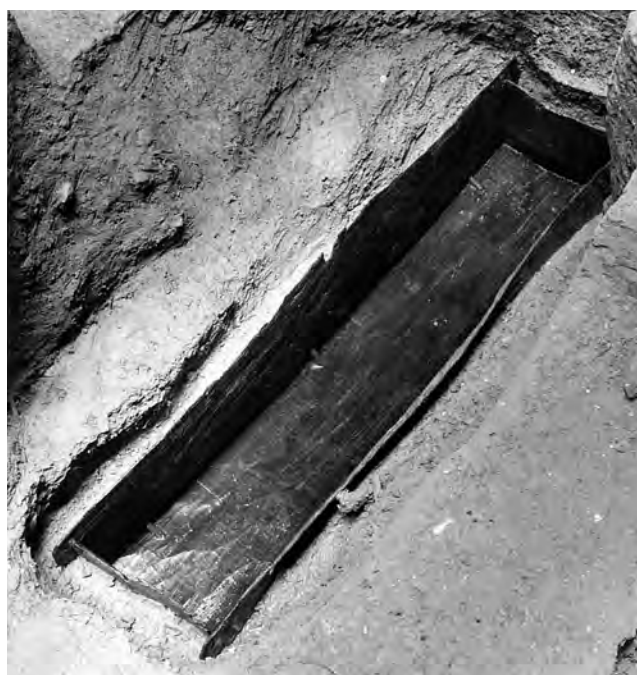
Fig. 188: Coffin, grave F1753, after excavation and removal of the skeleton. View south-west. Photo: Warwick Rodwell

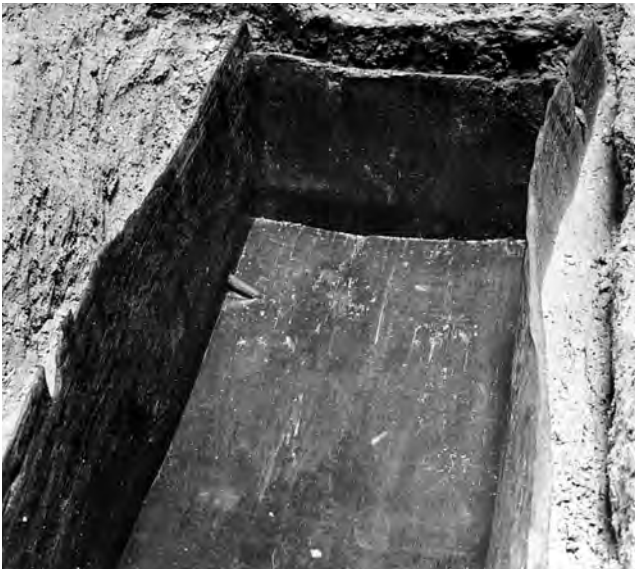
*Fig. 191: Coffin, grave F1753. Internal view of the west end, showing a skewed peg attaching the side to the base. Photo: Warwick Rodwell*

Both end-boards had their grain running vertically and were mounted on the base, being inset slightly from the extremities; two pegs secured each end to the base-board.<sup>44</sup> The side planks, 0.34 m in height, were placed outside the base and end-boards, and each was anchored to the base with three skewed pegs (Fig. 191). There was no form of jointing between the sides and the coffin-ends, the whole being tied together, and the ends maintained in an upright position, by long

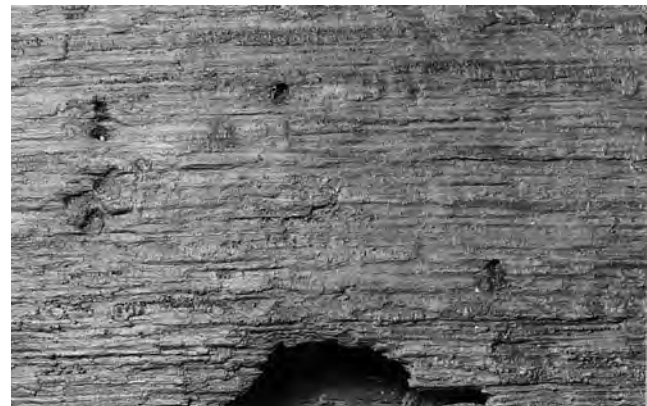
*Fig. 194: Coffin, grave F1753. Detail of the lid, showing wood-beetle infestation in the timber before it was used to make the coffin. Photo: Warwick Rodwell*

Finally, the lid was placed on the coffin, and was fixed with four skewed pegs, two on each long side. The lid was slightly wider than the coffin, and oversailed the ends by 30–50 mm; unlike the base, it was made from two planks,<sup>45</sup> the longitudinal joint being butted and presumably glued. Curiously, no evidence for edge-dowelling could be seen. Instead, the lid appears to have been strengthened simply by gluing battens to the underside. There may have been two or three, but only one batten (50 × 20 mm in cross-section) had survived at the west end of the coffin: it lay outside the end-board and must have been attached to the oversailing part of the lid: no nails, dowels or pegs were involved.<sup>46</sup> Two holes in the north-east corner of the lid seem not to be the result of decay, and may represent reuse of the plank. Also, the wider plank showed no sign of beetle infestation, but the narrower one had flight-holes of a size commensurate with death-watch beetle; these were in the timber before it was planked (Fig. 194).

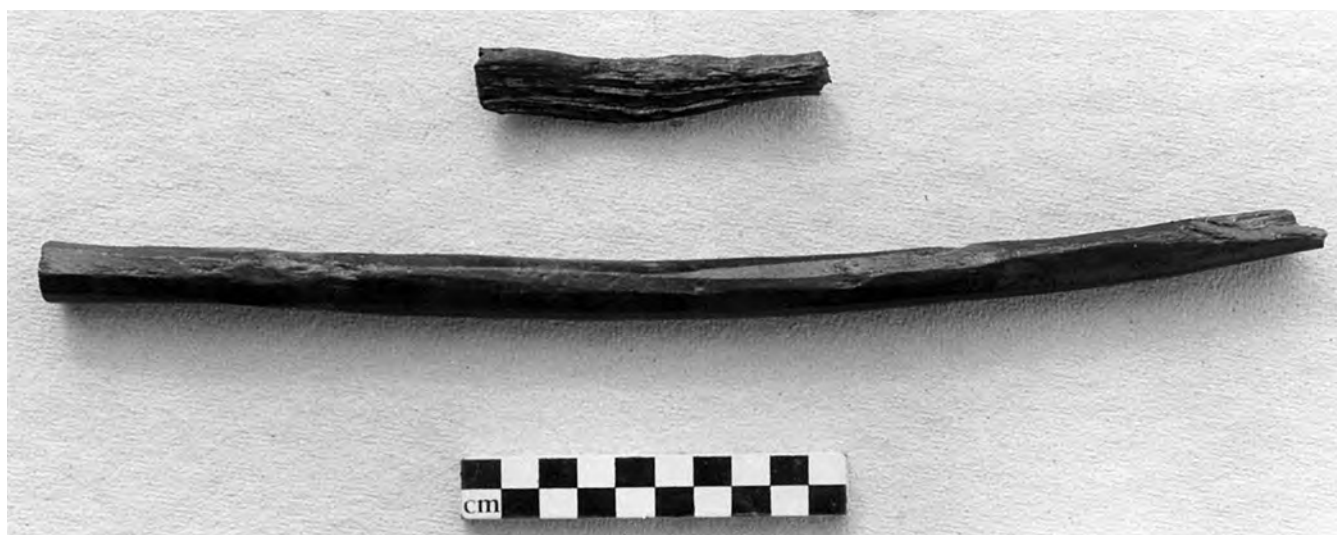
Fig. 196: Coffin, grave F1753. Examples of a peg and a tying-dowel used in the construction. Photo: Warwick Rodwell

with a sharp axe, skilfully wielded, beginning at the top of the board and working across its width. In the case of the base-board, about forty blows were required to trim the narrower end; although the cut edge is neat, each axe blow is detectable. The joiner was right-handed. Holes 13 mm in diameter were drilled to anchor the ends to the base, and pegs driven into these were 14 mm square. The skewed pegs used to anchor the sides to the base, and the lid to the sides, were slightly tapered and averaged 55 mm long; they had been trimmed with a knife to a roughly circular (but visibly faceted) cross-section. They were driven into drilled holes of 13 mm diameter. Some of the pegs were then split and wedged at the upper ends, presumably to tighten a slack fit. The long dowels, also 13 mm in diameter, used to tie the sides of the coffin together passed through pre-drilled holes in the planks, and were trimmed flush with the sides (Figs. 195 and 196). Again, some of their ends were split and wedged to

secure a tight fit; the wedges were *c.* 10 mm long. The pegs and dowels used in the construction comprised a mixture of oak, hazel and willow (or poplar).<sup>47</sup>

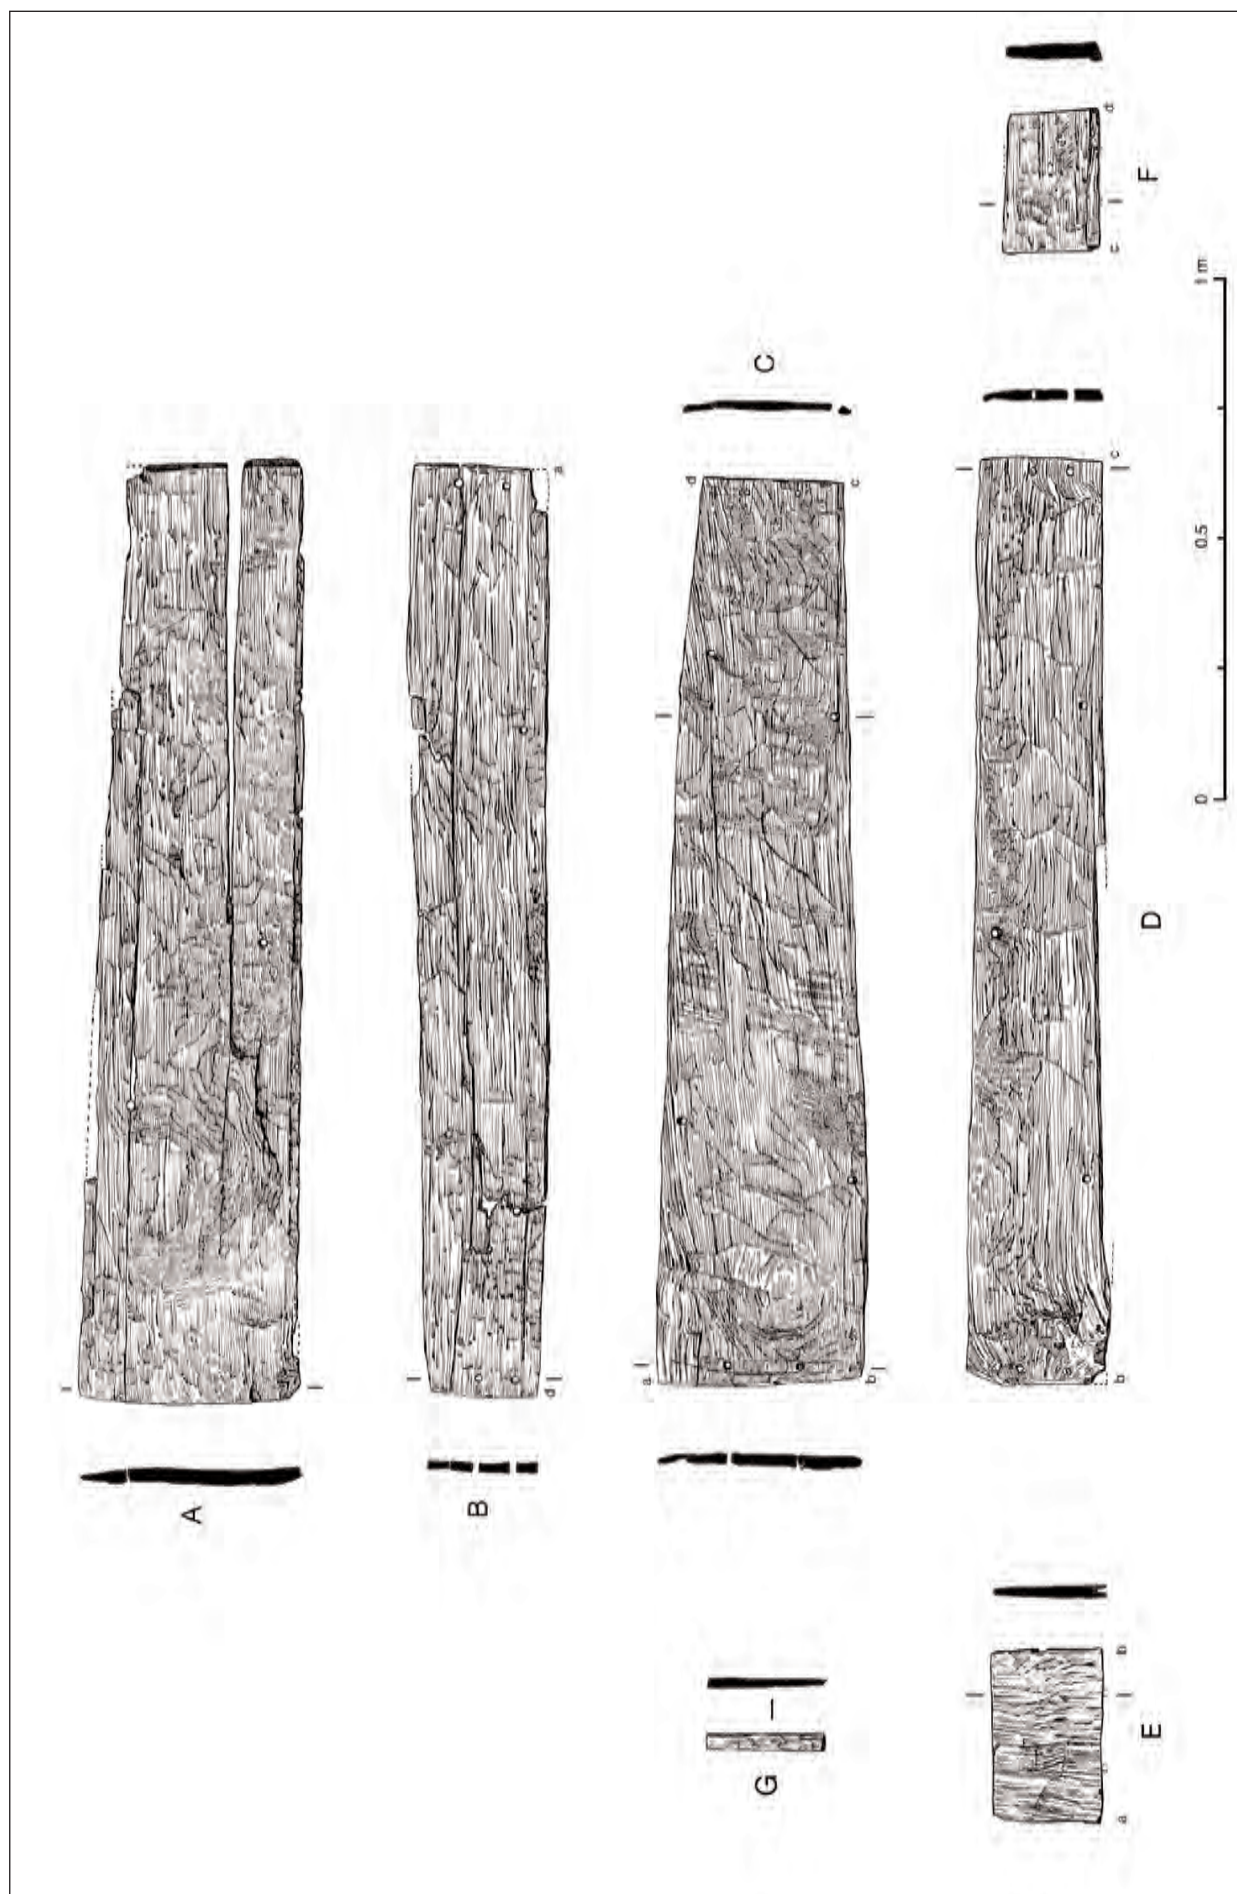
Fig. 200: Coffin, grave F3868. (A) lid; (B) north side (exterior); (C) base (interior); (D) south side (exterior); (E) west end; (F) east end; (G) wedge from south-west corner. Scale 1:15. Drawing: Judith Dobie

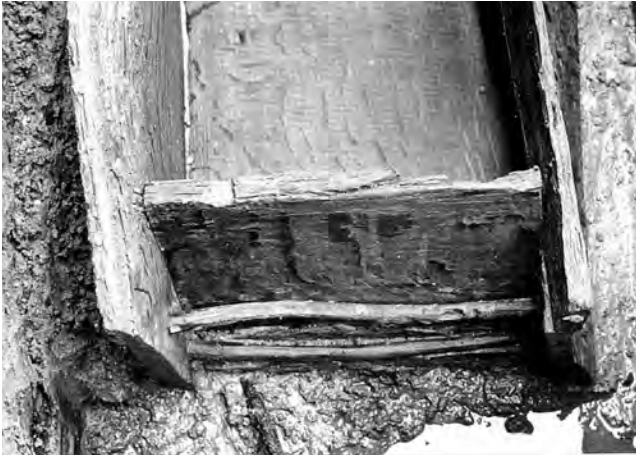
*Fig. 201: Coffin, grave F3868. Detail of the east end, showing the twin tying-dowels. Photo: Warwick Rodwell*

A large, well-preserved coffin: the base-board, curved at the broad end, measured 1.96 m long by 0.45 m wide, tapering to 0.31 m (Fig. 200). Unusually, the west end-board had vertical grain and the east had horizontal. The construction was similar to F3508, with two external tying-dowels at each end (Fig. 201). The lid was secured with three skewed pegs. The south side had the upper west corner cut off at an obtuse angle, which was probably a residual felling-cut rather than a deliberate feature.

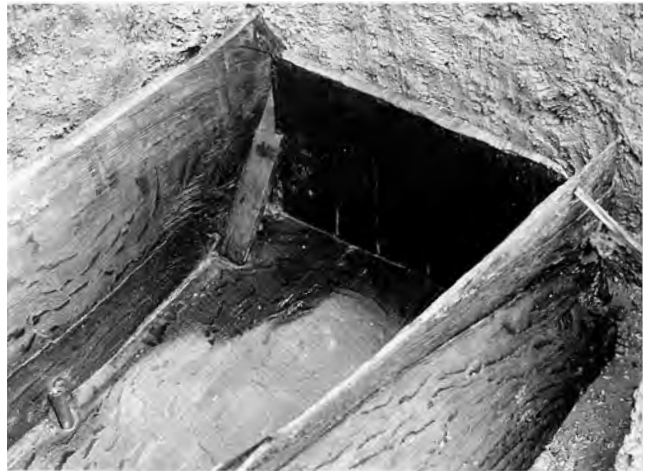
*Fig. 202: Coffin, grave F3868. Detail of the west end, showing the wedge passing through an angled slot in the edge of the board. Photo: Warwick Rodwell*

Two other anomalies merit mention. First, the east end-board carried an unnecessary shallow rebate across its full width, indicating reuse. Second, the west end-board had a small rectangular cut-out in the middle of its southern edge. This was effectively a slot, made using a chisel angled at 45 degrees to the plane of the board. Inserted into this skewed slot was an oak wedge 25 cm long, which pressed against the south side of the coffin (Fig. 202). Practically, all it could do would be to open up a slight gap between the west end-board and the south side; but that was certainly not desirable, since the two components were held together by tying-dowels. The slot and the long wedge were unquestionably deliberate features of this coffin's construction, but their function remains an enigma.
