# ST PETER'S

## Barton-upon-Humber, Lincolnshire

*A Parish Church and its Community*

HISTORY, ARCHAEOLOGY AND ARCHITECTURE

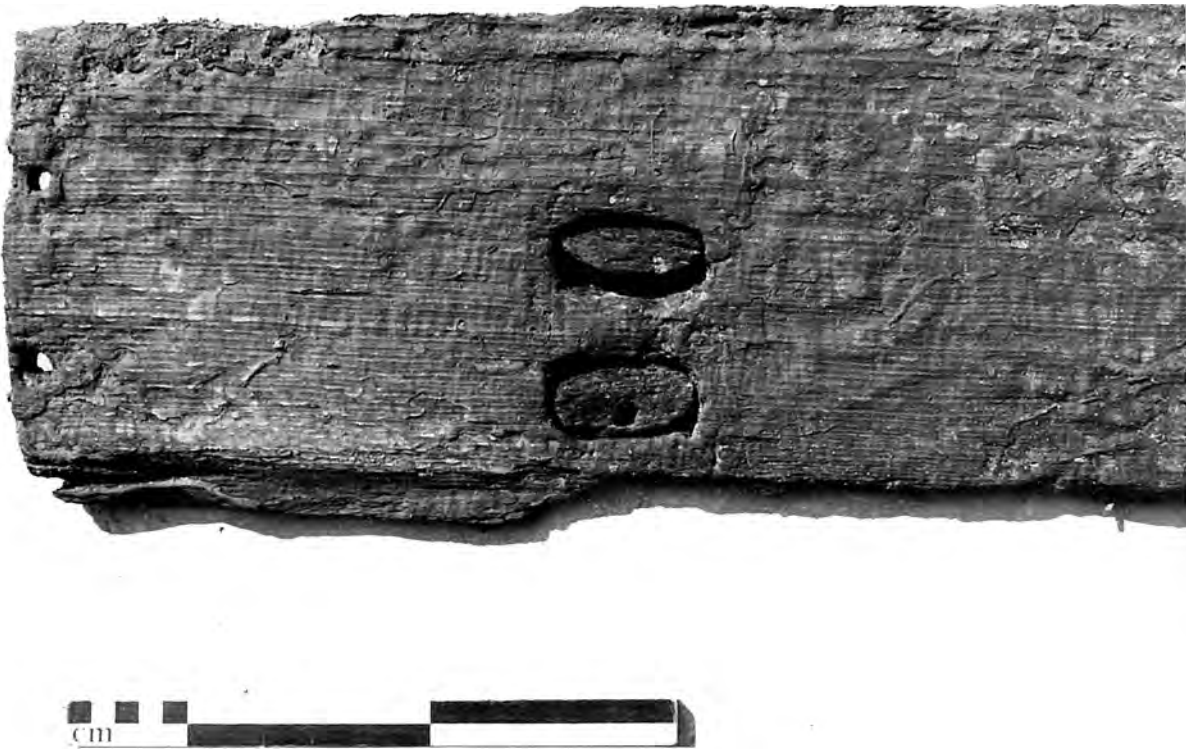
*Fig. 203: Coffin, grave F3946. Detail of part of the base board, showing peg-holes for the attachment of the east end and a pair of infilled mortices from the timber's previous use as a bench top. Photo: Warwick Rodwell*

The coffin was made from reused timber, the base-board having both beetle infestation and a pair of rectangular cut-outs (mortices) side-by-side: each measured *c.* 60 × 30 mm, and had been made using an auger 30 mm in diameter. The mortices were angled in a way that suggests this piece of timber had been the top of a bench with splayed legs (a form of construction that has persisted into modern times). The original bench must have been upwards of 1.4 m in length. The redundant mortices were plugged with pieces of oak (Fig. 203). One of the plugs had a hole (6 mm sq.) in it, apparently where a nail had once been driven through (and subsequently extracted). The nail-hole

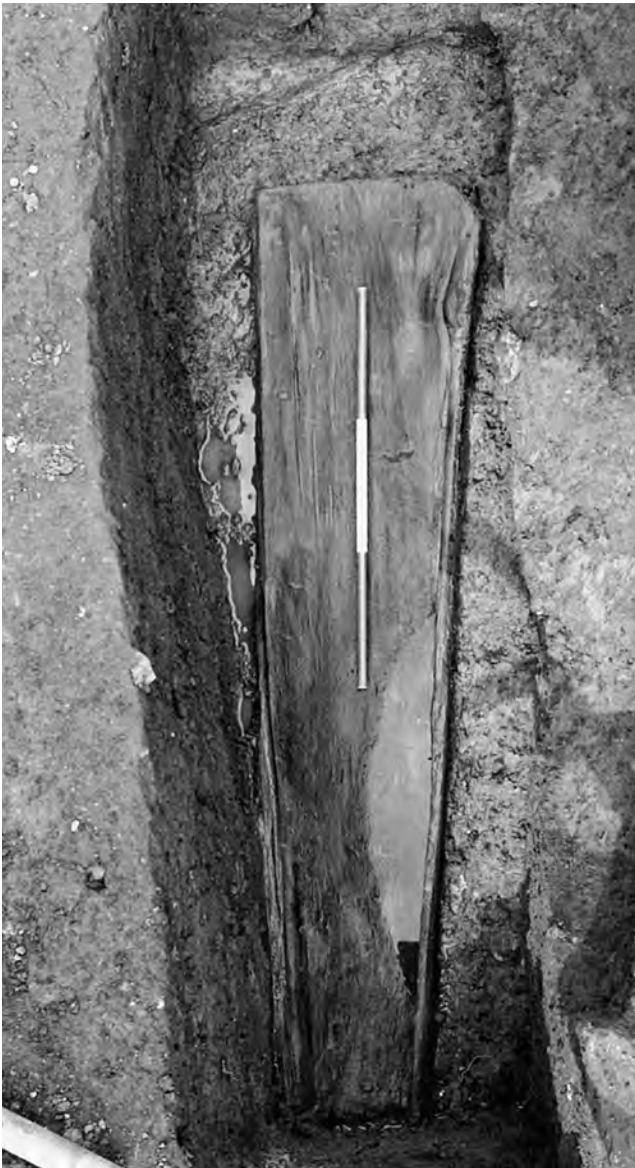
Fig. 204: Coffin, grave F3968, as found, with the lid intact. West is at the top. Scale of 75 cm. Photo: Warwick Rodwell

A well-preserved example, directly underlying coffins F3939 and F3946 (Figs. 204–207 and 209). The planks used for the base and sides were exceptionally thick (up to 45 mm); the north-west corner of the base had been cut off at 45 degrees, using an axe (*cf.* F3868) (Fig. 208). The sides were attached to the base by three horizontal pegs in each, providing the only instance of this form of construction. On the exterior of the south board were

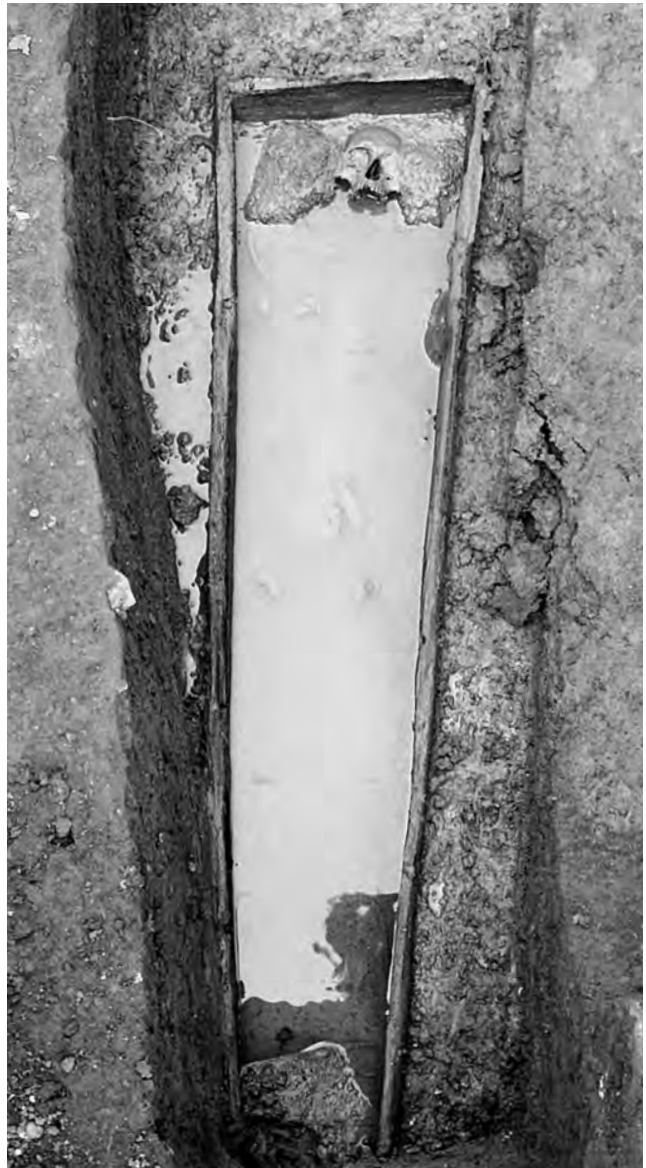
Fig. 205: Coffin, grave F3968. Waterlogged contents, as seen after removal of the lid. Note the mud 'pillow'. Photo: Warwick Rodwell

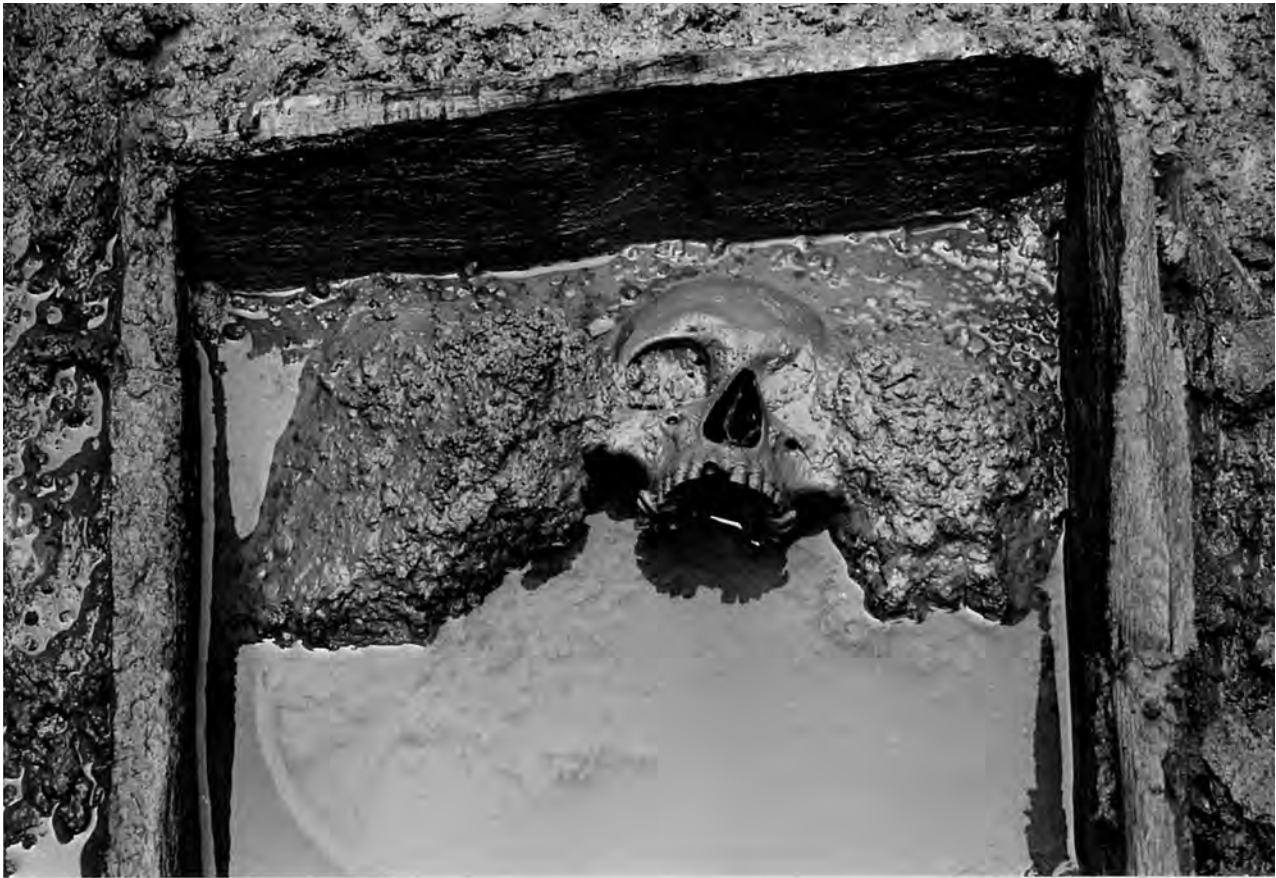
*Fig. 207: Coffin, grave F3968. (upper) The skull resting on a pillow; (lower) The chalk blocks which supported the pillow. Photos: Warwick Rodwell*

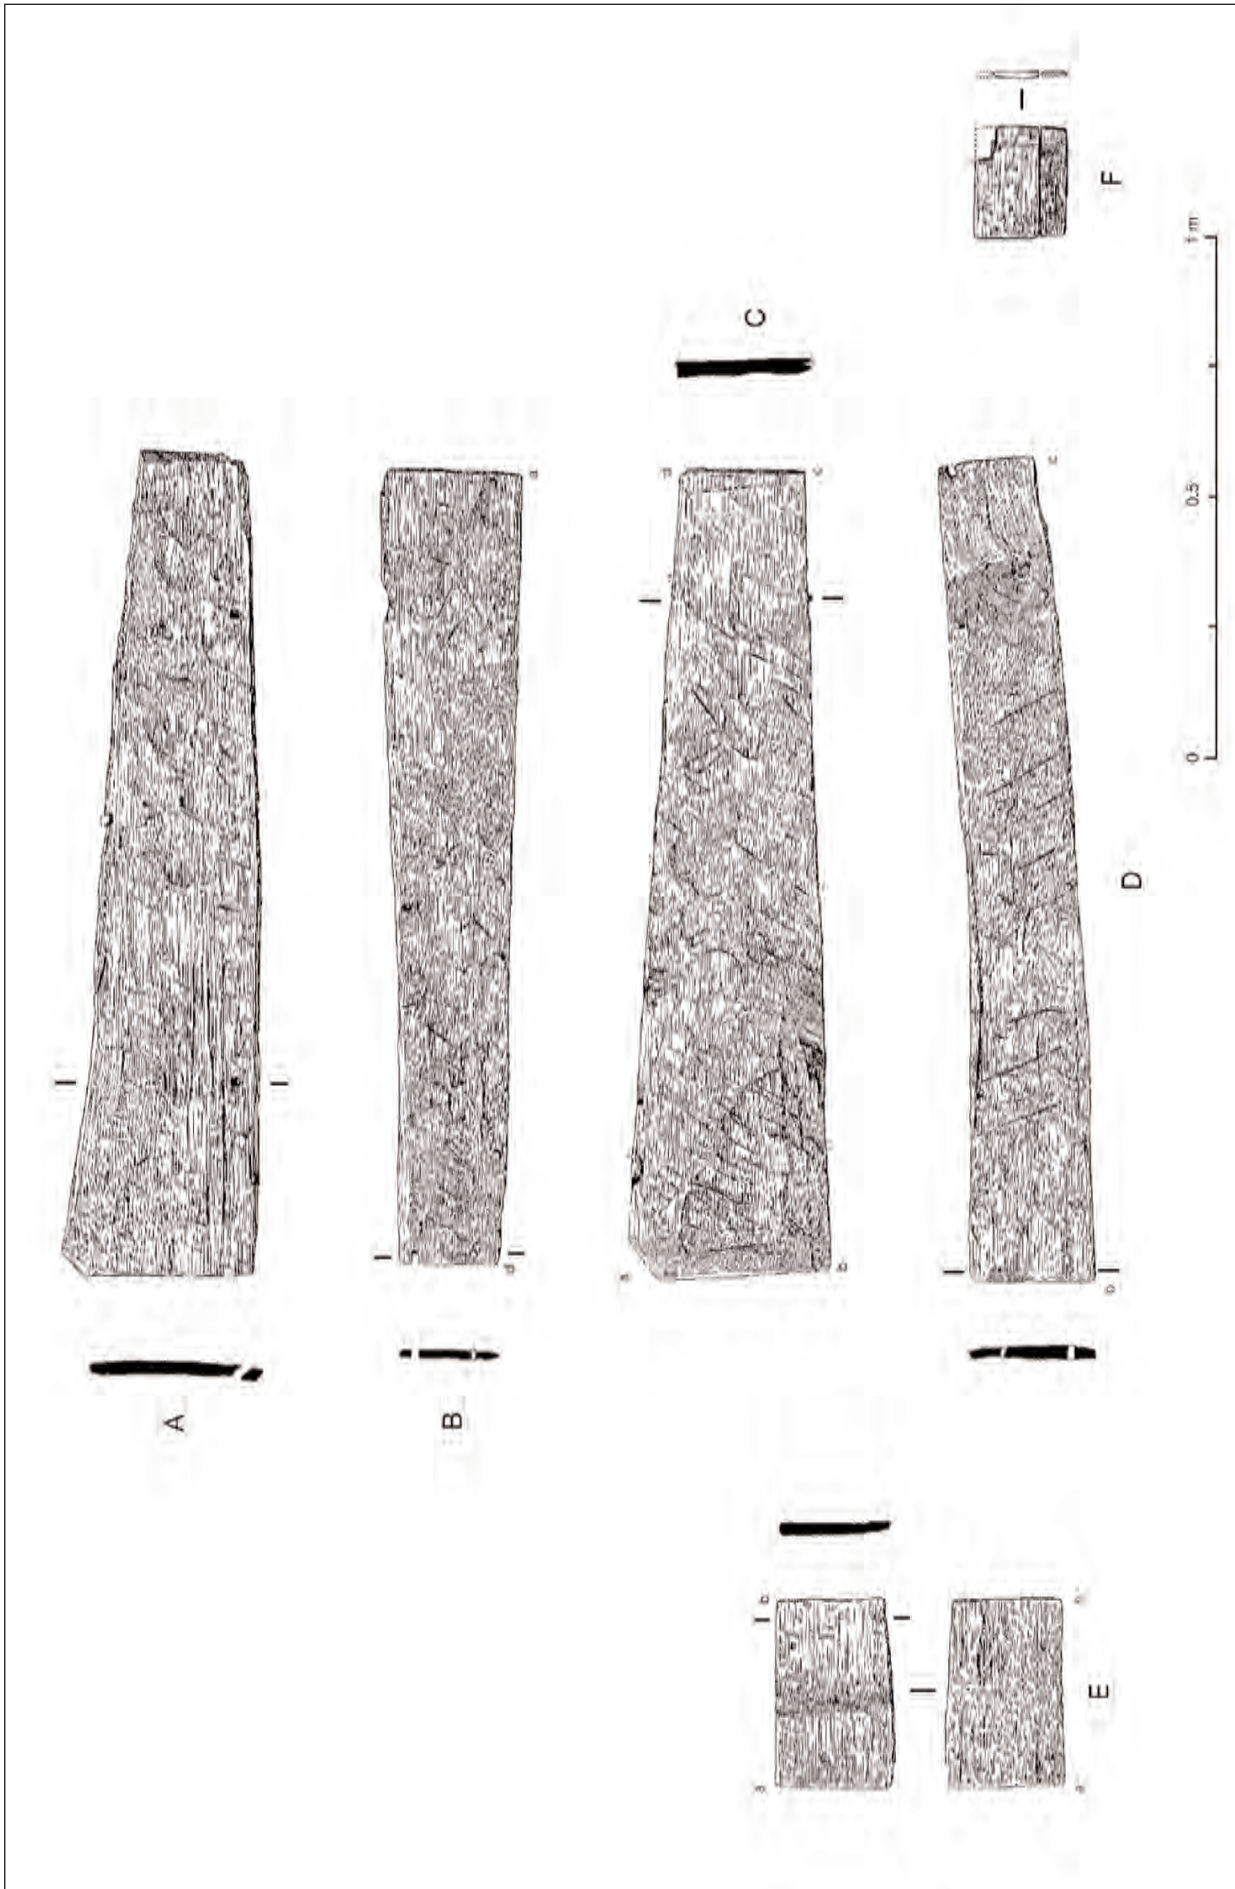
Fig. 209: Coffin, grave F3968. (A) lid (exterior); (B) north side (exterior); (C) base (interior); (D) south side (exterior); (E) west end (internal and external views); (F) east end. Scale 1:15. Drawing: Judith Dobie

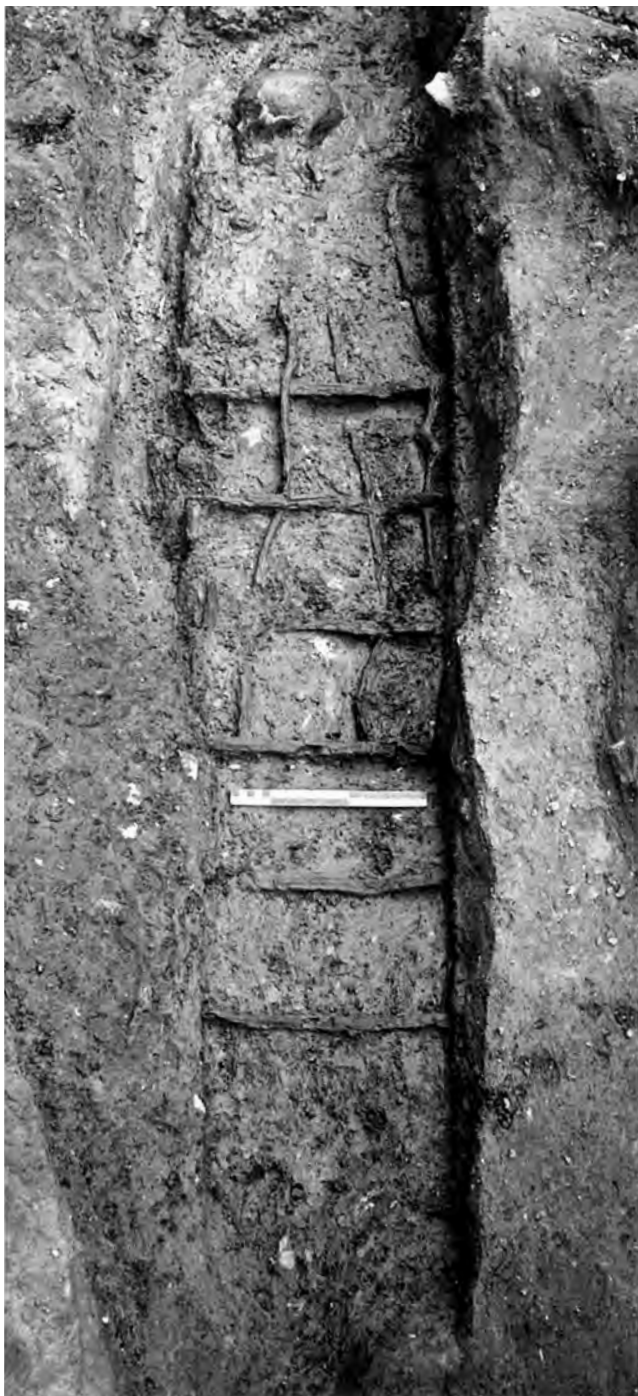
*Fig. 210: Coffin, grave F3974. Vestigial remains of the batten and wickerwork base, after removal of the skeleton (the visible skull belongs to an underlying burial). View west. Scale of 25 cm. Photo: Warwick Rodwell*

(cf. F3869); the east end was too decayed to provide any evidence. Little of the lid survived, but it appears to have been secured to the sides with skewed pegs, in the usual way. Beetle infestation was noted in all six boards.

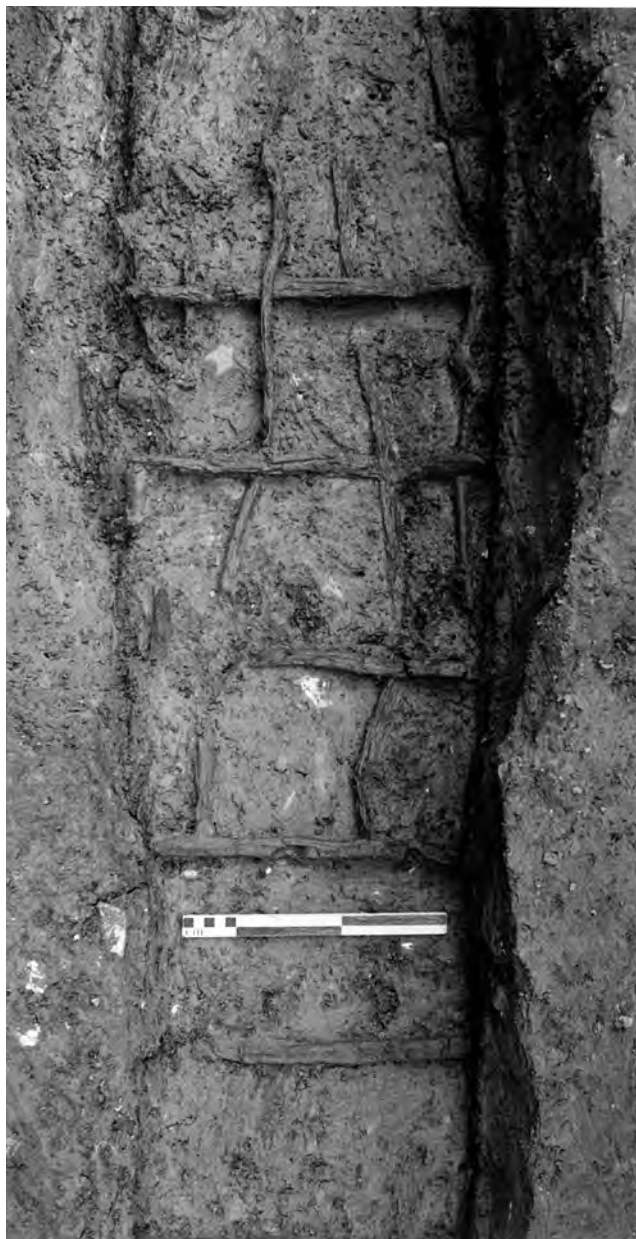
*Fig. 211: Coffin, grave F3974. Detail of the batten and wickerwork base. Scale of 25 cm. Photo: Warwick Rodwell*

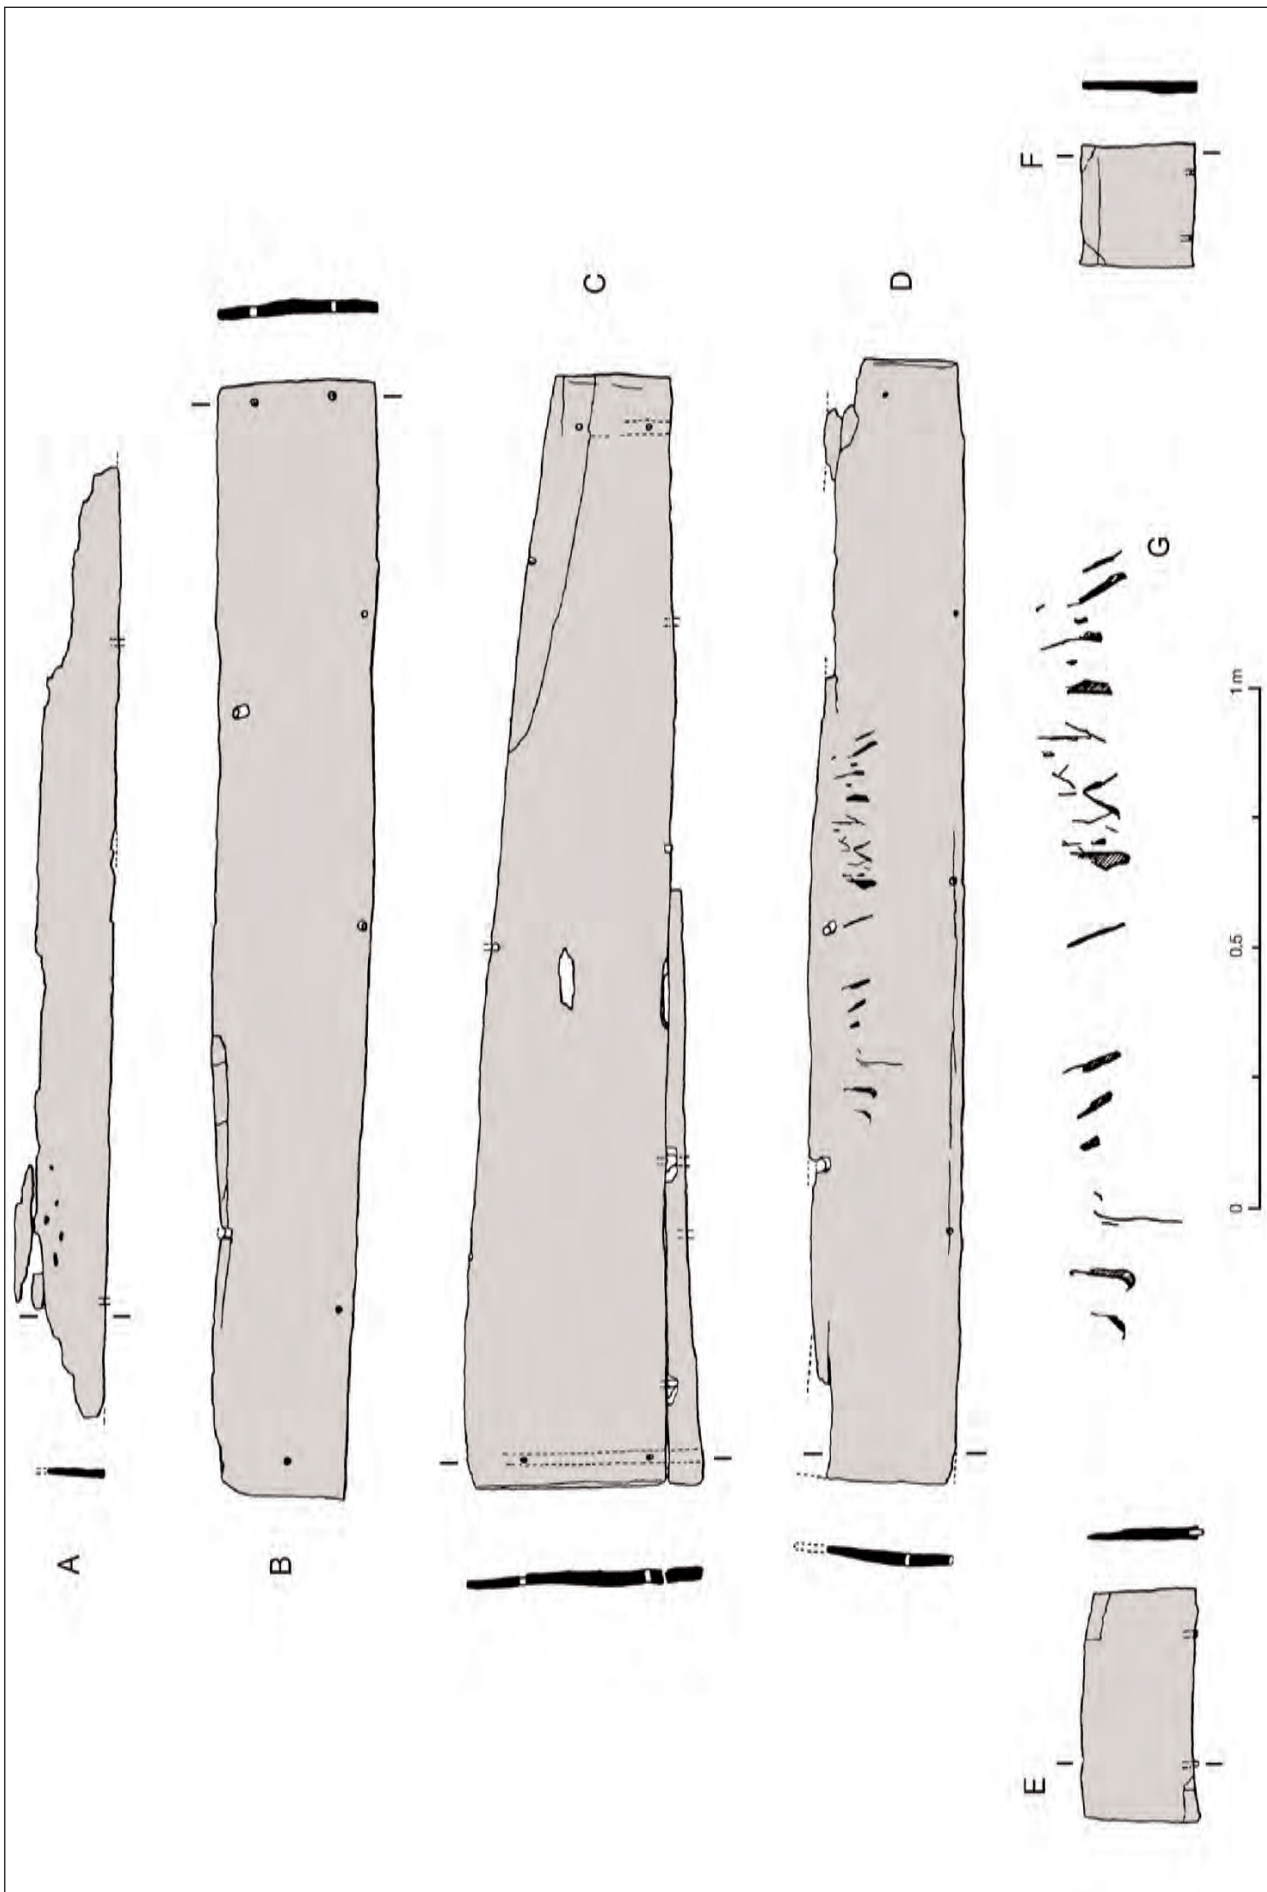
Fig. 213: Coffin, grave F5044, outline drawing. (A) lid; (B) north side (exterior); (C) base (interior); (D) south side (exterior); (E) west end; (F) east end; (G) inscription(?) on south side. Scale 1:15, except inscription, 1:7.5. Drawing: Judith Dobie

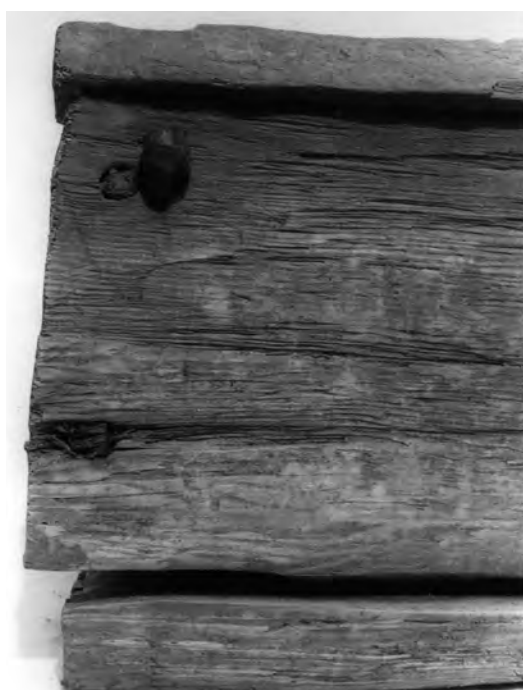
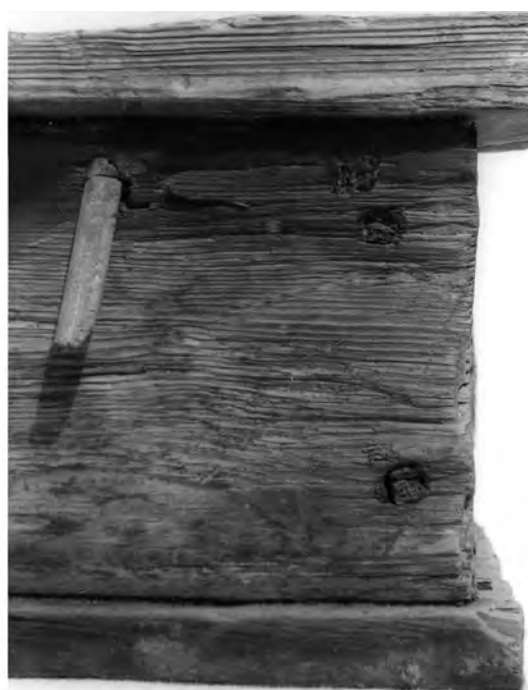
Fig. 219: Coffin, grave F5474. Details of pegging. A South side, west corner; B North side, west corner. Photo: Warwick Rodwell

face of the board. The ends were split and wedged. The lid was fixed with three pegs which were only slightly skewed from the vertical (*i.e.* not inserted at *c.* 45 degrees, like those in the oak coffins). One, on the north side, was 100 mm long and protruded through the side of the coffin, but was not trimmed off flush (Fig. 219B).

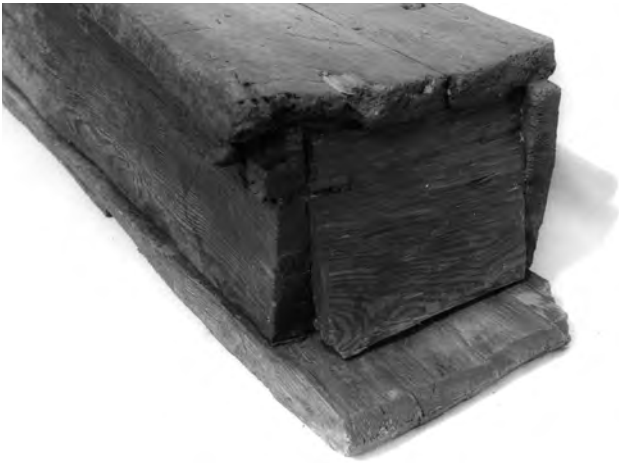
Fig. 220: Coffin, grave F5474. The coffin from the south-east, showing the tilted east end board. Photo: Warwick Rodwell

two vertical pegs did not re-engage with the holes in the west end-board, which simply sat down on the base. Consequently, when the coffin was excavated, it was found with the east end skewed, and the basal pegs at the west end performing no function, but simply projecting into the internal void.

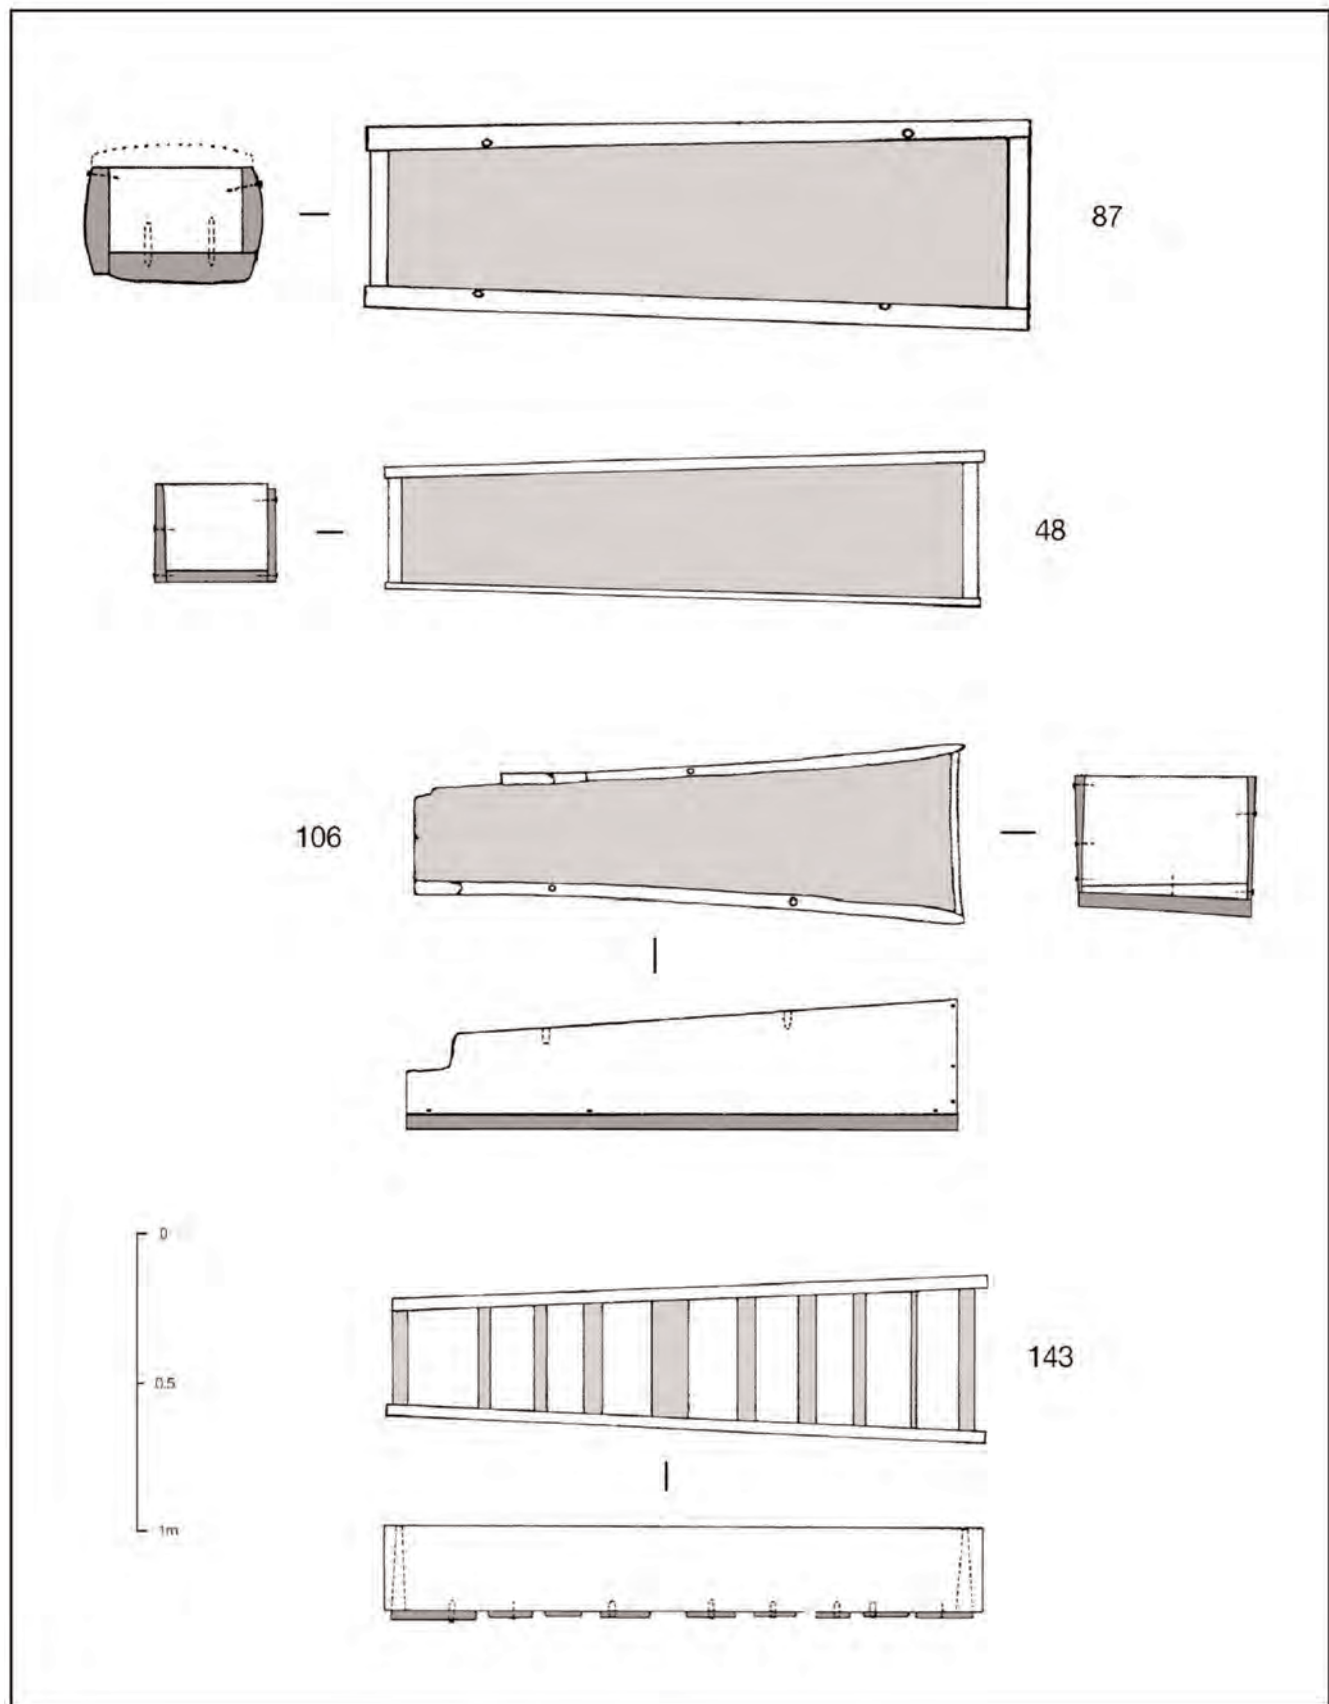
Fig. 224: Lund, Sweden. Details of coffin construction, graves 48, 87, 106 and 143. Scale 1:25. After Blomqvist and Mårtensson 1963

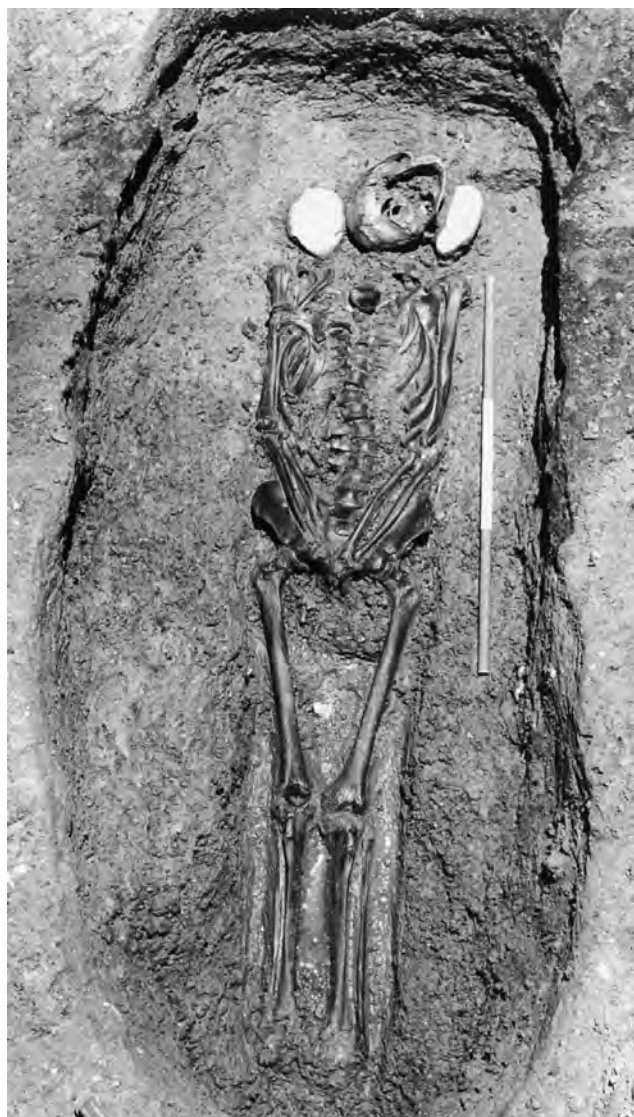
*Fig. 225: A large, squarely cut grave (F1621) containing vestigial remains of a timber coffin which was a close fit for the corpse. The skull was supported by two flint nodules. View west. Scale of 75cm. Photo: Warwick Rodwell*

Head-supporting stones were recorded in fifty-four of the excavated graves, nearly all of which were certainly coffined. While the evidence for a coffin was slight in five of these burials, grave size and shape provide convincing indications (*e.g.* F1621; Fig. 225). There were only two examples (F7311 and F7405) of stones used to prop the skull in definitely uncoffined burials (although even these may have had timber covers). Two arrangements were noted: 'pillow-stones' (one or more stones placed under or behind the skull to support it) and 'ear-muffs' (a pair of stones flanking the skull to prevent the head from rolling to one side). The materials used for these supports were very varied and clearly not specially selected: they included flint, chalk, sandstone and other erratics, quern fragments and domestic objects of fired clay (*e.g.* loomweights).

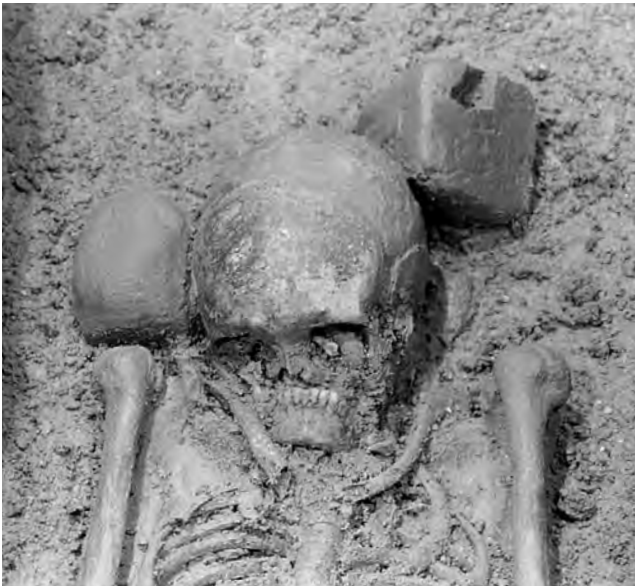
Fig. 226: Grave F1424, showing a pebble and a clay loomweight (right) used as skull supports. Photo: Warwick Rodwell

Twenty-six graves each contained two supporting stones, all but nine of which exhibited explicit evidence for a coffin. One of the exceptions, grave F3966, contained a piece of burnt limestone on the north side of the head and a fired-clay loomweight on the south (both ear-muffs were red in colour, but this was probably fortuitous rather than by choice), and was thought at the time of excavation to lack a coffin, being covered instead by a charred board. However, the grave was large enough to have held a complete coffin or timber lining, and the charred board covering the burial may have been the only surviving evidence for this. In the case of F4124 an indentation in the sandy base of the grave revealed the outline of the coffin, of which nothing survived. Inside, the skull had two supports, one a pebble and the other a triangular clay loomweight (Fig. 226).

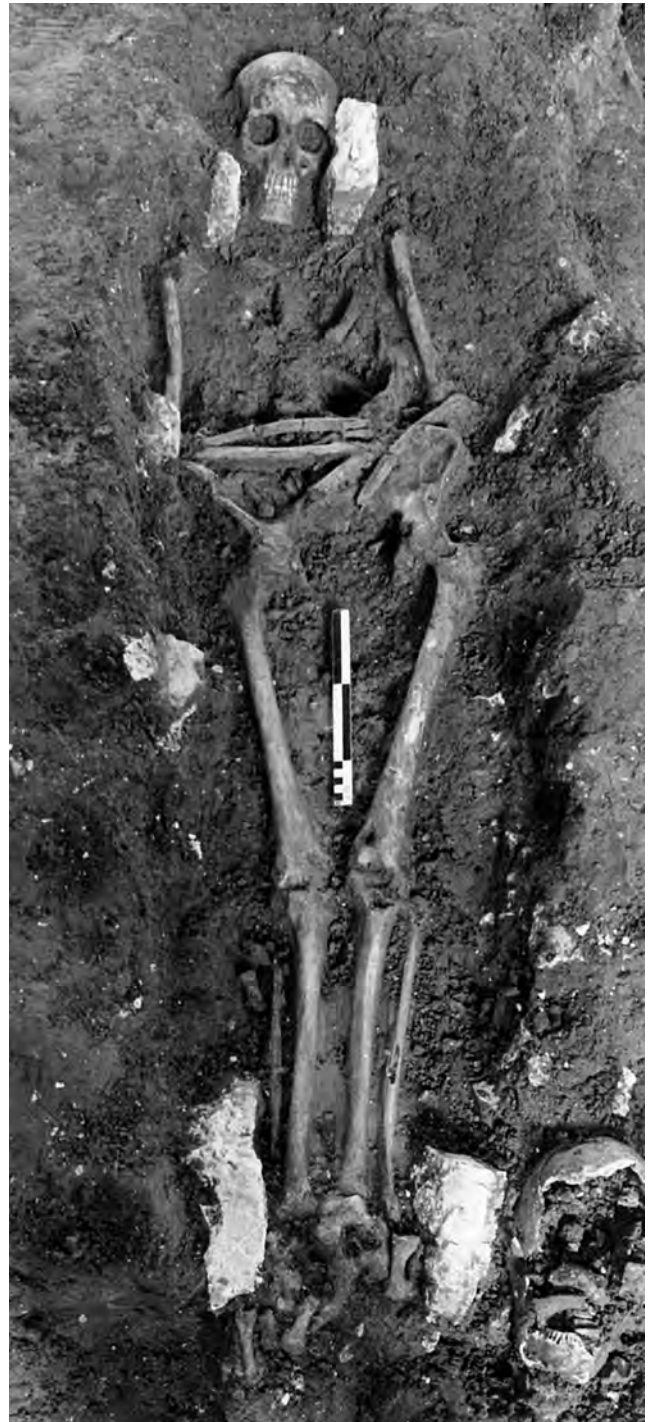
Fig. 227: Grave F1464. A coffined burial with chalk blocks supporting the skull and feet. View west. Scale of 25 cm. Photo: Warwick Rodwell

side, and two smaller pieces (one of limestone, the other a fragment of gritstone quern) cradling the top of the head. There were no instances of additional stones laid over the face, as at Raunds (*cf.* Boddington 1996, figs. 46–9 and 54). A single instance of stones at the feet was recorded in a coffined burial: grave F1464 had two flat pieces of chalk serving as ear-muffs, and two more as ankle-props (Fig. 227). Another piece of chalk beside the dexter thigh was probably fortuitous.

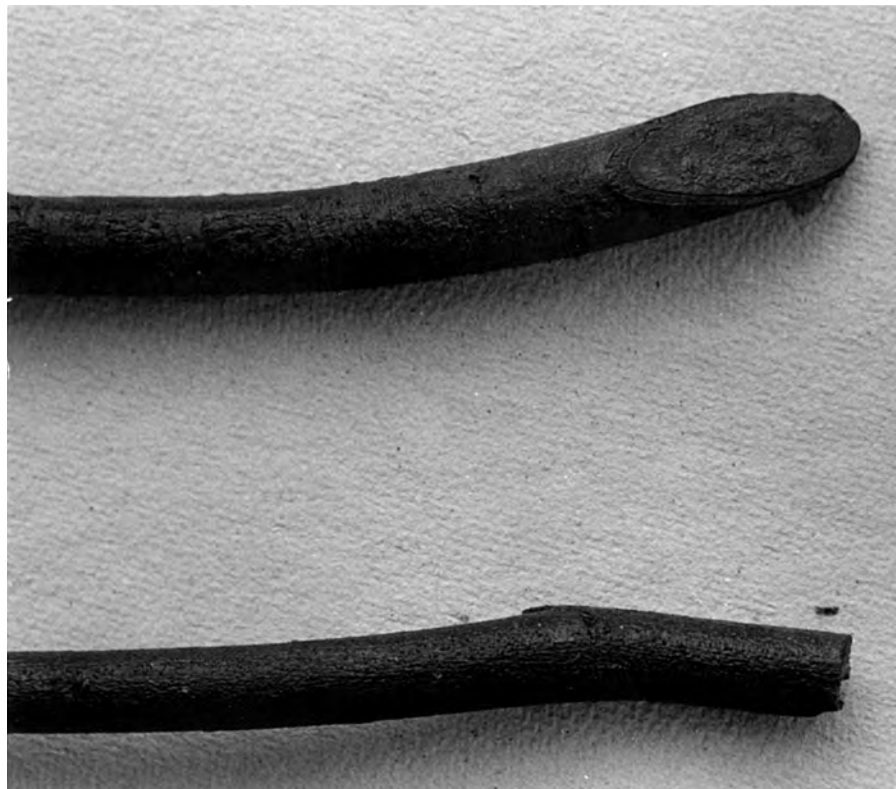
*Fig. 229: Grave F1790. A, The two coppice-rods of willow/poplar; B, Details of one obliquely cut and one snapped end. Photos: Warwick Rodwell*

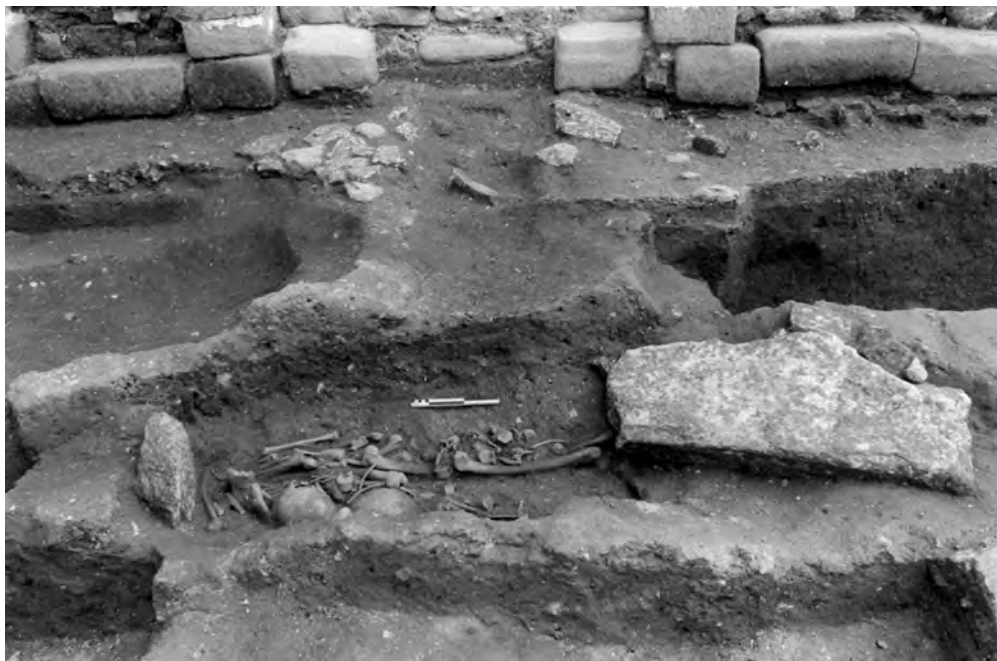
Fig. 233: Grave F7263. As found, with the charnel deposit in the upper filling, and the broken and partly displaced grave-cover. View south, showing also the hollow path leading to the (blocked) north door of the tower. Scale of 25 cm. Photo: Warwick Rodwell

The grave was shallow and the upper part of the fill contained an assemblage of disarticulated bones which included two skulls (Figs. 233 and 234). The bones had clearly been laid with some care and extended along the full length of the grave, but their origin is unknown: there was no indication that the grave had disturbed any earlier interments. Laid directly over the disarticulated remains at the west end was a large fragment of a tapered limestone grave-cover (F7292) and several small fragments of similar material. The cover was probably at contemporary ground level, but had been slightly disturbed: it was skewed off-axis and tilted. Later features had removed any cover-stones that might have lain over the middle and eastern parts of the grave.

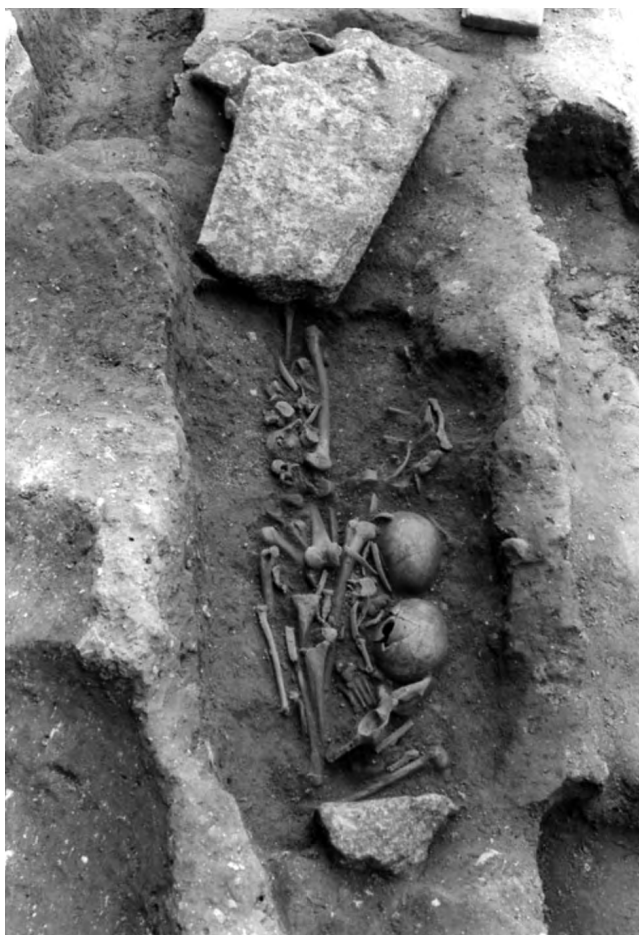
Fig. 234: Grave F7263. Detail of the chancel deposit and fragments of limestone grave-cover. View west. Photo: Warwick Rodwell

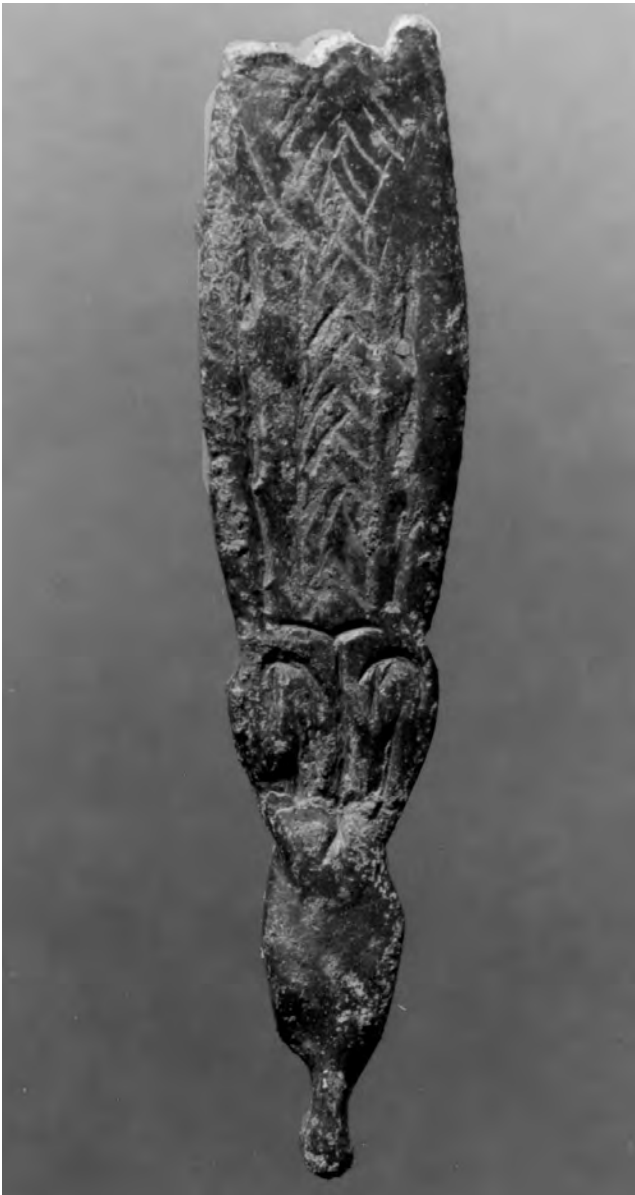
*Fig. 237: Copper-alloy strap-end with cast and incised decoration. Ninth century. Length 56 mm. Photo: Warwick Rodwell*

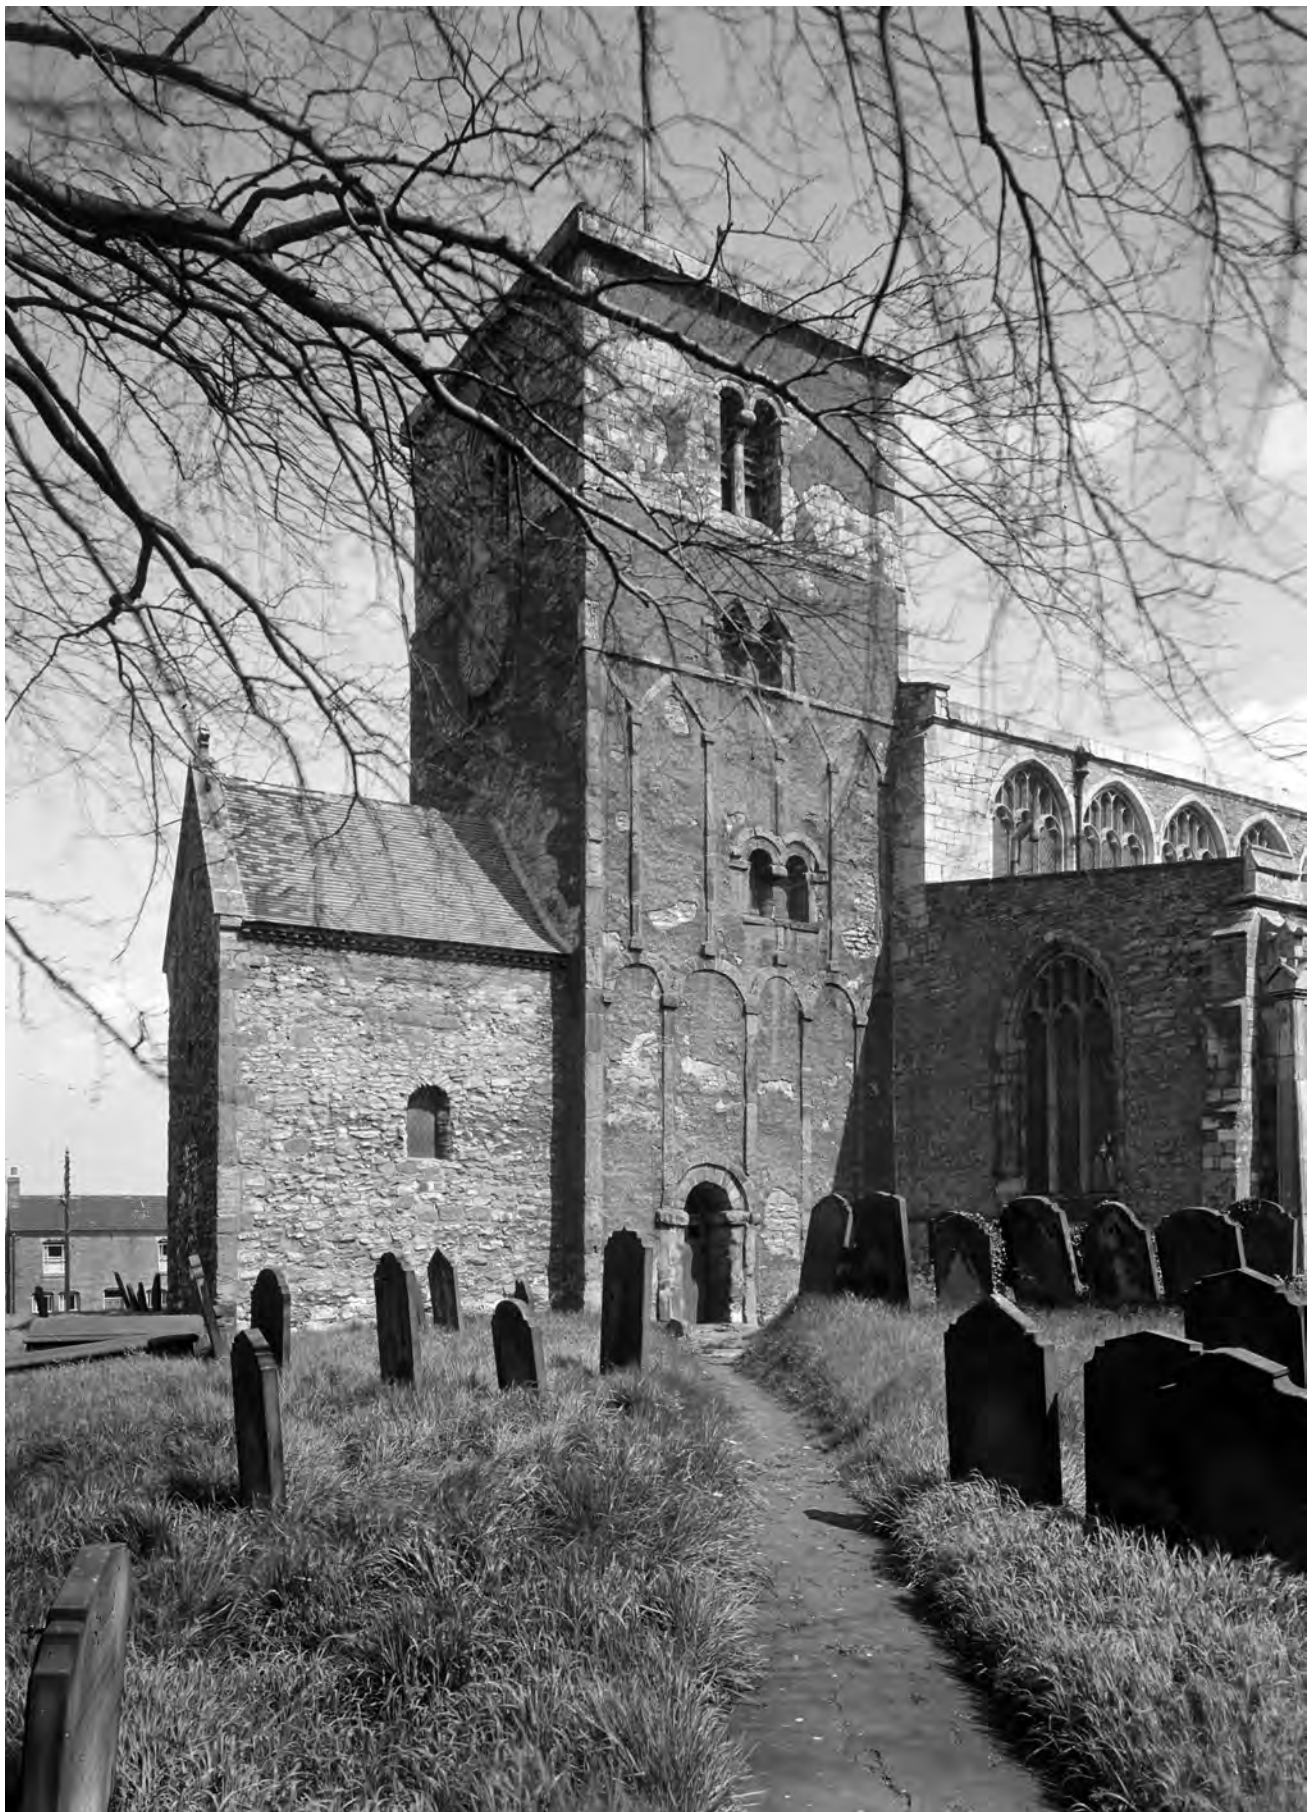
*Fig. 239: St Peter's tower and annexe from the south-west, 1953. This shows the church prior to re-rendering in 1965 and graveyard clearance in 1966. Photo: English Heritage, NMR*

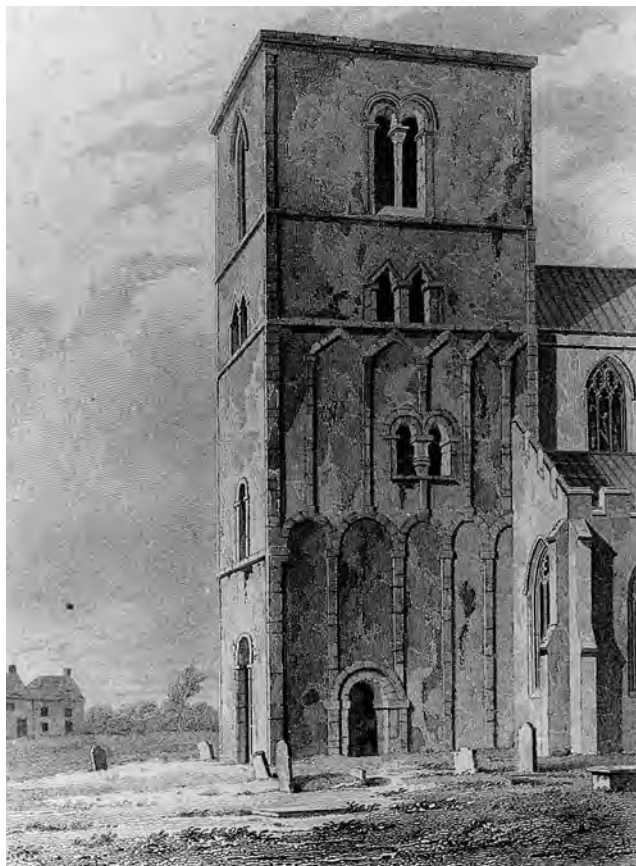
Fig. 242: St Peter's tower from the south-south-west, omitting the western annexe. Drawn by Augustus Pugin, 1819. Britton 1826
