# ST PETER'S

## Barton-upon-Humber, Lincolnshire

*A Parish Church and its Community*

HISTORY, ARCHAEOLOGY AND ARCHITECTURE

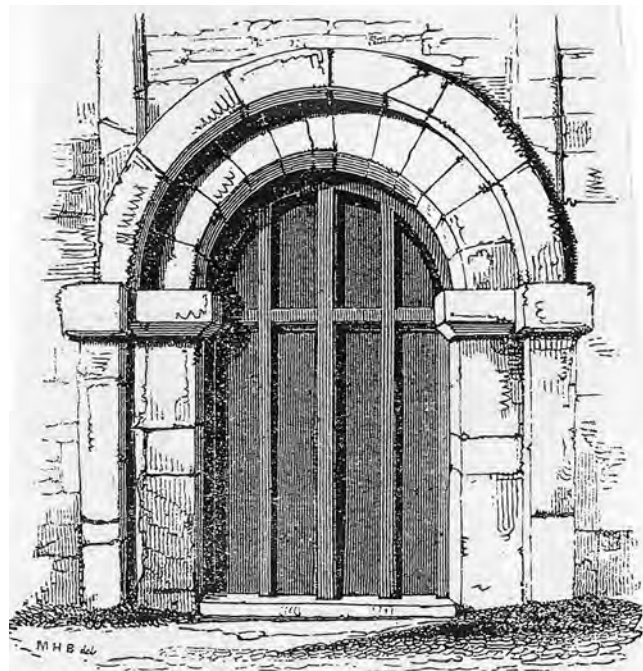
Fig. 249: Tower doorways. A (upper), north (interior, despite the grass in the foreground), drawn by J.H. Parker and O. Jewitt in the 1840s (cf. Fig. 321). B (lower), south (exterior), drawn by M.H. Bloxham in the 1830s. Note the Tudor panelled door, which is no longer extant. Both drawings are at the same scale. Rickman 1848; Bloxham 1841

The south elevation of the tower was drawn by Hesleden in the early 1830s, with only a hint of the annexe shown (Fig. 247).<sup>11</sup> For the work of a Bartonian, this view embodies some curious errors, most notably the relationship of the pilaster-strips to the south doorway.<sup>12</sup> Hesleden also drew a pair of views of the tower doorways, equally remarkable for their inaccuracy: the south door has the imposts at dramatically different levels, and the relationship between the doorway and the pilasters bears no resemblance to reality; the north doorway is shown from the interior. This is one of only two antiquarian views taken from that side (Fig. 248).<sup>13</sup> Comparison with other contemporary drawings of the doorways is instructive (Fig. 249).

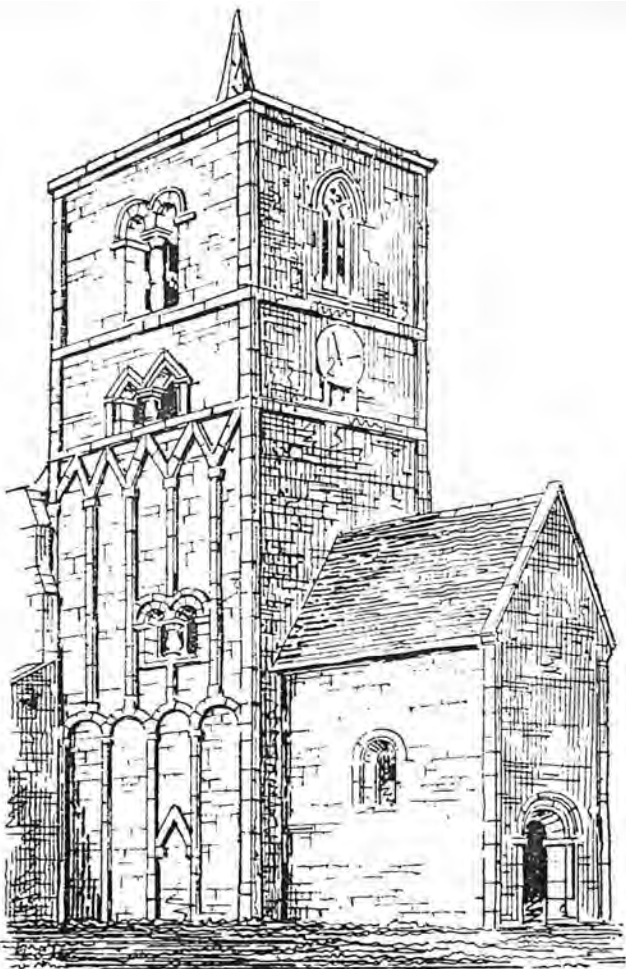
Fig. 251: Tower and western annexe. View from the north-west, showing the intruded west doorway and a flèche for which there is no other evidence. Drawn for Sir George Gilbert Scott in the 1860s. Scott 1879

in the annexe, which subsequently resulted in its dismantling and the infilling of the opening, in 1869–70. Although short-lived, the alteration was recorded in a drawing by Sir George Gilbert Scott, and subsequently published in 1879 (Scott 1879, 54) (Fig. 251). The doorway was to cause great confusion in the architectural record for a century to come. Even as early as 1867, the modified annexe was accepted as 'a building, forming a kind of porch or galilee, also of rude and early character ... [with] rude round-headed doorways to the Tower and at the west side' (Glynne 1898, 201–2).

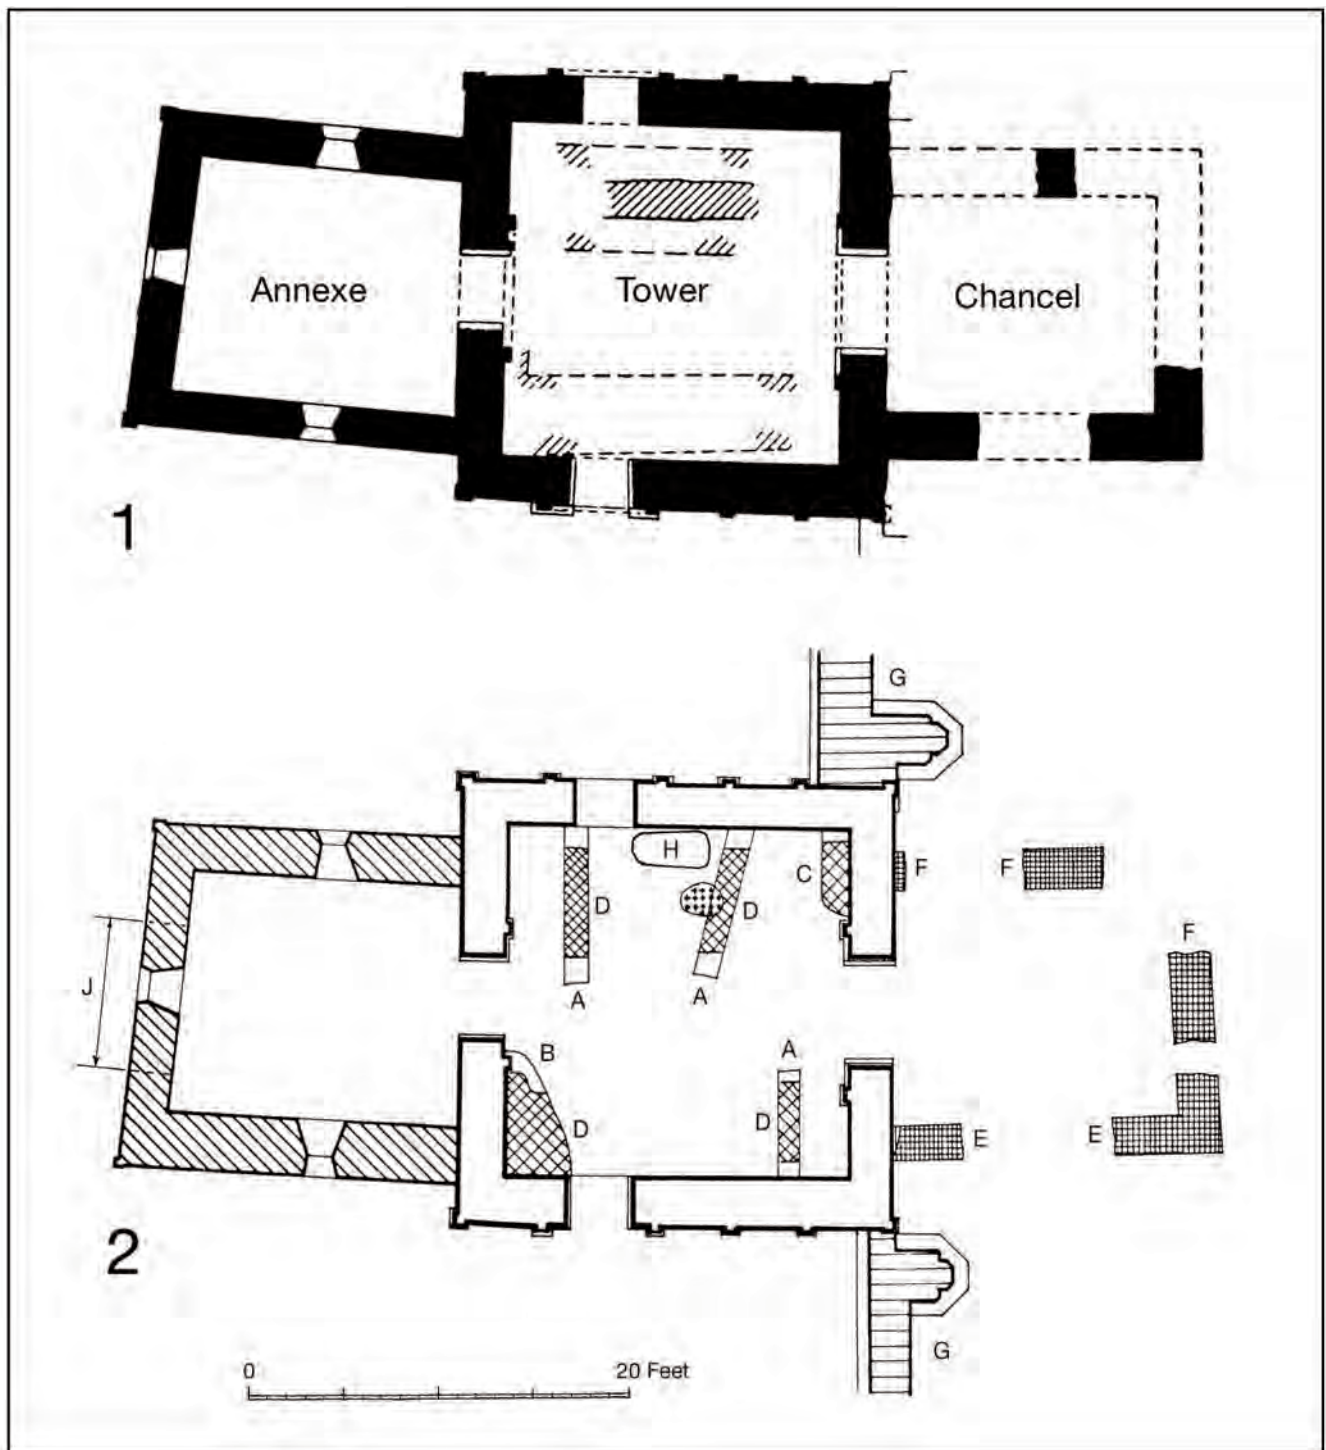
Fig. 254: Archaeological plans of the Anglo-Saxon church. 1, interpretive drawing showing the supposed earlier foundations (hatched) under the floor of the turriform nave, based on Bilson's excavations of 1912–13. Drawn by A.W. Clapham. 2, plan showing archaeological trenches. A, excavated 1913; B, excavated 1913 and 1945; C, excavated 1945; D, mortar 'foundations'; E, foundations of chancel, seen 1898; F, foundations of chancel exposed 1951–54; G, walls of medieval aisles and arcades; H, brick-lined furnace; J, infilled west doorway. Drawn by H.M. Taylor. Clapham 1930; Taylor 1974b

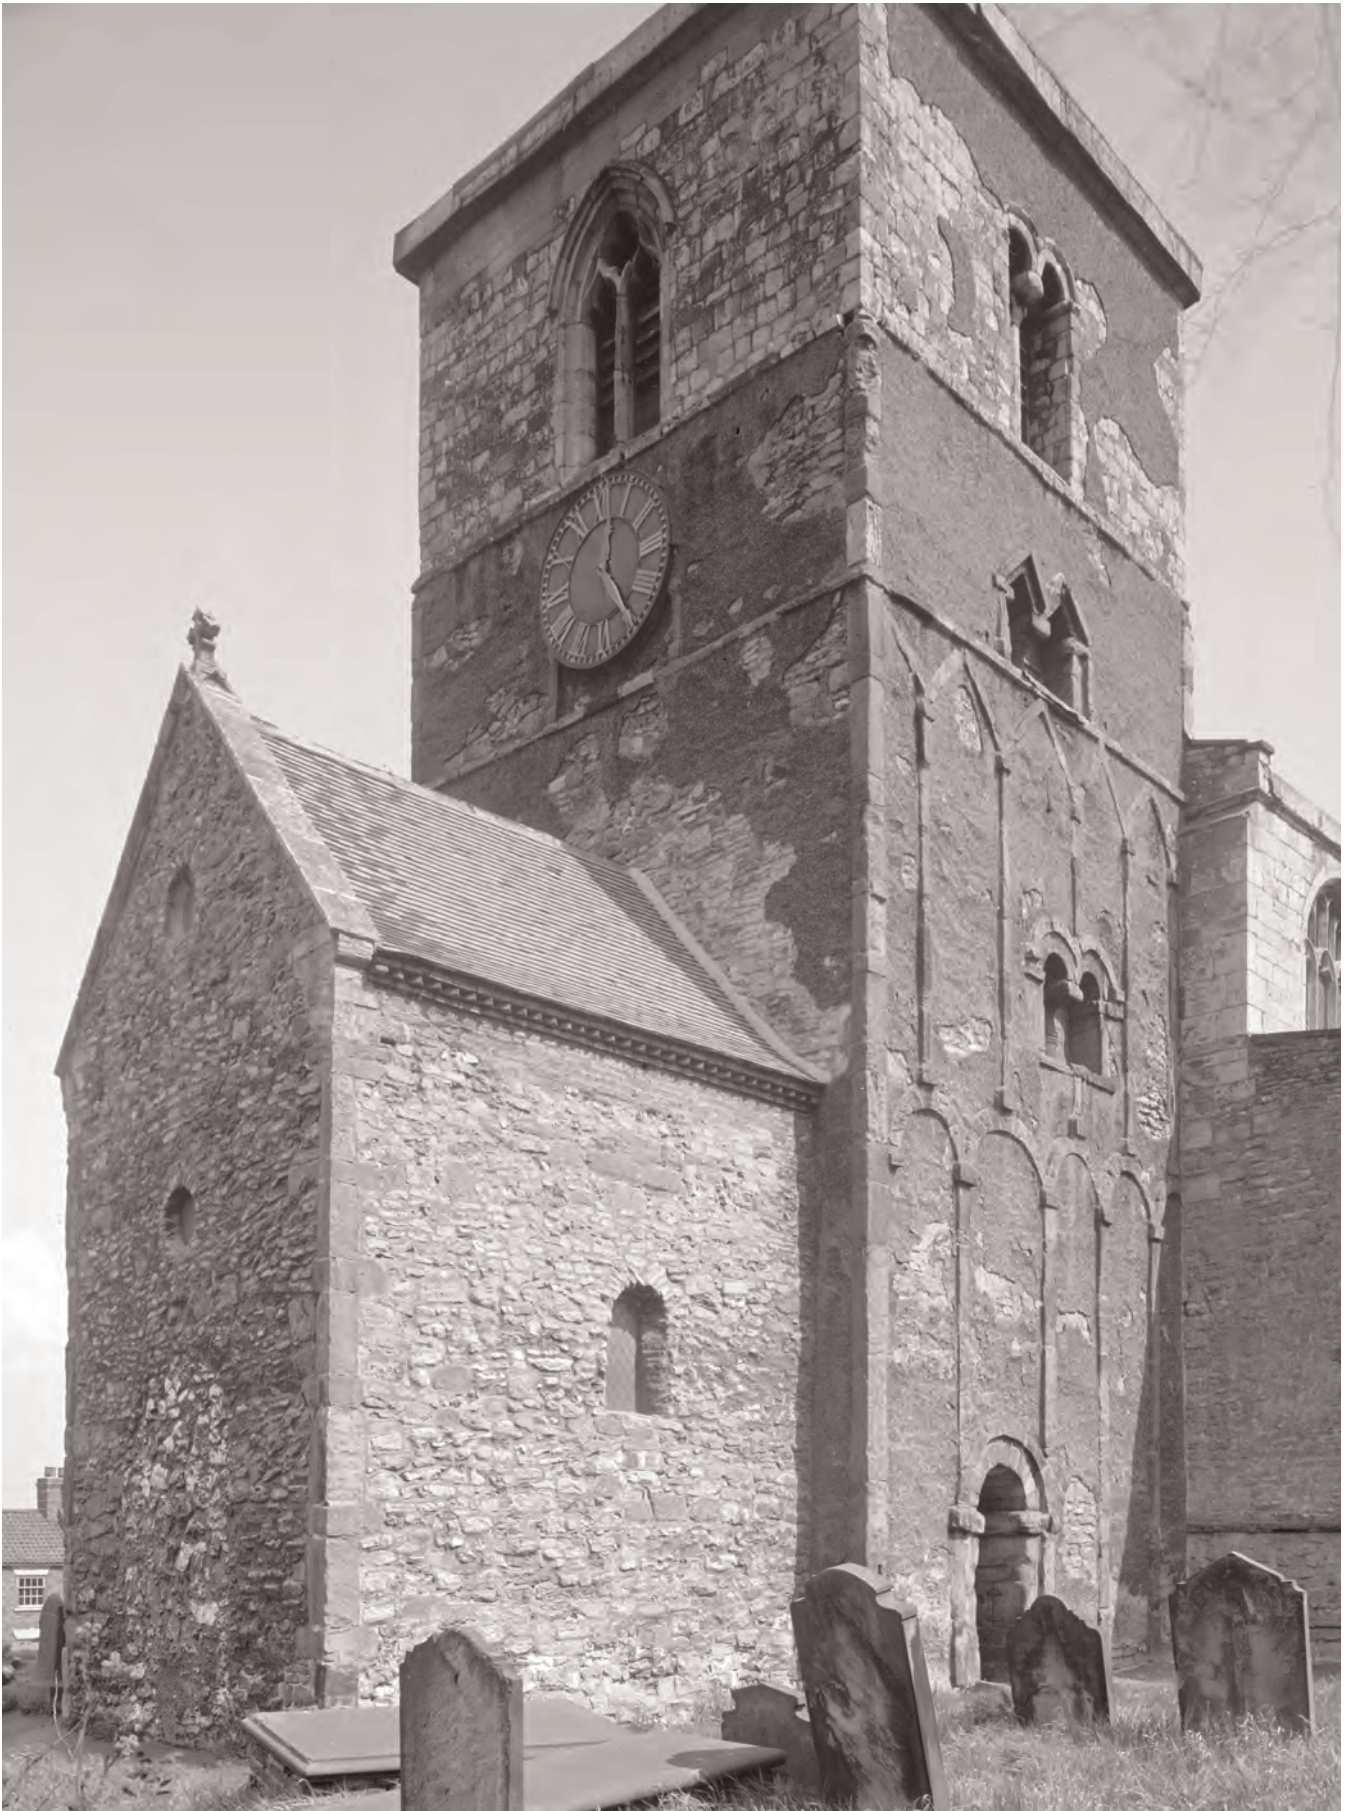
*Fig. 255: Tower and western annexe, 1953. By this time the rendering had been stripped from the annexe, revealing the infilled doorway in the west wall. Photo: English Heritage, NMR*

In 1923, Varah caused the Victorian pebbledash to be removed from the exterior of the annexe (Fig. 255; Varah 1928, opp. 4), fully revealing the infilled opening, which gave rise to ‘much comment of varying value. One remark, made by more than one person, that the western door was used within little more than living memory, needs to be mentioned as a certain case of mistaken recollection lest it should gain currency, as it might well do in the absence of any authentic knowledge’.<sup>42</sup> Nevertheless, the man who had been responsible for dismantling the pseudo-Saxon doorway was still living at the time.<sup>43</sup>

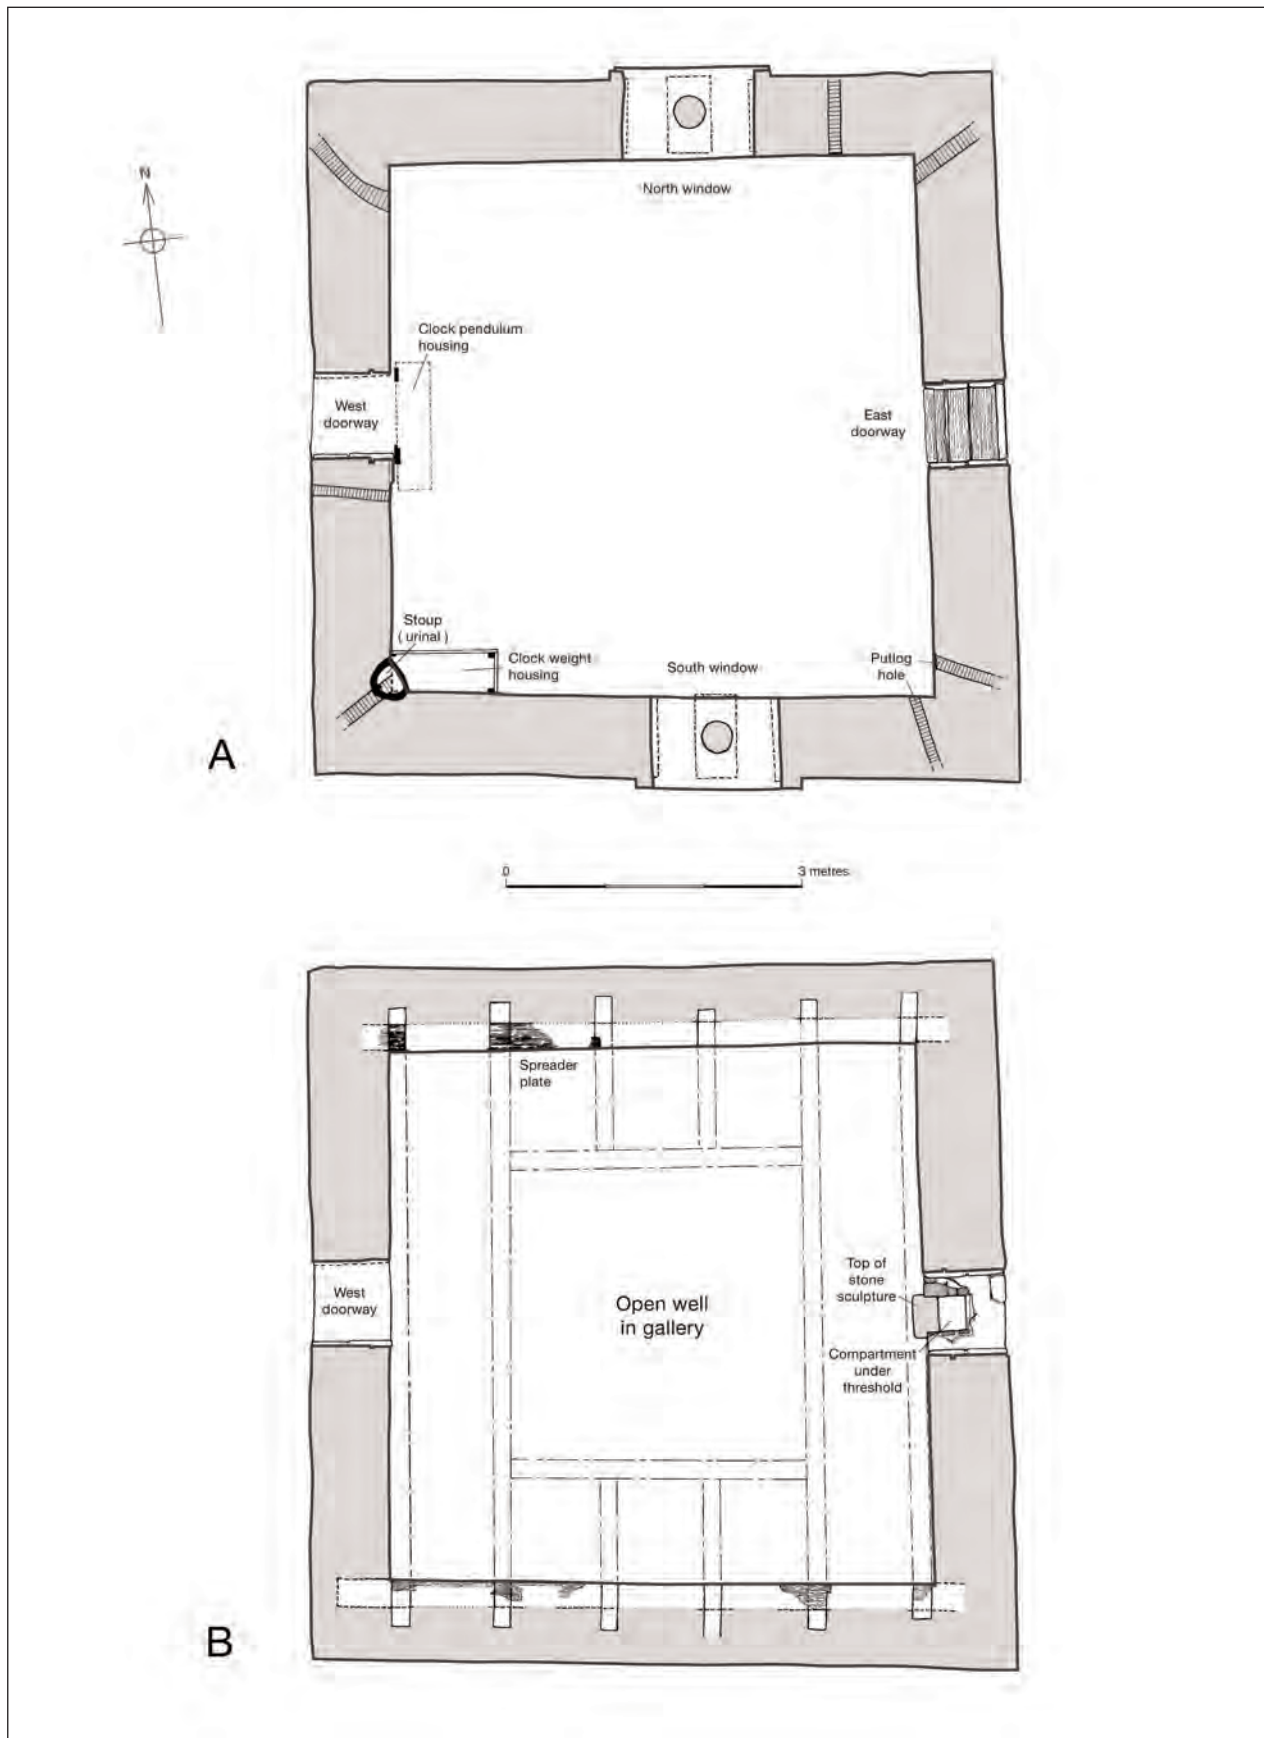
Fig. 257: Tower: plans of Stage 1B, 1980. A, window sill level, showing investigated putlog holes and later features associated with the post-medieval ringing-chamber; B, floor (gallery) level, showing the remains of the spreader-plates in the north and south walls and pockets for the six joists. The floor-frame for the gallery has been reconstructed. The compartment under the timber threshold of the east doorway is post-medieval. Scale 1:75. Drawings: Warwick Rodwell

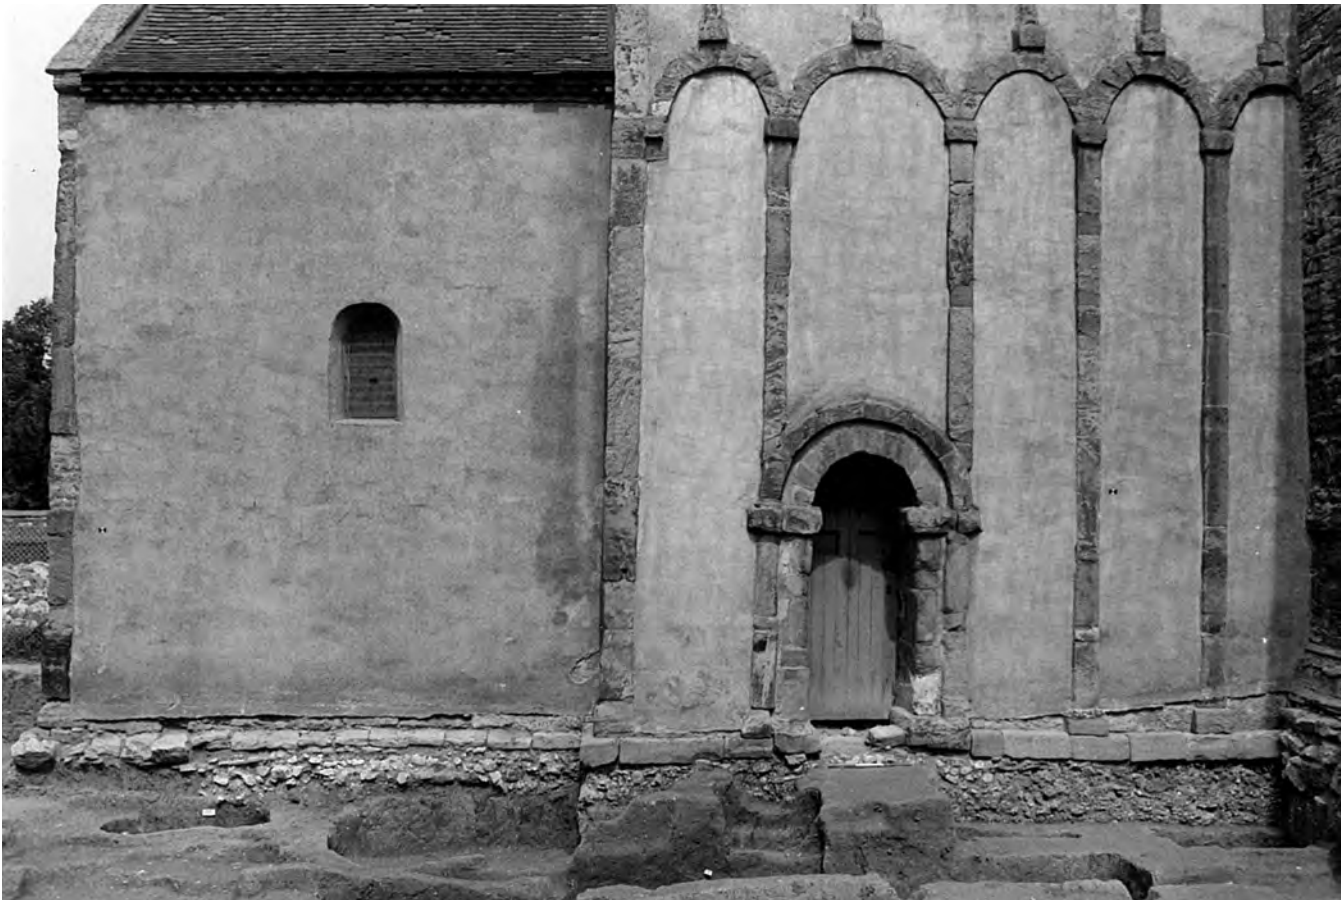
Fig. 260: Tower (Stage 1A) and annexe from the south, after excavation, 1981. Photo: Warwick Rodwell

Externally, the tower measures 7.2 m (23½ ft) square in plan, and the walls rise from a ground-level plinth comprising large blocks of gritstone of varying lengths (Fig. 260). The plinth is square-edged, unmoulded and projects by 5–10 cm beyond the wall face. It is interrupted by the doorways and does not continue across the east and west faces, returning only far enough to meet the abutments of the chancel and baptistery, both of which had their own plinths.

The first register (Stage 1A) comprises five bays of tall, narrow arcading with semicircular heads (Fig. 260). The pitch approximates to 1.2 m (4 ft), except in the case of the second bay from the west, where, on both the north and south, it has been expanded to 1.7 m (5½ ft) to accommodate a doorway, and the arch has been commensurately flattened and stretched to fit. Although varying in size, the voussoirs of the arches have been individually shaped, and many are non-radially jointed; between adjacent bays are special voussoirs, acting as double springer-blocks (Fig. 261). The voussoirs are so eroded that many now give the impression of being bevelled on the upper face, which was not originally the case. In each arch the central keystone is larger than the other voussoirs, but does not project beyond them. Being protected from above,

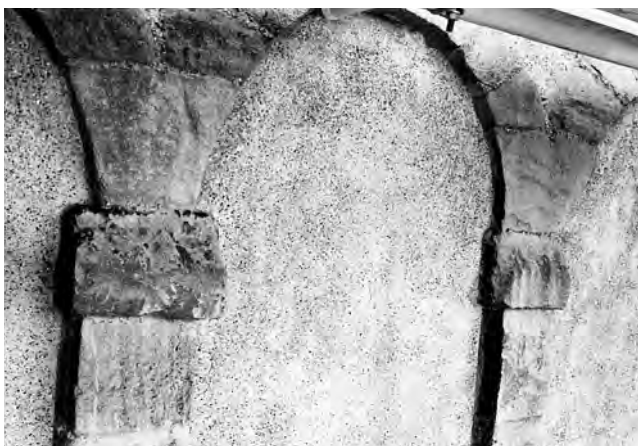
*Fig. 261: Tower: Stage 1A, north. Wall-arcading, showing trapezoidal double-springers supported by the plain rectangular capitals of the pilasters. Photo: Warwick Rodwell*

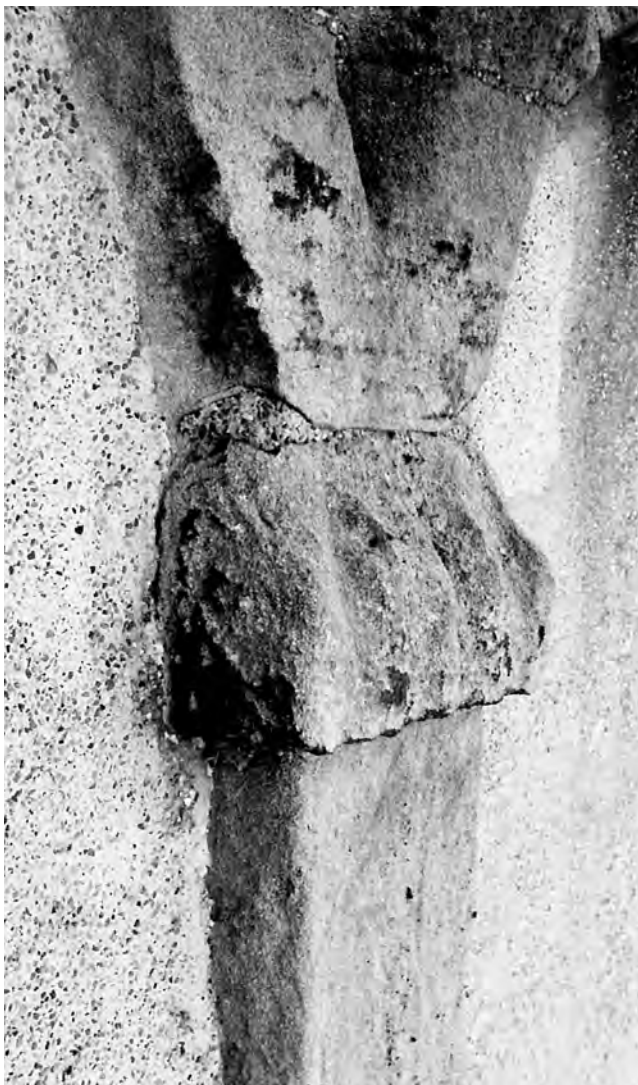
*Fig. 262: Tower: Stage 1A, south. Plain rectangular capital, now heavily eroded and giving a false impression of being decoratively fluted. This capital supports the only example of a double-springer at this level which was specially shaped to seat the lowest voussoirs of the adjoining arches. Photo: Warwick Rodwell*

The springers rest on plain rectangular capitals which are only slightly wider than the pilaster-strips that support them. Many of the capitals give the appearance of having bevelled upper angles, or fluting on the vertical faces (Fig. 262). Again, these 'decorative' effects are entirely fortuitous, being the result of weathering and variations of hardness within the 'grain' of the gritstone. The effects can be of dramatic appearance and are present throughout the tower. By and large, tall vertical stones were edge-bedded, and many of these have developed pseudo-fluting (*cf.* Potter 2005). By contrast, blocks that have their longer dimension in the horizontal plane were face-bedded and weathering has given them false bevels and semblances of other linear mouldings.

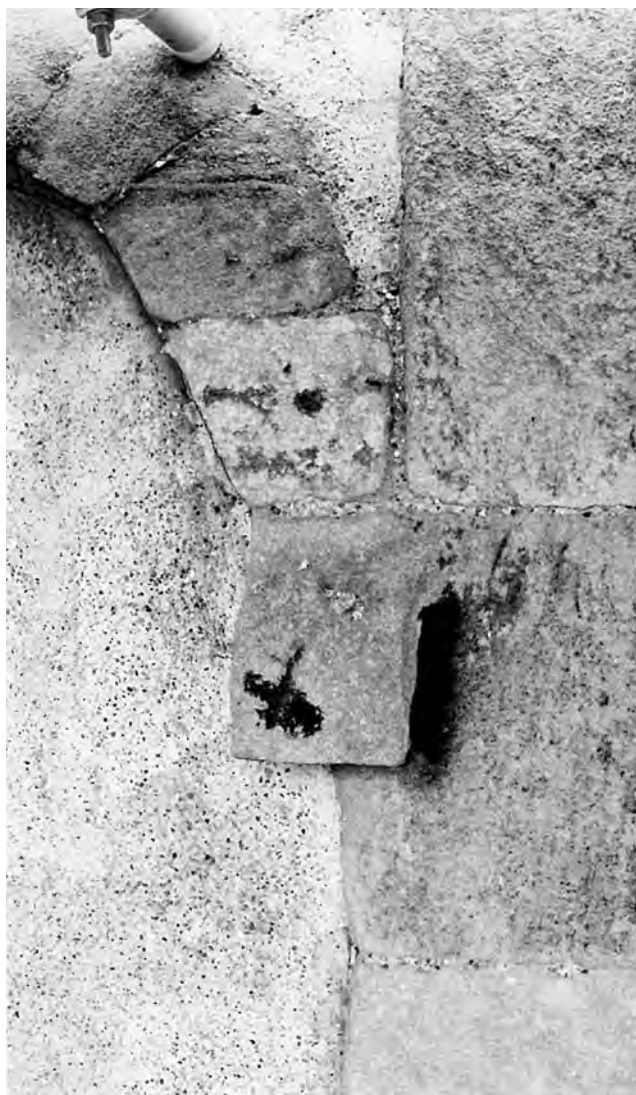
*Fig. 263: Tower: Stage 1A, north. Square impost at the west end of the wall arcading. This detail, which is integral with the ashlar of the north-west quoin, projects both laterally and forwards. Note the small, non-radial voussoirs. Photo: Warwick Rodwell*

At the western ends of the arcades, the arches spring from plain imposts or brackets which are integral with the quoins of the tower; these specially shaped blocks represent a higher level of sophistication in masoncraft than is present at some of the other points of junction (Fig. 263). The eastern terminations of the arcades are doubtless similar, but are concealed by the abutment of the medieval aisles. The pilaster-strips are of regular long-and-short construction, and each has a plain rectangular base-block similar to the capital, resting on the ground-level plinth (Fig. 264).

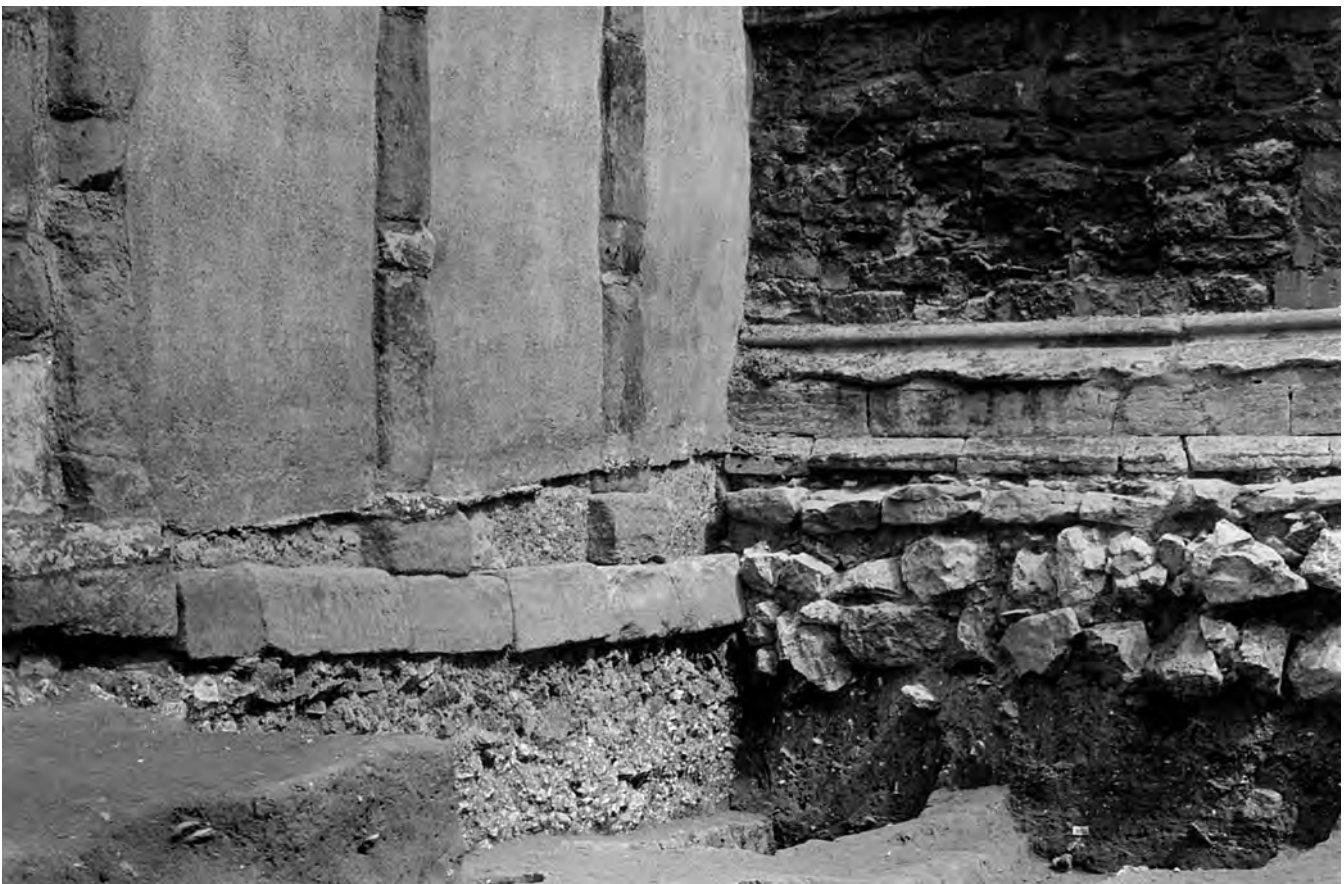
*Fig. 264: Tower: plinth and base-blocks of the pilasters, exposed by excavation. These had been buried by the rising churchyard level by the late thirteenth century, when the south aisle (right) was built. Photo: Warwick Rodwell*

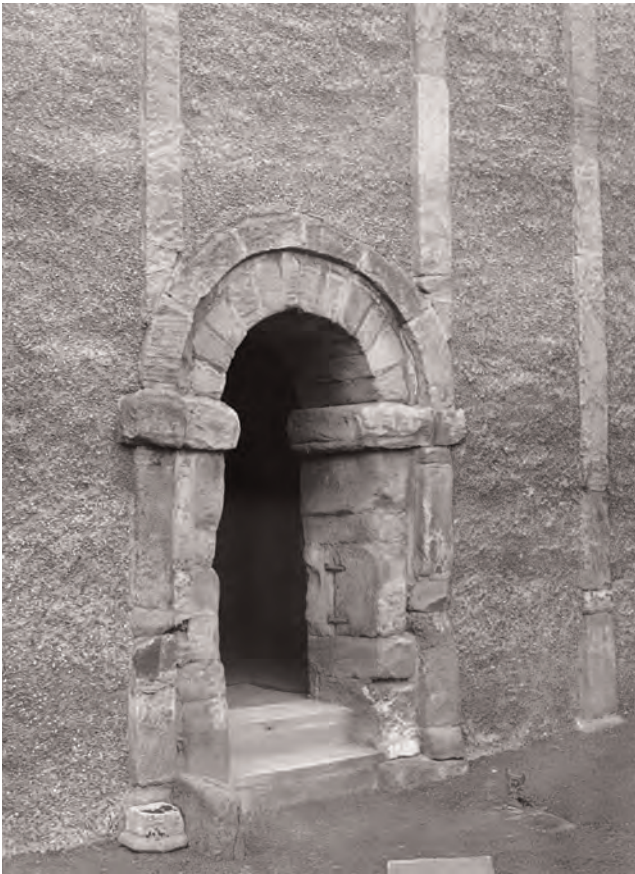
Fig. 266: Tower: south doorway, c. 1900. Taken before internal floor level was lowered and the steps removed. This also shows the pebbledash rendering that was applied c. 1870. Photo: English Heritage, NMR

**South doorway** (Figs. 259, 5, 266 and 267)

The round-headed doorway is set in the second of the five bays of external arcading. The opening is 1.05 m (3½ ft) wide and passes through the full thickness of the south wall without rebate or splay. The jambs are lined with gritstone blocks, alternating between deep and shallow courses, thus giving an external appearance of long-and-short work.<sup>47</sup> The jambs are founded on base-blocks that project both forwards and laterally (5 cm) into the opening, and are also raised slightly above the general plinth level. Surmounting the jambs are heavy impost blocks, again projecting forwards and laterally, and the lower arris bears a moulding (Fig. 268, nos. 3 and 4). The semicircular arch is composed of twelve unmoulded voussoirs. Outlining the doorway is a plain, square-section label, the ends of which are seated on small blocks projecting from the flanking stripwork of the wall arcading. The label interrupts the stripwork, thereby imparting greater *gravitas* to the doorway.

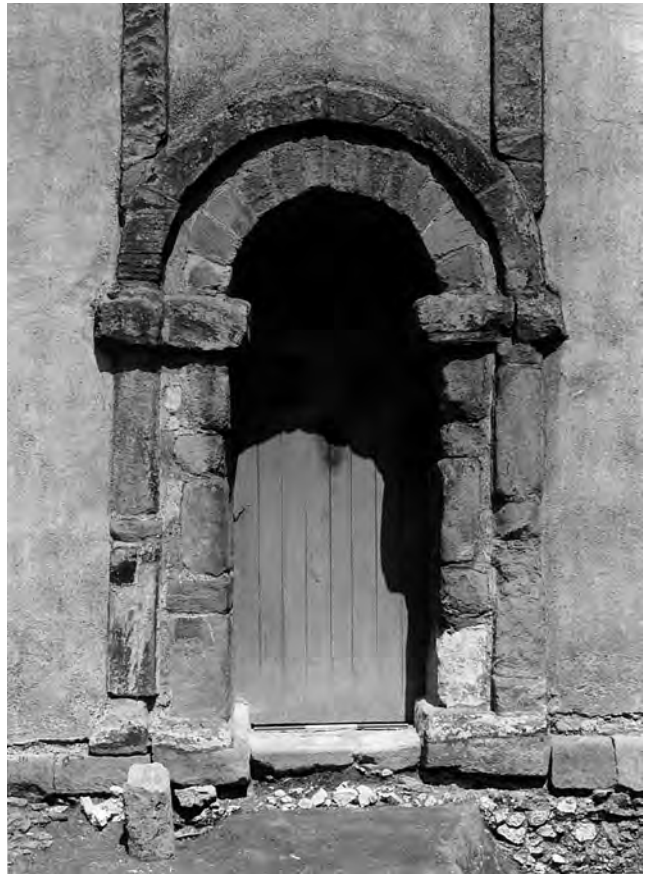
Fig. 267: Tower: south doorway and threshold, fully revealed after excavation, 1981. Scale of 75 cm. Photo: Warwick Rodwell

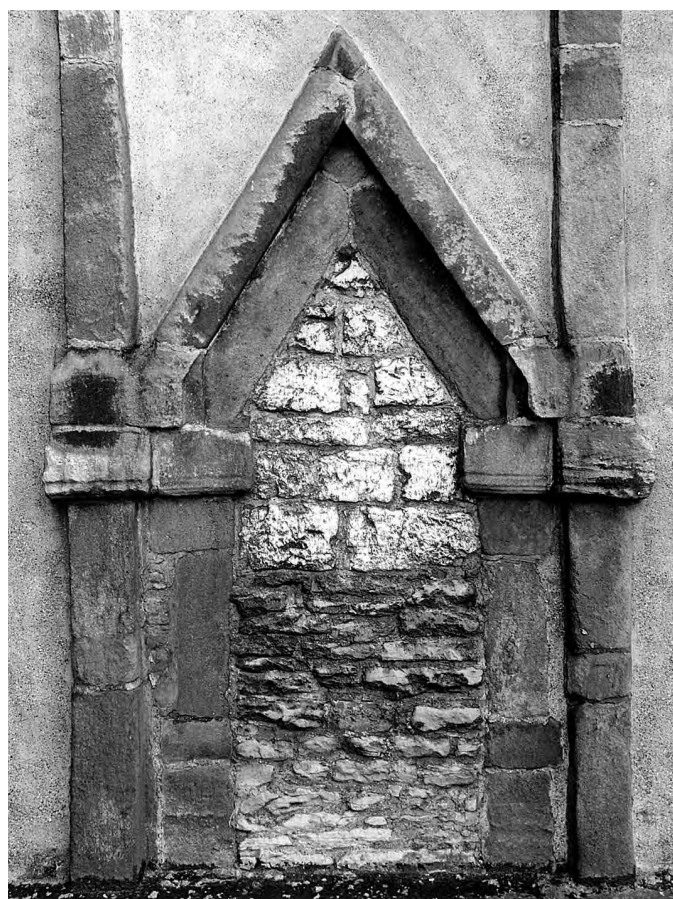
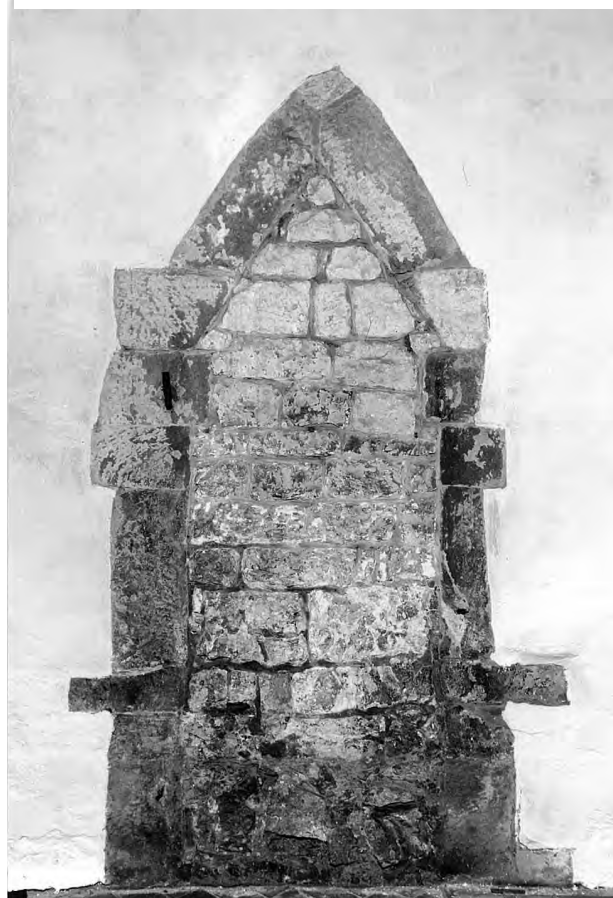
A (left) and B (below)

Fig. 269: Tower: Stage 1A, north doorway, 1972. A, external, and B, internal views at the same scale and vertically registered, illustrating the difference between ground and floor levels. Photos: English Heritage, NMR

**North doorway** (Figs. 259, 7, 269, A, and 270)

Directly opposite the south doorway is another of slightly smaller size, with a triangular head. Up to impost level the construction is identical, but the width is only 92 cm (3 ft). However, instead of carrying a ring of voussoirs, the moulded imposts support a pair of canted slabs forming a steeply pointed head to the opening (Fig. 271, A). The mouldings are similar to those on the south doorway (Fig. 268, nos. 1 and 2). Also, the imposts are extended laterally by additional blocks that break through, and bond with, the vertical lines of the decorative stripwork. Furthermore, the triangular head is flanked by an outer order of stripwork (the equivalent of a label), which projects further and is seated on corbel-like blocks that are integrated with the vertical stripwork (Pl. 23; Fig. 271, B). The north doorway displays the most sophisticated masoncraft in the tower, a fact doubtless observed by Buckler in the 1820s, when he made careful drawings to illustrate its construction (Fig. 245).

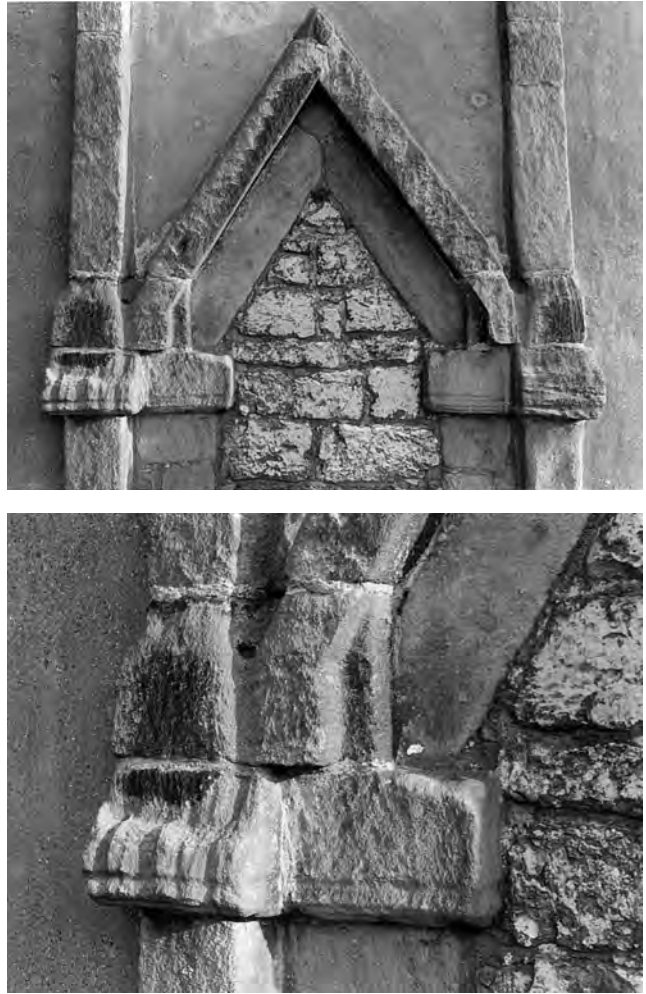
Fig. 271: Tower: north doorway. A (upper), the triangular head. B (lower), construction detail of the eastern impost. Photos: Warwick Rodwell

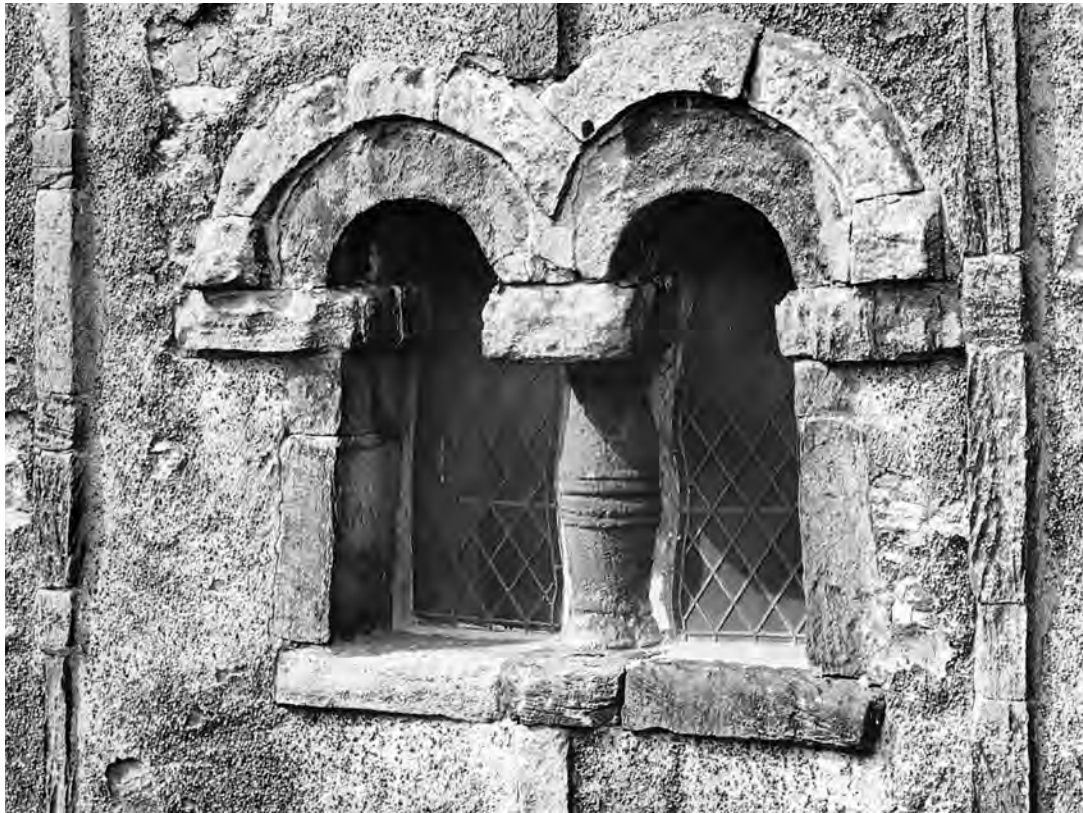
Fig. 272: Tower: Stage 1B. South gallery window, 1965. Photo: David Lee Photography

**North and south windows** (Fig. 272)

There are no windows in Stage 1A, but Stage 1B is lit by round-arched double openings on the north and south: they are positioned a little to the east of centre. It will be argued that they lit a gallery (pp. 268–9). The sills and jambs are square-edged, and the paired openings separated only by a gritstone baluster which stands in the middle of the wall and supports a flat slab (through-stone) carrying the two unmoulded arches.<sup>48</sup> The imposts and through-stones are all basally chamfered, but have a plain arris on the upper angle. The baluster, which is moulded in imitation of lathe-turning, is aligned with the third pilaster of the stripwork arcade, the window openings thus piercing the third and fourth bays. Since the bays themselves are of unequal width, the window positions are disconcertingly asymmetrical within the tower elevations. Similarly, the level at which the windows are set bears no relation to the architectural frame: they simply float in such a manner as to give the impression to the casual observer

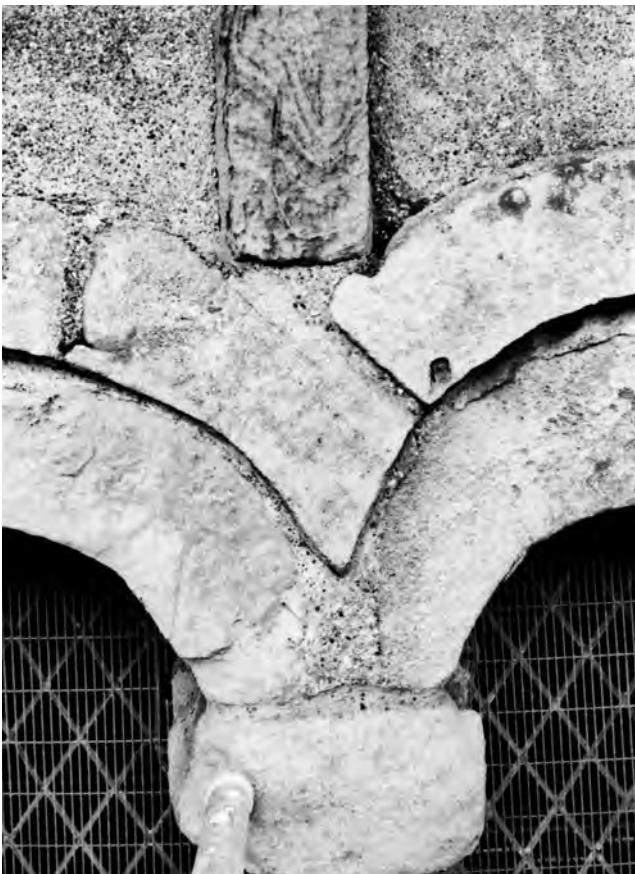
Fig. 273: Tower: Stage 1B, south. Function of the interrupted pilaster-strip with the head of the gallery window. Photo: Warwick Rodwell

that they could be secondary insertions. The windows are, however, unquestionably primary. The junction between the window head and the interrupted pilaster is remarkably clumsy. Instead of cutting a three-way springer-block for the arches and pilaster seating, as the medieval mason would have done, the mouldings are simply stacked one upon another (Fig. 273).

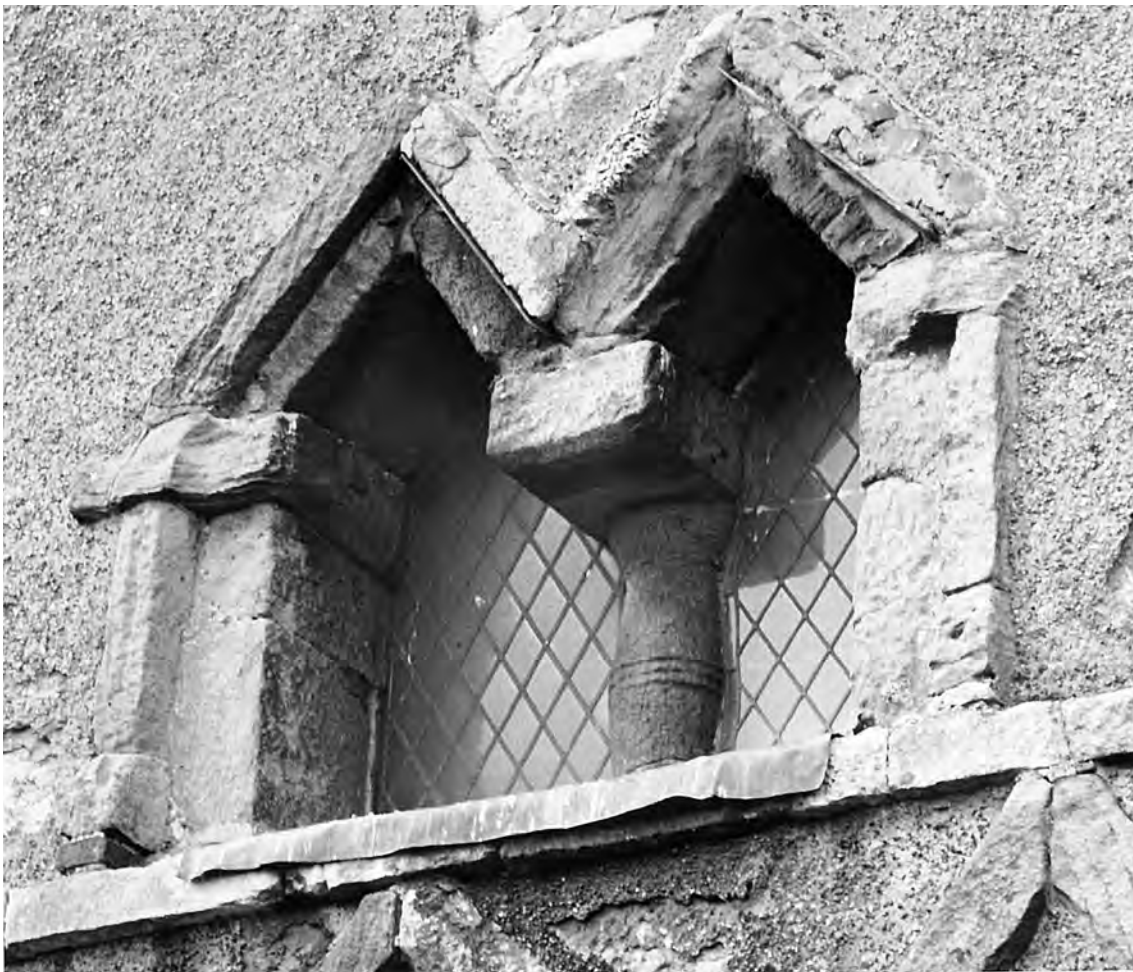
Fig. 275: Tower: Stage 2. South double belfry-opening, 1965. Photo: David Lee Photography

### *North and south belfry openings* (Fig. 275)

The basic construction of the triangular-headed double openings is generally similar to that of the round-headed windows in the stage below, but with greater elaboration. Again, the openings are separated by a single, central baluster supporting a through-stone which serves as an impost-block for the two triangular heads. The external jambs of the apertures are plain, square-edged and have imposts too. In plan, these imposts are stepped because not only do they carry the slabs forming the heads of the openings, but also the projecting stripwork mouldings (labels) that frame those heads. The jambs too are flanked by stripwork, a detail not found in the double windows in Stage 1B.

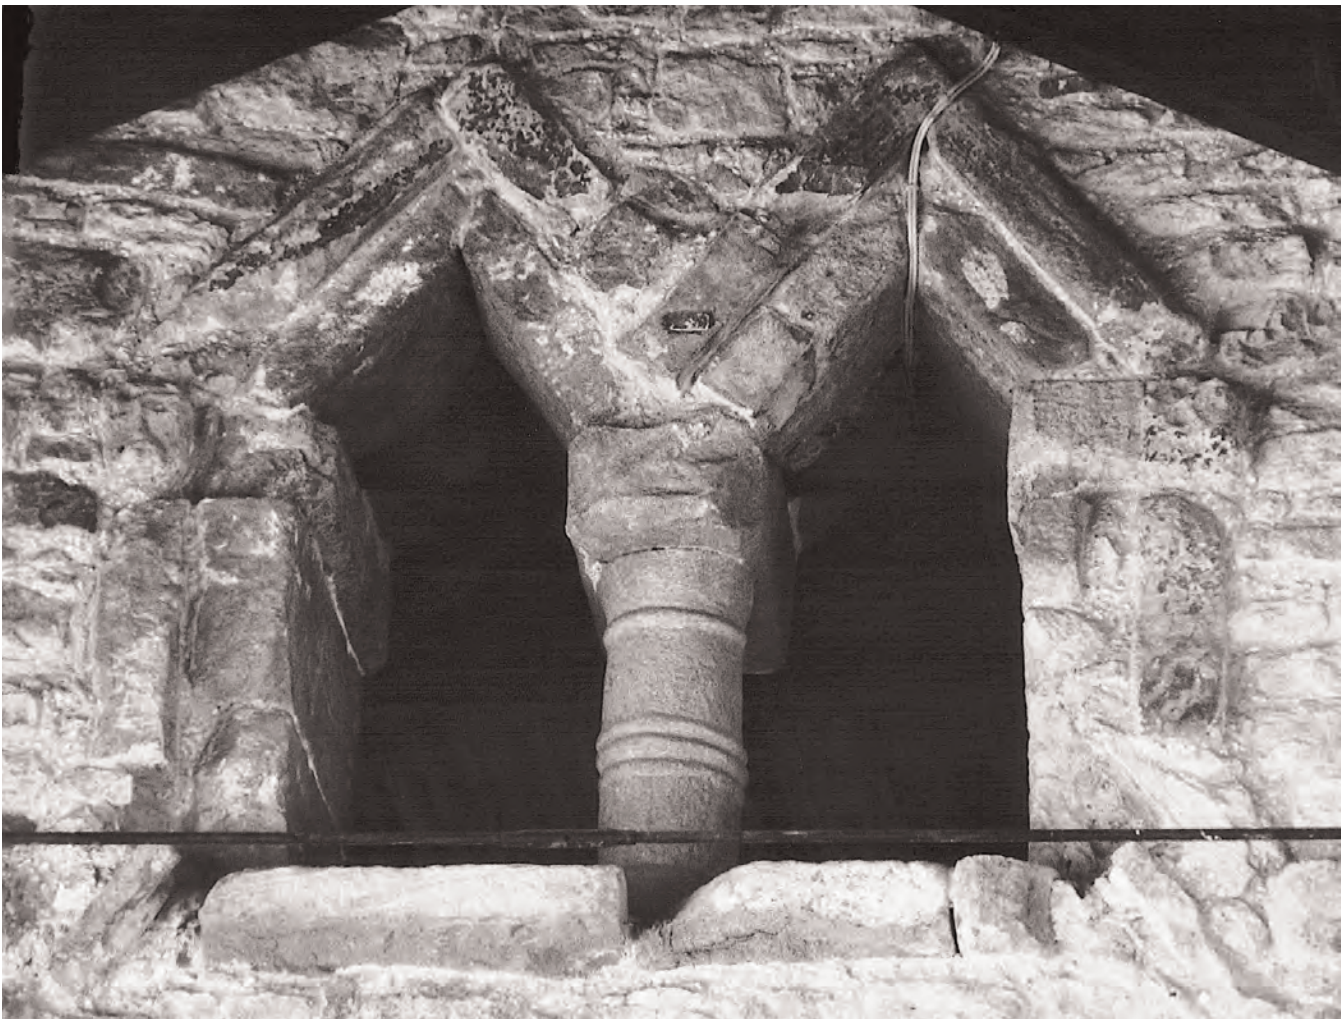
*Fig. 276: Tower: Stage 2. East double belfry-opening, seen from within the medieval nave. Note the remains of the head-stops, particularly on the left. See also Fig. 377. Photo: Derek Craig. © Corpus of Anglo-Saxon Stone Sculpture*

#### **East belfry opening** (Figs. 276 and 289)

The impost blocks both carry the eroded remains of carved human heads (Fig. 377). It is certain that no similar elaboration existed on the imposts of the other belfry openings, and it seems likely that these were the only examples of external sculpture on the Period 2 tower.
