# ST PETER'S

## Barton-upon-Humber, Lincolnshire

*A Parish Church and its Community*

HISTORY, ARCHAEOLOGY AND ARCHITECTURE

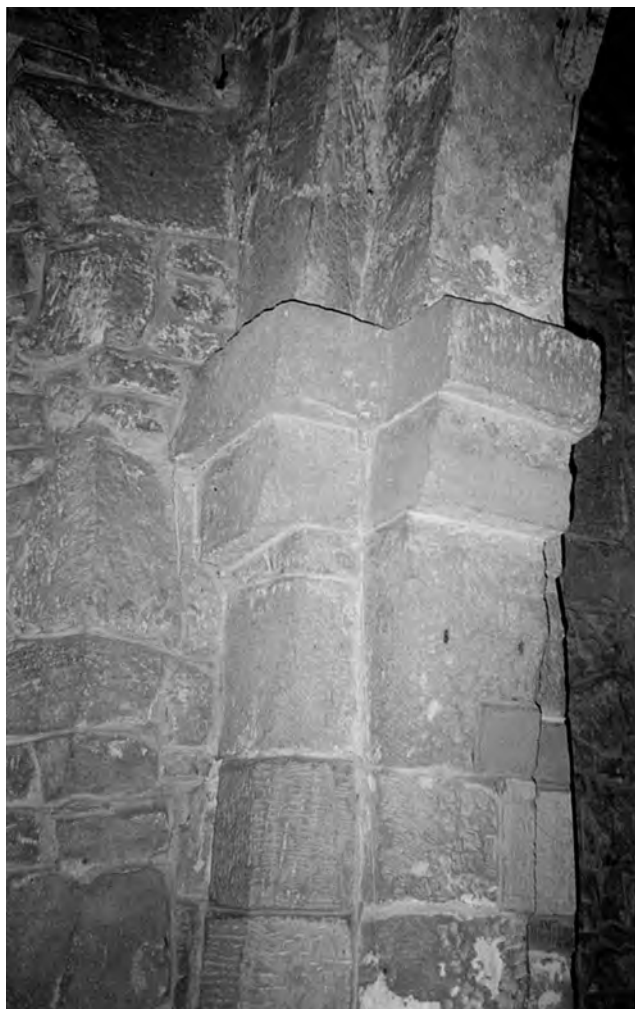
Fig. 280: *St John the Baptist, Kirk Hammerton (W. Yorks.). South respond of the chancel arch, showing the monolithic double impost of gritstone. Photo: Warwick Rodwell*

The east wall is dominated by the largest and most elaborate arch in the church. It is tall, round-headed and monumental in stature: the arch passes squarely through the wall without any splay or rebate. Large blocks of gritstone line the aperture, which is 1.68 m (5½ ft) wide, and 3.6 m (12 ft) high, to the springing-line. There is a projecting base-course, and a double impost which is unmoulded: the latter comprises two stepped courses of squared gritstone. The two-tiered imposts of the chancel arch at Kirk Hammerton (W. Yorks.) are identical, although slightly smaller in scale; there, each impost is cut from a single block of gritstone (Fig. 280). Similar imposts appear in other Anglo-Saxon buildings and on the Deerhurst Virgin panel (Fig. 384).

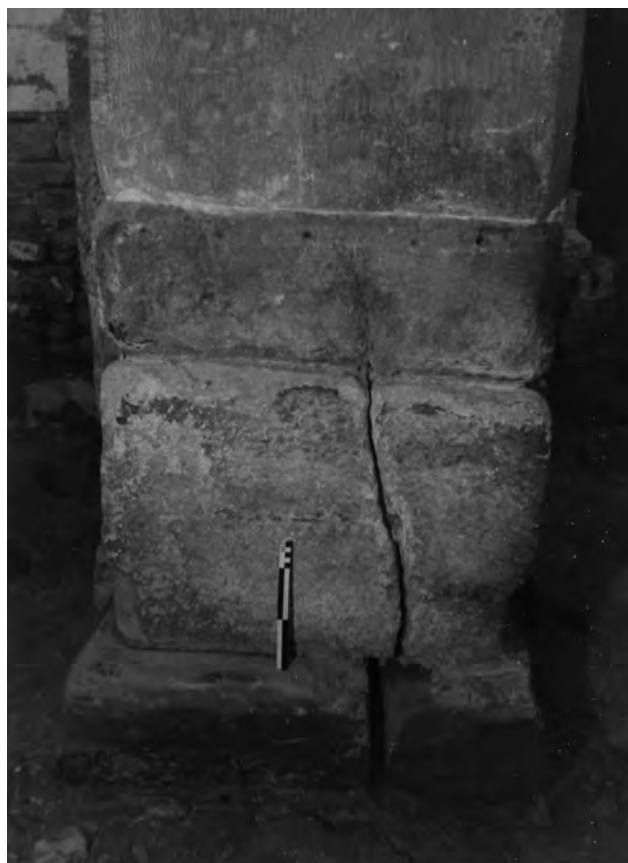
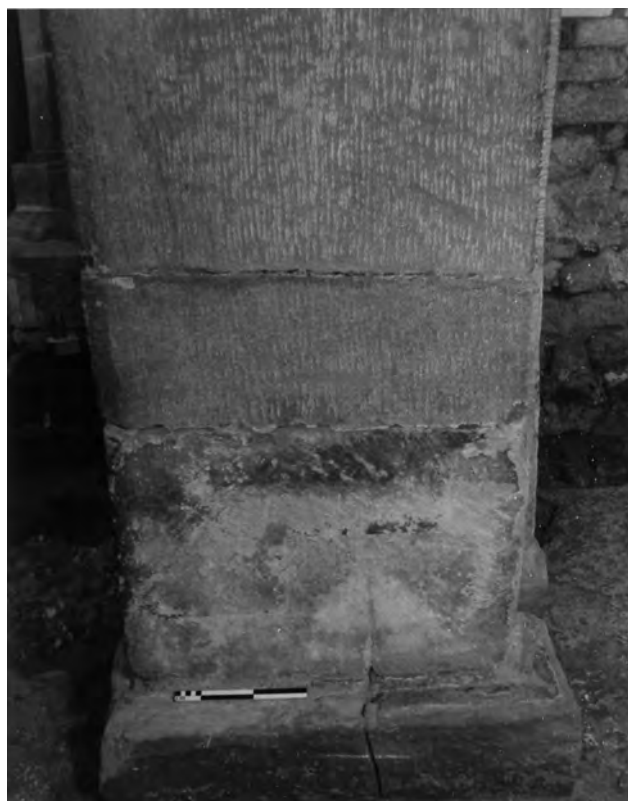
Fig. 281: *Tower: Stage 1A, eastern arch. A, north, and B, south responds and bases, showing settlement fractures and Victorian redressing of the masonry (vertical clawing). Scale of 25 cm. Photos: Warwick Rodwell*

The pattern was repeated in the chancel, although there were fewer pre-church graves present, and in two instances the original burials had not been exhumed, with the consequence that the skeletons were severed by the foundation trench for the east wall (F1364 and F1400). Considerable ground settlement has taken place since the tower was constructed, as evidenced by the fractured and undulating nature of the plinth (Figs. 260 and 270) and the splitting of some of the large blocks lining the reveals of the major openings (Fig. 281).

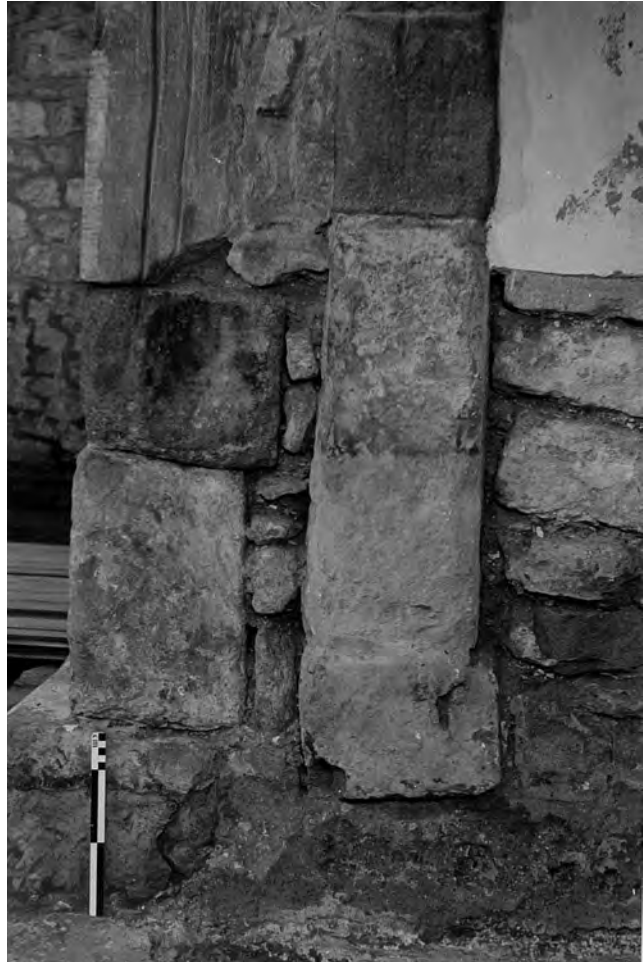
Fig. 283: Tower: Stage 1A. Detail of the base of the south-flanking pilaster-strip of the eastern arch. Note the horizontal line on the first upright stone of the pilaster, defining the pre-1912 floor level in the tower; the burning and consequent decay of the small block in the arch reveal; and the vertical implement-sharpening marks on the stone above. Scale of 25 cm. Photo: Warwick Rodwell

The bases and impostes project both into the reveals and forward of the wall-face on the west; they do not project on the east, where all the components of the arch are flush with the rubble wall-face. The bases are somewhat worn, and might originally have had chamfered arrises, although this is very unlikely. The crude, diminutive chamfers on the jambs and impostes were all added in the nineteenth century (p. 522). Both responds are fractured at the bottom as a result of stress induced through foundation settlement (Fig. 281). The arch itself is formed of medium-sized voussoirs, many of which are non-radial, especially the lower stones on either side. The whole of the opening is outlined on the west by a square-edged pilaster-strip which has its own base-blocks and stepped impostes, all structurally linked to those of the arch itself (Figs. 282 and 283).

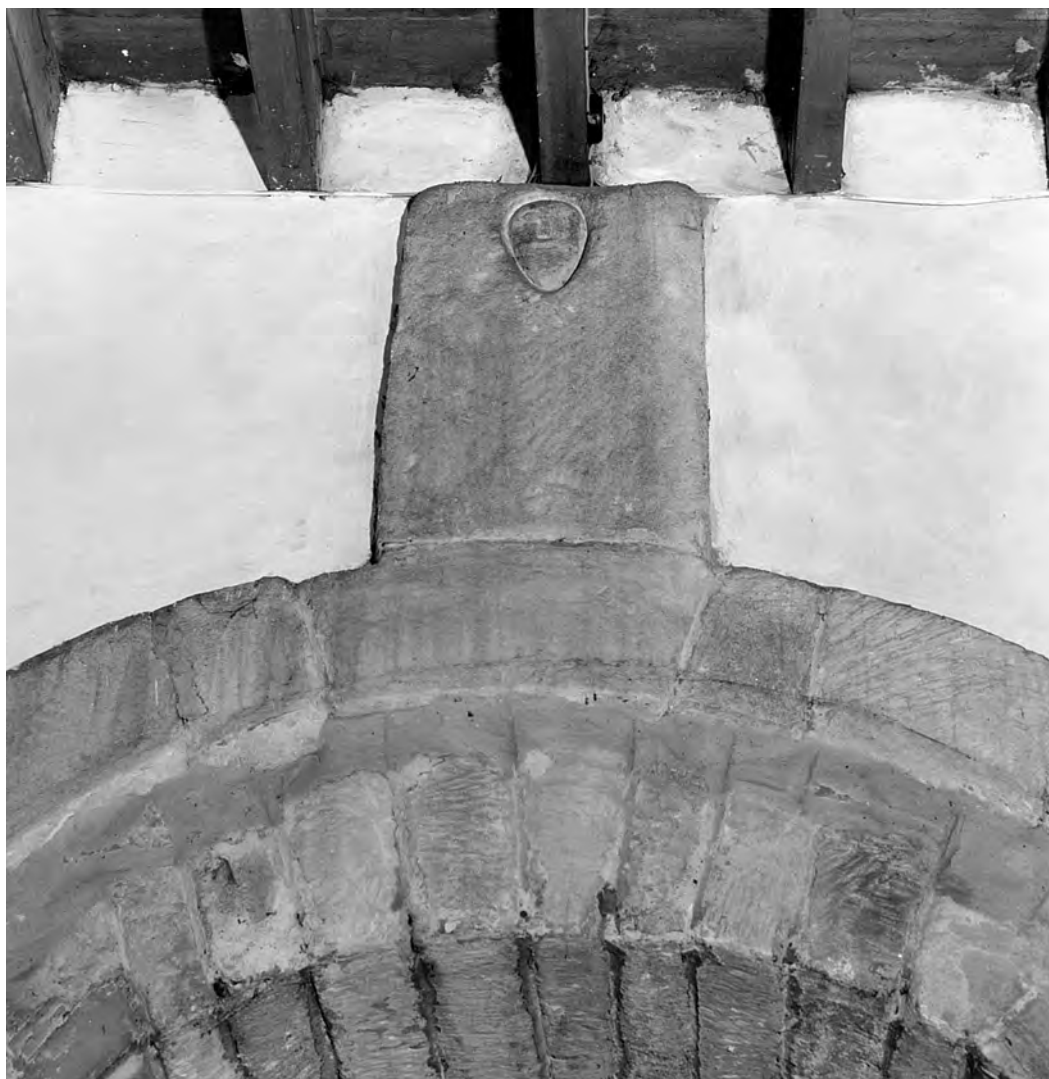
*Fig. 284: Tower: Stage 1A. Sculptured panel above the eastern arch, 1972. Photo: English Heritage, NMR*

Resting centrally on the pilaster-strip, or label, outlining the arch is a rectangular block of gritstone, 46 cm wide by 70 cm high (18 × 27½ ins), having the appearance of a false keystone (Fig. 284). The block projects from the wall-face to the same extent as the pilaster-strip (c. 5 cm), and the joint between them is tight. Their surfaces are thus fully contiguous, and the panel has no frame or edge-moulding. Towards the upper edge of the block is a *bas-relief* carving of a small

human head, frontally presented. It is of elemental form, and the lightly incised features consist of almond-shaped eyes (the sinister one damaged), a squarish nose, and a short straight mouth. The 'chin' is depicted as being very pointed and out of proportion to the rest of the features: there can be little doubt that it is not just the chin but also a pointed beard which is represented only by its outline (Fig. 285). The remainder of the stone panel is blank, with no hint of any other sculpted detail having been hacked off. Examination of the stone shows that the original tooling (now faint) is present, and leaves no doubt that the sculptured element is as complete today as it ever was.

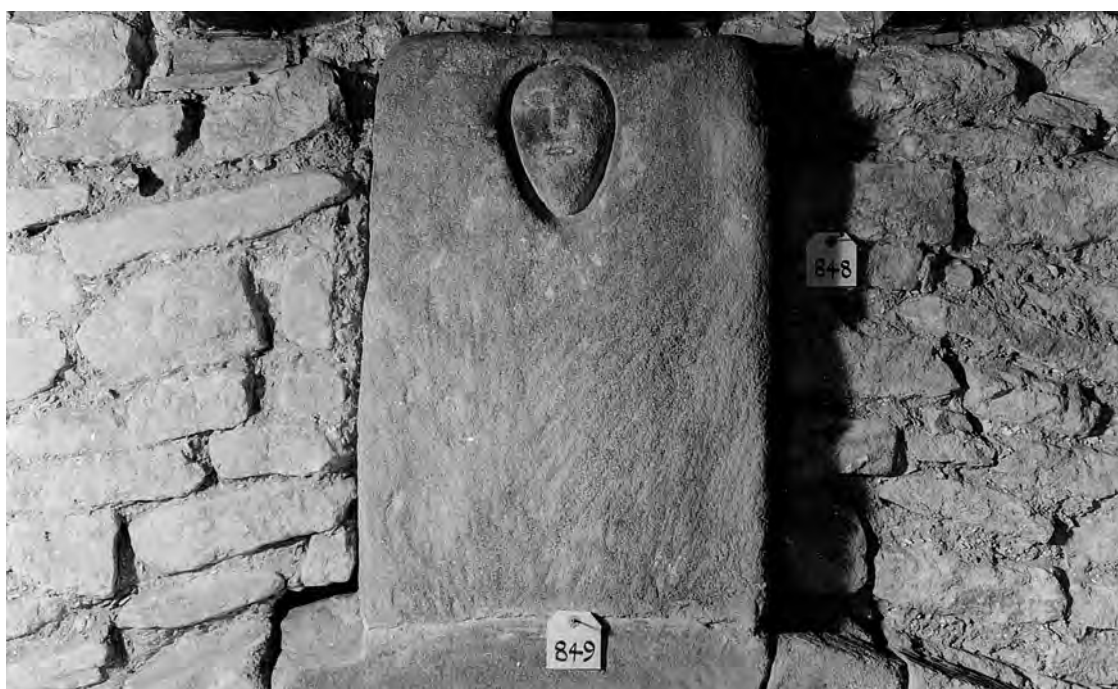
*Fig. 285: Tower: Stage 1A. Detail of the sculptured face on the panel above the eastern arch, 1980. Photo: Warwick Rodwell*

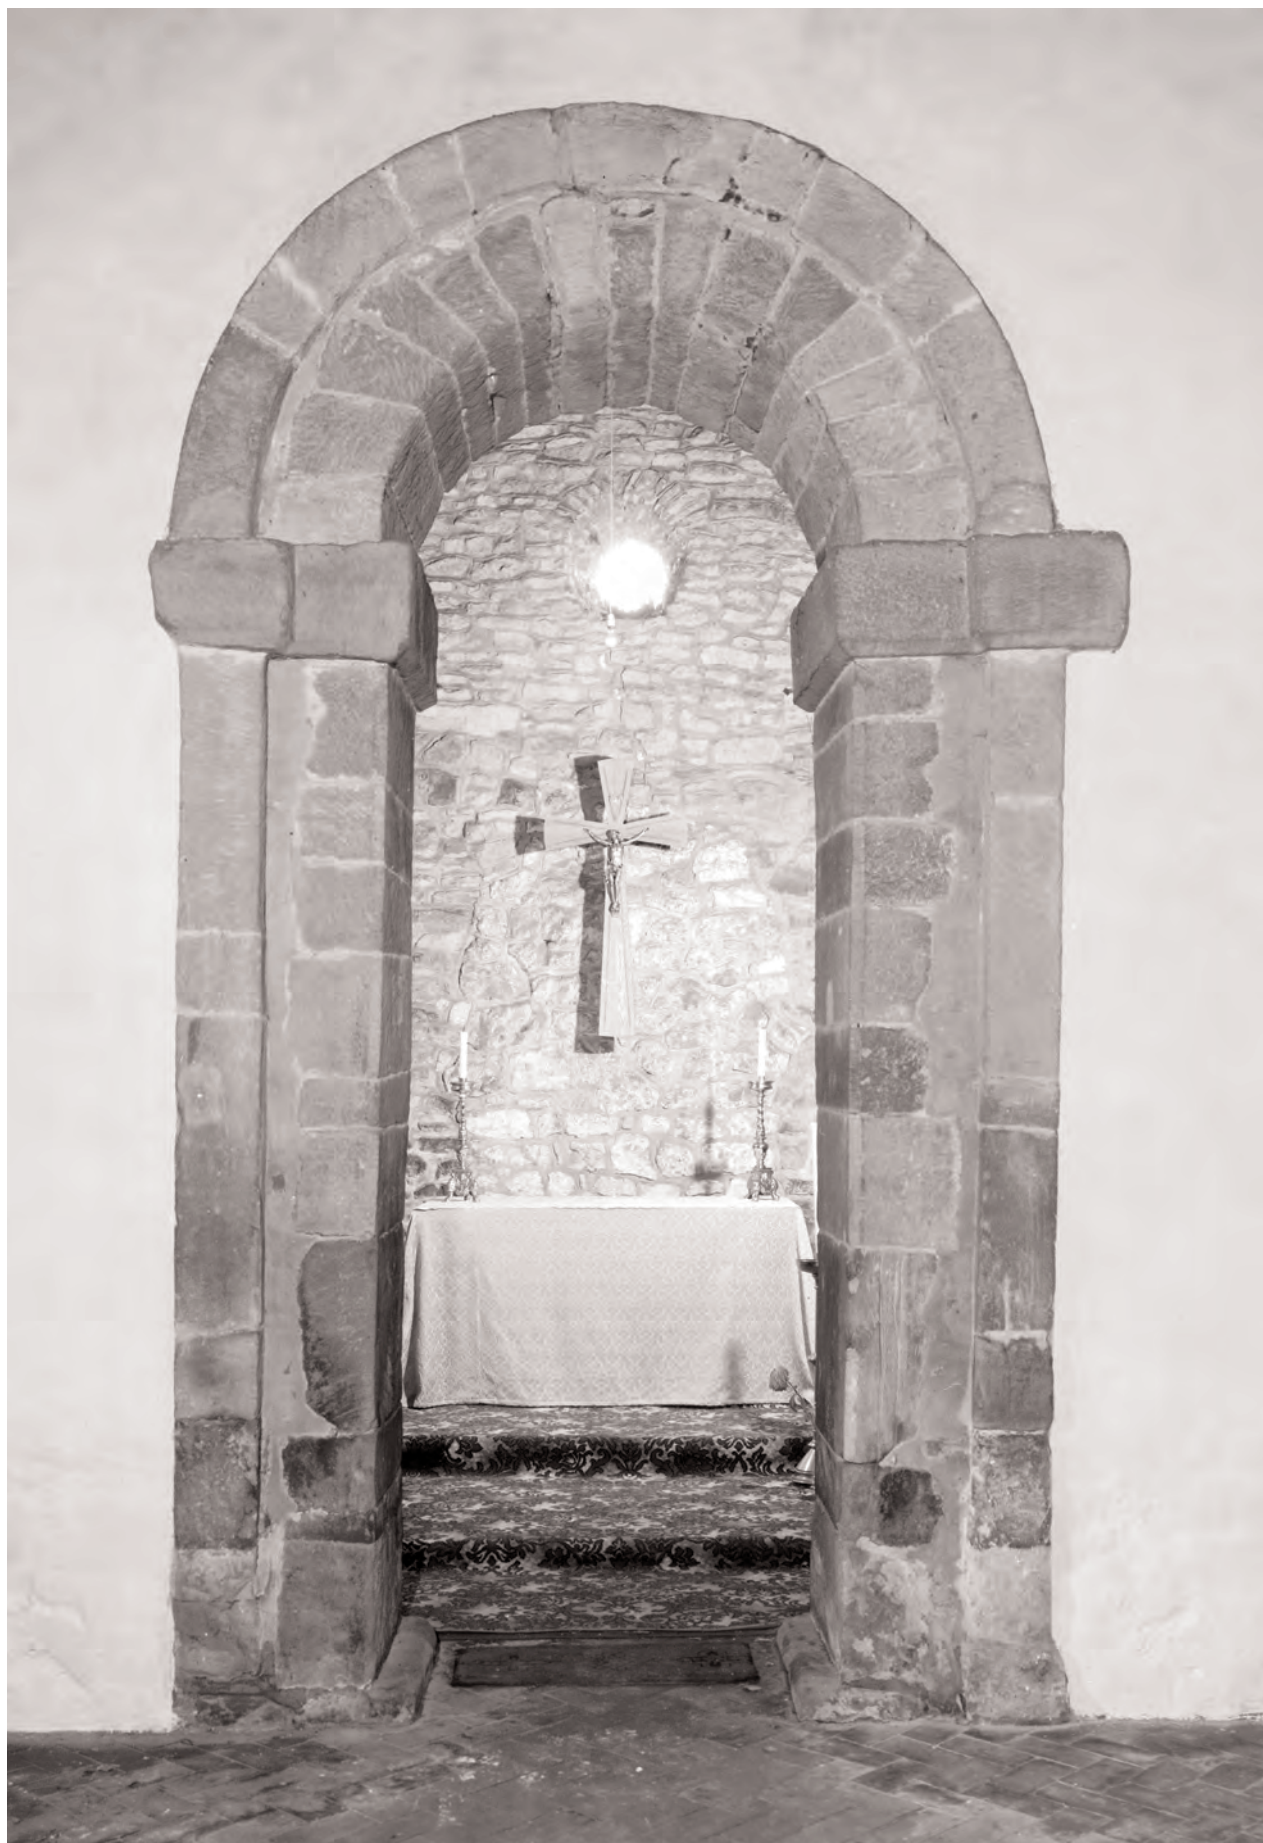
*Fig. 287: Tower: Stage 1A. Western arch, viewed from the east, 1972. Photo: English Heritage, NMR*

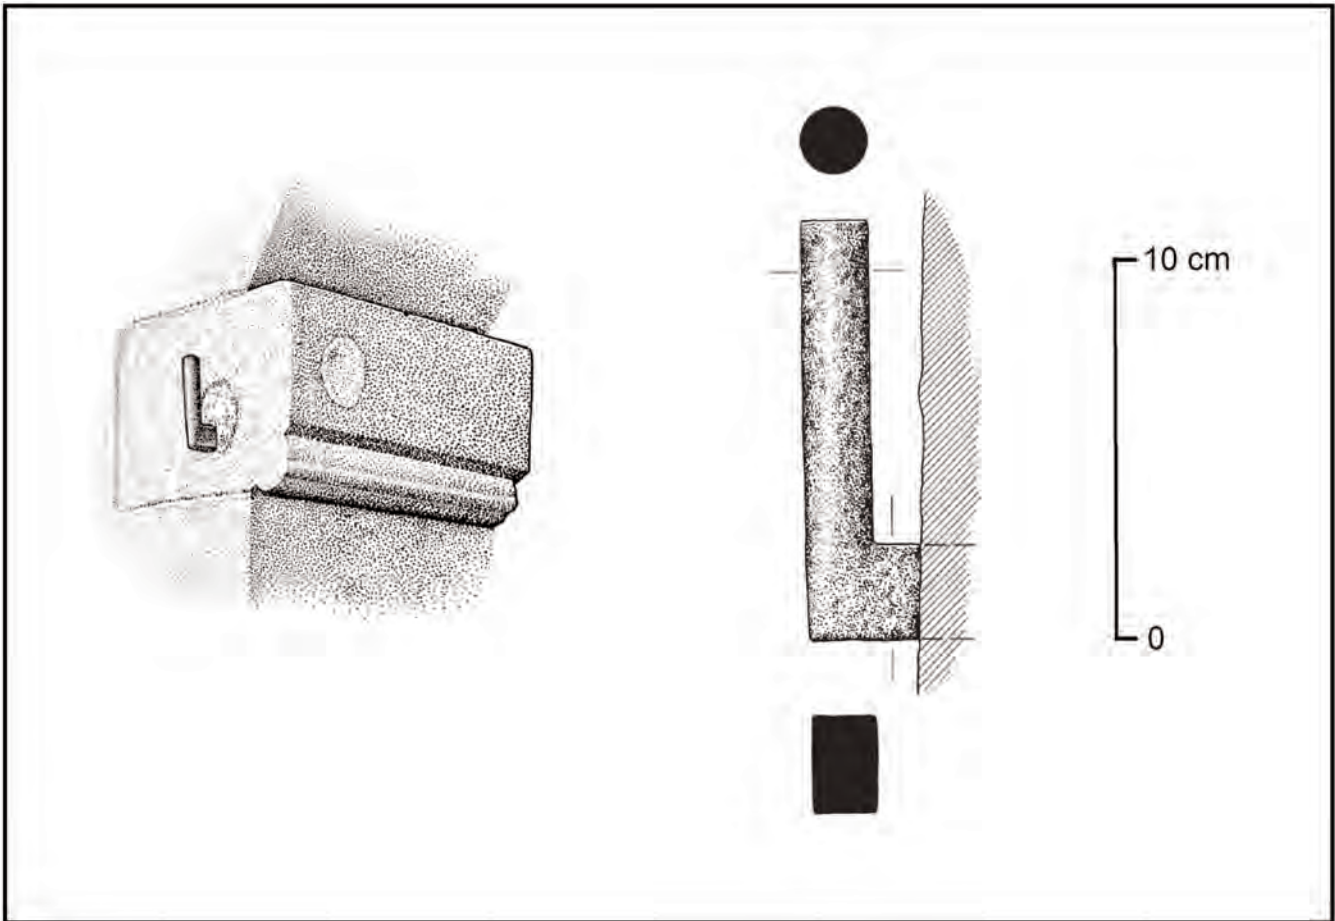
Fig. 288: Tower: Stage 1A, north doorway. Detail of western impost with the original iron hinge-crook leaded into the block. Hinge-crook scale 1:2. Drawing: Simon Hayfield

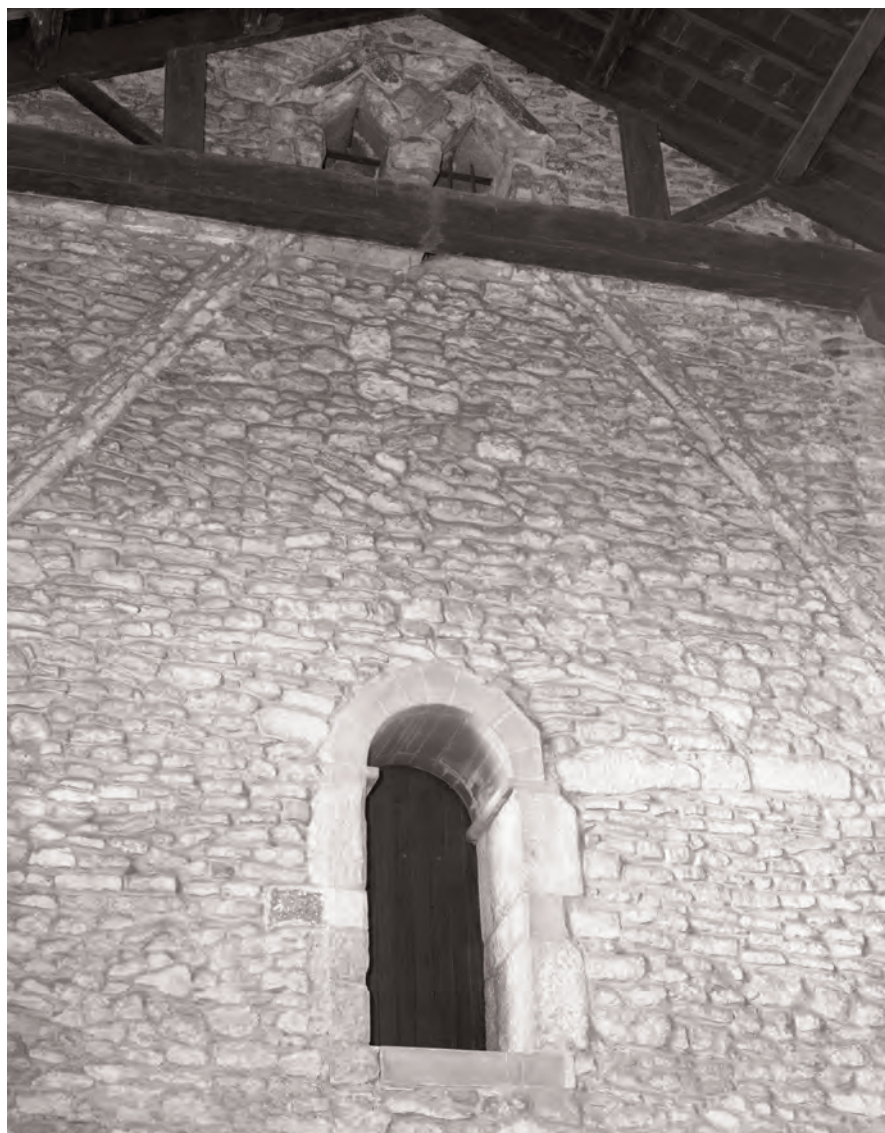
*Fig. 289: Tower: Stage 1B. High-level doorway in the east wall (east face), 1972. The voussoirs and impost of the arch date from 1858. Photo: English Heritage, NMR*

The east wall of the gallery stage is pierced at its centre-point by a small round-headed opening, the threshold of which was at floor level, but has since been cut away. The aperture is 90 cm wide and lined with grit-stone blocks, alternately laid upright and flat, so that in elevation the west side of the arch appears to have jambs of long-and-short work. There are no mouldings

or projections on either wall face, but the base-blocks project into the opening. The original height of the arch, to its springing point, was *c.* 1.6 m (5¼ ft), where imposts probably also projected into the opening, but these have been lost. The present thin imposts and neat voussoir arch were entirely fabricated in 1858 (p. 522), replacing the original semicircular head which was of rubble, like that which survives in the west doorway of Stage 1B. The threshold was also replaced with a stone kerb flush with the east face of the arch.

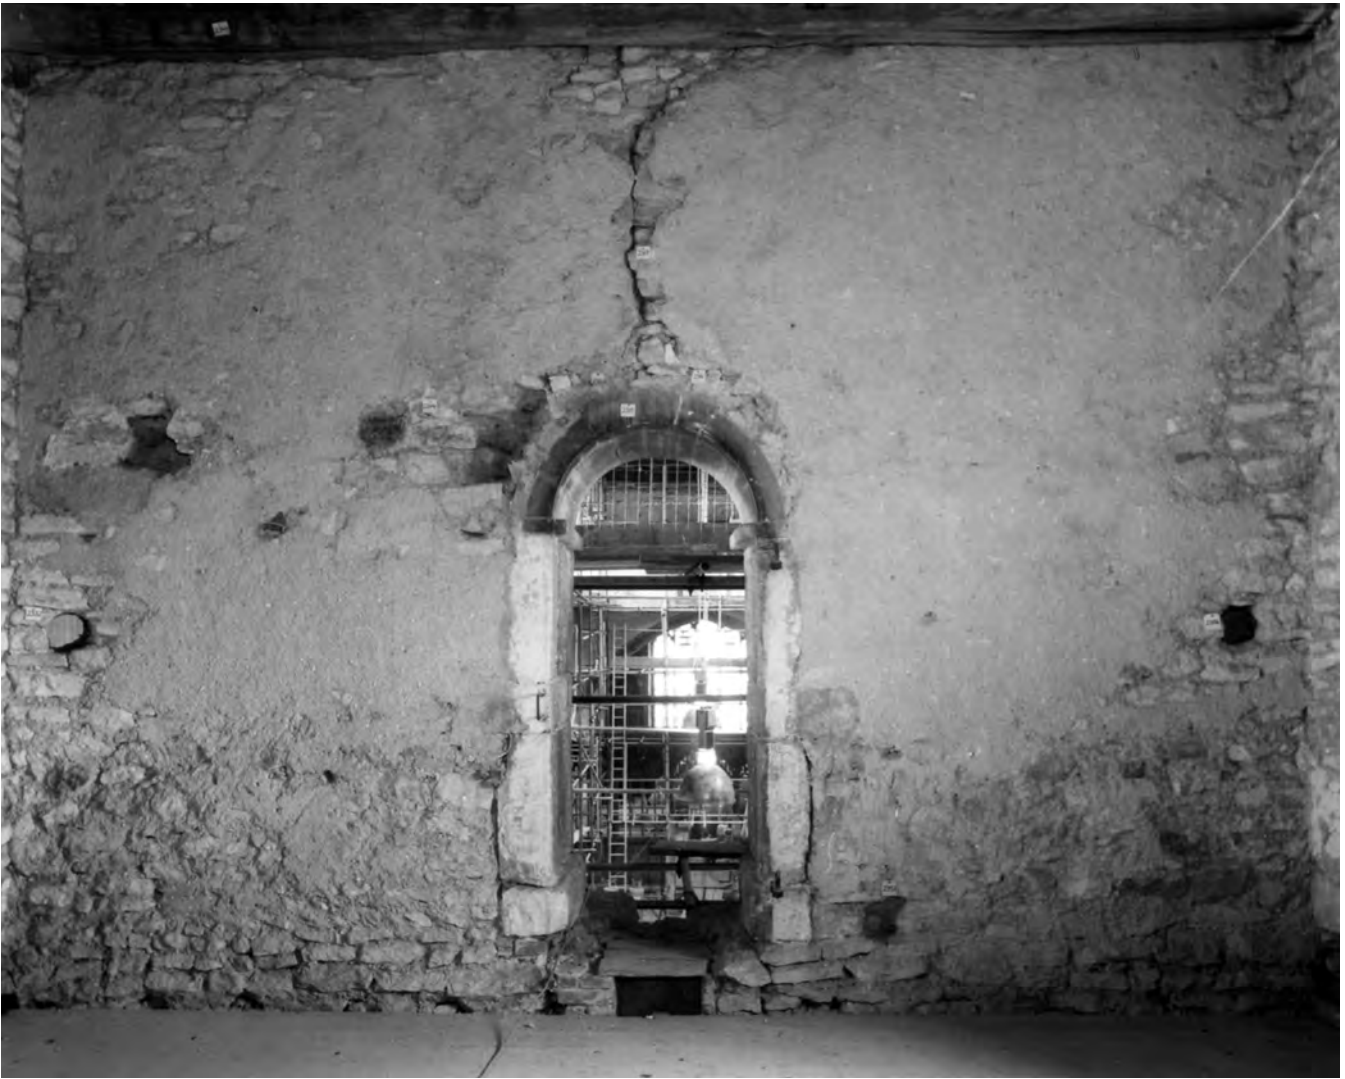
*Fig. 290: Tower: Stage 1B, interior. High-level doorway in the east wall (west face), and surviving Anglo-Saxon wall-plaster, 1983. The darker stones comprising the arch date from 1858. Photo: English Heritage Photo Library*

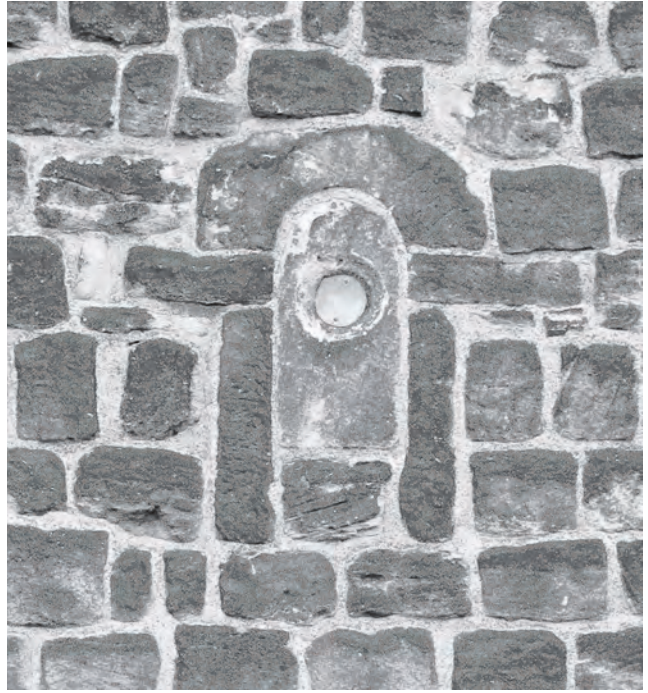
*Fig. 292: St Paul, Jarrow (Durham). Monolithic window head formed from a block of Roman masonry. Photo: Warwick Rodwell*

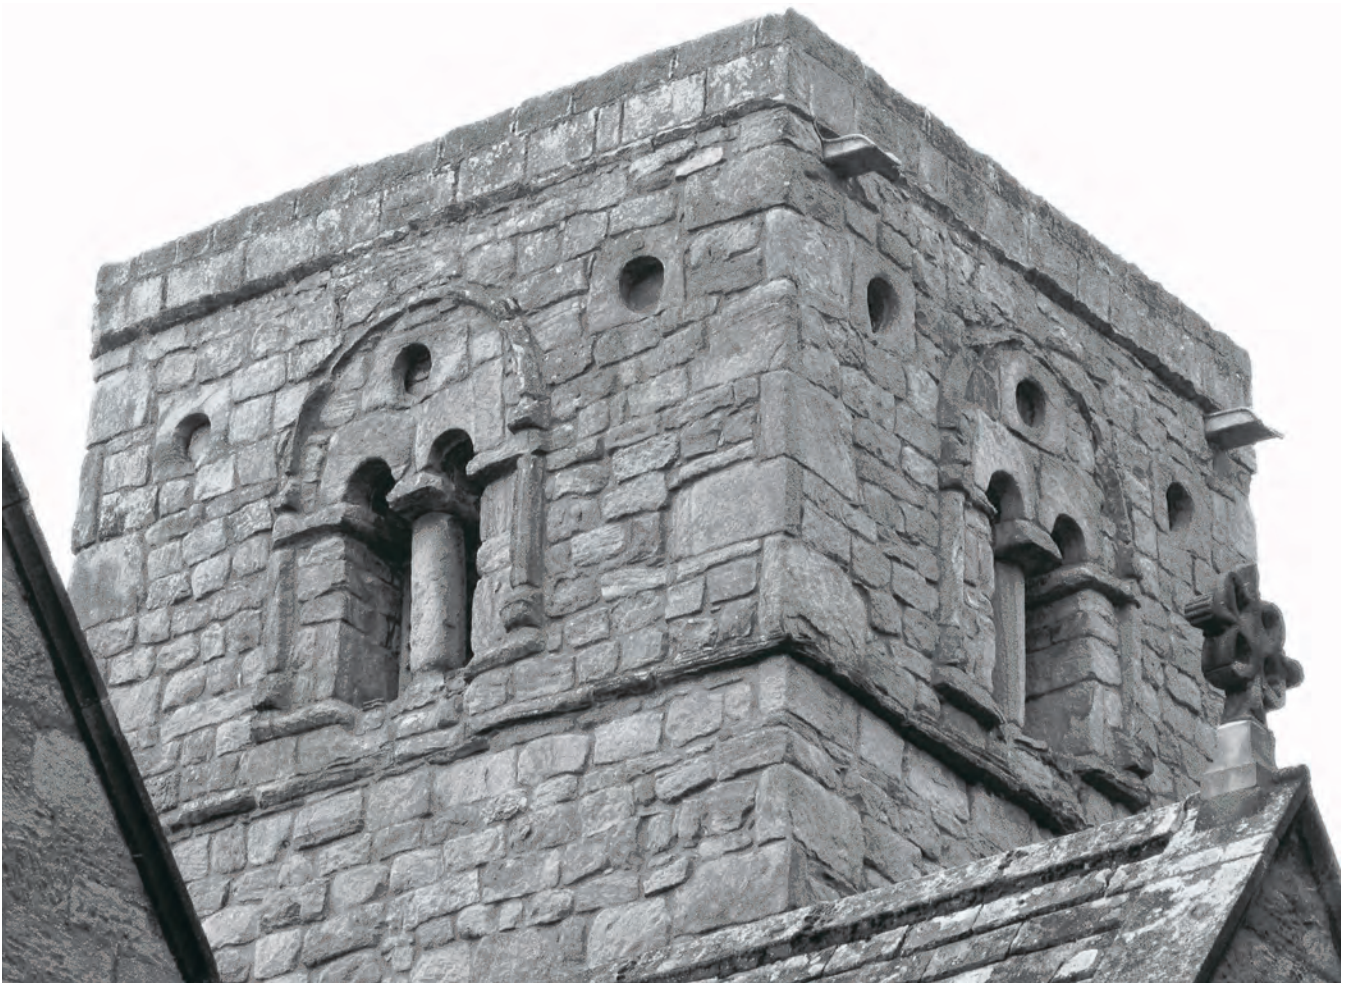
*Fig. 293: St Andrew, Bywell (Northumb.). Semicircular heads of the double belfry openings formed from rectangular blocks of Roman masonry, possibly reused window heads. Photo: Warwick Rodwell*

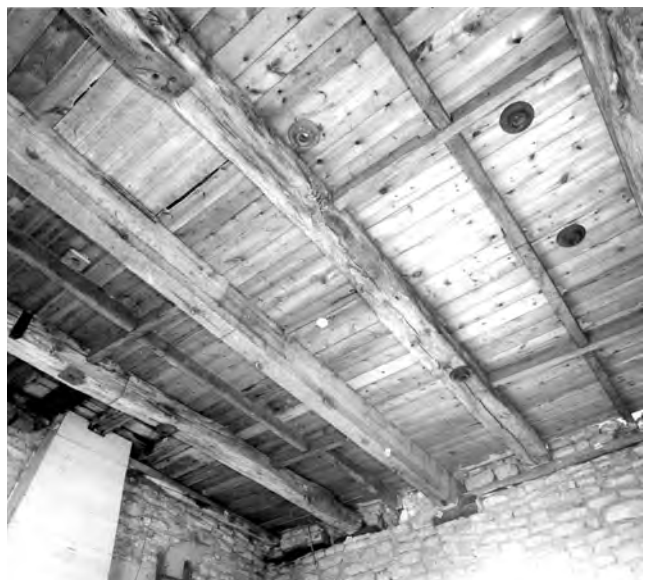
Fig. 295: Tower: floor between Stages 1B and 2. The joists are medieval and later, but the thin spreader-plate in the north wall (right), upon which their ends rest, is primary Anglo-Saxon. Also partly visible on the west side is the casing of the clock pendulum (1852). View north-west, 1983. Photo: English Heritage

A second internal floor marked the division between Stages 1 and 2. As with the gallery below, the floor comprised a series of joists running north-south, although in this case there were seven, rather than six. Again, the ends of the joists rested on spreader-plates that were built into the north and south walls. Decayed sections of the northern plate remained (Fig. 295), but the southern one had entirely disappeared. Although a post-medieval floor occupied the same position, remains of all the pockets carrying the original joists were recorded. Well-defined impressions of some joist-ends were preserved in the core-mortar. The dimensions of the joists were slightly smaller than those of the gallery.

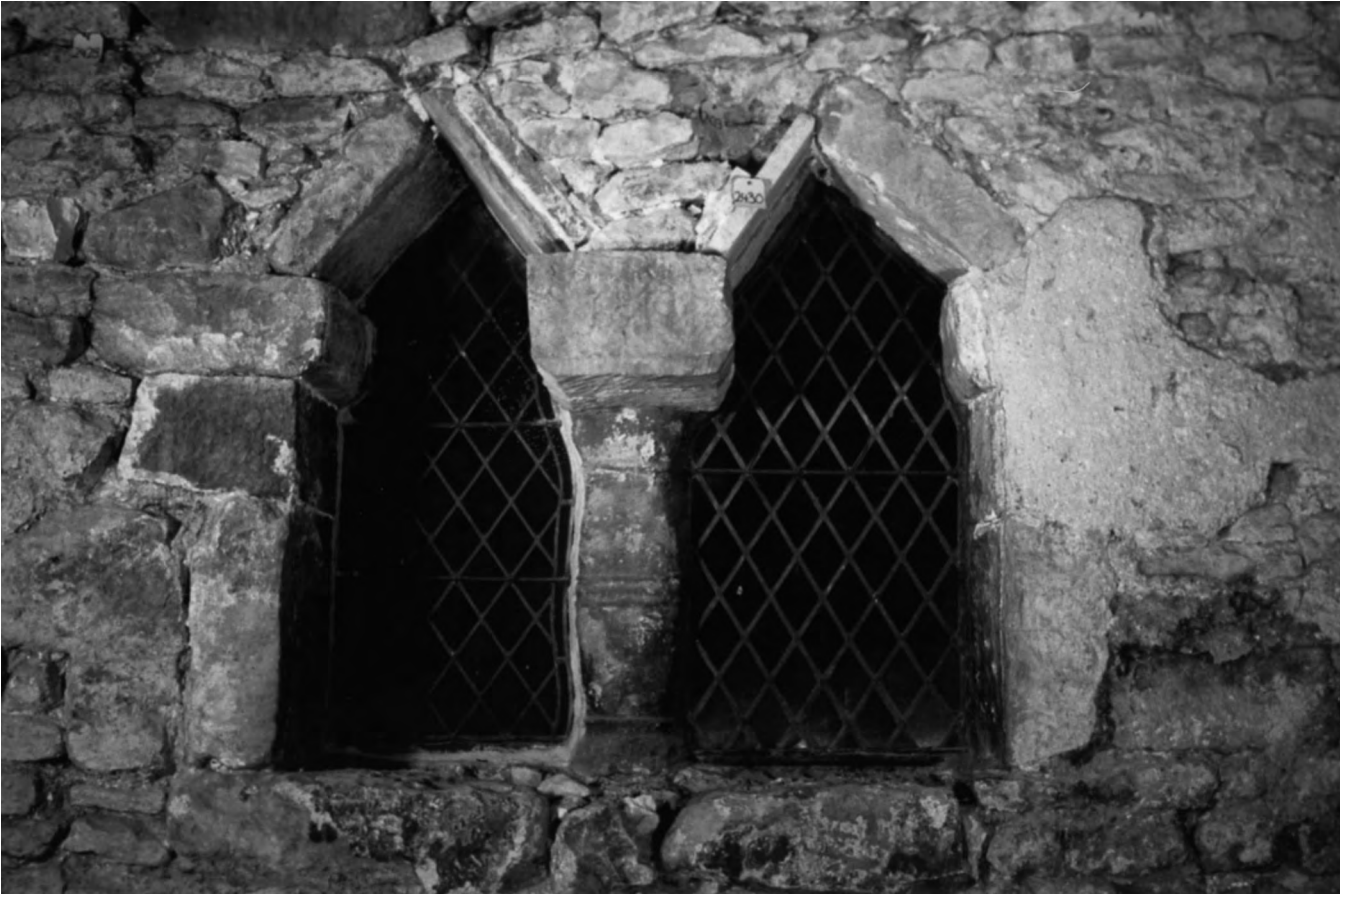
*Fig. 297: Tower: Stage 2. South belfry opening with original wallplaster overlapping the right-hand reveal, 1983. Note the nineteenth-century slabs of Yorkstone, replacing original timbers on the two inner slopes of the gabled heads. Photo: Warwick Rodwell*

**Belfry openings** (Figs. 297, 298, 299 and 300, B)

The triangular-headed double belfry-openings are preserved in all four walls, although those on the west remain blocked with medieval masonry. As with the double windows in Stage 1B, the internal reveals are featureless, being formed from stones of various sizes and types, which were intended to be concealed by wallplaster. In part, the original plaster survives on the south opening, overlapping its western jamb (Fig. 297). The sills are all flat and made from a mixture of squared stone and rubble, again plastered. The mid-wall shafts rest on large blocks of gritstone. For the most part, the triangular heads consist of pairs of flat slabs of gritstone, laid on a tilt and touching one another at the apex (Figs. 298 and 299).

In the case of the southern and western openings, however, baulks of timber were employed as substitutes for stone in the two elements rising off the central through-stone. None of the four timbers survives, and when the southern opening was unblocked in 1852 thin slabs of Yorkstone were inserted, more-or-less in the original timber pockets (Figs. 297 and 300). At the same time, the doubtless seriously decayed remains of the timbers were removed from the western belfry opening and the voids infilled with stone rubble. Inspection of the mortar core revealed that there had

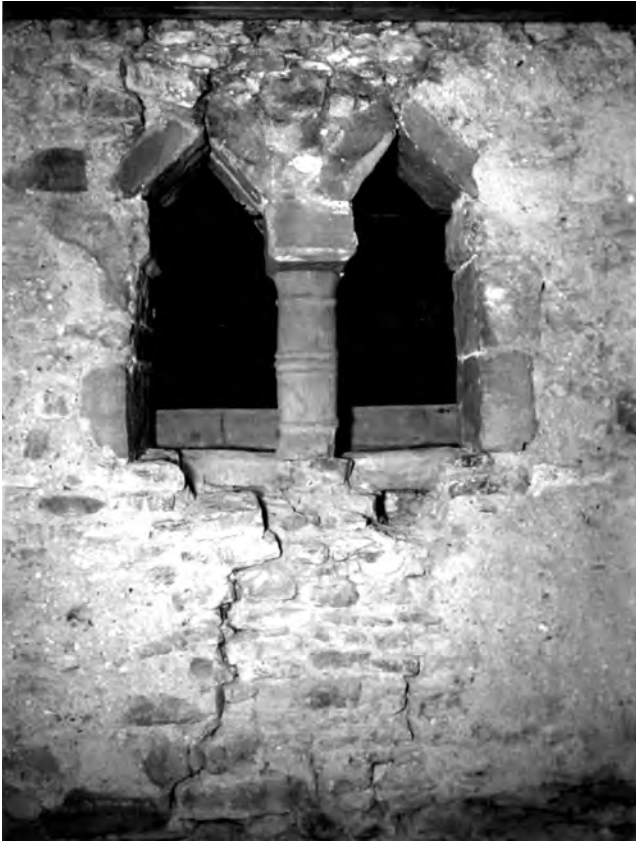
Fig. 299: Tower: Stage 2, interior. East belfry opening, 1983. Note also the cracks in the masonry above and below. Photo: Warwick Rodwell

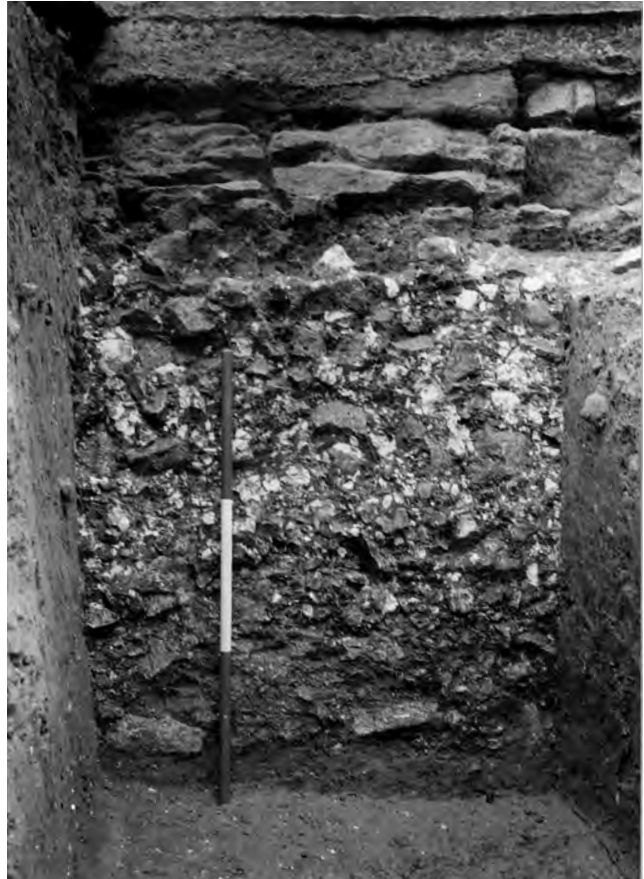
Fig. 303: Western annexe. External face of the rubble foundation on the west side, with the severely fractured limestone plinth course above. Scale of 75 cm. Photo: Warwick Rodwell

Excavation revealed that the foundations for the three-celled church were constructed in a single operation. The square foundation for the tower was continuous on all sides, without interruptions where openings were anticipated in the superstructure. The trench was dug into the clay subsoil to a depth of 95 cm (3 ft), but its width varied somewhat, owing to the instability of the ground in places: localized collapses of the sides had occurred before the foundation filling was inserted. The intended trench width seems to have been of the same order as the depth. The filling comprised small chalk fragments embedded in yellow sandy mortar. No evidence of layering was detectable within the fill (Fig. 303).

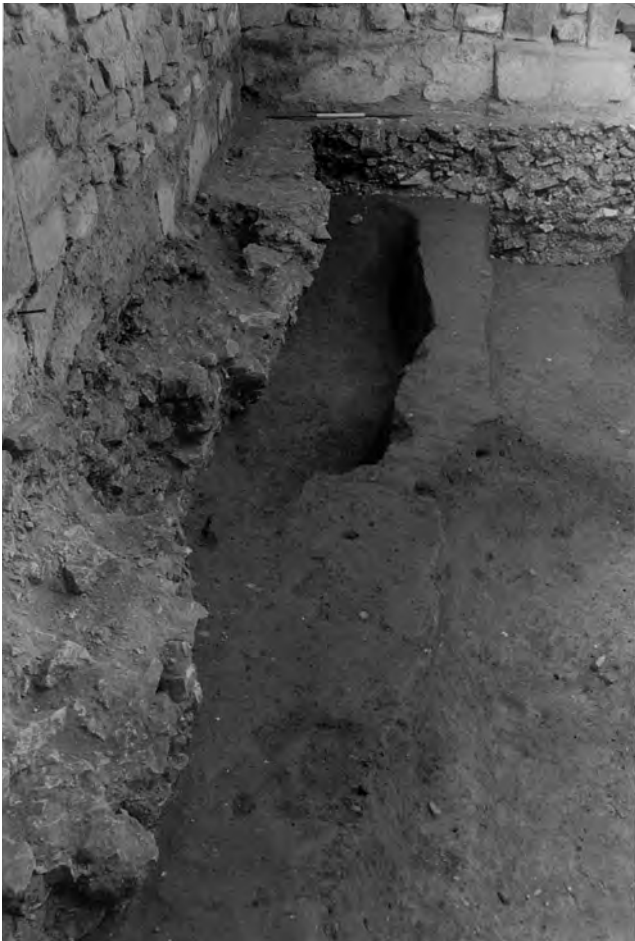
*Fig. 304: Tower: interior. Irregular outline of the foundation on the north side (left), resulting from the slumping of the unstable fillings of exhumed graves. View east. Scale of 75 cm. Photo: Warwick Rodwell*

In part, the trenches were dug through the uncompacted fillings of graves which then slumped, giving rise to characteristic bulges in the sides of the foundation (Figs. 256 and 304). This is well illustrated in the north and south foundations of the tower.<sup>57</sup> The evidence is consistent with excavation having taken place in wet weather. However, the graves beneath the tower and baptistery were found, with a single exception (F716), not to contain skeletal remains, indicating that

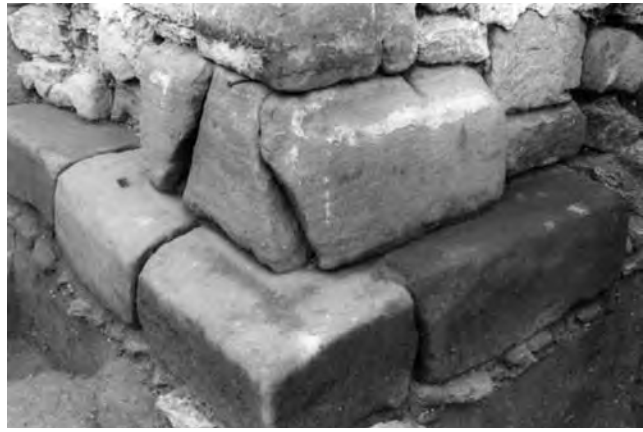
A

*Fig. 305: Tower: details of the plinth at the north-west corner. A, gritstone plinth and fractured base-block of the quoin. B, a small mortice in one of the plinth blocks on the north. Photos: Warwick Rodwell*

west sides, for the abutment of flanking chambers.<sup>58</sup> The bases for the quoins and pilasters rest on the plinth and are inset by half its width (Fig. 305, A). The walling is constructed mainly of small limestone rubble, with various other materials incorporated, randomly laid in a generous amount of lime mortar.<sup>59</sup> The dressings are largely of gritstone ashlar which has been recycled from a Roman building, and was imported to Barton for the purpose, possibly from as far afield as York (pp. 325–6).<sup>60</sup> For the most part, the dressings are not especially well keyed into the structure; this applies particularly to the tall upright blocks, used in both the quoins and the stripwork. The linings and surrounding stripwork of the two major arches in the nave (east and west) are effectively unbonded to the adjacent masonry (p. 265).

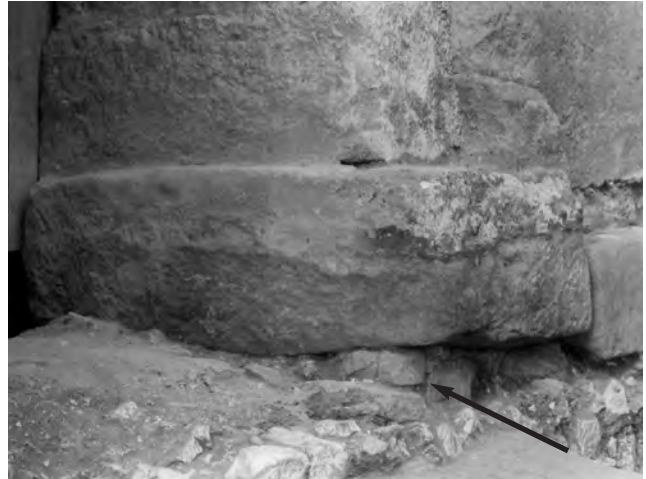
*Fig. 306: Tower: south doorway, eastern jamb. Detail of the gritstone base, with masons' waste used as packing material for levelling the block. Photo: Warwick Rodwell*

Re-dressing of the Roman gritstone took place on site, the soil around the primary church containing masons' waste (virtually all redeposited in later graves). Chips and small fragments were commonly used as wedges and packing material when levelling the plinth blocks for the tower (much evidence survived on the north side), installing the base-blocks for openings (e.g. the south doorway; Fig. 306), and setting up large

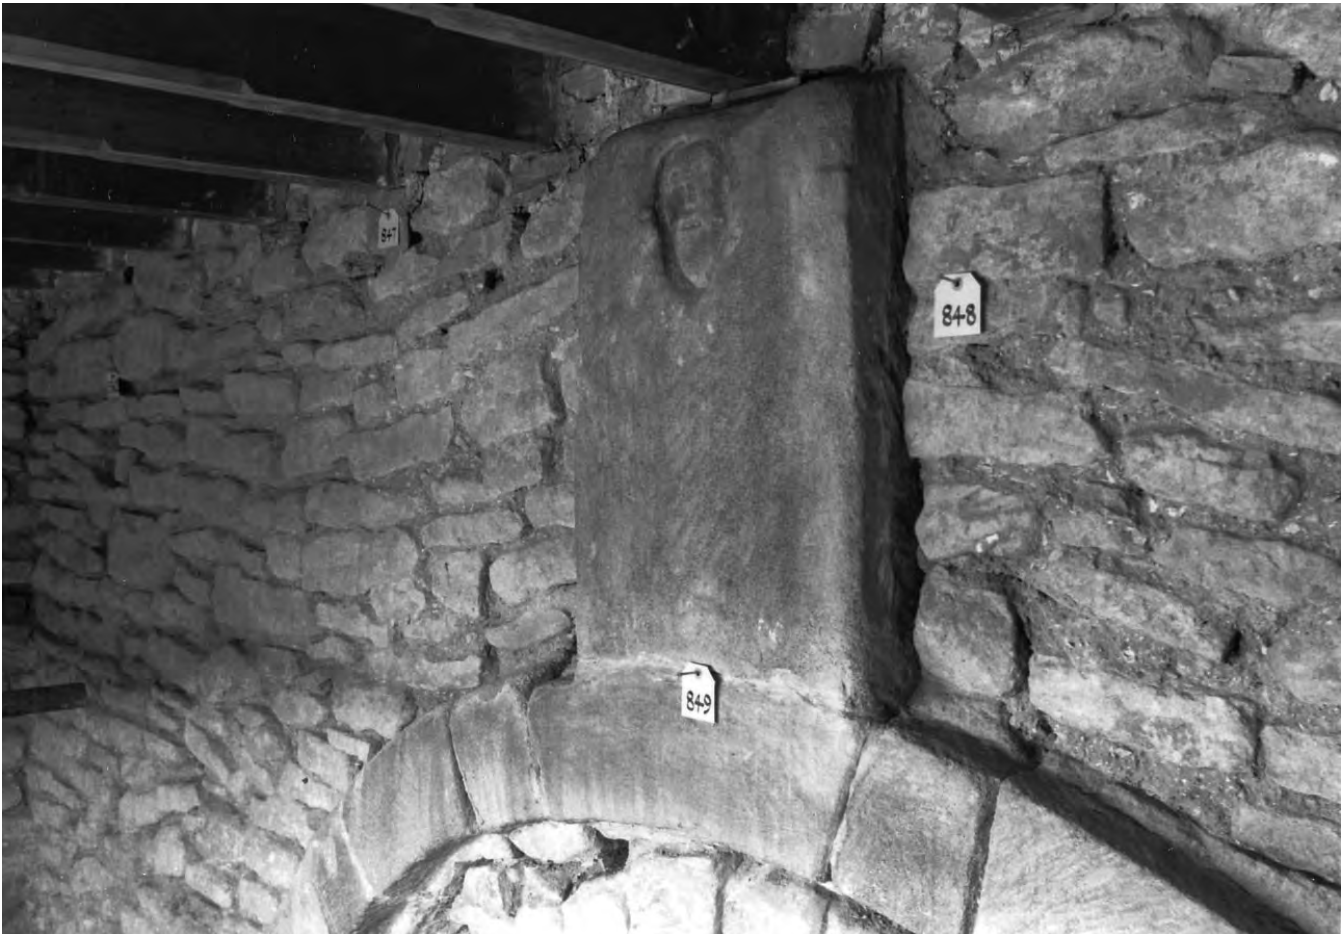
Fig. 309: Tower. 'Humping' of the masonry courses over the eastern arch. View north-east. Photo: Warwick Rodwell

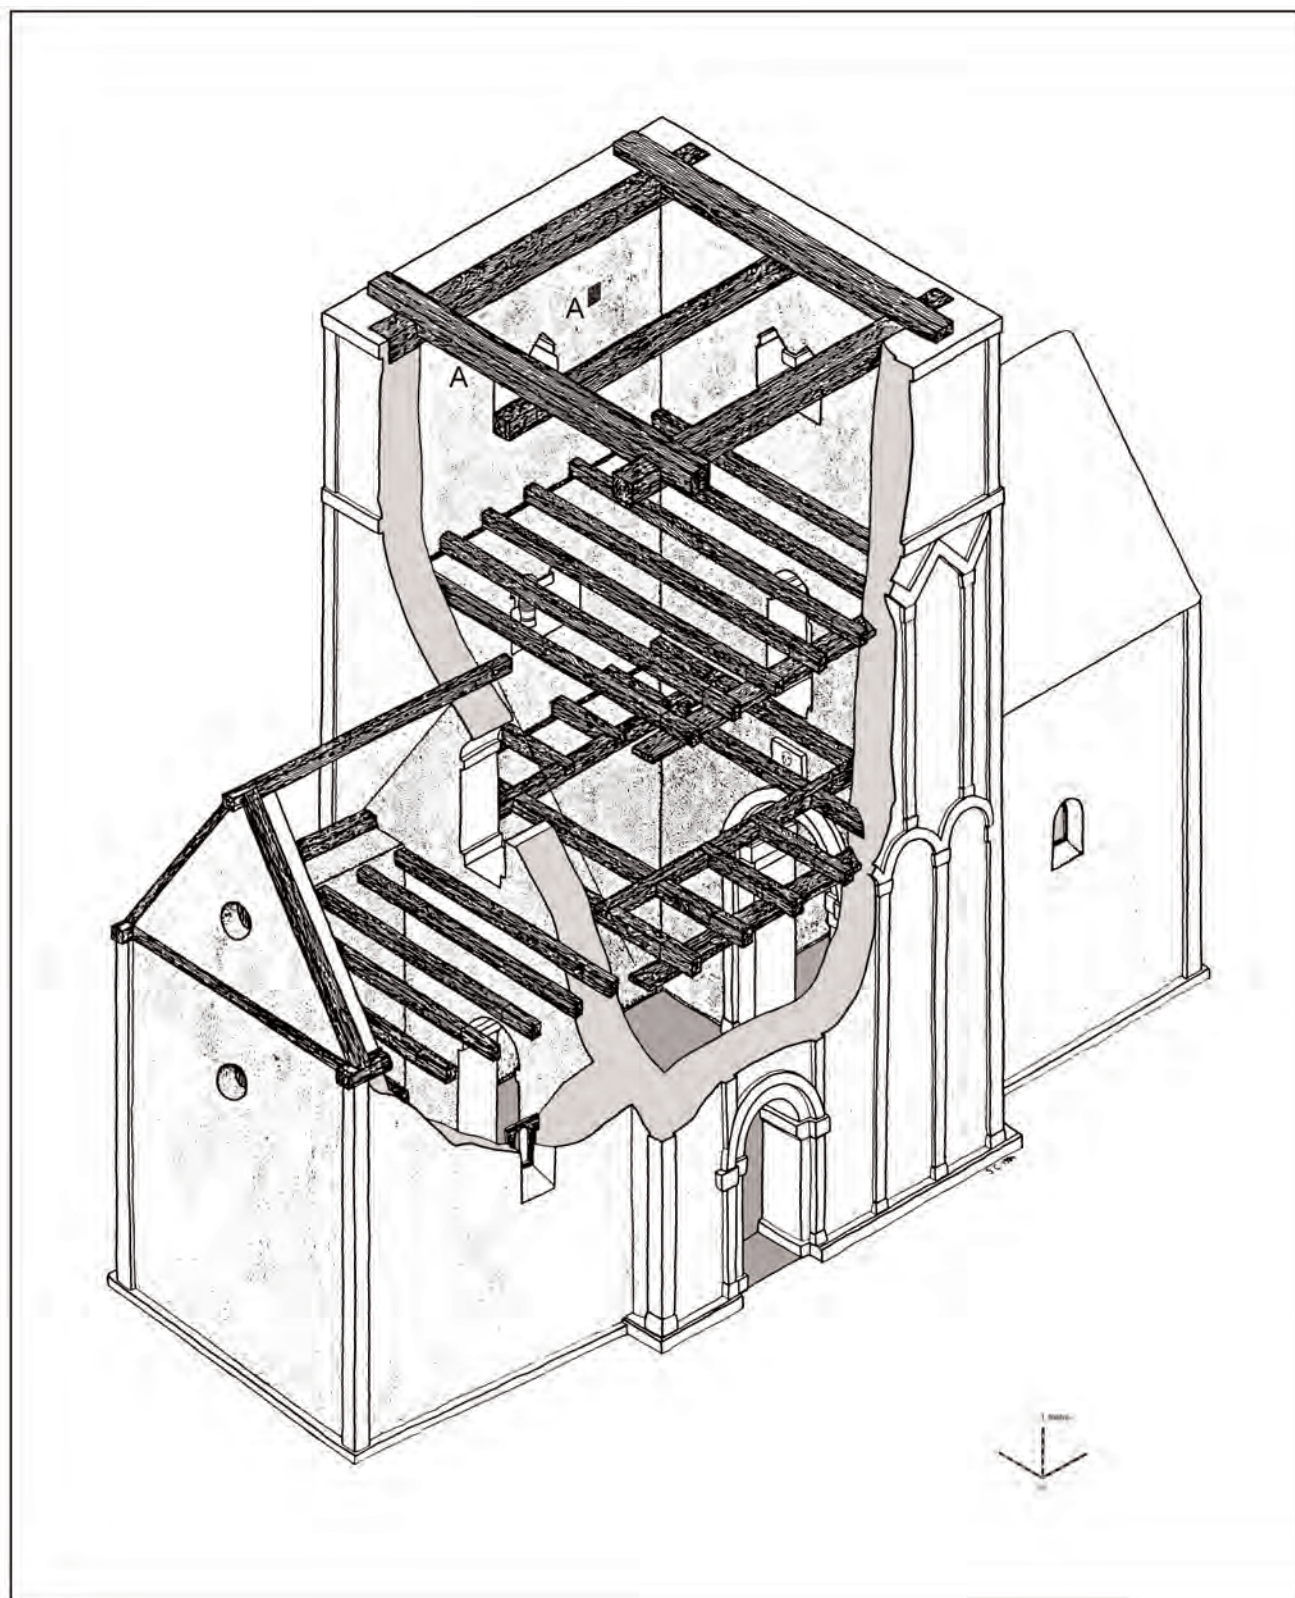
*Fig. 311: Cutaway isometric reconstruction of the floor and roof timbers in the tower-nave and baptistery, based on evidence encapsulated in the walls (cf. Fig. 301). Bell-hanging beams (AA) are omitted for clarity. View north-east. Drawing: Stephen Coll*
