# ST PETER'S

## Barton-upon-Humber, Lincolnshire

*A Parish Church and its Community*

HISTORY, ARCHAEOLOGY AND ARCHITECTURE

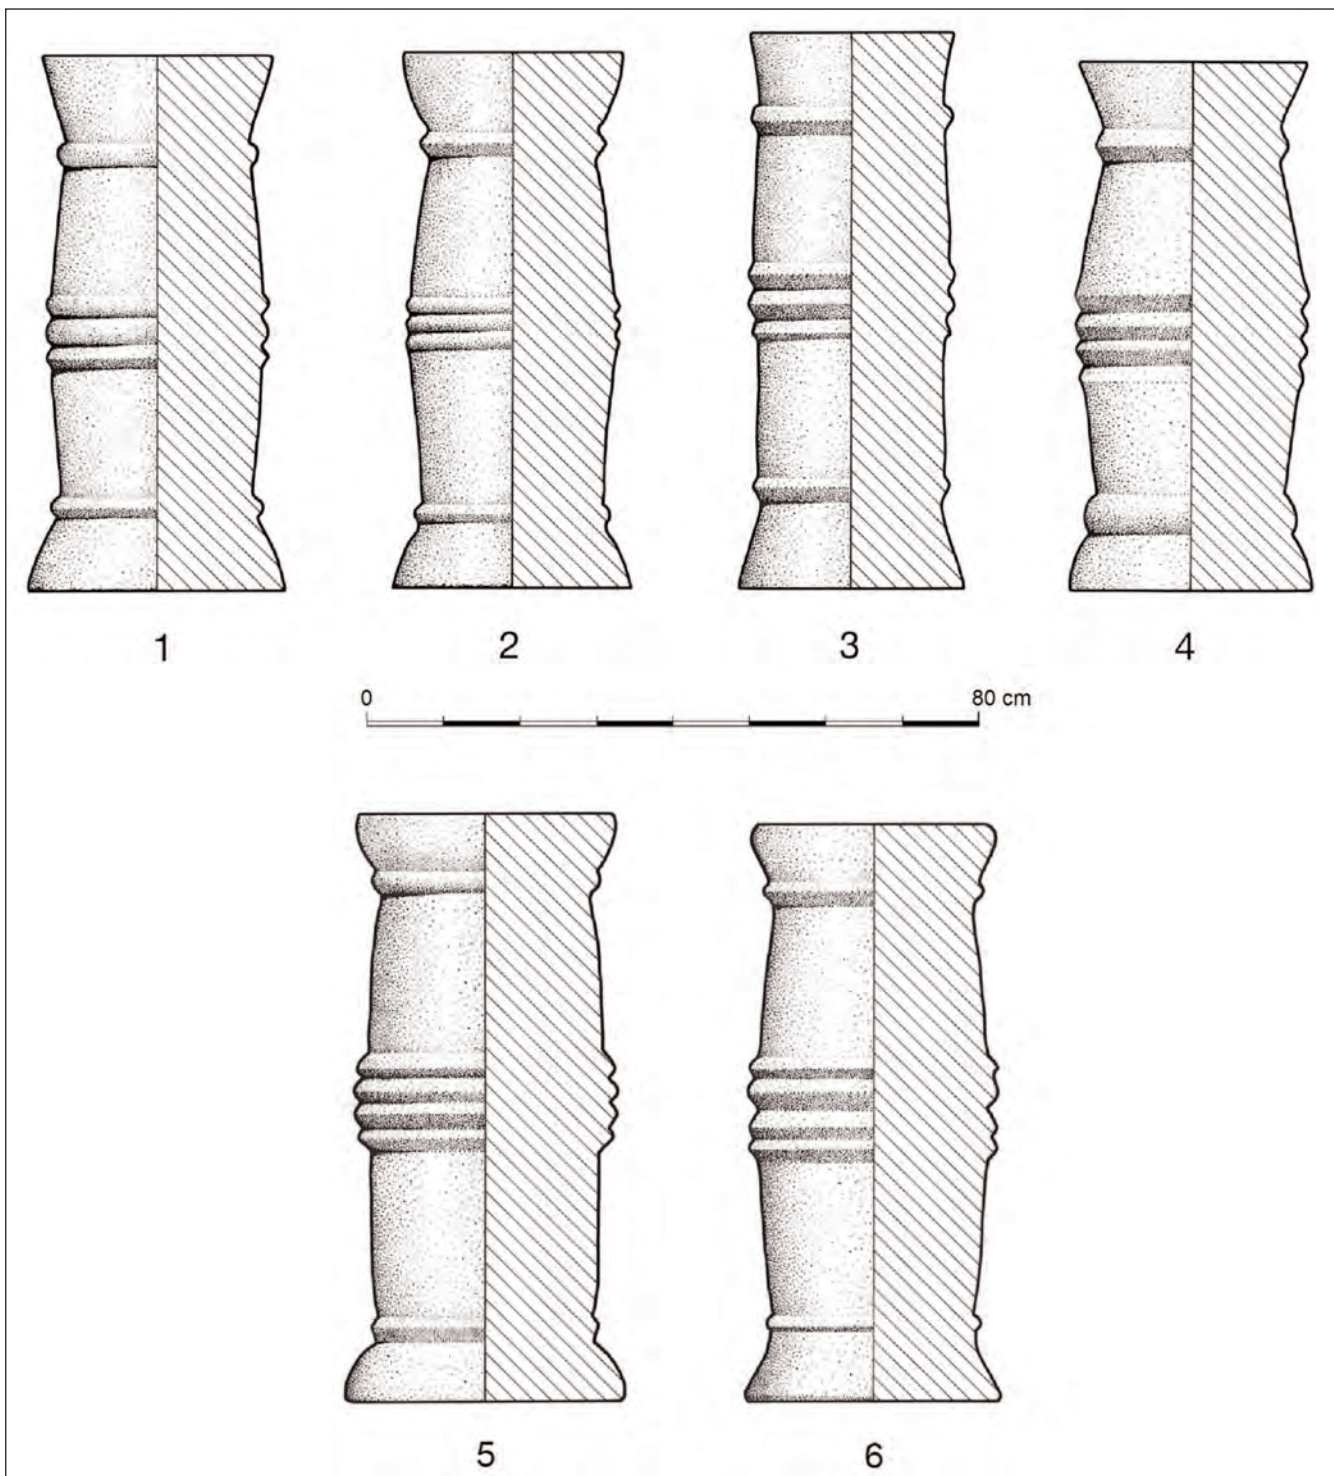
Fig. 312: Tower: Stages 1B and 2. Profiles of the six gritstone baluster-shafts employed in the double openings. Belfry: 1, north; 2, south; 3, east; 4, west. Gallery: 5, north; 6, south. Scale 1:10. Drawing: Simon Hayfield

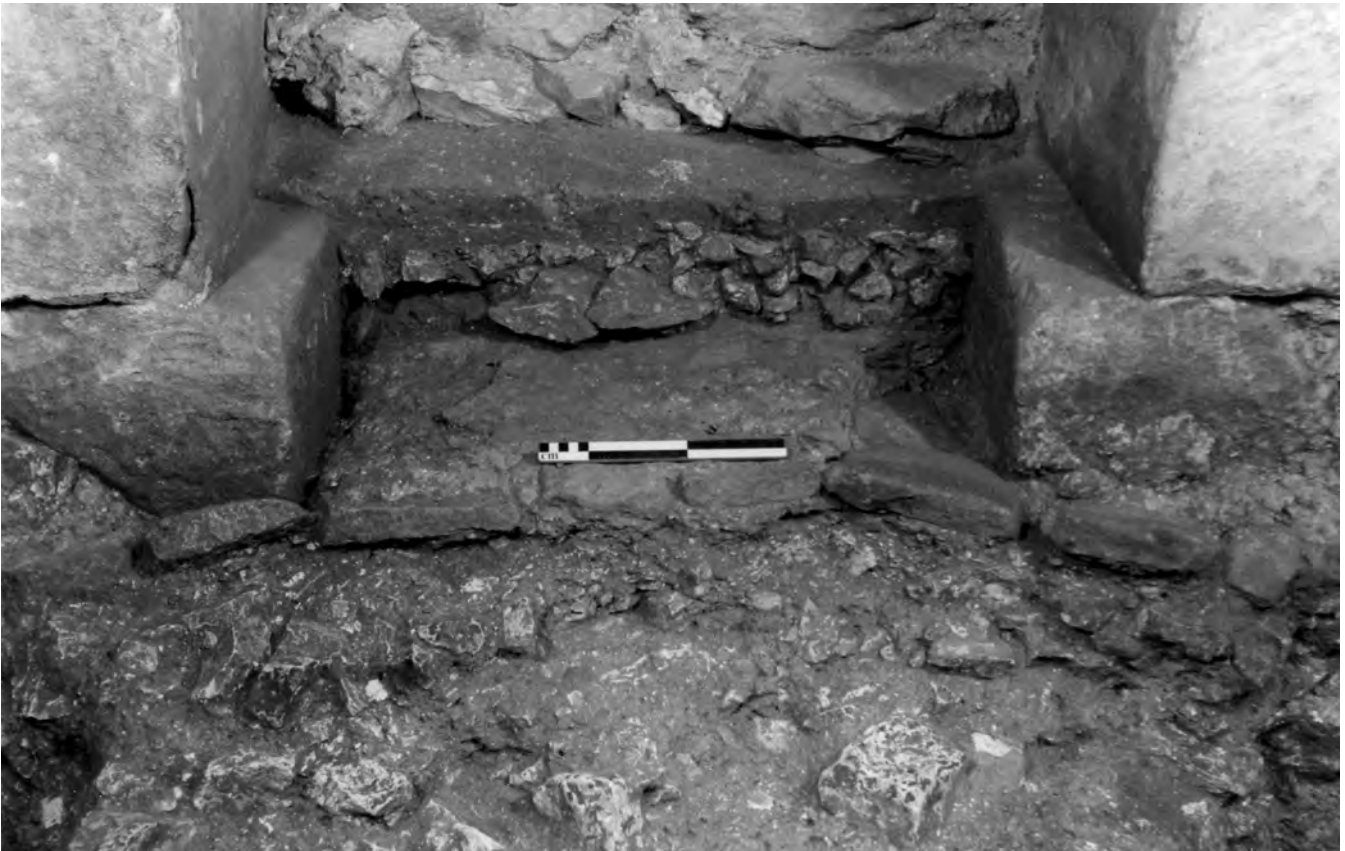
*Fig. 316: Tower: threshold of the north doorway. The opening was originally edged with flat pieces of stone and finished with lime concrete; small rubble and a layer of grey loam were deposited over the threshold in Period 5, before the doorway was completely infilled with rubble. View north. Scale of 25 cm. Photo: Warwick Rodwell*

The floor screed, like the wallplaster, was carefully prepared and well laid, and it was once continuous through the east and west arched openings and into the lateral chambers; the same surface evidently ran into the north and south doorways too. It was preserved on the north, the doorway having been infilled (Fig. 316), but wear and later disturbances had removed nearly all the evidence in the south doorway, although traces had been sealed beneath slightly later threshold blocks (p. 373). Almost certainly, the floor throughout the three cells was near-level when originally laid. As excavated, however, the thresholds of the east and west archways stood slightly proud of the surfaces to either side; they also exhibited distinct 'humping' towards the centre of each opening (Figs. 317 and 318). These effects were caused by settlement as the considerable weight of the tower compressed the foundations: the thresholds were not subjected to any loading. Furthermore, in places where the lime concrete abutted the walls, its surface was distorted and had been dragged down with the subsidence of the foundations (Fig. 319). Subsequent stratigraphy within the tower confirms that these movements occurred early in its history.

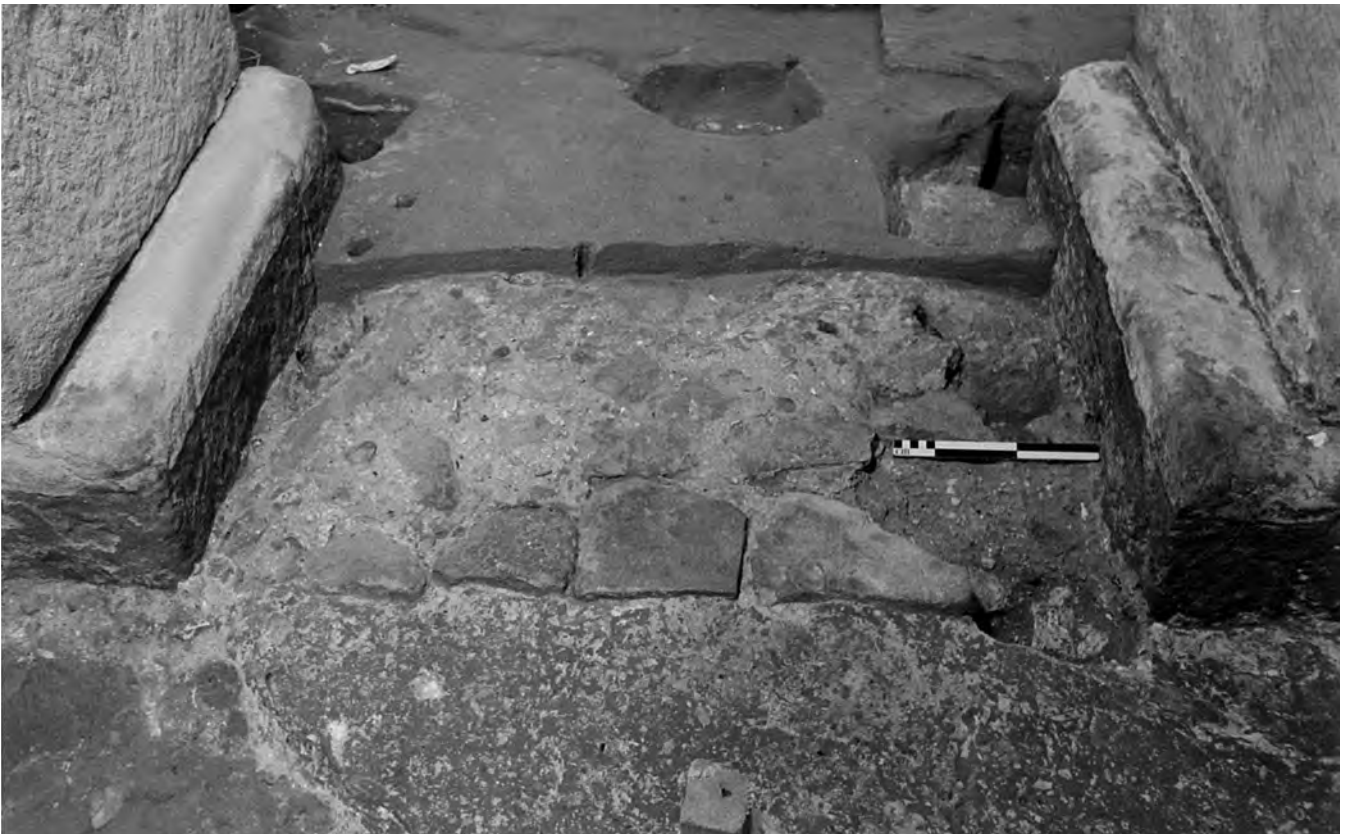
*Fig. 317: Tower: threshold of the western arch, edged with flat stones. Overlying the primary lime-concrete surface is an accumulation of grey silty soil. View west. Scale of 25 cm. Photo: Warwick Rodwell*

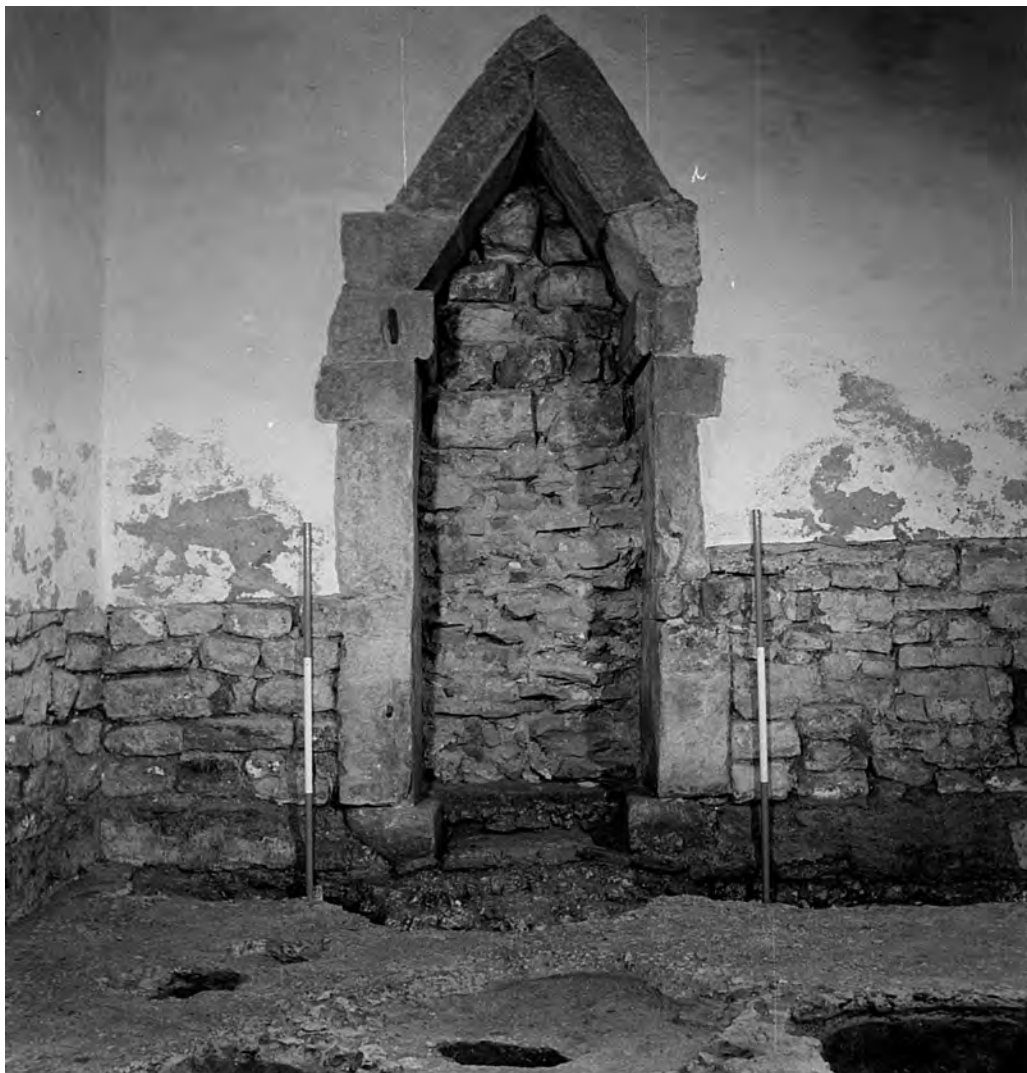
*Fig. 321: Tower: north doorway. The 2 m ranging-poles mark the positions of the postholes for a portal-frame flanking the opening. Photo: Warwick Rodwell*

The primary floor was intact over approximately half of the interior of the tower, and was best preserved towards the north; survival was poorest in the centre and in the south-west quarter, doubtless as a result of prolonged use of the south door. The floor was pierced by various postholes and other small features, most if not all of which related to post-Saxon phases. Although no stratigraphic relationship with the floor was preserved, it seems clear that postholes flanking the north and south doorways belonged to the primary phase: three of the four survived intact (F674, F675 and F677; Figs. 320 and 321). A later feature had largely removed evidence for the posthole on the east flank of the north doorway. The fillings of all three retained evidence for the rectangular form of the timbers that they once held. The postholes were

45–60 cm in depth, indicating the need for the timbers to be securely groundfast. The evidence points to the provision of portal-frames around the doors,

which would do much to explain why the inner faces of these (and other) Anglo-Saxon doorways were utterly plain and devoid of projecting masonry. The possibility that the doors were framed by decoratively carved surrounds – as seen in some early Scandinavian churches – should be seriously considered (Rodwell 1986, 165–7).

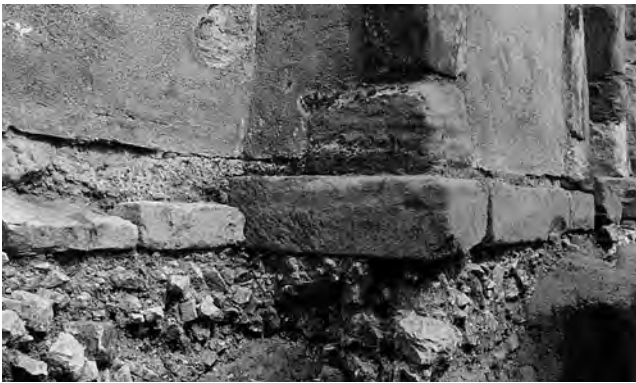
*Fig. 325: Tower: gritstone plinth at the south-west corner, abutted (left) by the shallower limestone plinth of the western annexe. Photo: Warwick Rodwell*

Externally, the annexe is a plain structure, with rendered rubble walls rising from a plain, unmoulded plinth at ground level. The latter is composed of small, flat slabs of Lincolnshire limestone, which were only roughly dressed and butted up to the tower plinth (Fig. 325). They are now frost-shattered and badly decayed; some are missing altogether (Figs. 260 and 326). The two western quoins are formed with blocks of gritstone, arranged as long-and-short work, and these stand slightly proud of the adjacent wall-faces. As with the tower, the 'tails' of the horizontal blocks, which are tied into the rubblework, were dressed back *in situ*, so that they would be concealed by rendering (see further, p. 327). The quoins were thus designed to appear pilaster-like, with sharp arrises. The west end terminates in a gable with an upstanding verge; this has nineteenth-century limestone kneelers and copings, and is crowned by a gable-cross that appears to be fourteenth century (Figs. 324 and 539). The eaves are finished with three projecting courses of eighteenth-century brickwork with dogtooth ornament, and the roof is covered with modern red clay tiles.

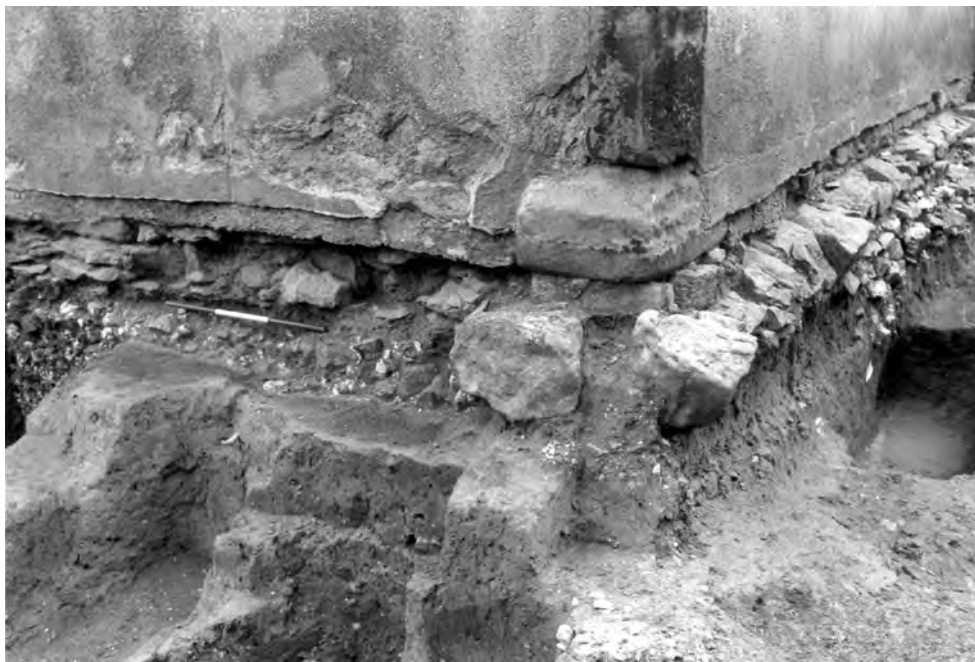
*Fig. 326: Western annexe: south-west corner. The limestone plinth running around the base of the walls is present but heavily decayed on the south (right), while on the west (left) it has largely disappeared. Scale of 75 cm. Photo: Warwick Rodwell*

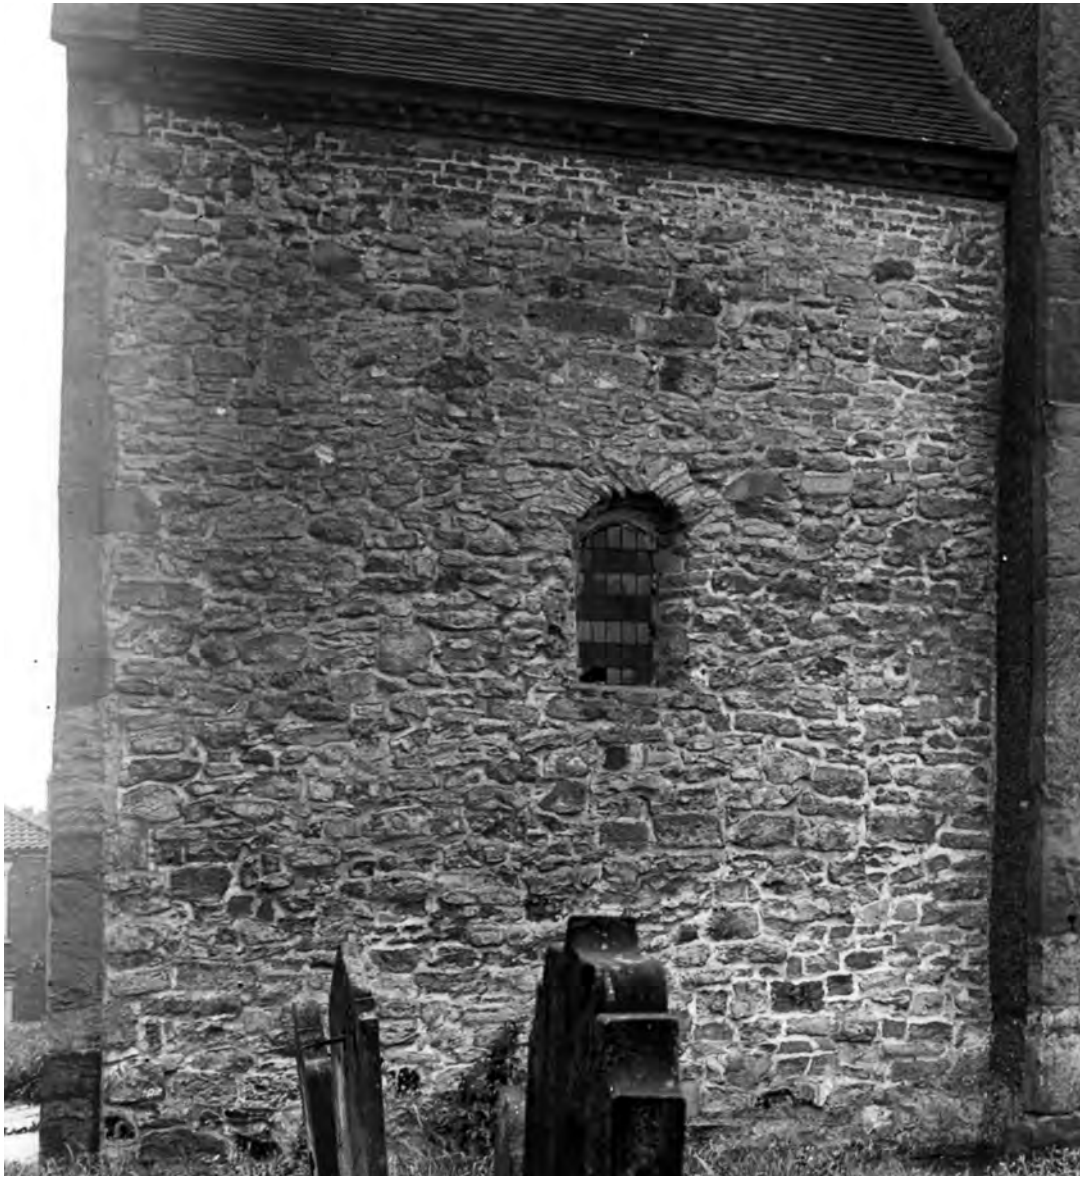
*Fig. 327: Western annexe: the south wall in the 1950s; it had been stripped of rendering in 1923, exposing the rubble construction. Photo: The Courtauld Institute of Art, London*

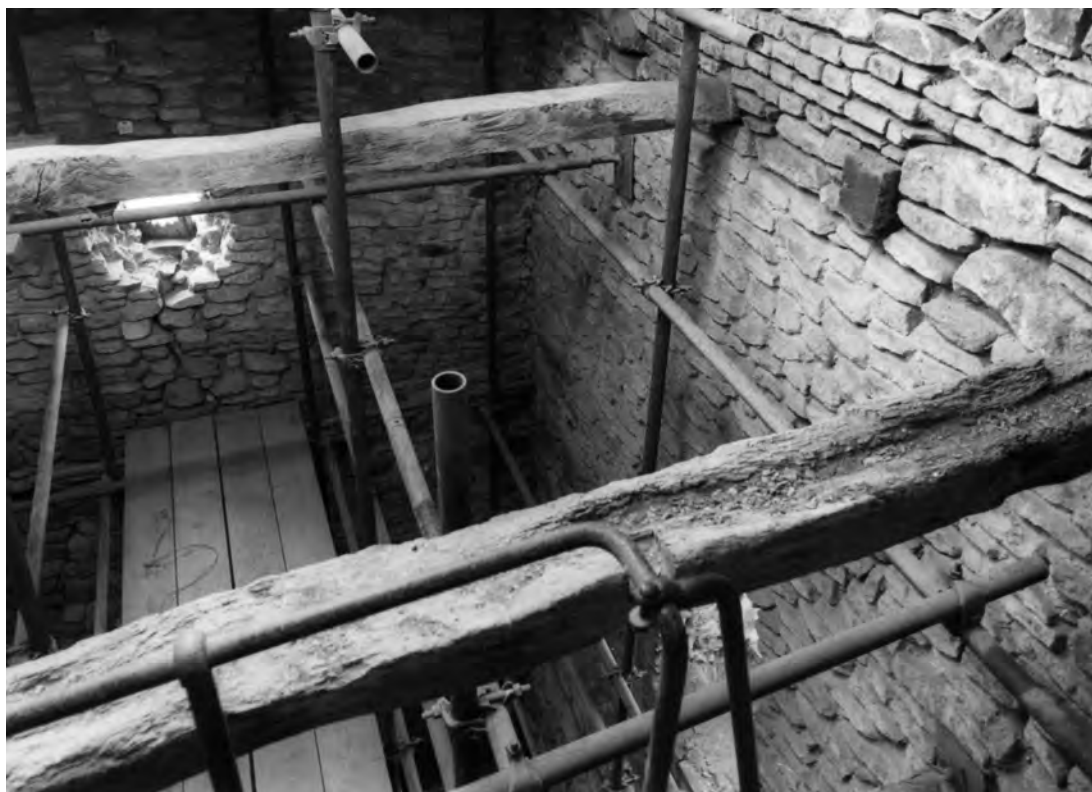
*Fig. 328: Western annexe: the upper part of the north wall, showing two existing floor joists (the nearer one being primary) and the sawn-off stump of a third in between. View north-west, 1983. Photo: English Heritage*

the north, the latter dimension (20½ ft) equating with the threshold of the gallery-level doorway in the tower (Fig. 308). The tops of the walls are much disturbed by works associated with later roofs, but nevertheless they retain evidence of former flooring at eaves level. One complete oak joist remains, with its ends embedded in primary construction mortar, and the sawn-off end of another occurs next to it in the north wall (Figs. 328 and 329). Further joist-ends exist in both walls, but these are set in post-medieval masonry and brickwork, and are unlikely to be primary timbers.<sup>69</sup>

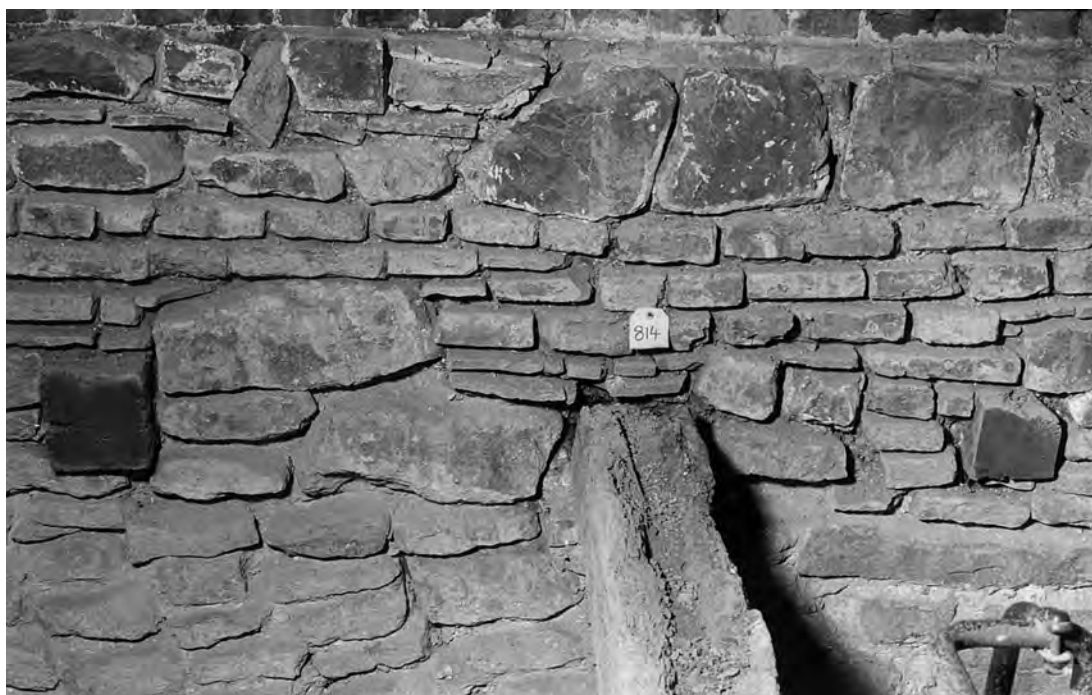
*Fig. 329: Western annexe. The top of the north wall, showing one primary floor joist in situ and the stumps of two others that have been sawn off. Photo: Warwick Rodwell*

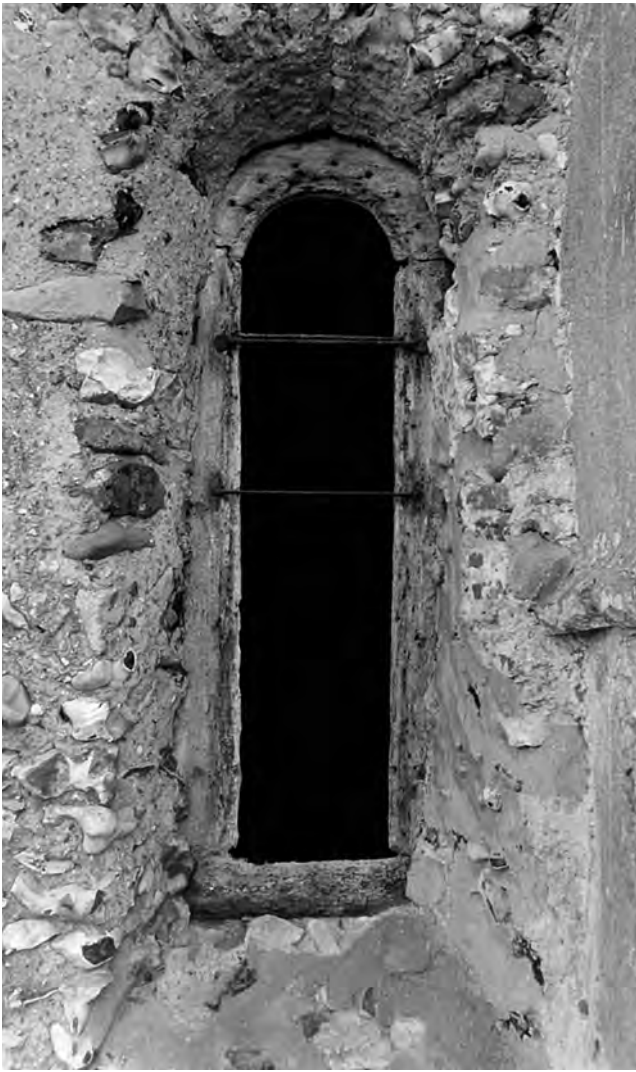
Fig. 331: St Botolph, Hadstock (Essex). Jointed oak frame of a double-splayed window in the north wall of the nave, integrally built with the flint-rubble masonry. Note also remains of the original lime-render in the reveal and on the external wall face (upper left). Photo: Warwick Rodwell

carpentered oak frames of the type that still survive at Hadstock (Essex) and elsewhere:<sup>72</sup> each comprised a sill, a pair of stiles and a shaped head (Fig. 331). The head was a rectangular baulk of timber with a semicircular cut-out to form the window arch. A series of small holes drilled into each face, concentrically around the arch, provided anchoring points for the basketwork hoods that supported the masonry heads of the outer and inner splays while their bedding mortar was setting (Fig. 332). Although no evidence survives at St Peter's, it was usual for the basketwork to be left in place, providing a useful key for the plaster lining to the head of the splay. Impressions left by woven cane-work in the mortar have been recorded in window heads at Hadstock, Hales (Norf.) and elsewhere (Rodwell 1986, 164–6).

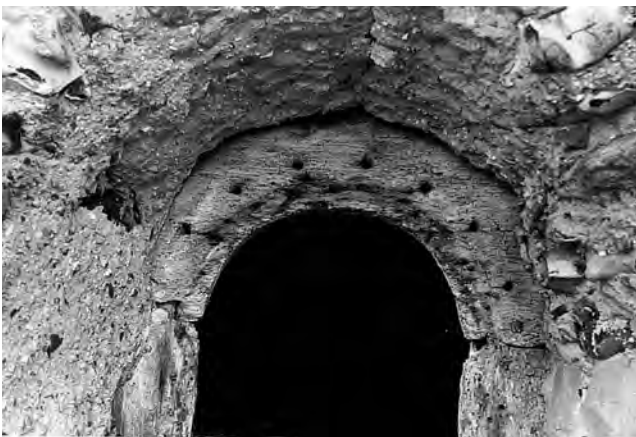
Fig. 332: St Botolph, Hadstock (Essex). Semicircular head of a jointed window frame in the nave, showing the arc of small holes used to anchor the basketwork hood which served as a former for the arch of flint rubble. Note the preserved wattle impressions in the soffit. Photo: Warwick Rodwell

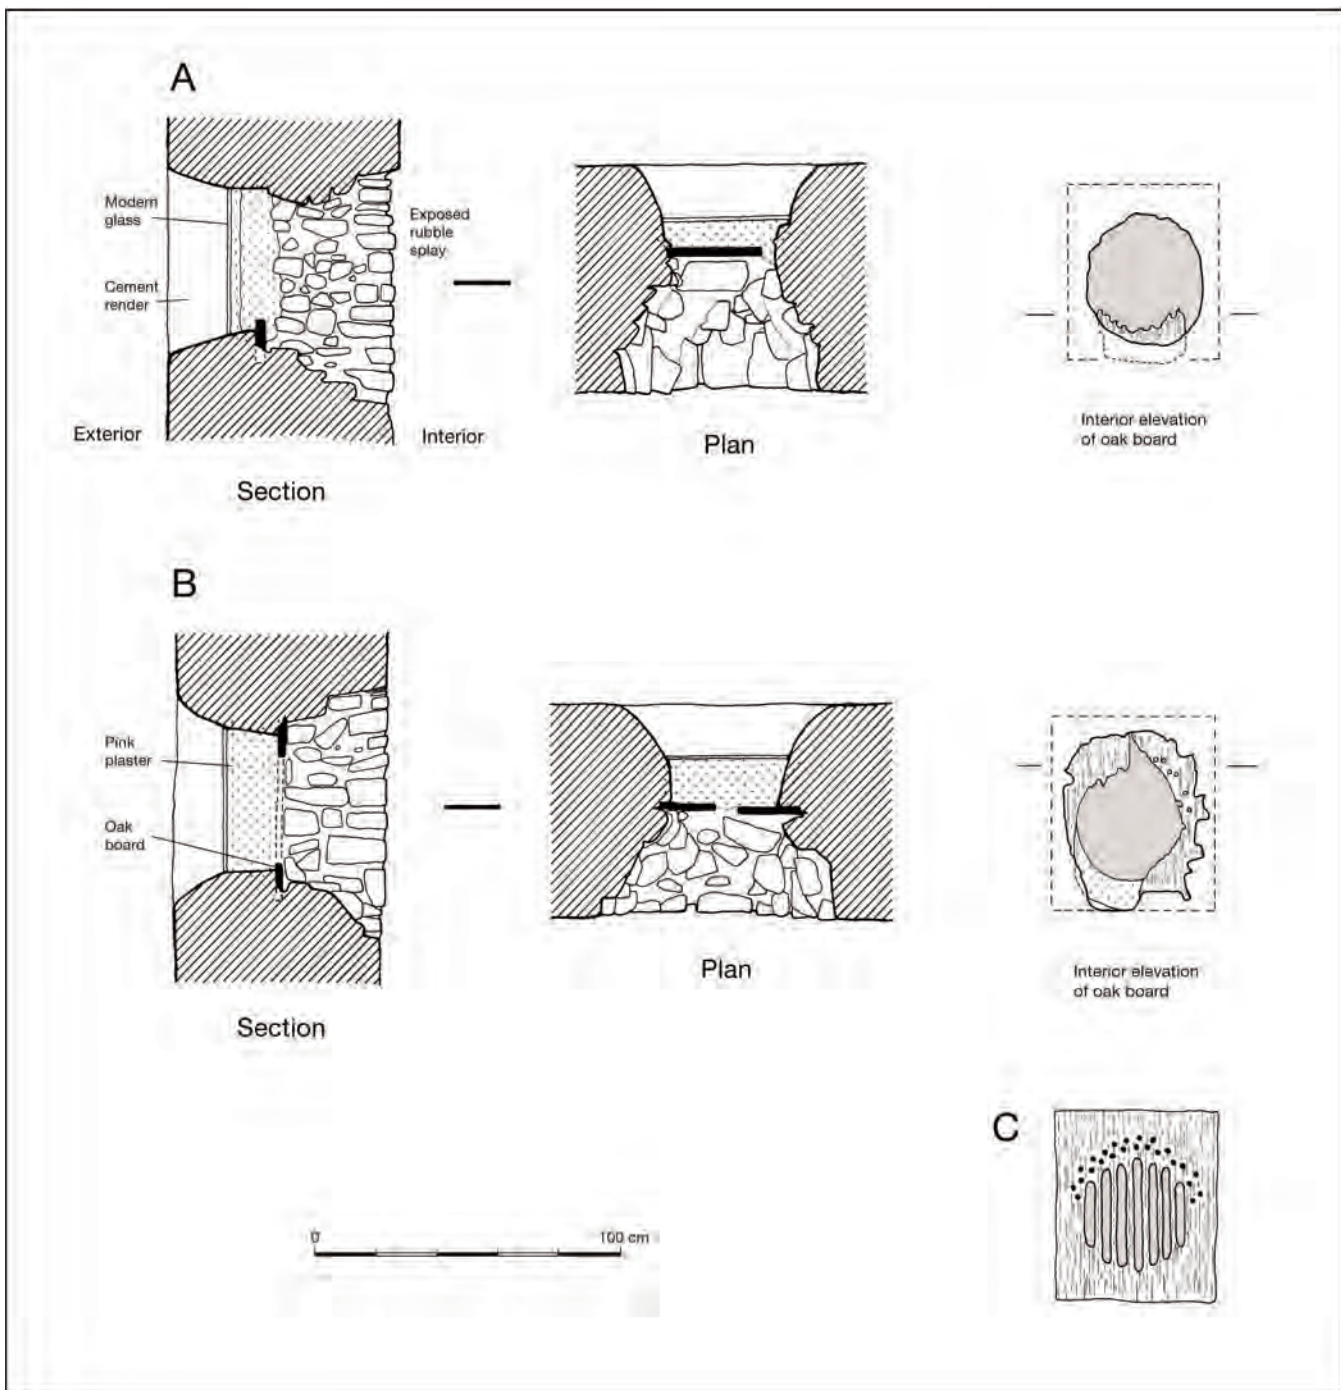
Fig. 333: Western annexe. Plans and sections through the oculi in the west wall, and internal elevations of the surviving fragments of pierced window-boards contained in them. A, lower oculus; B, upper oculus; C, reconstruction of a window-board. Scale 1:25. Drawings: Stephen Coll and Warwick Rodwell

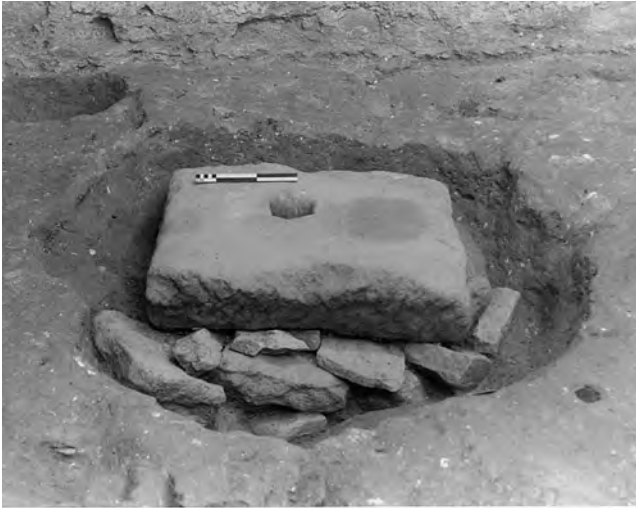
*Fig. 338: Western annexe. Gritstone block to support the Anglo-Saxon font, showing the construction pit and soak-away made of limestone fragments. Note also the pattern of wear on the upper face of the block, especially at the near right-hand corner, the side from which the font would principally have been approached. View west. Scale of 25 cm. Photo: Warwick Rodwell*

thrown into the hole; this was not a constructed foundation, the rubble being loose and voided (Fig. 338). The filling of the pit, around the gritstone block, was in two layers: the lower 10 cm comprised clay, above which was clean chalk and flint gravel. The lime-concrete floor was then laid, lapping over the surface of the block and masking its outline.

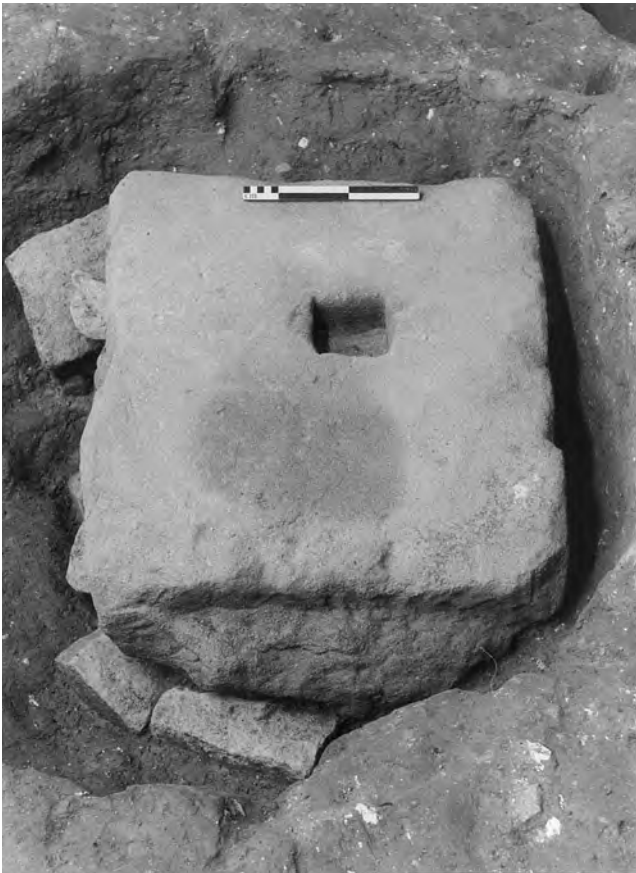
*Fig. 339: Western annexe. Close-up view of the gritstone font base, showing the mortice in the upper face and the cut-and-break line along the near edge. View south. Scale of 25 cm. Photo: Warwick Rodwell*

the stem and bowl. The surviving base exhibits various features which point to its earlier history: first, it has been fashioned from a longer block, as shown by the cut-line on its north end and the different types of tool-marks on its edges (Figs. 339 and 817). Second, the upper surface exhibits considerable signs of wear, and the arrises are rounded: this occurred before use in the church. Third, the mortice is primary. Collectively, these features point to the stone having originated as a stylobate block from a Roman portico or colonnade, the column-bases of which were secured with tenons. When the block was cut down the mortice was retained as a near-central feature, possibly implying that it was reused to locate the font stem in position (although that must be very doubtful, since the stems of fonts were not normally tenoned into their bases).

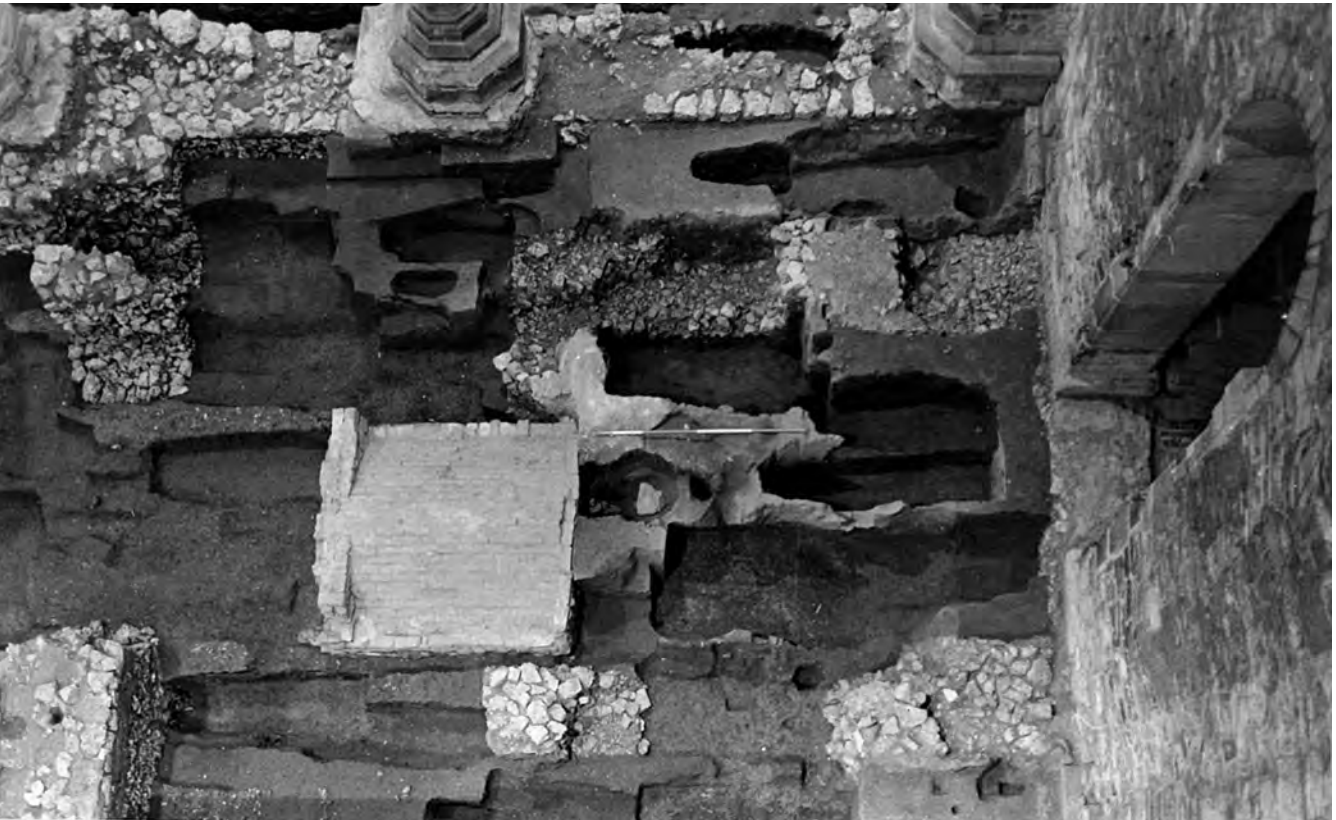
*Fig. 340: Foundations of the Anglo-Saxon chancel and the nave of the Saxo-Norman church which encased it. The chancel arch of the tower-nave is on the right. View south. Scale of 2 m. Photo: Warwick Rodwell*

Nothing survives of the chancel above ground level, except the vertical scars where its north and south walls were keyed into the east face of the tower (Figs. 252, 258 and 347). Excavation beneath the floor of the present nave (Area 1) revealed the foundation plan, although much cut about by later features (Figs. 256, 340 and 341). The construction was identical to that

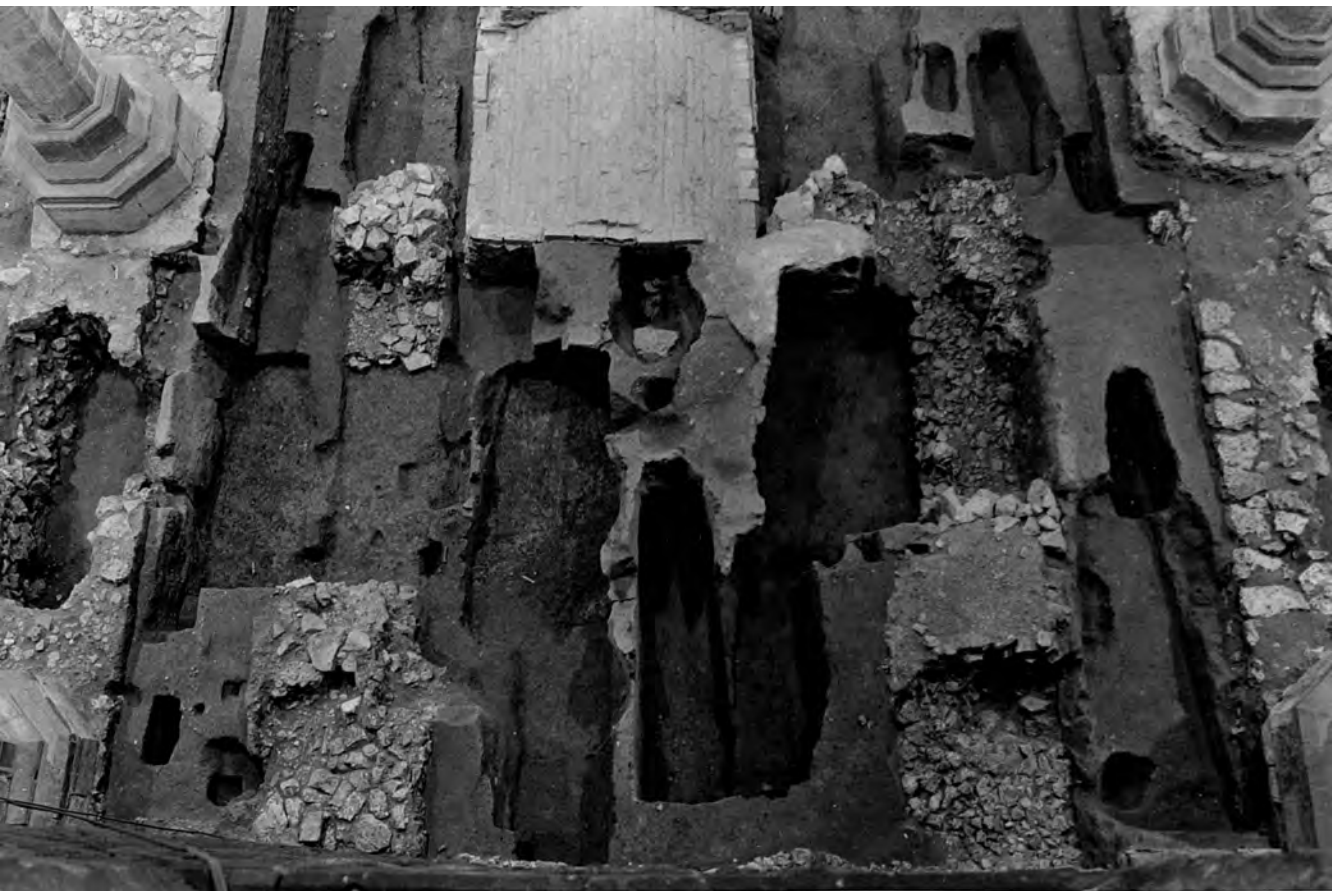
*Fig. 341: Fragmentary foundations of the demolished Anglo-Saxon chancel, after the excavation of all later features. Overhead view from the high-level doorway in the tower. East is at the top. Scale of 2 m. Photo: Warwick Rodwell*

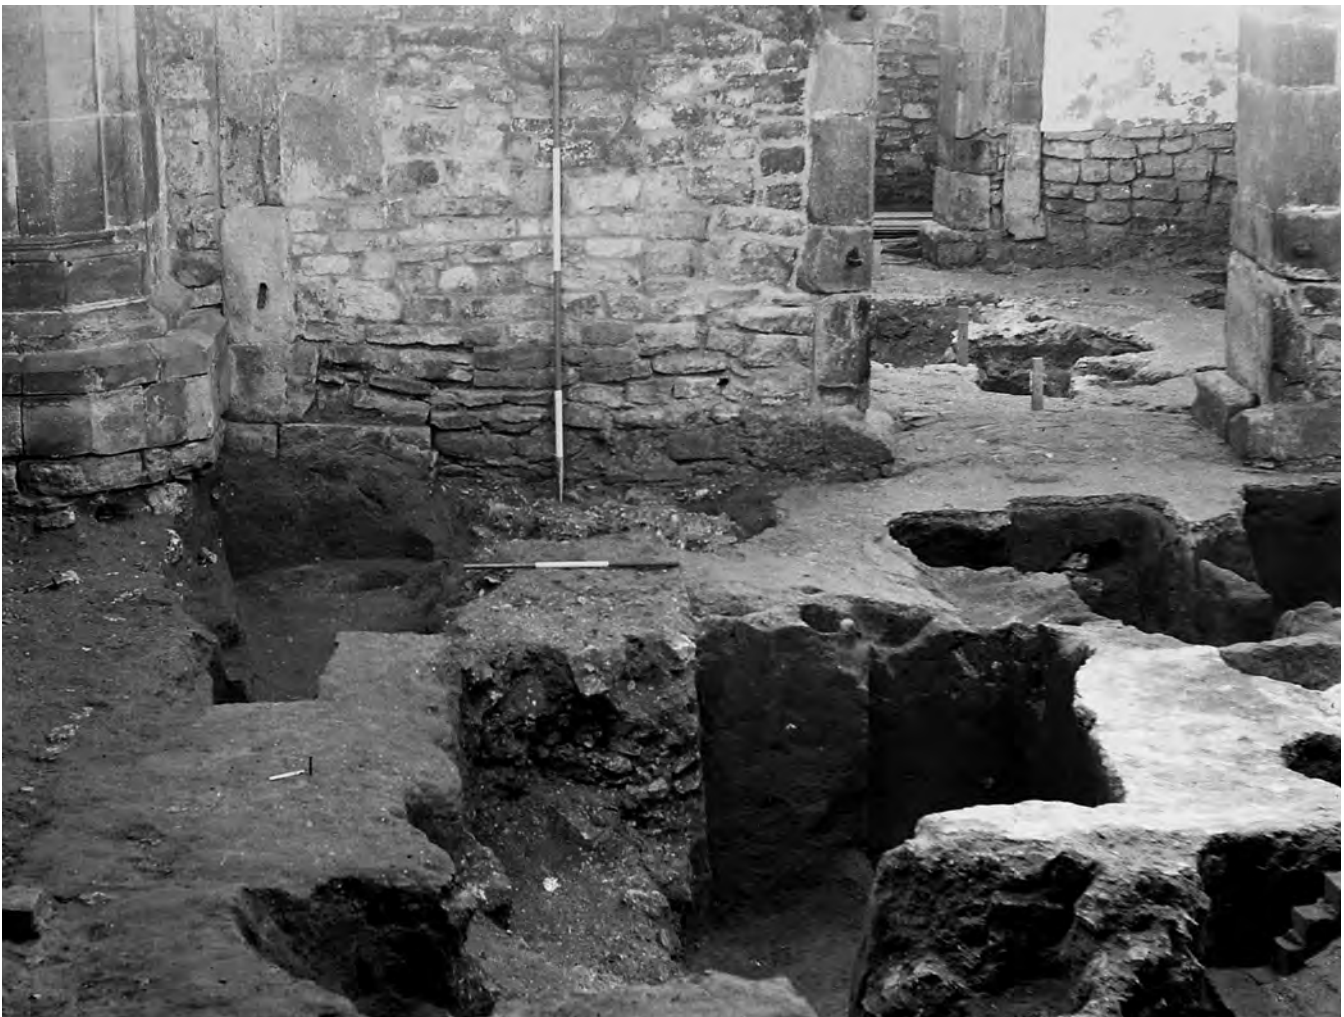
*Fig. 342: Chancel: foundation for the south wall, partly sectioned by a later grave. View west. Scales of 2 m and 75 cm. Photo: Warwick Rodwell*

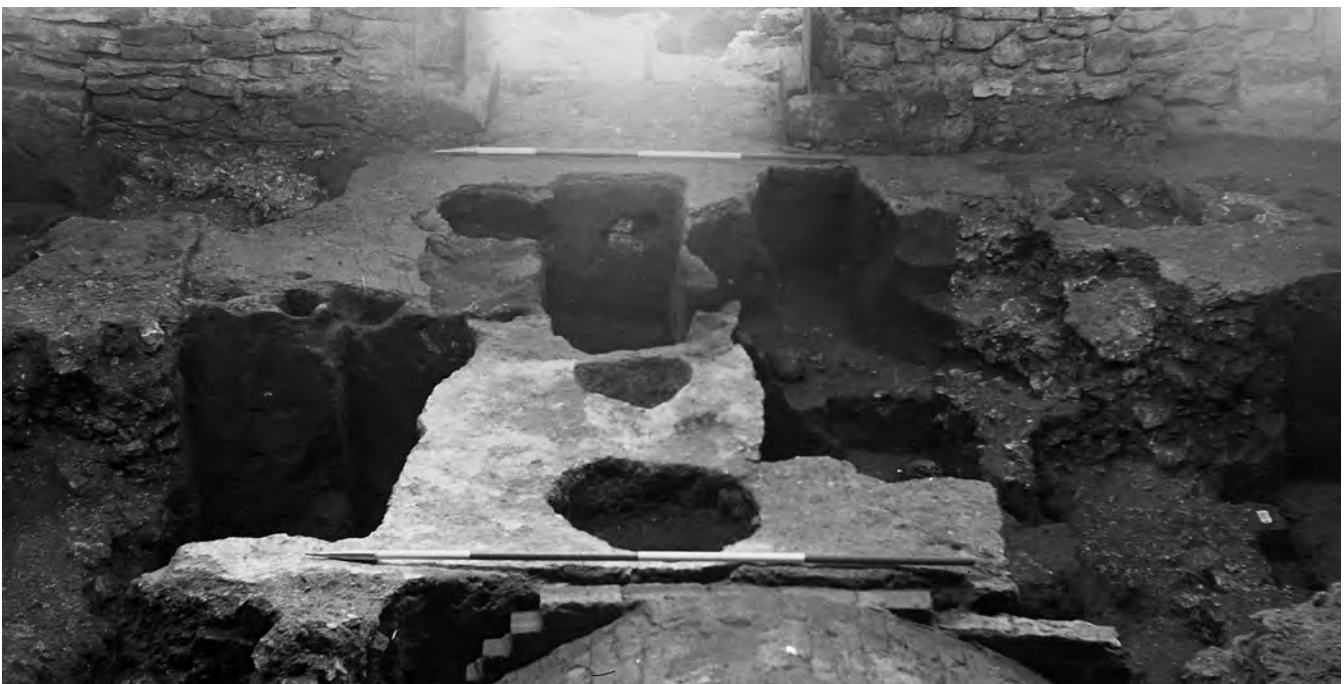
Fig. 343: Site of the Anglo-Saxon chancel with primary white lime-concrete floor, much disturbed by later features. The south wall foundation is glimpsed on the left; the north foundation is on the right, but largely dug away. The east wall was removed by the brick vault in the foreground. View west. Scales of 2 m. Photo: Warwick Rodwell

The lime-concrete floor of the tower continued into the chancel, but its survival was very patchy. It appears to have covered only the western half, ending at the line of a timber screen which ran across the chancel at its mid-point (Fig. 256). Evidence for the screen was found abutting the south wall, where several slots and small postholes had survived later disturbances (F215–F218). The existence of a permanent division here is also reinforced by the fact that the primary lime-concrete floor (F534) did not occur in the eastern half of the chancel: instead, a different type of floor was present which appeared to be composed entirely of crushed chalk and small gravel (F219; Figs. 343 and 344). The surface was worn and undulating, but there was no change of level between the two floors.

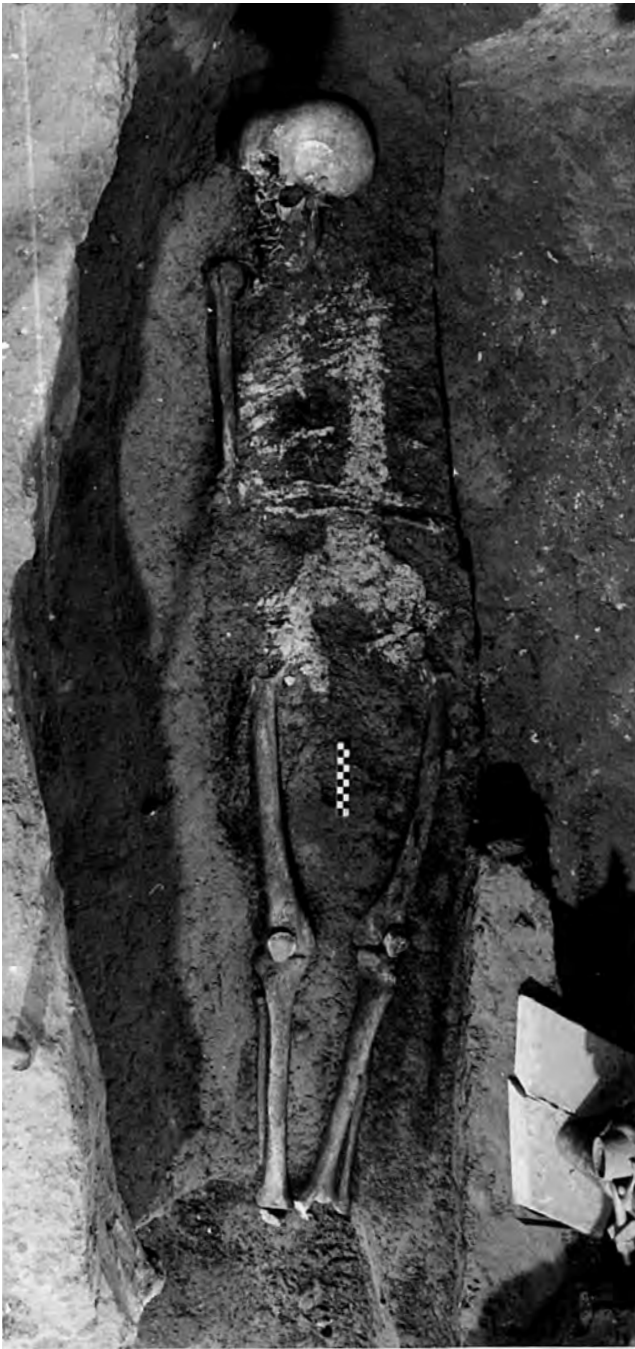
Fig. 346: Chancel: grave F1386, view west. Scale of 10 cm. Photo: Warwick Rodwell

grave (F1386) had been dug before the lime-concrete floor was laid, and thus the interment presumably took place while the church was in the final stage of construction. The outline of a coffin was partly preserved on account of the timber from which it was made having been charred. After the lime-concrete floor had been laid, the filling of the grave subsided and the floor broke up and sunk (Fig. 345). The burial was unusual for Barton in that the bones of the pelvis and torso had decayed to such an extent that nothing was recoverable: they appeared in the ground as cream-coloured pulp. In contrast, the bones of the skull, right arm (the left was missing) and legs were in average condition (Fig. 346). Such markedly different decay mechanisms, within a single adult grave, raise the possibility that some form of treatment, such as embalming, was applied to the corpse. Although positive evidence for embalming is lacking, this pattern of differential bone decay is regularly encountered on high-status sites.<sup>83</sup>

A small, rectangular area of rubble foundation (F167) had been constructed partly over the grave. The rubble comprised chalk, ironstone and pebbles, laid in a matrix of clay. This feature was complete and had the appearance of being the support for the southern end of an altar.
