# ST PETER'S

## Barton-upon-Humber, Lincolnshire

*A Parish Church and its Community*

HISTORY, ARCHAEOLOGY AND ARCHITECTURE

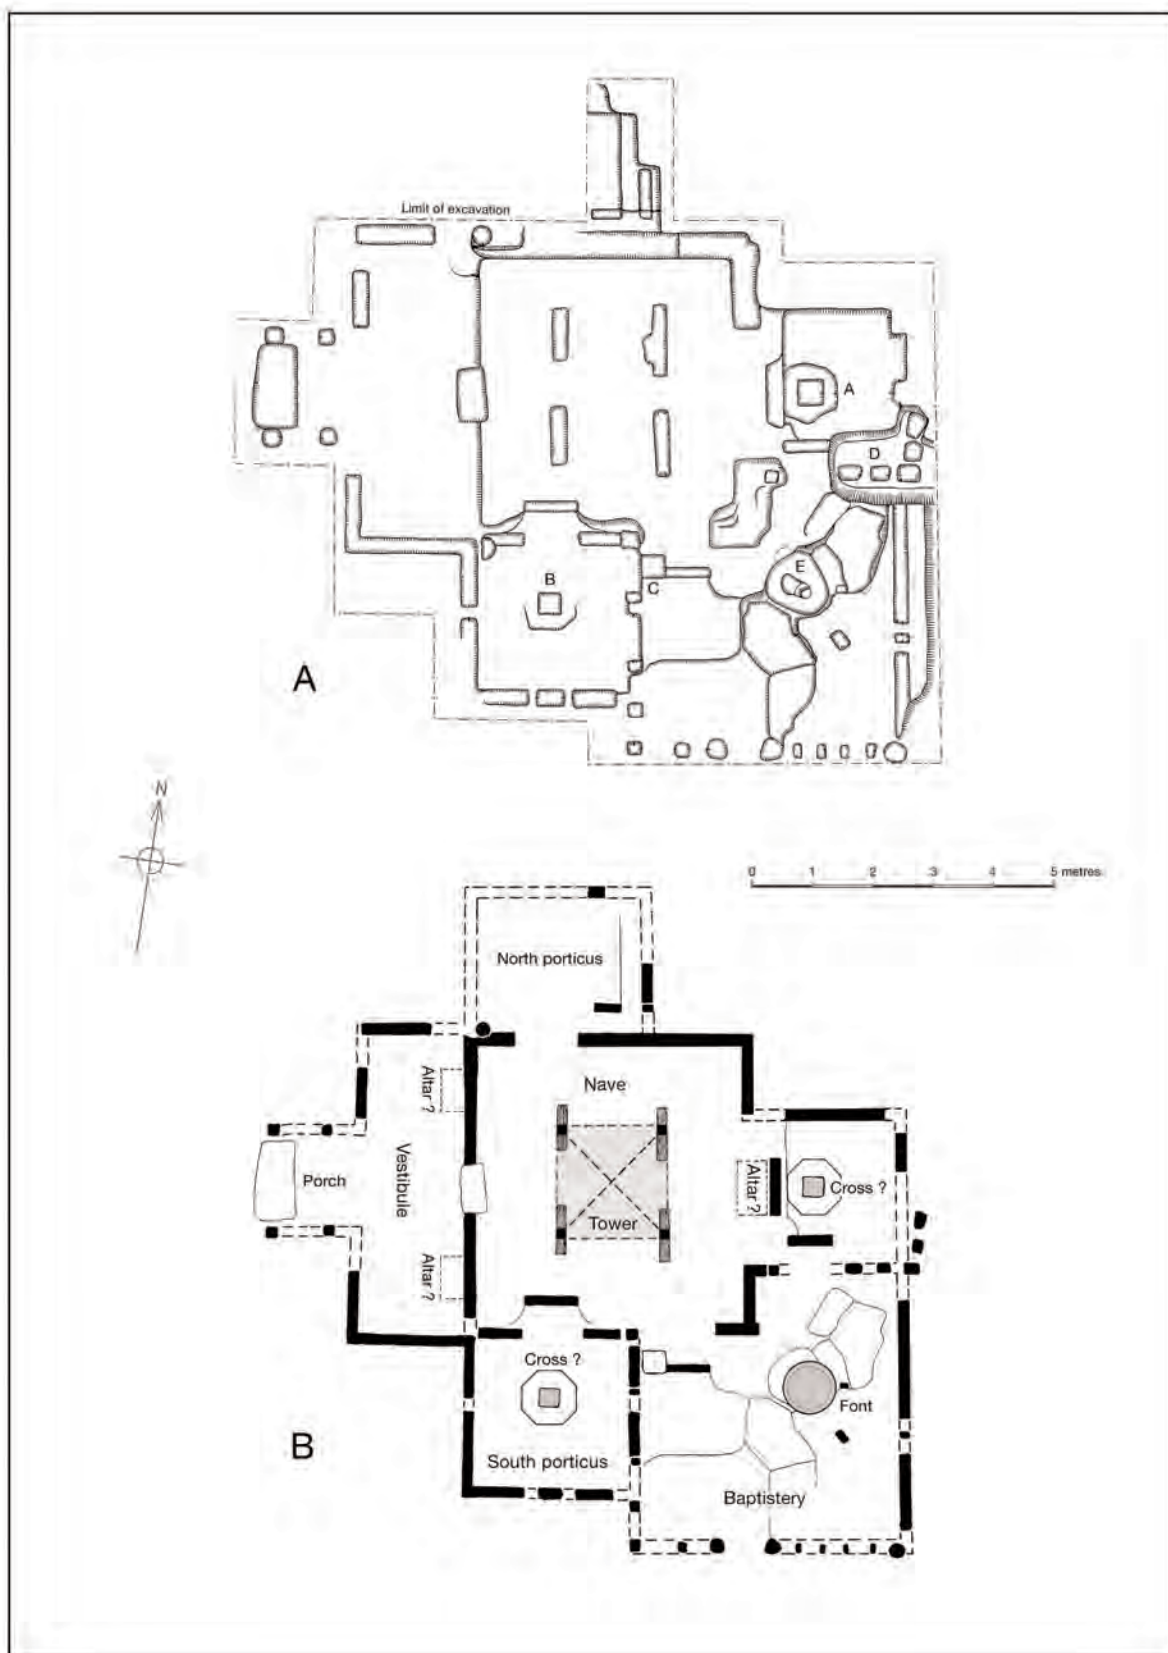
Fig. 348: Potterne (Wilts.). Cruciform timber church found by excavation. A, excavation plan. After Davey 1964. B, interpreted foundation and function plan. Scale 1:125. Drawing: Warwick Rodwell

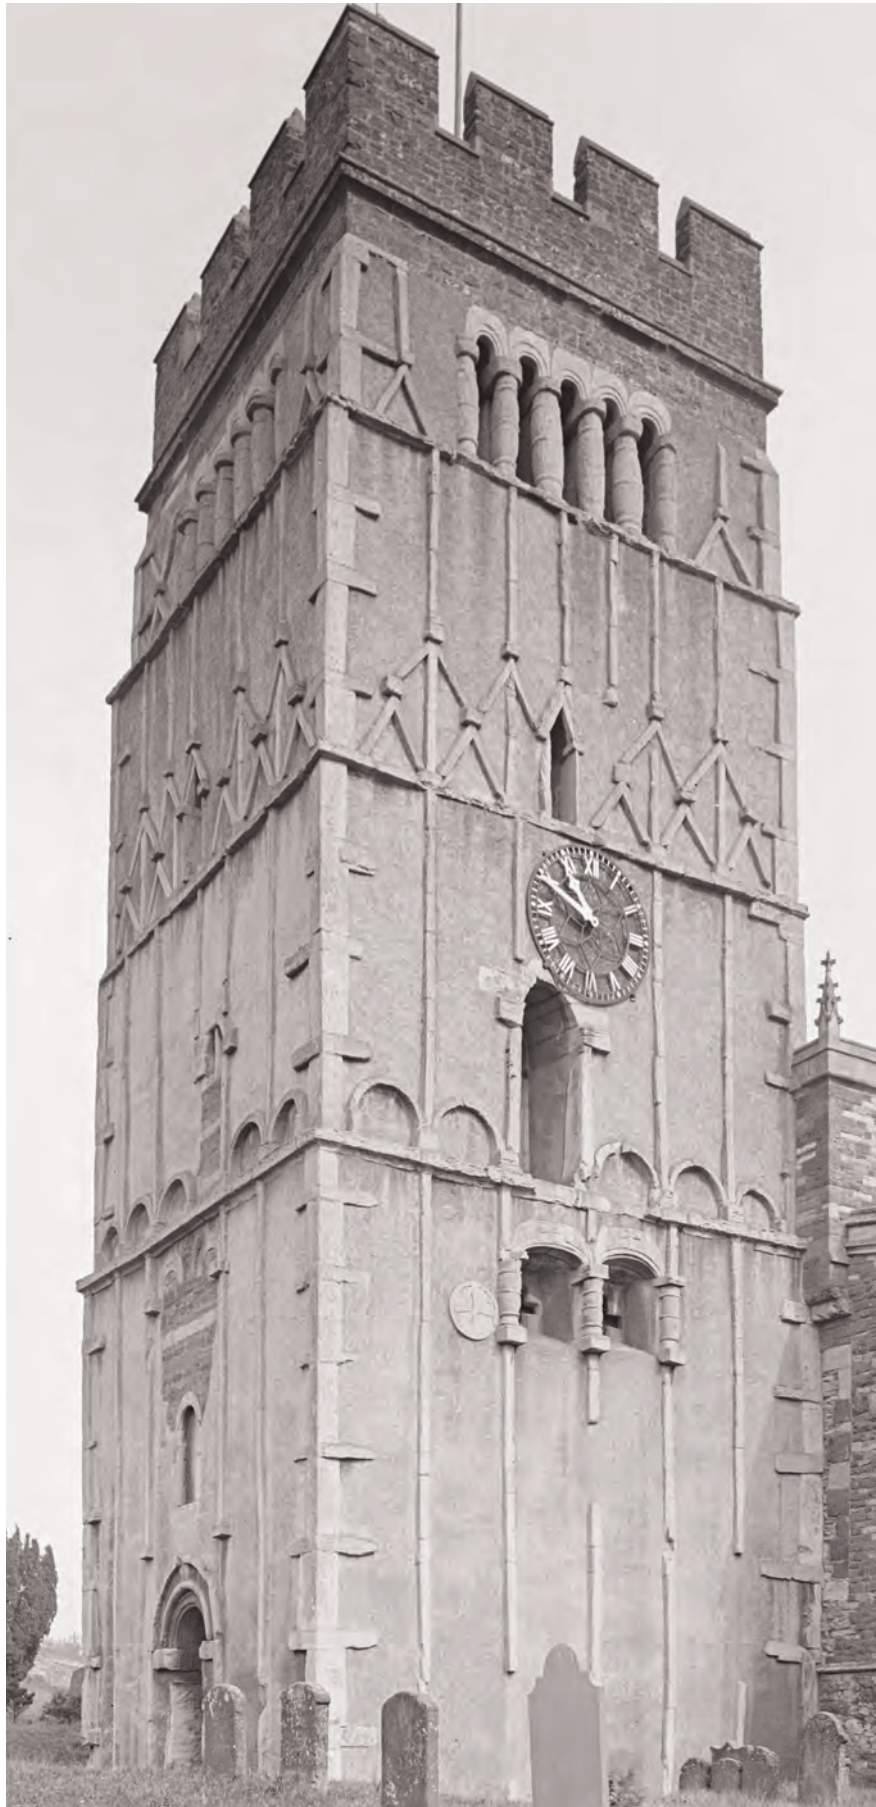
*Fig. 354: All Saints, Earls Barton (Northants.). Turriform nave of Saxo-Norman date. View from the south-west. Photo: English Heritage, RCHME*

Next to Barton-upon-Humber, this is the most important example, where interpretation of the surviving tower as a turriform nave, with a small but now-lost chancel to the east, is demanded by the architectural evidence (Fig. 354, Audouy *et al.* 1995). It did not have any appendage to the west.

St Peter's is one of the three notable examples of English towers festooned with stripwork, in the form of multiple pilasters and raised surrounds to openings. The most elaborate of the trio is Earls Barton (Figs. 354 and 363), and the plainest is Barnack (Pl. 25A); several other churches display simpler schemes. The origin and purpose of pilaster-stripwork has been much debated since the mid-nineteenth century. Initially, antiquaries saw it as a skeuomorph for timber framing, but in the twentieth century an idea developed that pilaster-strips somehow contributed to the inherent strength of rubble walling, tying the face-work to the core. This theme was explored by Taylor (1970; 1978, 924–7). Investigations into the fabric of the tower at Barton revealed that the blocks upon which the stripwork is formed are variable in size, and often do not penetrate deeply into the core of the walls (pp. 265–7). Indeed, the upright stones are very shallowly embedded and, far from adding structural strength, they detract from it by introducing multiple vertical lines of weakness in the facing. Also, the presence of stripwork around major arches prevents the jamb-stones of the latter from being bonded into the adjacent walling. Although it might be argued that stripwork surmounting external doorways and windows fulfilled a water-shedding function, like a hood-moulding in a medieval building, this was clearly not its intended purpose either. Also, mouldings which lack undercutting are not very effective for water-shedding.

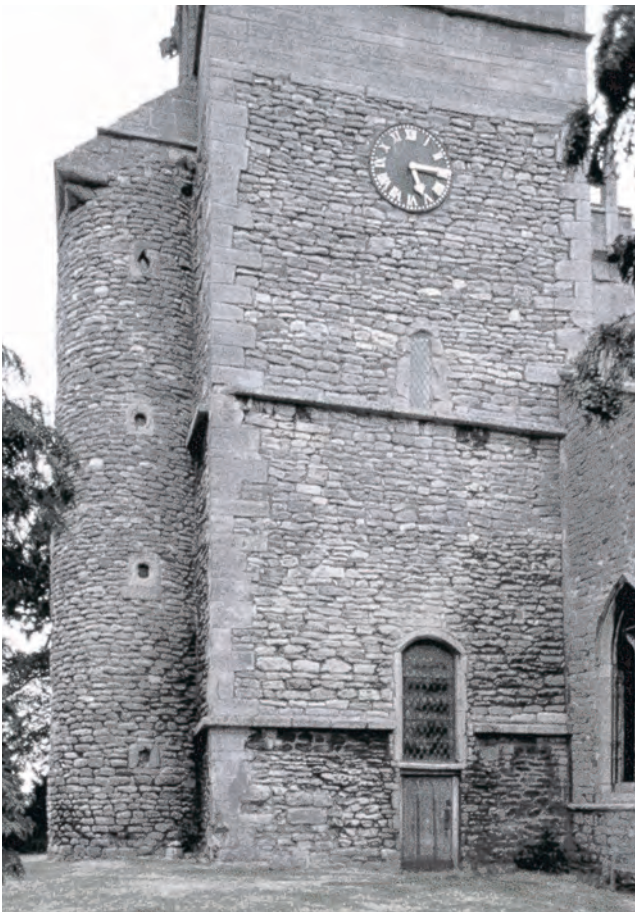
Fig. 356: *All Saints, Hough-on-the-Hill (Lincs.)*. Tower with attached western stair-turret. South elevation. Photo: Warwick Rodwell

This has been claimed as the third turriform church in Lincolnshire, although the evidence is equivocal. It has a lofty, unbuttressed tower 6.9 m square externally, which appears to abut the west end of an earlier nave of similar width (Taylor and Taylor 1965, 321). Attached centrally to the west side is a circular stair-tower 3.4 m in diameter (Thurlby 2003, fig. 51).

Dimensionally, the plan is similar to Broughton, and it is this comparison which seems to have given rise to the suggestion of a tower-nave (Thompson 1907–08, 45; 1911a, 32; Brown 1925, 295; Stocker and Everson 2006, 13). If, however, the structural sequence at Hough was correctly identified by the Taylors, then the tower has always been a western appendage and not a turriform nave. On the other hand, it is curious that there is no tower arch in the east wall, only a small thirteenth-century doorway. Hence, the wall between the tower and the present nave was perhaps rebuilt when the latter was constructed, removing a former chancel arch, the bonding scars of the chancel walls, and possibly a high-level doorway too. Much is uncertain, and a detailed archaeological study of this interesting church is called for.<sup>97</sup>

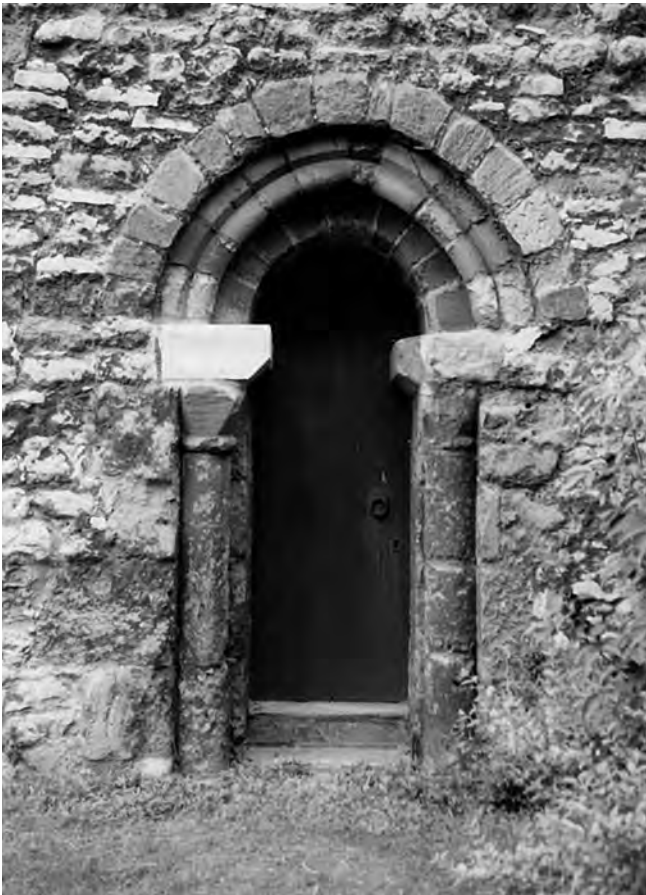
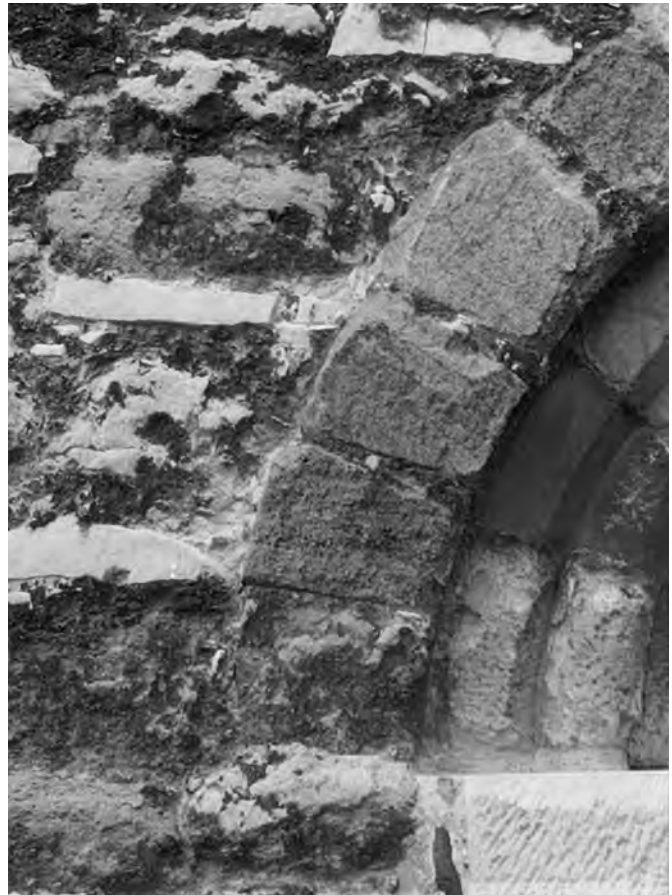
*Fig. 359: St Mary, Broughton (Lincs.). A, south doorway to the tower; B, detail of the reused, non-fitting gritstone voussoirs in the outer arch of the doorway. Photos: Warwick Rodwell*

As a result of a recent detailed study of this church by Michael Shapland, a much clearer understanding of its complex petrological make-up and architectural evolution has emerged. The late eleventh-century turritiform nave and attached stair-turret to the west both contain small quantities of gritstone ashlar, the employment of which is markedly different from Barton. In the first place, gritstone does not appear in the fabric until 2.25 m above ground level (Fig. 353). Up to that point the masonry is mainly ironstone. The voussoirs in the moulded inner order of the south door arch are of sandstone, and those of the plain outer order are gritstone: some are clearly reused components from an arch of smaller radius, presumably Roman (Fig. 359).

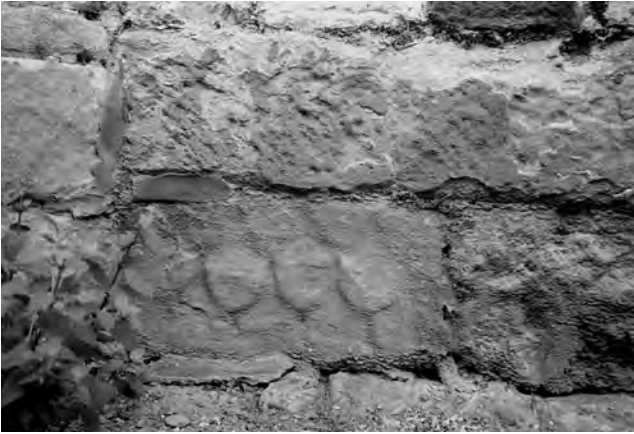
*Fig. 361: All Saints, Winteringham (Lincs.). Fragments of Roman monumental sculpture in gritstone reused in the tower. (above) imbricated leaves; (below) fluted pilaster. Photos: Warwick Rodwell*

Characteristic Roman tooling is present on faces which have not been subjected to secondary re-dressing, and the occasional Lewis hole and cramp-hole has been noted (Figs. 305 and 362). For the most part, the original use of the gritstone blocks is not readily identifiable, but those now in the tower at Winteringham are exceptional. They include fragments of fluted pilasters and imbricated leaves, the kind of detail one might expect to be derived from a Roman temple, monumental arch, or other major public structure. Stones used in the chancel arch at Barton appear to be recut voussoirs from a domical vault, and the morticed block which formed the font base has the appearance of a section of stylobate. Reused Roman voussoirs occur at Broughton, too. Finally, at both Barton and Broughton column drums are present, and at least three different diameters are represented.

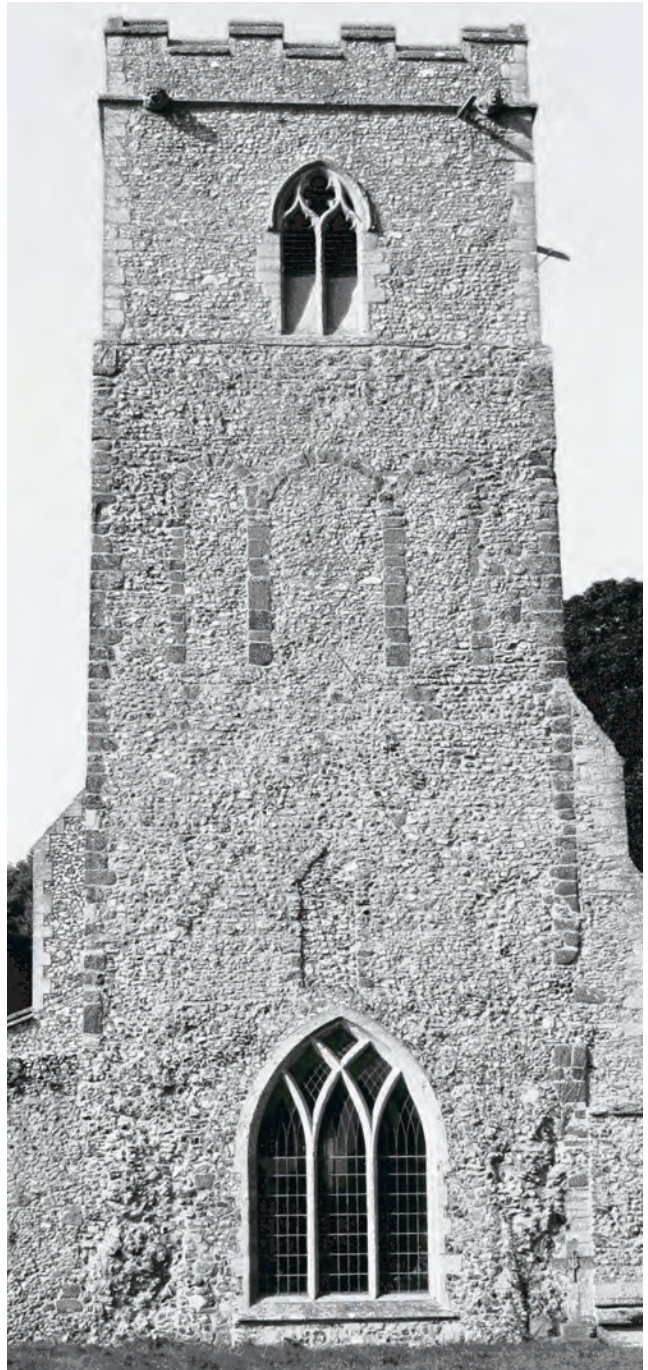
Fig. 369: St Mary, Flitcham (Norf.). East face of the former axial tower, showing the blind arcade of three bays on the third stage. The chancel has been demolished and the window marks the site of the chancel arch; above is a triangular-headed doorway that probably opened from a gallery into a chamber above the chancel. Photo: Warwick Rodwell

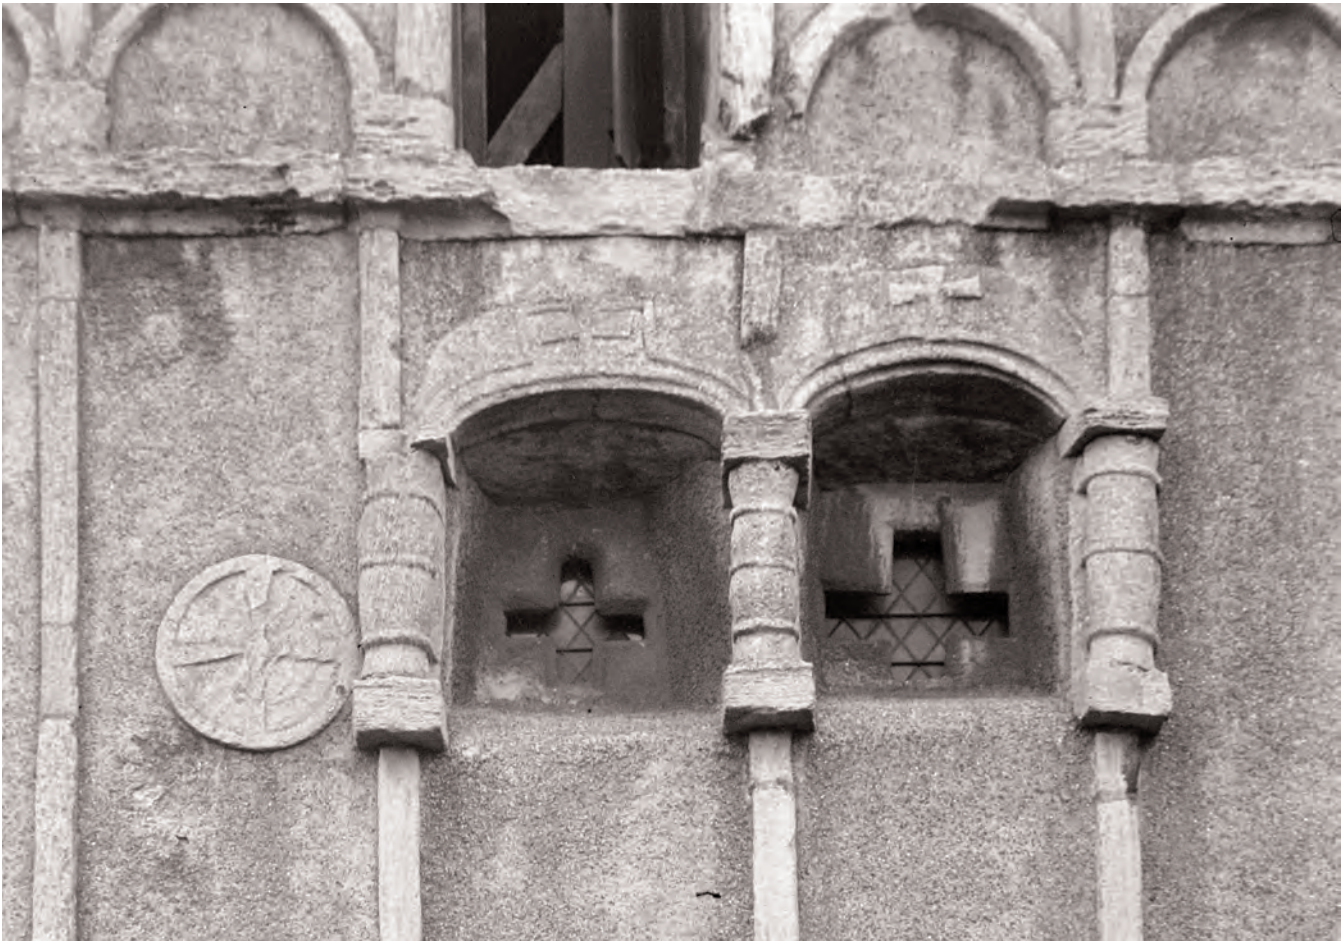
Fig. 372: *All Saints, Earls Barton. Detail of the double opening in the ground stage of the south wall, showing the visually 'applied' balusters with profiles similar to those of the mid-wall shafts at Barton. Photo: English Heritage, NMR*

Another borrowing from carpentry is seen in the heavy balusters used in the double openings of many eleventh-century English churches: they can be circular, square or polygonal in plan. Although at Barton they are circular and clearly imitate wooden balusters, it seems certain that these gritstone blocks were hand-cut, not lathe turned. Although a turntable may have been employed as an aid, the irregularities in the mouldings are consistent with hand cutting. Moreover, the least heavily weathered baluster – that on the east – displays clear marks of vertical tooling on the plain parts of the shaft and oblique tooling on the conical upper end, and some of the rings are askew (Pl. 22; Fig. 314). It is unlikely that a lathe-turned baluster would have been hand finished in this way.<sup>137</sup> The work involved in the manufacture of a hand-cut baluster of this type was prodigious: a wooden one could be turned on a lathe in less than two hours, while cutting one by hand in a material as intractable as gritstone would not take less

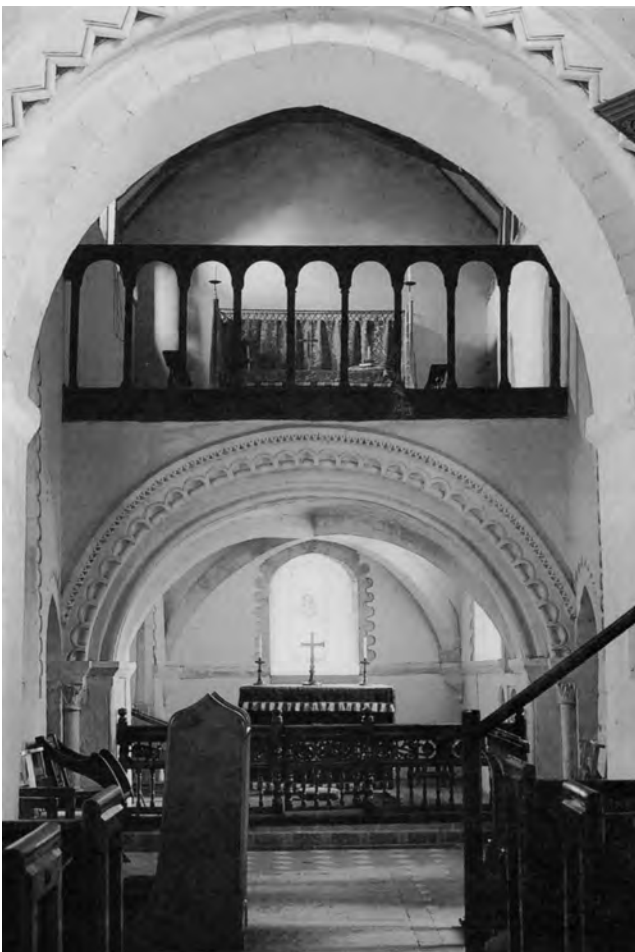
Fig. 376: *St Nicholas, Compton (Surrey). Romanesque arcaded timber balustrade to the gallery chapel above the chancel. View east. Photo: Mervyn Blatch*

At Barton, a ladder-stair with an angle of 60 degrees, rising from east to west, could have been comfortably sited against the north wall; its carriages would have been 6.8 m (22¼ ft) long. The stair width would have been no more than 60–70 cm, as would have been the required aperture in the floor of the gallery at the point of emergence; that would not have obstructed free passage around a gallery 1.25 m in width. The stair may or may not have had a handrail and balustrade, but the gallery almost certainly would have done. Although it can only be supposition, the case for an arcaded balustrade in this architectural setting seems strong, since the semicircular arch is the dominant feature of the tower, both externally and internally. The only surviving Romanesque timber gallery balustrade is at Compton church (Surrey), the form and scale of which would be wholly in keeping for Barton (Fig. 376; Pevsner and Cherry 1971, 166; Blatch 1997, 94).

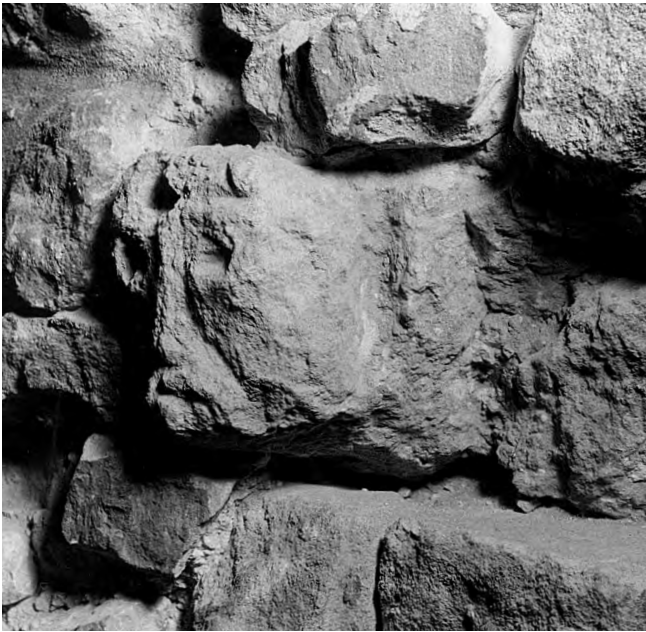
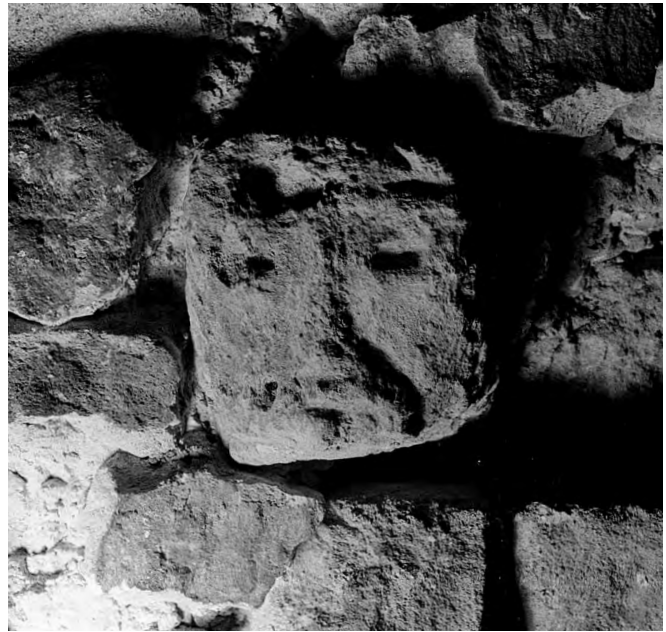
*Fig. 377: St Peter, Barton-upon-Humber. Tower: Stage 2, exterior. Southern label-stop on the eastern belfry opening, in the form of a human head. Height c. 15 cm. Photos: Warwick Rodwell*

The two heavily weathered human heads forming the label-stops of the eastern double belfry-opening are seemingly unique (Fig. 377), although there are animal-heads over doorways at St Mary, Deerhurst and Limply Stoke (Som.) (Taylor and Taylor 1966; Taylor 1978, 1057–8), and at Barnack and Alkborough (the latter 15 km west of Barton) beast-heads were placed centrally over the west window in the tower.<sup>145</sup> However, a single male head, of generally similar appearance to one at Barton, occurs internally on the division between the openings of the northern double window on the first floor at Sompting,<sup>146</sup> and at Great Hale an apparently female figure occupies one complete jamb of a small window in the south face of the tower.<sup>147</sup> Pairs of moustachioed and bearded male heads flanking openings, and door-jambs in particular, are known from Scandinavia in the twelfth century, and it is instructive to compare the Barton heads with those at Timmele, Sweden (Svanberg 1970, pl. 56).

The Barton heads are so badly weathered that their features cannot be described in detail. They were originally external but, considering that they have been protected by the nave roof since the fifteenth century, it is surprising how eroded they are. The northern head is now almost featureless and even the sex cannot be determined with certainty, although it is probably male, but the southern head is better preserved, and it clearly represents a moustachioed male. The eyes are sunken, and now have the appearance of gouged-out pits, but may originally have been drilled; the nose is long and flattened, and the lips are prominent. A horizontal line across the forehead may represent a fringe of hair, or a headdress. The deep hollowing of the eyes

strongly suggests that these were originally filled with a contrasting material – glass or coloured stones – to impart greater vibrancy to the faces. Drilled eyes are a well-known feature of Anglo-Saxon figure sculpture found all over central England. They are crisply

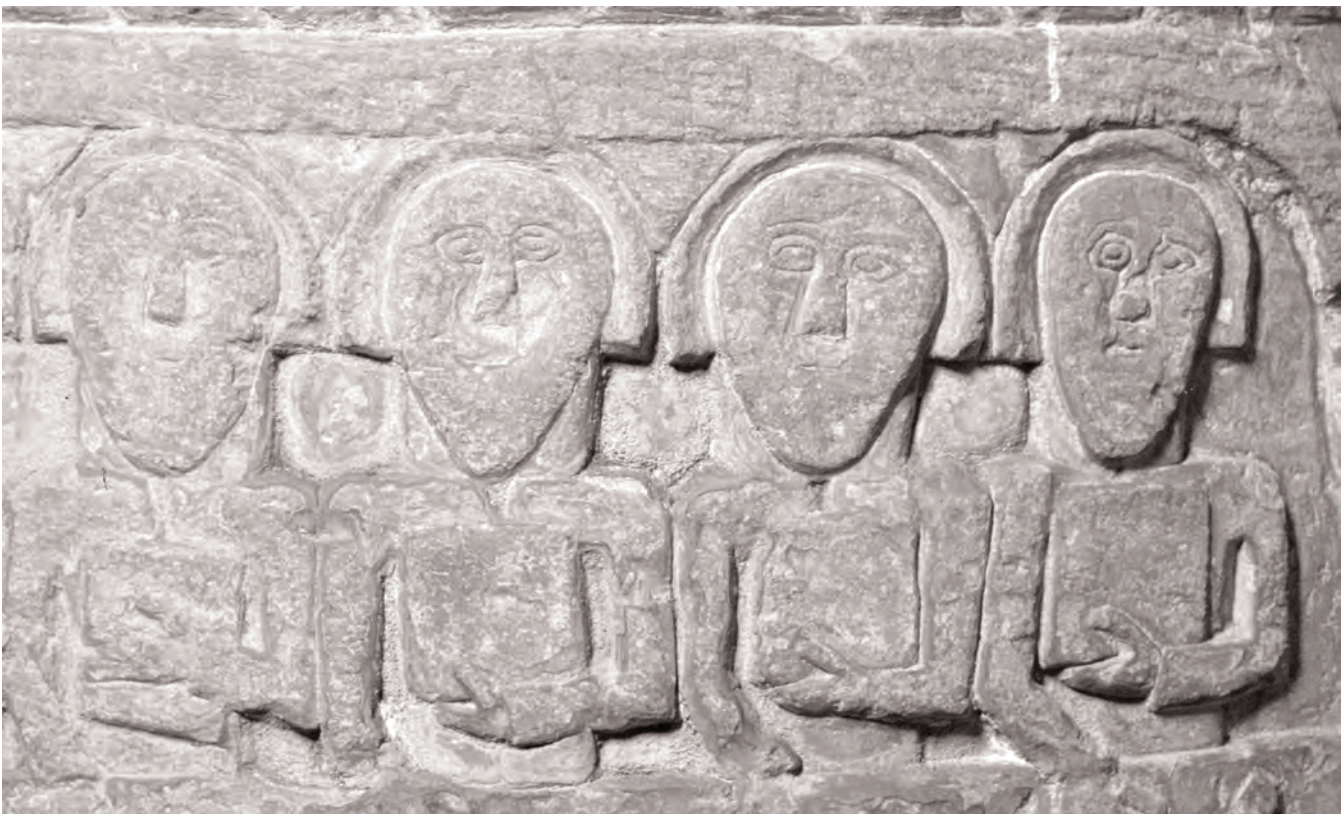
Fig. 382: *St Nicholas, North Grimston (E. Yorks)*. Detail of heads portrayed on the font bowl. Photo: English Heritage, NMR

Closely similar in appearance, scale and execution to the Barton face is one on a slab of granite in St Lawrence's church, Jersey. Although now cut down and presented as an antiquarian exhibit in a nineteenth-century buttress, this slab was clearly once part of an early medieval panel depicting an unidentified figure: again, only the facial outline was lightly incised in the stone, although in this instance two small incisions on the chin indicate the beard; and the remainder of the image must have been executed in paint (Fig. 381). The identity of the figure cannot be determined, and the date is uncertain but is likely to be eleventh or twelfth century. Some idea of the intended appearance of the Barton face may be gained by comparison with the heads of the Apostles carved on the Norman font bowl at North Grimston (Yorks.), which are uncannily similar (Fig. 382; Pevsner and Neave 1995, pl. 14). A small bearded head of late Saxon date,

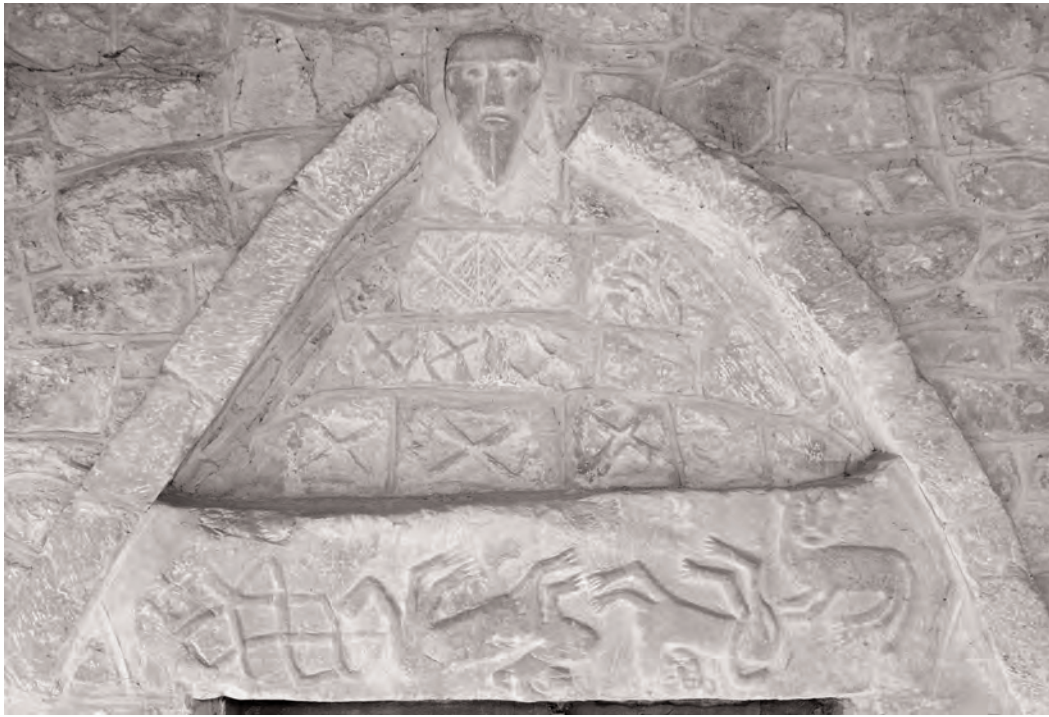
Fig. 383: *St Mary, Stottesdon (Salop.)*. Reset Anglo-Saxon head sculpture in the tympanum over the west tower doorway. Photo: English Heritage, RCHME

reset over the Norman west doorway at Stottesdon church (Salop.), also has similar facial features to that at Barton (Fig. 383; Croom 1988, fig. 14).

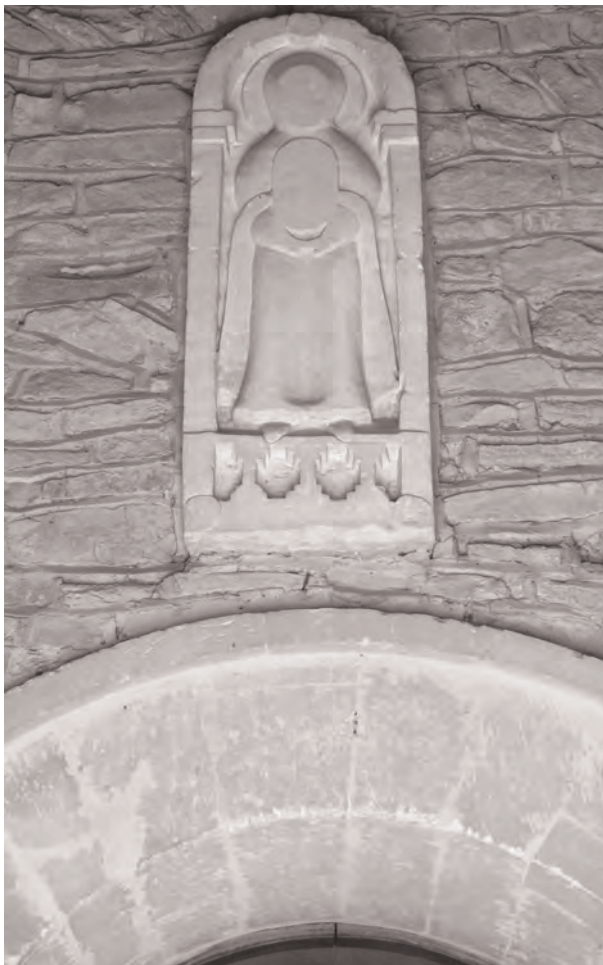
Fig. 384: *St Mary, Deerhurst (Glos.)*. Part-sculptured panel of the Virgin and Child, above a high-level arch in the west tower. Photo: Richard Bryant

It is not difficult to find analogues for figures executed partly in sculpture and partly in paint. Flanking the late Saxon arch leading into the former apsidal sanctuary at Deerhurst, is a pair of high-level stone panels with gabled tops, which appear to be plain. However, substantial traces of paint remain on one of these, showing that it formerly carried a depiction of a standing, nimbed figure within an architectural frame (Bagshaw *et al.* 2006). Also at Deerhurst, in the east wall of the tower, is a round-headed panel which stands just above the major arch, and there is no reason to doubt that it is in its original position. The panel is a *bas-relief* of the Virgin Mary, apparently seated, and displaying on her lap an oval shield (Fig. 384). The Virgin is depicted in simple outline, and has no carved facial detail. The shield is also represented by a plain oval area of uncarved stone, with no hint of the Christ Child who would have been portrayed on it. The finer details of the Virgin, and the Child in his entirety, were depicted in paint, and considerable traces of pigment survive, enabling an outline reconstruction<sup>149</sup> (Bailey 2005, 8–9; Gem and Howe 2008, 139–42). The systematic examination, recording and analysis of paint traces at Deerhurst has revealed how vividly the sculpture, mouldings and walls of this church were decorated in the ninth century (Gem and Howe 2008).

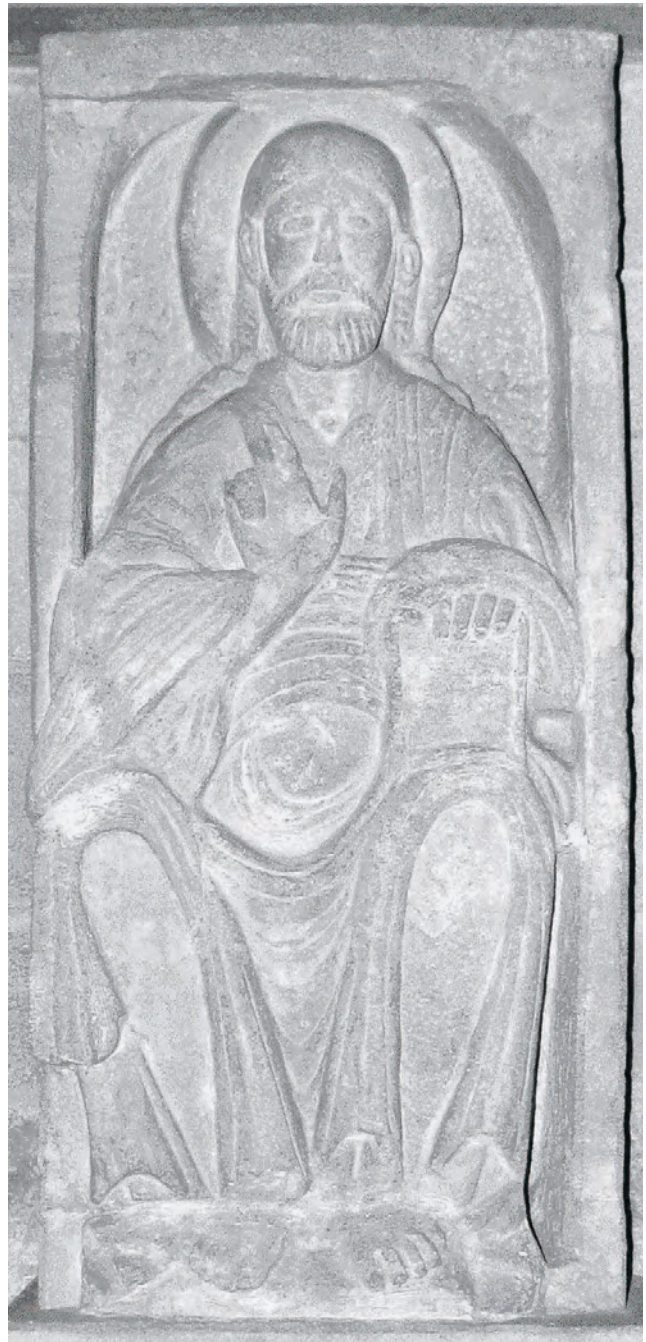
Fig. 386: *St John the Baptist, Barnack (Northants./ Cambs). Ex situ sculptured panel depicting Christ in Majesty. Photo: Warwick Rodwell*

The proportions plainly argue for a seated figure, and a depiction of Christ in Majesty would be most likely (Rodwell 1990, 165); a possible reconstruction, demonstrating how such a figure could be comfortably accommodated on the stone, is given in Figure 385. It may perhaps be compared with the rectangular panel depicting Christ in Majesty at Barnack, a relief sculpture dating from the early eleventh century (Fig. 386; Dickinson 1968, 13). The panel is *ex situ* and its original function is unknown. Unfortunately, no trace of ancient painting survives on the coarse-grained stone at Barton, which was thoroughly scoured in the restoration of 1858–59, when the surrounding wallplaster was also stripped. It would not be surprising if the panel were once flanked by a pair of angels, painted on the wallplaster. For a fuller discussion of the Barton panel in relation to other representations of the Crucifixion and Christ in Majesty above chancel arches, see Everson and Stocker 1999, 101–2.<sup>154</sup>

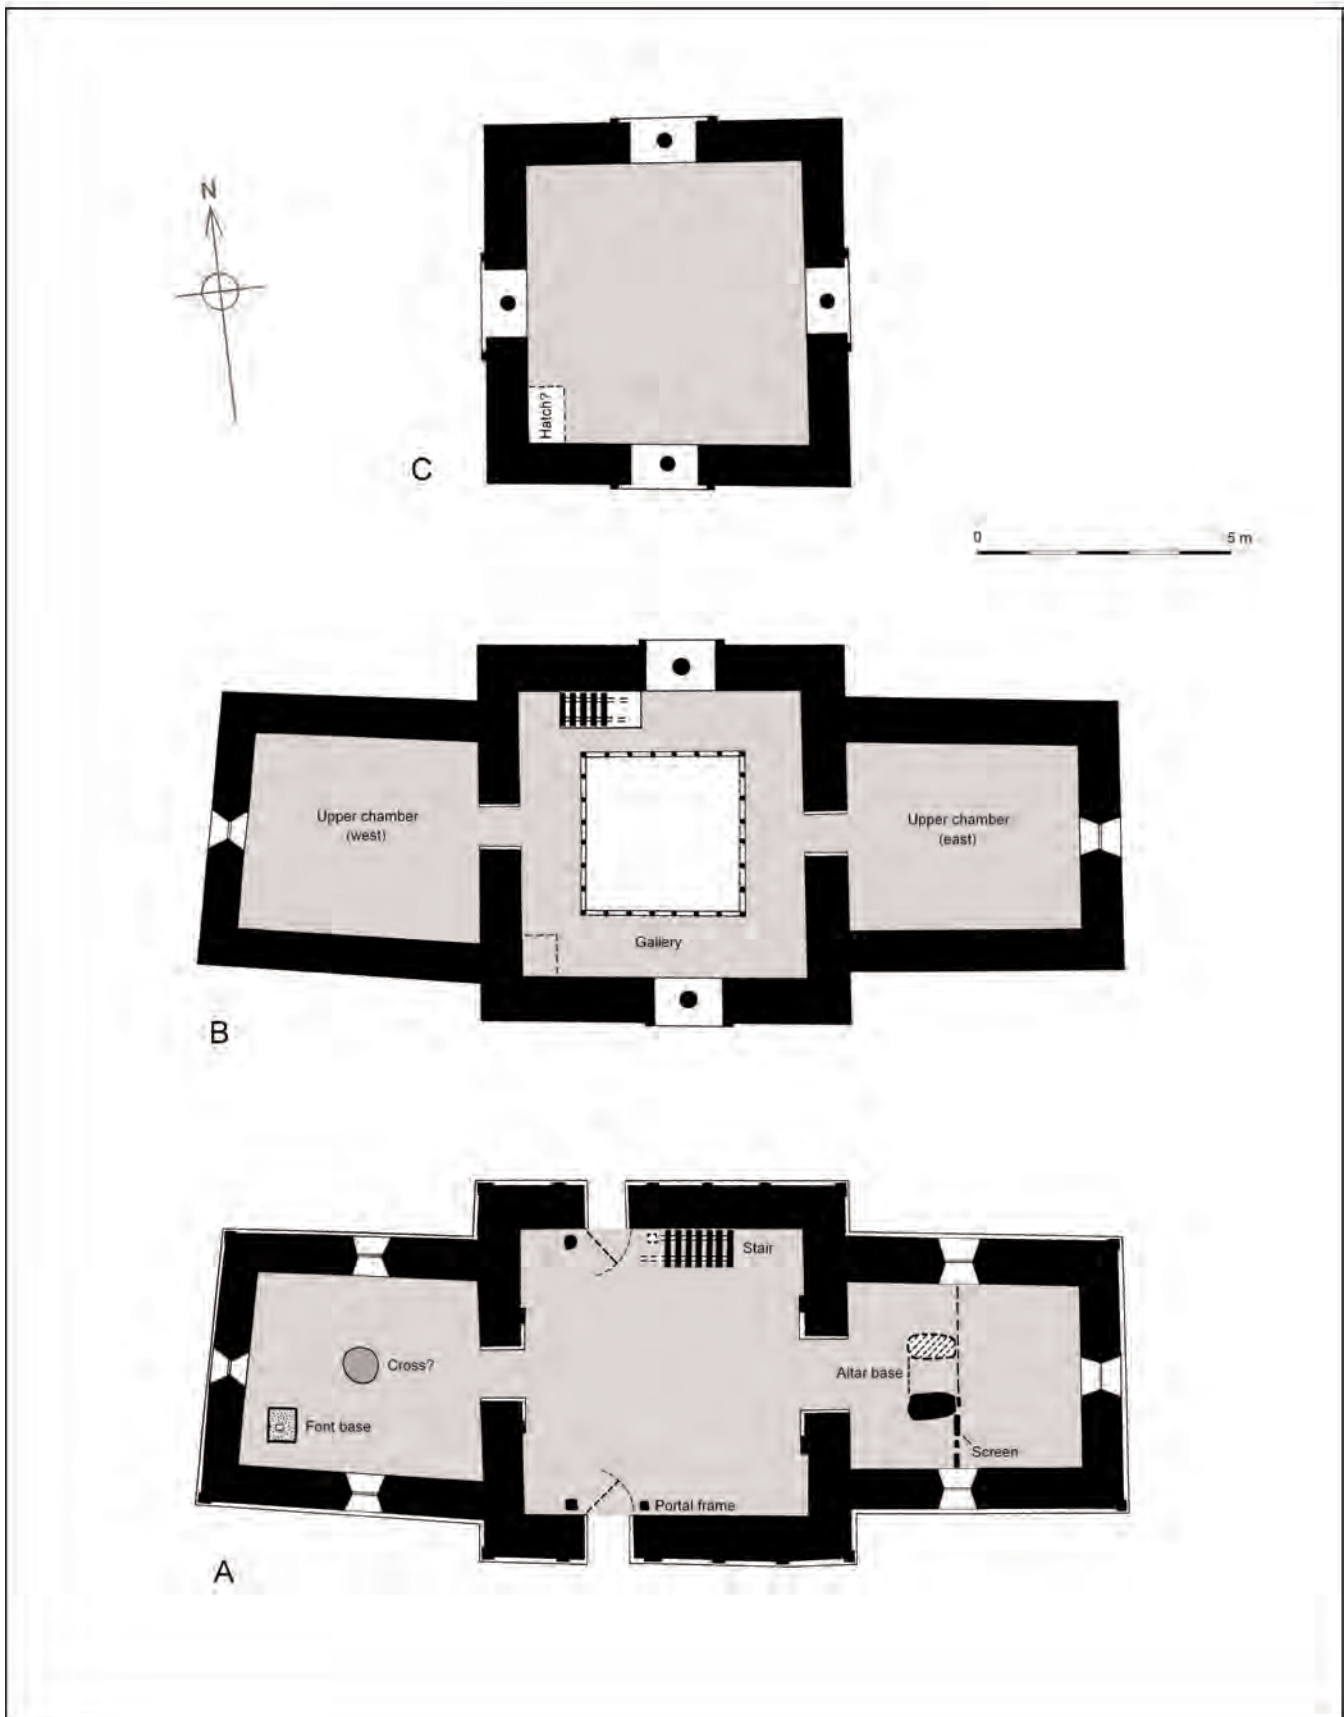
Fig. 387: St Peter, Barton-upon-Humber. Reconstructed plans of the Period 2 Anglo-Saxon church. A, ground level; B, gallery and upper-chamber level; C, belfry level. Scale 1:150. Drawing: Warwick Rodwell

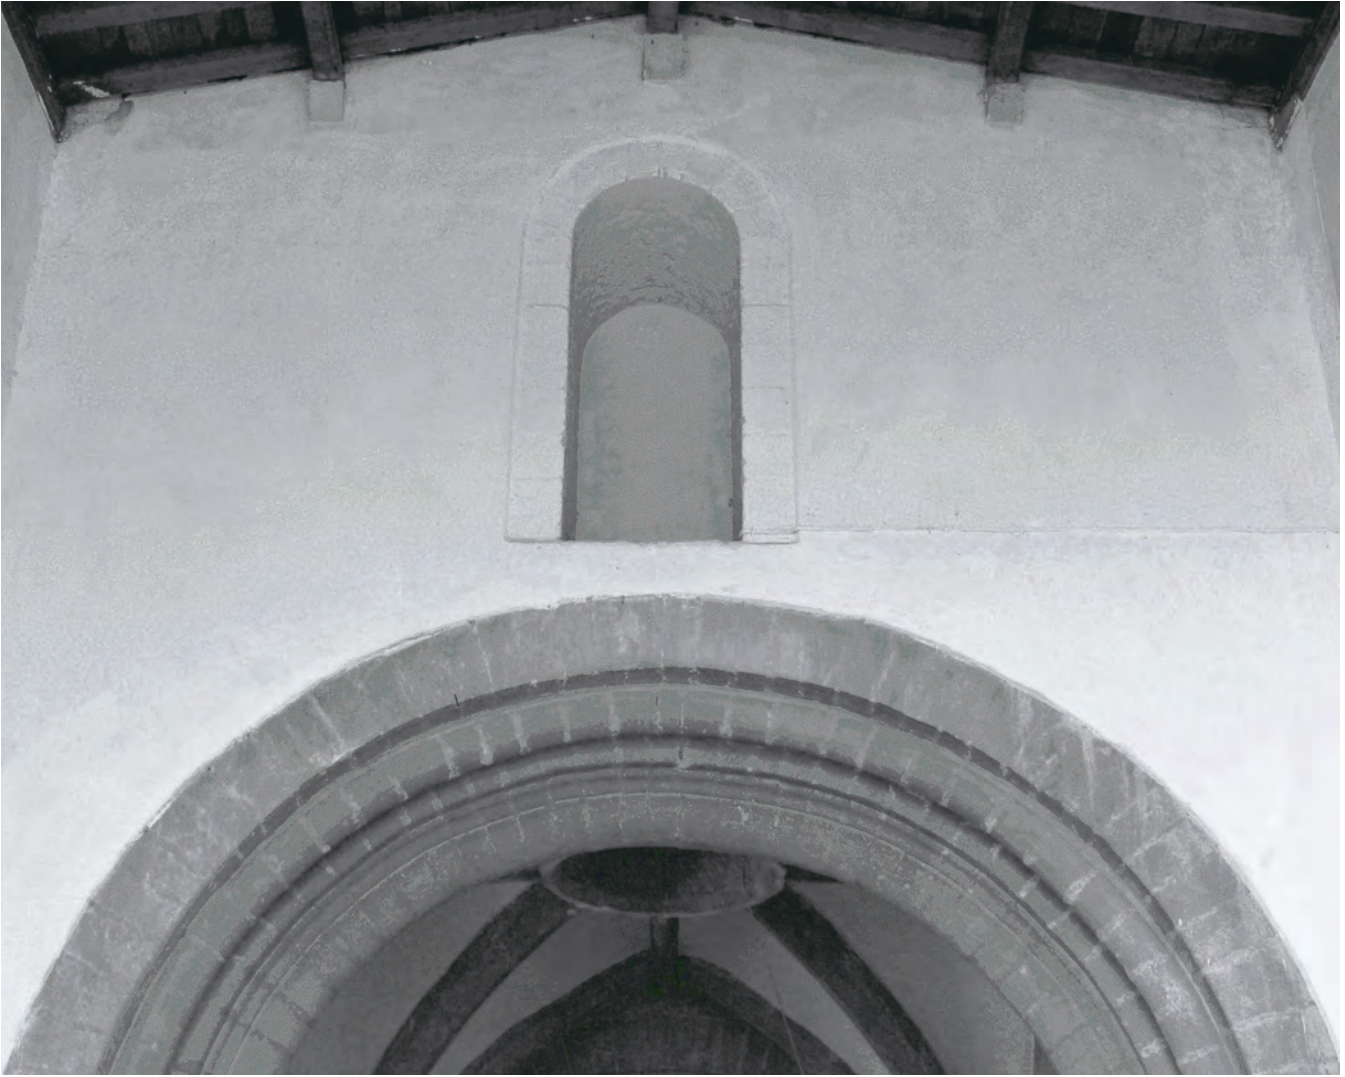
Fig. 388: *St Kyneburgha, Castor (Cambs.)*. High-level doorway at the east end of the nave. Photo: Warwick Rodwell

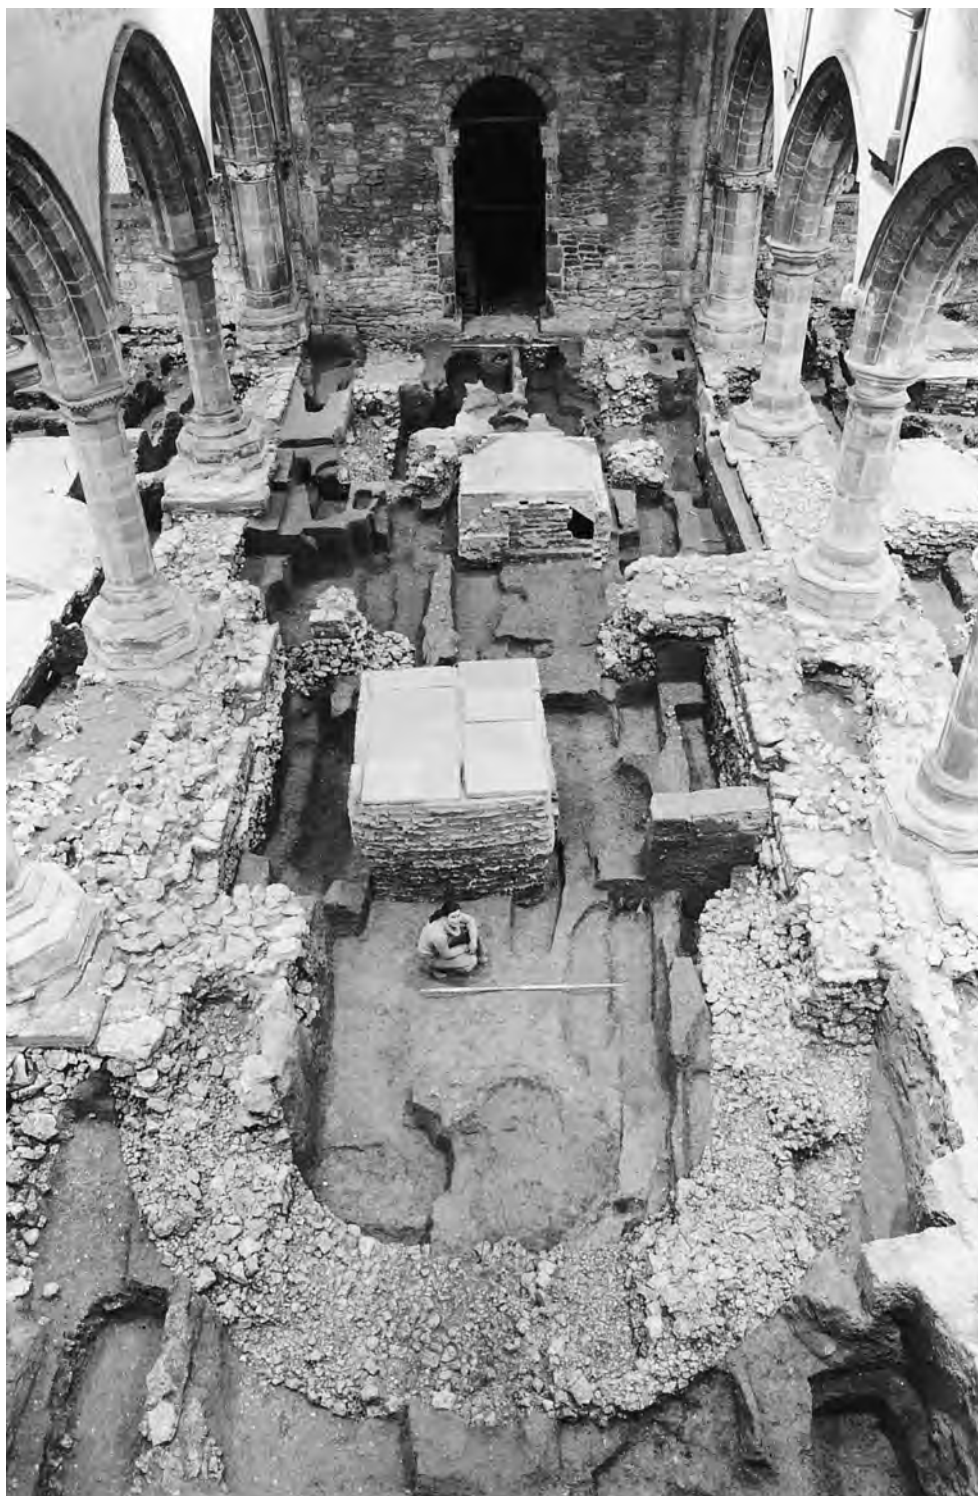
*Fig. 390: The three-celled Saxo-Norman church revealed during excavation in the nave in 1980. View west. Scales of 2 m. Photo: Warwick Rodwell*

The tiny Anglo-Saxon chancel was replaced by a new rectangular nave and a chancel with an apsidal sanctuary (Fig. 390). Only the foundations of these have survived, and even they are fragmentary at the east end (Fig. 391). The foundation trenches were up to 1.3 m deep and taken down to a firm clay bed, cutting through numerous graves in the process: no prior exhumation of skeletal remains took place on this occasion. The lower levels of the trenches were filled with compacted chalk nodules and brown clay, laid in alternating bands (F484). Towards the top, however, the outer faces of the foundation were constructed of larger chalk blocks, roughly squared, coursed and bedded in hard, brown gravelly mortar. Between the facings was a banded core of small chalk rubble and mortar; up to four of these footing courses survived on the north side. On average, the foundation trench was 1.2 m (4 ft) wide, but increased to 1.4 m in the apse, where
