# ST PETER'S

## Barton-upon-Humber, Lincolnshire

*A Parish Church and its Community*

HISTORY, ARCHAEOLOGY AND ARCHITECTURE

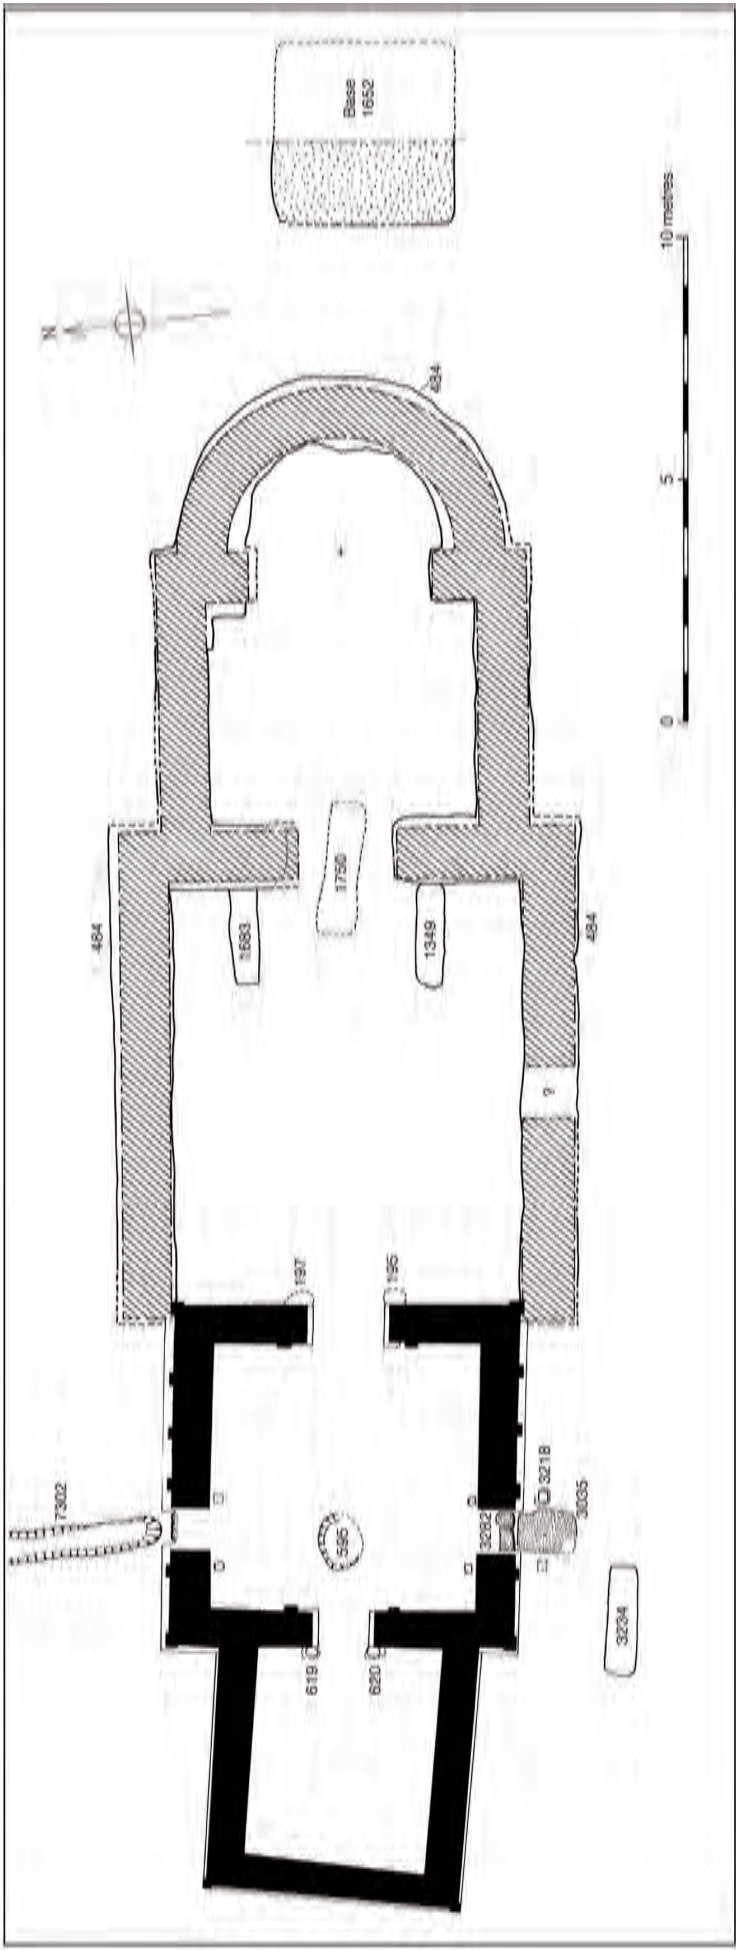
Fig. 391: Foundation plan of the Period 3 Saxo-Norman church and associated features. Standing fabric is shown in black and the reconstructed plan of the demolished walls is hatched. Scale 1:150. Drawing: Warwick Rodwell

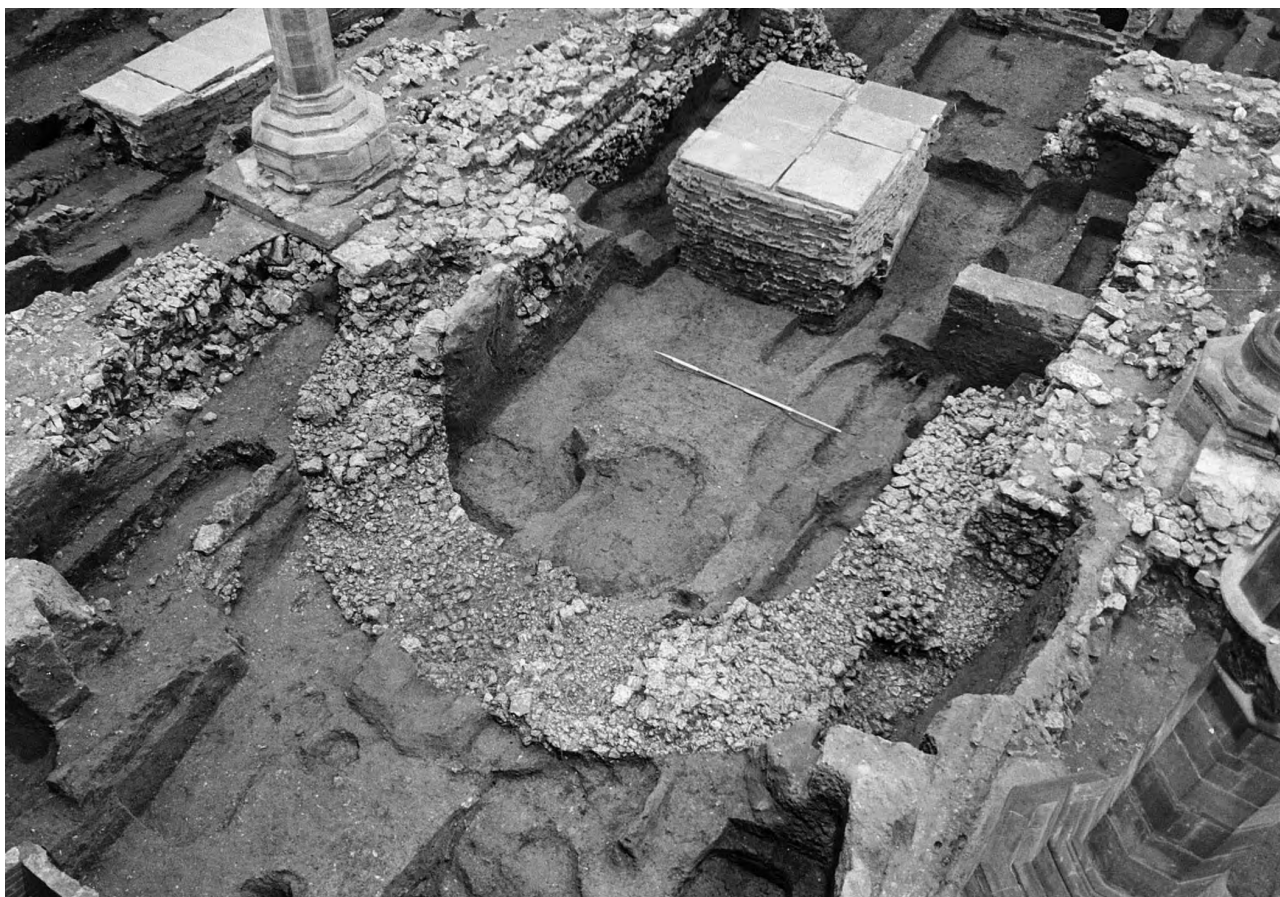
*Fig. 392: Foundations of the chancel and apsidal sanctuary of the Period 3 church. View south-west. Scale of 2 m. Photo: Warwick Rodwell*

The nave was of squat proportions, being only 8.65 m (28½ ft) long internally, and was not quite a true rectangle in plan. On average, it measured *c.* 10 m (33 ft) by 9.3 m (30½ ft) externally, and the also-squat chancel was 5.6 m (18½ ft) long by 7.6 m (25 ft) wide, with an unstilted, apsidal sanctuary (Figs. 393 and 394). The offset in plan between the chancel and nave was equivalent to almost a wall's thickness on either side, while the offset between the sanctuary and chancel was half that amount. It is clear that walls were laid out by their centre-lines and a regular system of measurement was employed. There is no hint of separate provision for buttressing, but shallow pilasters could have been accommodated on the foundation.

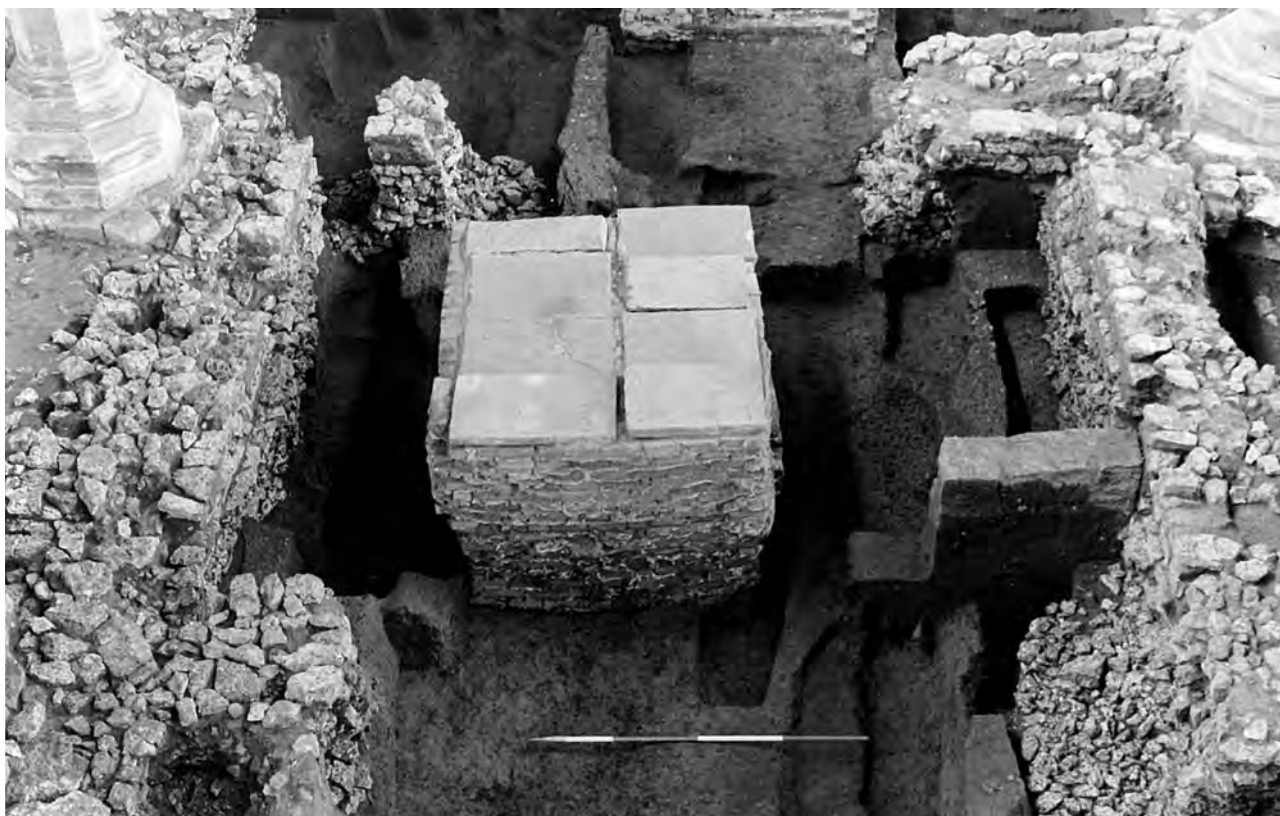
*Fig. 393: Foundations of the chancel of the Period 3 church. In the centre is the brick-lined, double-burial shaft of the Scriveners. View west. Scale of 2 m. Photo: Warwick Rodwell*

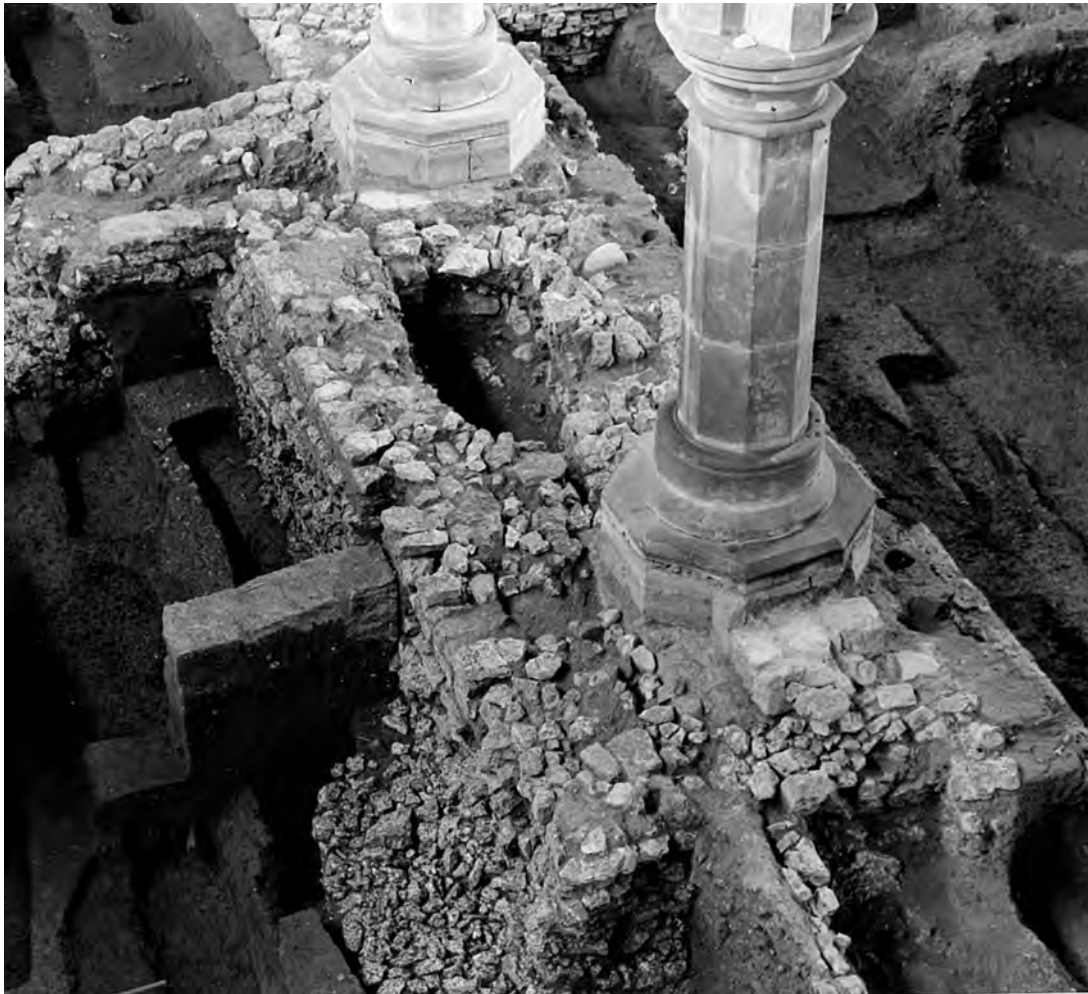
*Fig. 394: Saxo-Norman chancel. Foundation of the north wall, with the Period 4A Norman nave wall alongside (supporting later arcade piers). View north-west. Photo: Warwick Rodwell*

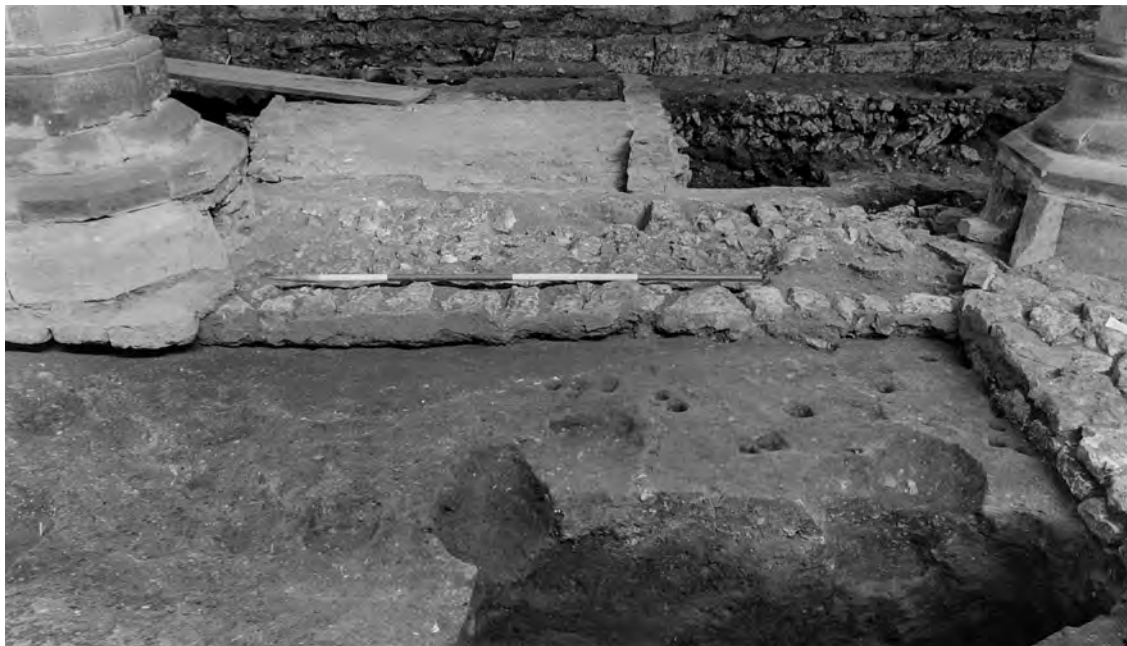
*Fig. 395 Saxo-Norman nave. Surface of the construction level in the north-east angle. View north. Scale of 2 m. Photo: Warwick Rodwell*

The upcast soil from the foundation trenches (F1537, sandy clay with occasional pieces of chalk and mortar) was spread within the walls of the new church, raising its level and forming a sub-floor (F1522). A few small post-holes cut into this layer must have been associated with the construction work (Fig. 395). After the new church was built, the redundant Anglo-Saxon chancel was demolished, down to its foundations, the mortar and small rubble deriving from its walls being spread to form a floor (F187), sealing all previous features and deposits.

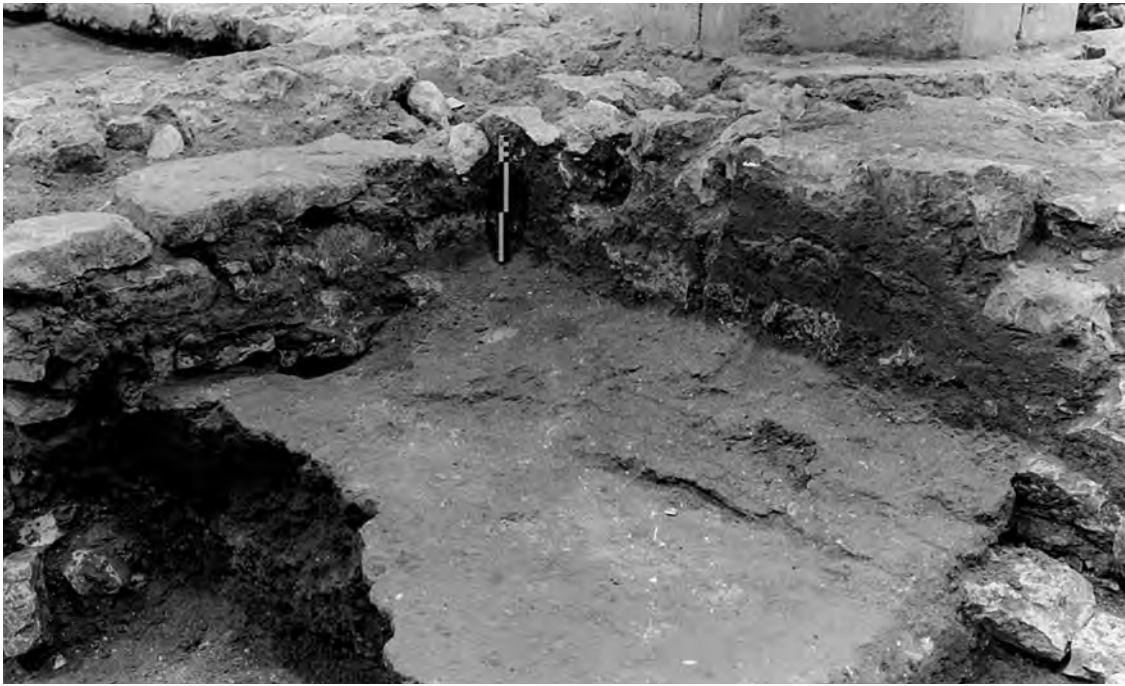
*Fig. 396: Saxo-Norman chancel. Construction level in the north-west corner. Note the spread of mortar and masons' waste rising up alongside the north wall. View north-west. Scale of 25 cm. Photo: Warwick Rodwell*

The masons' working level was well preserved in places, particularly in the chancel, where a characteristic spread of mortar spillage, wedge-shaped in cross-section, lay against the walls (Fig. 396). The same brownish mortar that was used in constructing the walls was also applied as rendering; in the nave a strip of this survived to a height of c. 12 cm (Fig. 397). It did not have a decorated surface, and its preservation was due to the fact that the rendering was applied before

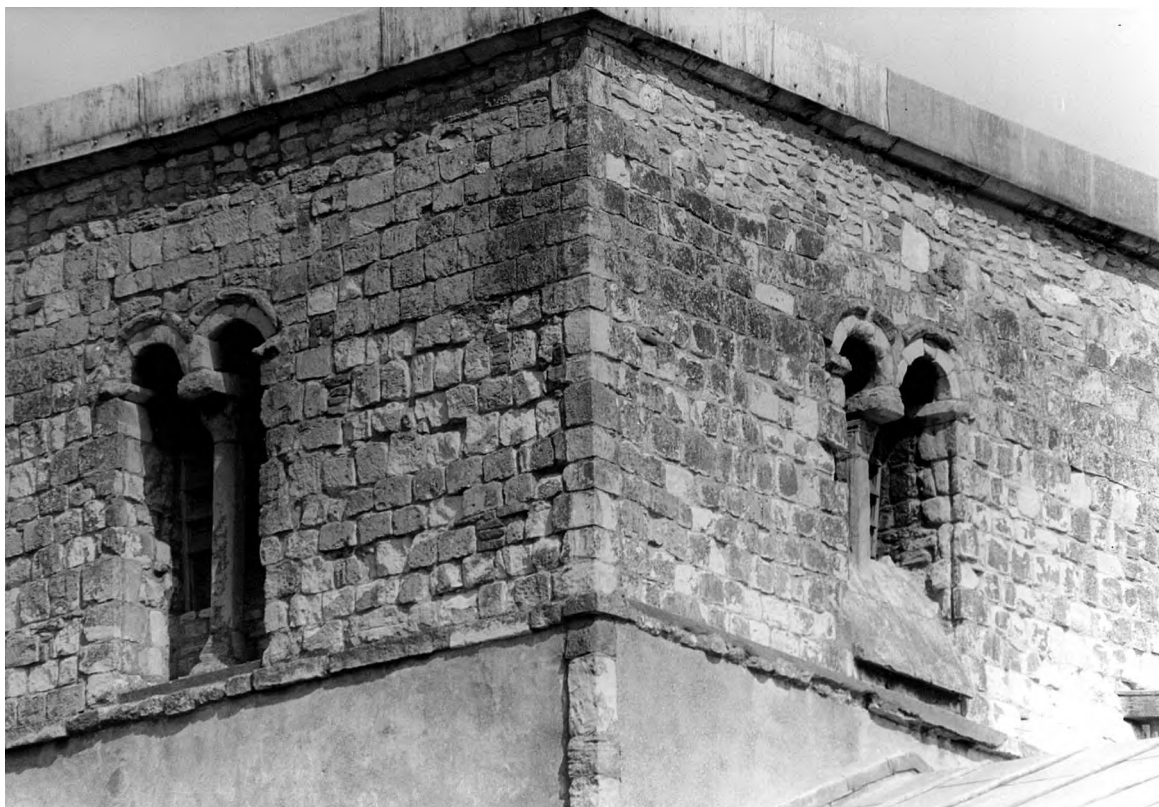
*Fig. 399: Tower: Stage 3, belfry. View from the south-east, showing the ashlar masonry construction. Photo: Warwick Rodwell*

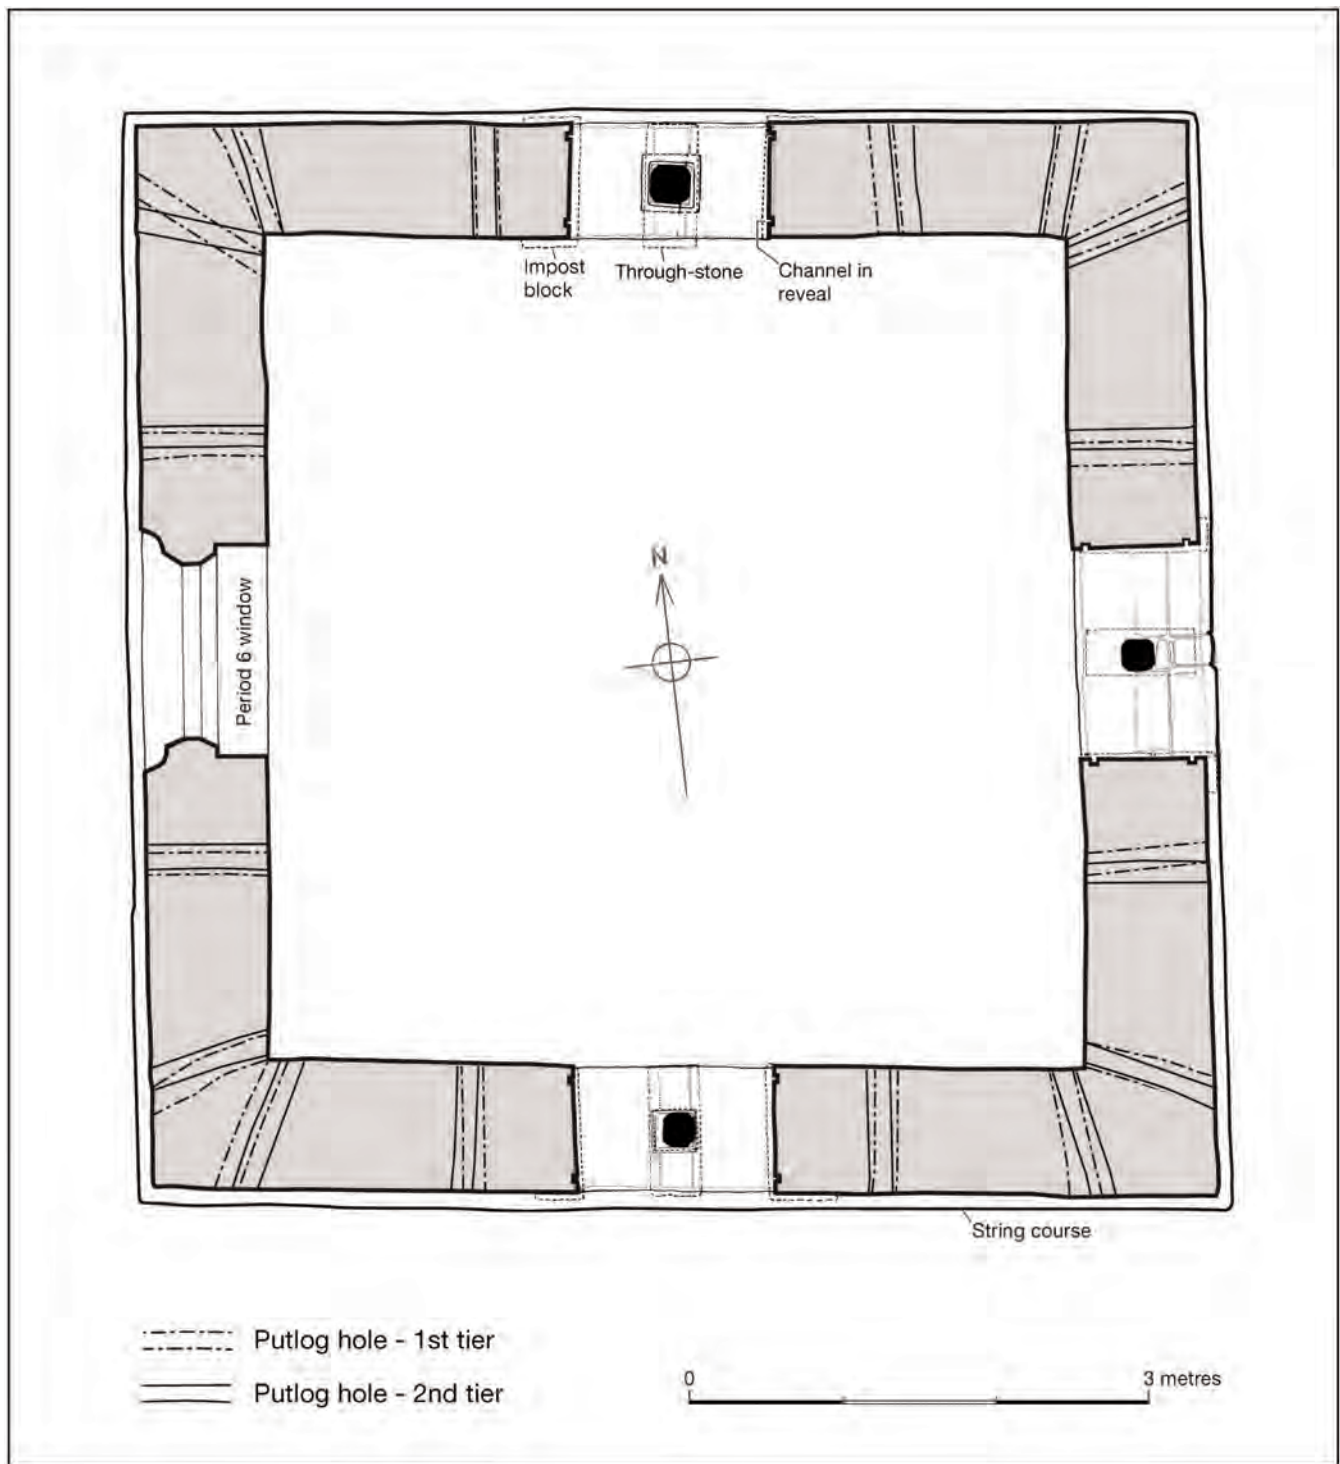
Fig. 400: Tower: Stage 3. Plan of the Period 3 belfry at sill level, showing the locations and angles of the first and second tiers of putlog holes. Also indicated (by broken lines) are the imposts and through-stones of the three surviving original belfry openings. Drawing: Stephen Coll and Warwick Rodwell

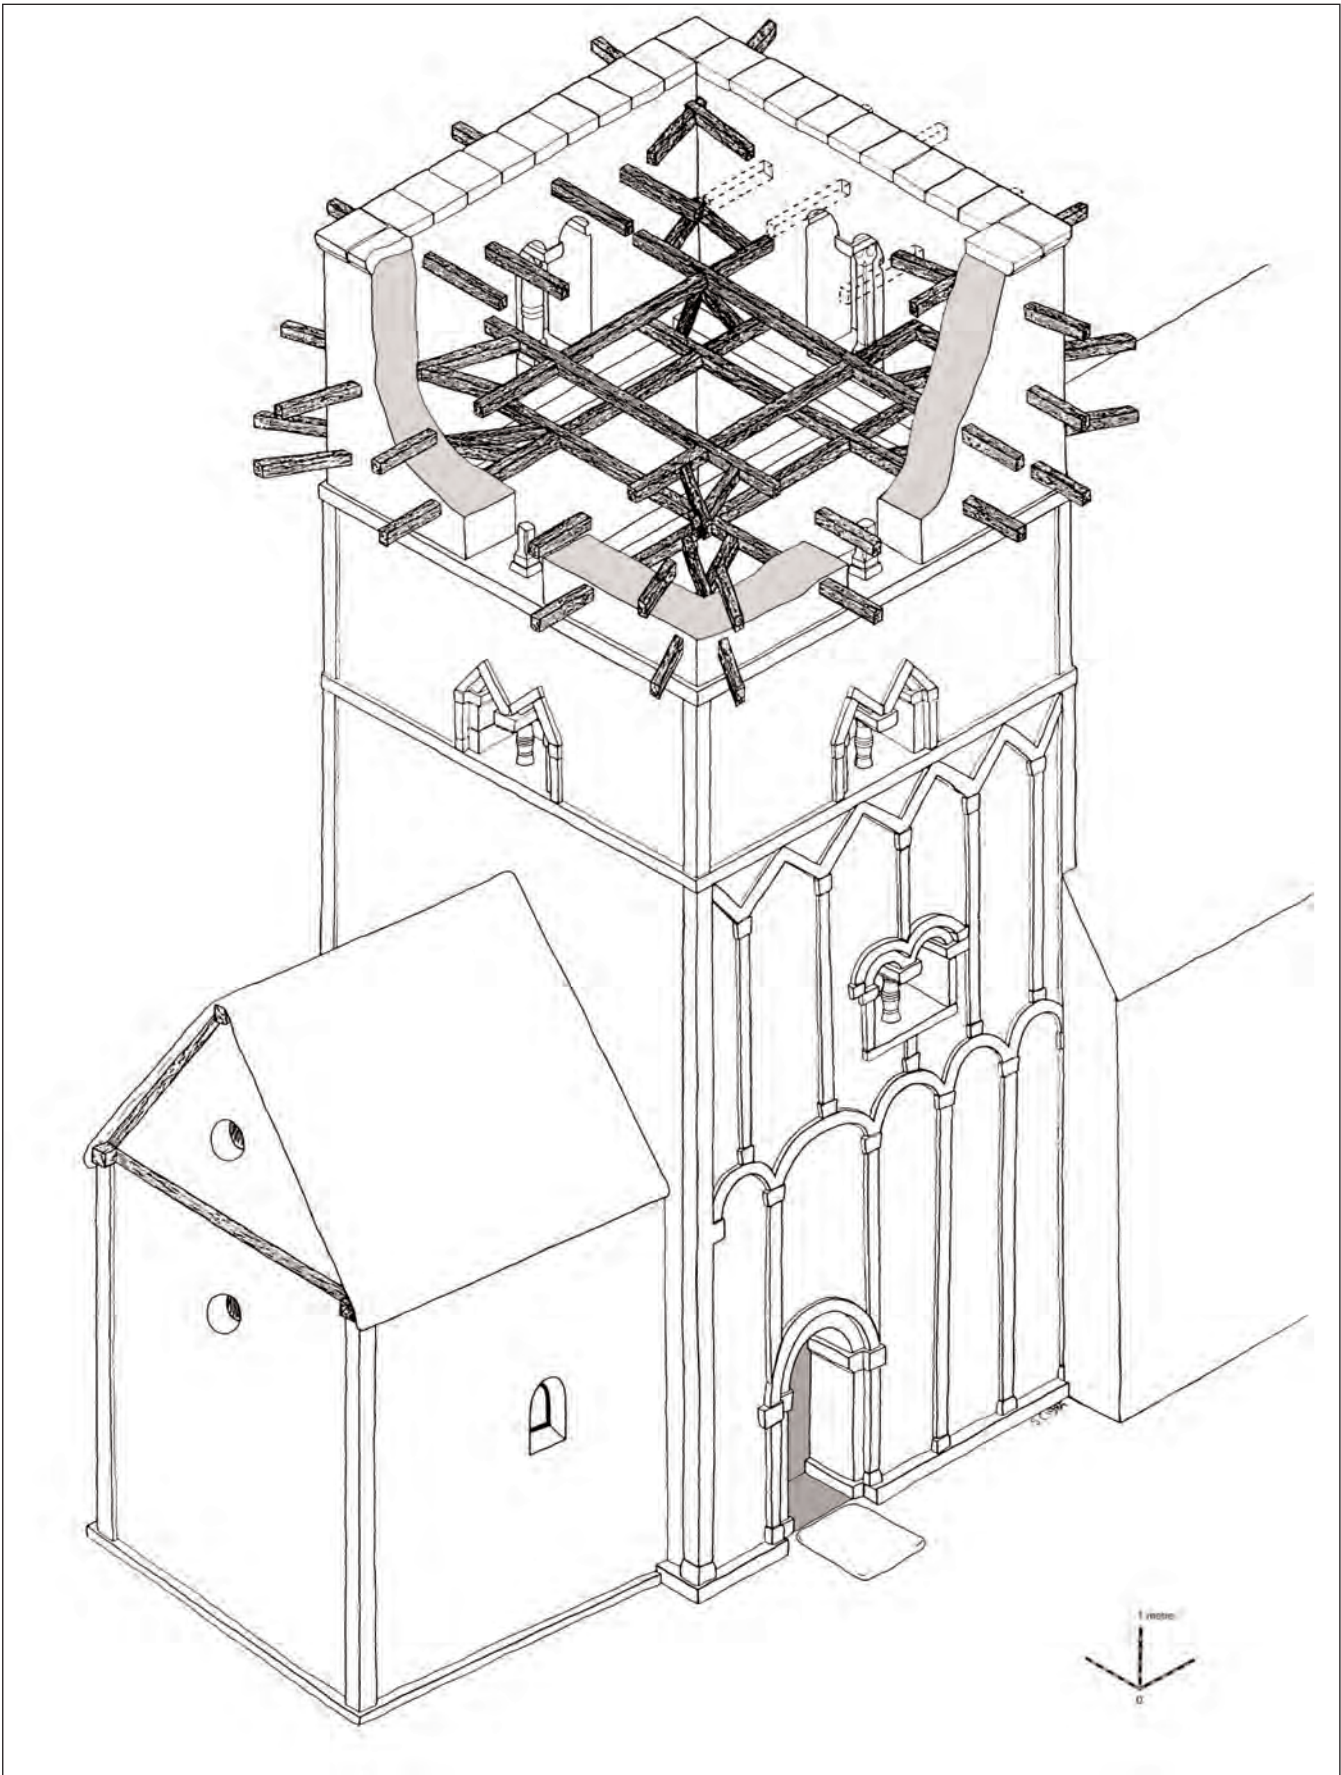
*Fig. 401: Tower. Cutaway isometric view, showing a reconstruction of the timber framing erected integrally with the Saxo-Norman belfry. This framing probably acted as an anchor for a roof spire, as well as supporting the bells. Initially, the timbers projected through the walls, to provide cantilevered scaffolding platforms. Drawing: Stephen Coll*

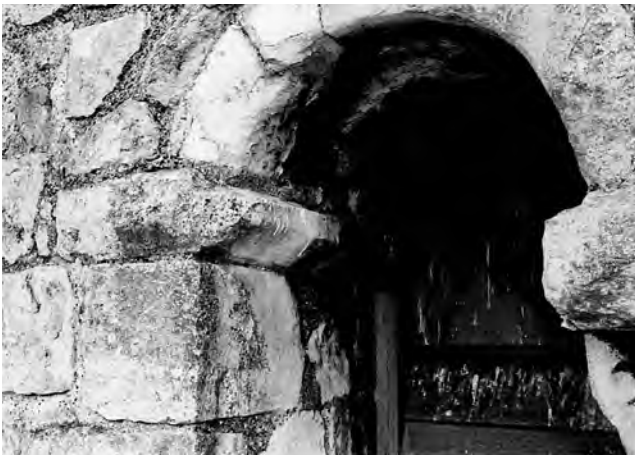
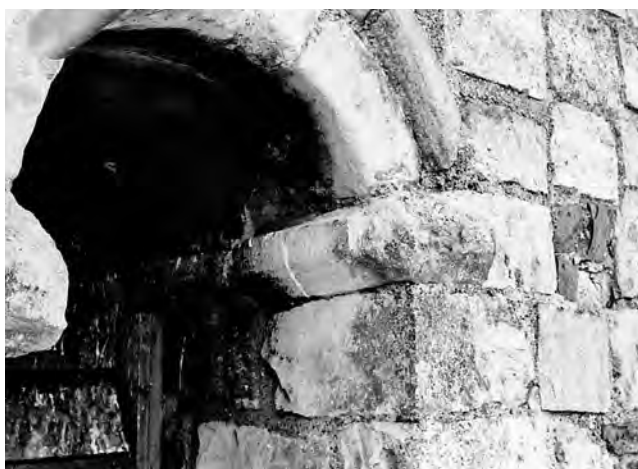
Fig. 403: Tower: Stage 3, southern belfry openings. Details of the double-chamfered string-course blocks reused as imposts. Upper, western aperture. Lower, eastern aperture. Photos: Warwick Rodwell

slabs are similar, but deeper. However, the imposts on the south face differ by being double chamfered (Fig. 403), and while these have the appearance of being reused string-course mouldings (perhaps deriving from the chancel of the previous church, p. 305), similar double-chamfered imposts occur on the belfry openings at St Mary-le-Wigford, Lincoln (Taylor and Taylor 1965, fig. 177).

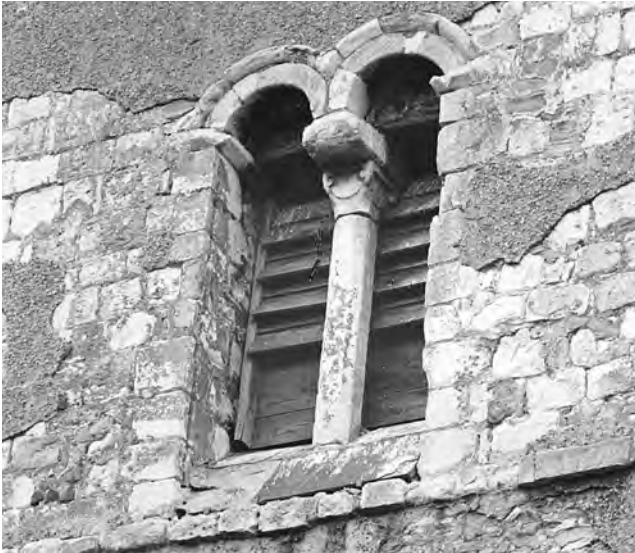
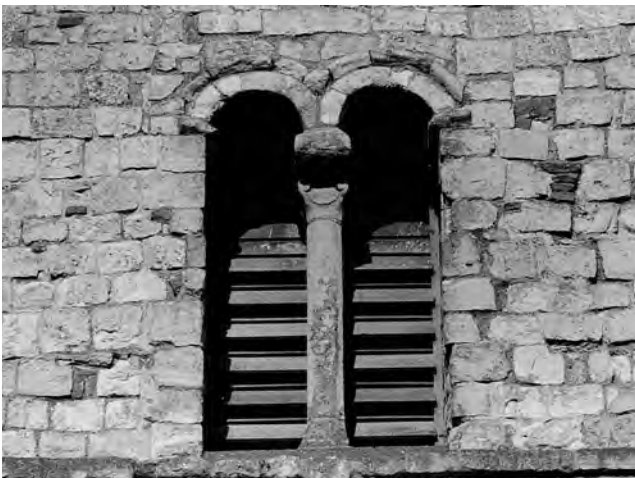
*Fig. 405: Tower: Stage 3, south face of belfry. Upper, before restoration in 1965 (note the raised sill and decayed rendering of c. 1870). Lower, in 2000. Photos: David Lee Photography; Warwick Rodwell*

#### ***South opening*** (Fig. 405)

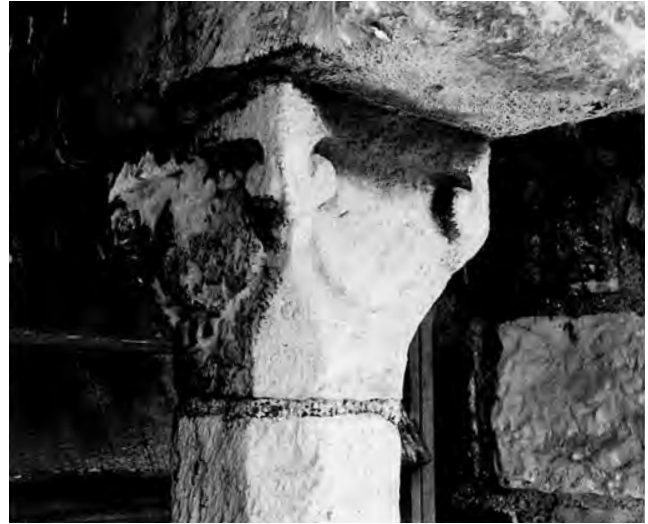
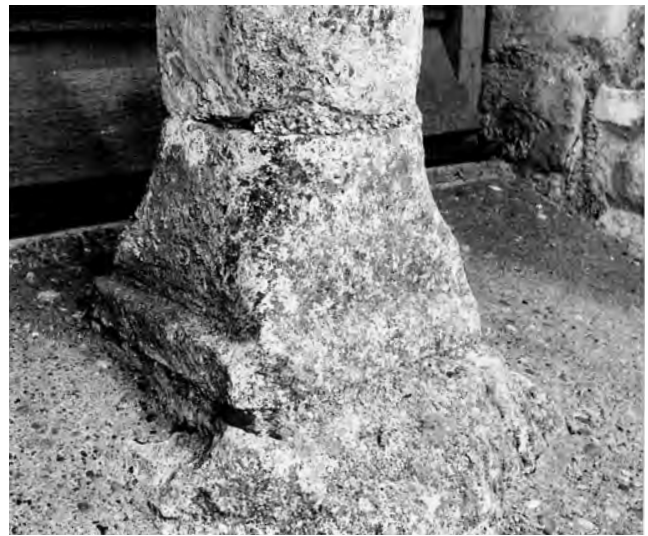
*Fig. 406: Tower: Stage 3, south side of belfry. Capital and base of the mid-wall shaft. Both viewed from the south-west. Photos: Warwick Rodwell*

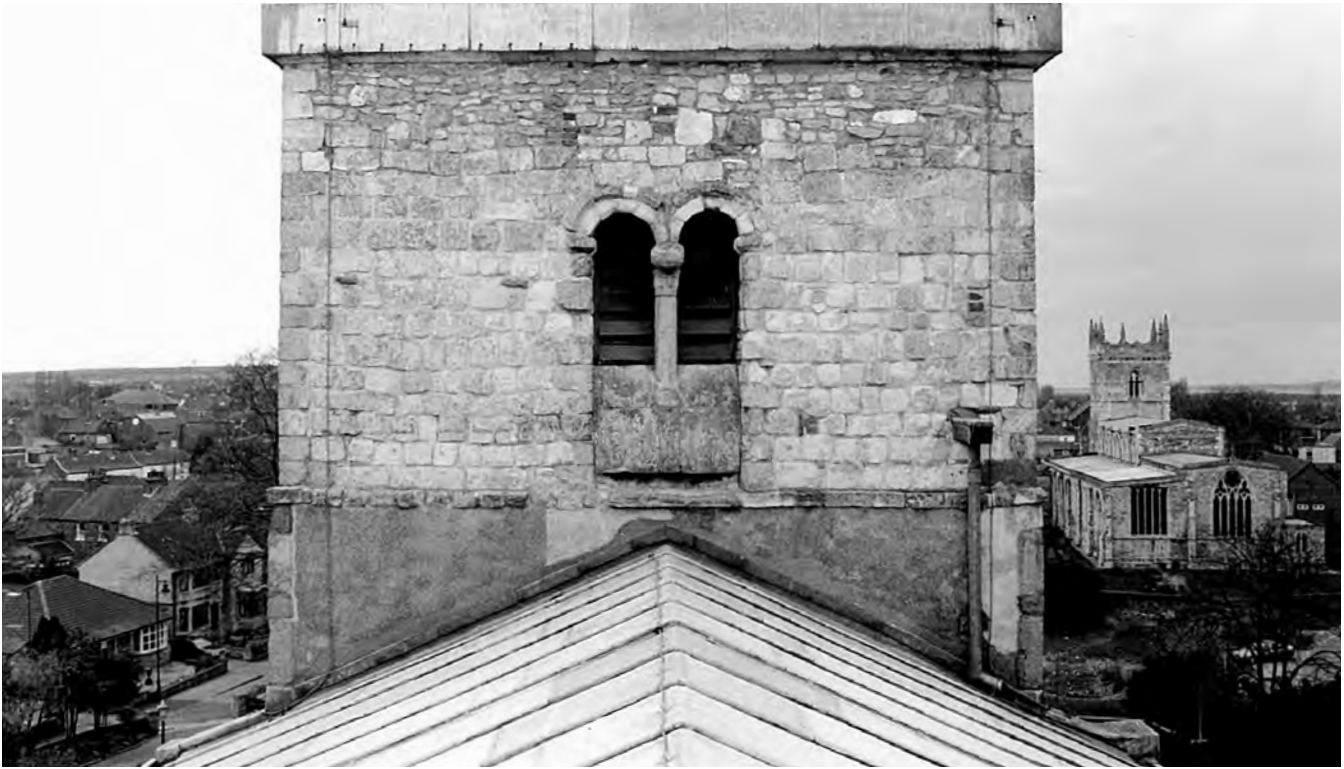
Fig. 408: Tower: Stage 3, east face. Saxo-Norman belfry in 2000, with St Mary's church beyond. Photo: Warwick Rodwell

#### ***East opening*** (Figs. 408 and 409)

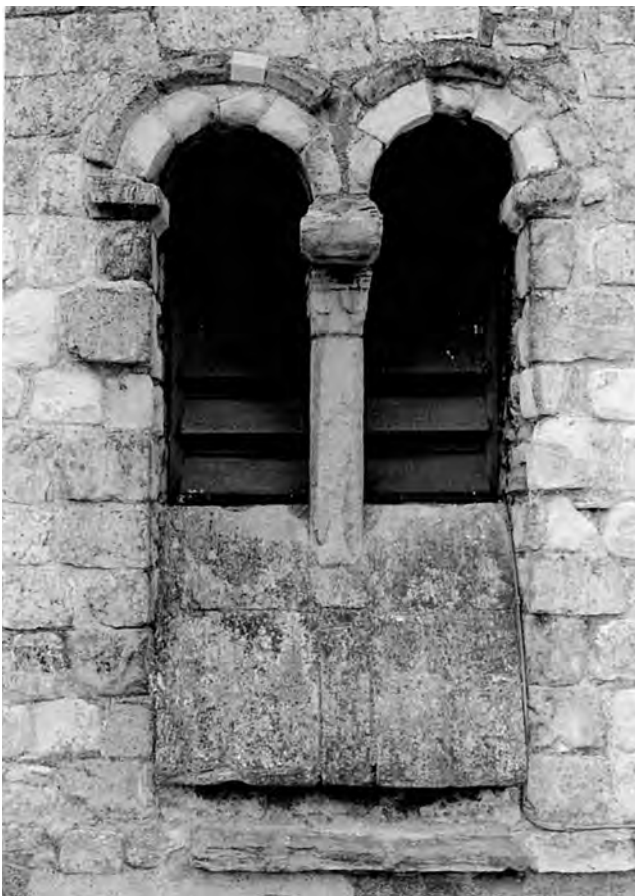
Fig. 409: Tower: Stage 3, east face. Double belfry-opening with later raised sill. Photo: Warwick Rodwell

Again, the single-piece shaft is an irregular octagon in section and has a separate faceted capital; presumably there is also a separate base, but this has been obscured by later infilling of the lower part of the belfry opening. The capital is square with a moulded abacus, and the facets of the shaft run directly on to it. Three faces of the capital are ornamented with raised imbrications, or shingles, there being two each on the east and north faces, but only one on the south; the west face is undecorated (Fig. 410). The treatment mimics tegulation, as found on some later eleventh-century grave-covers.<sup>9</sup>

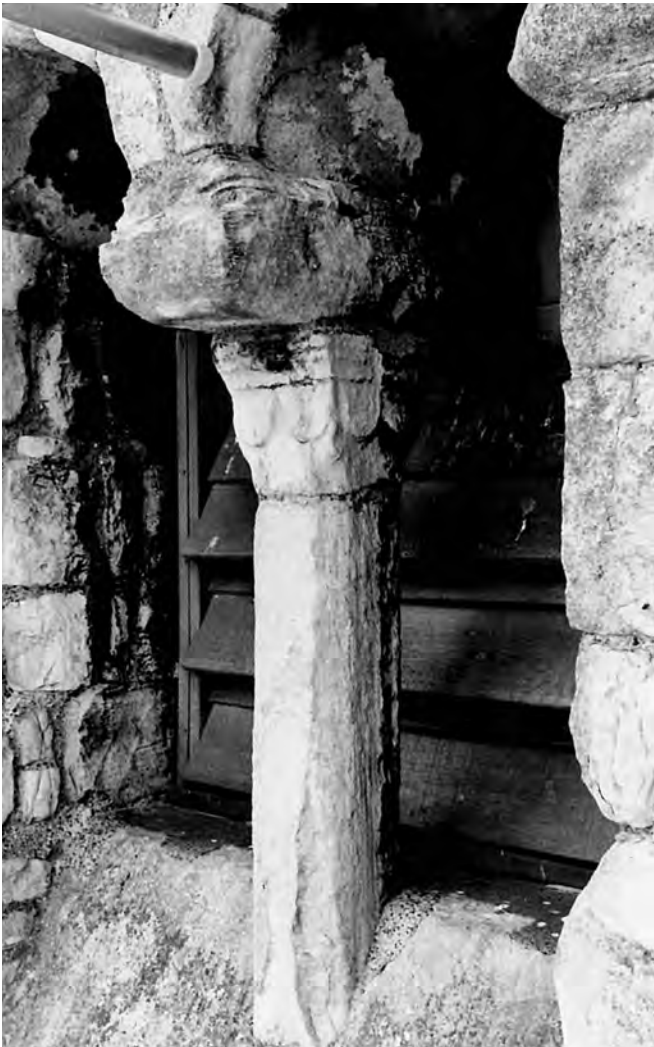
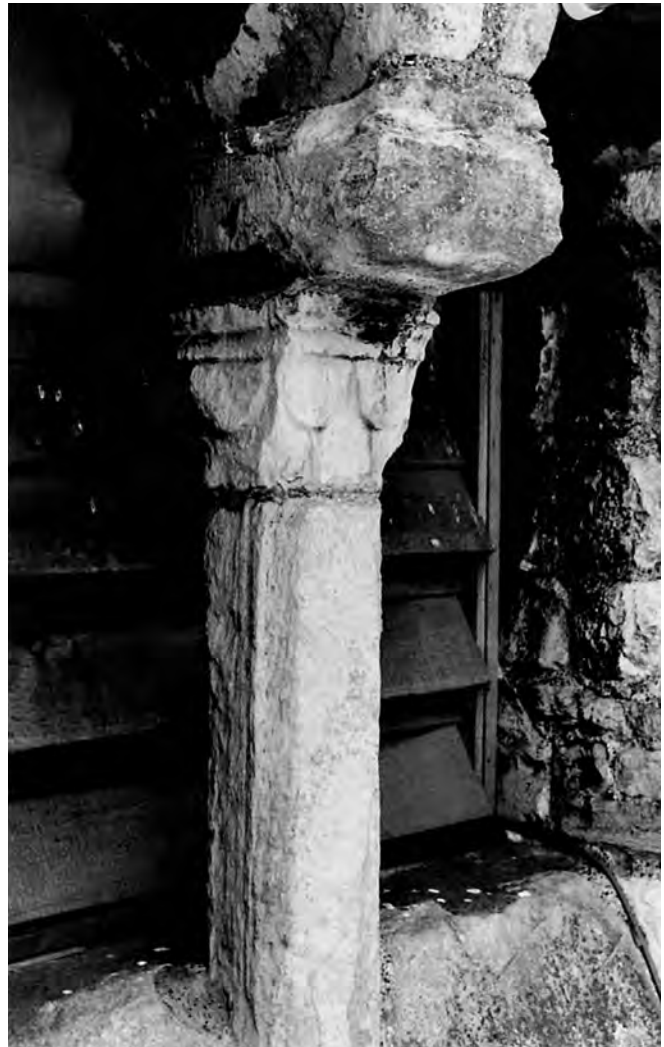
*Fig. 410: Tower: Stage 3, east face. Capital of the mid-wall shaft, 2005. Left, view south-west. Right, view north-west. Photos: Warwick Rodwell*

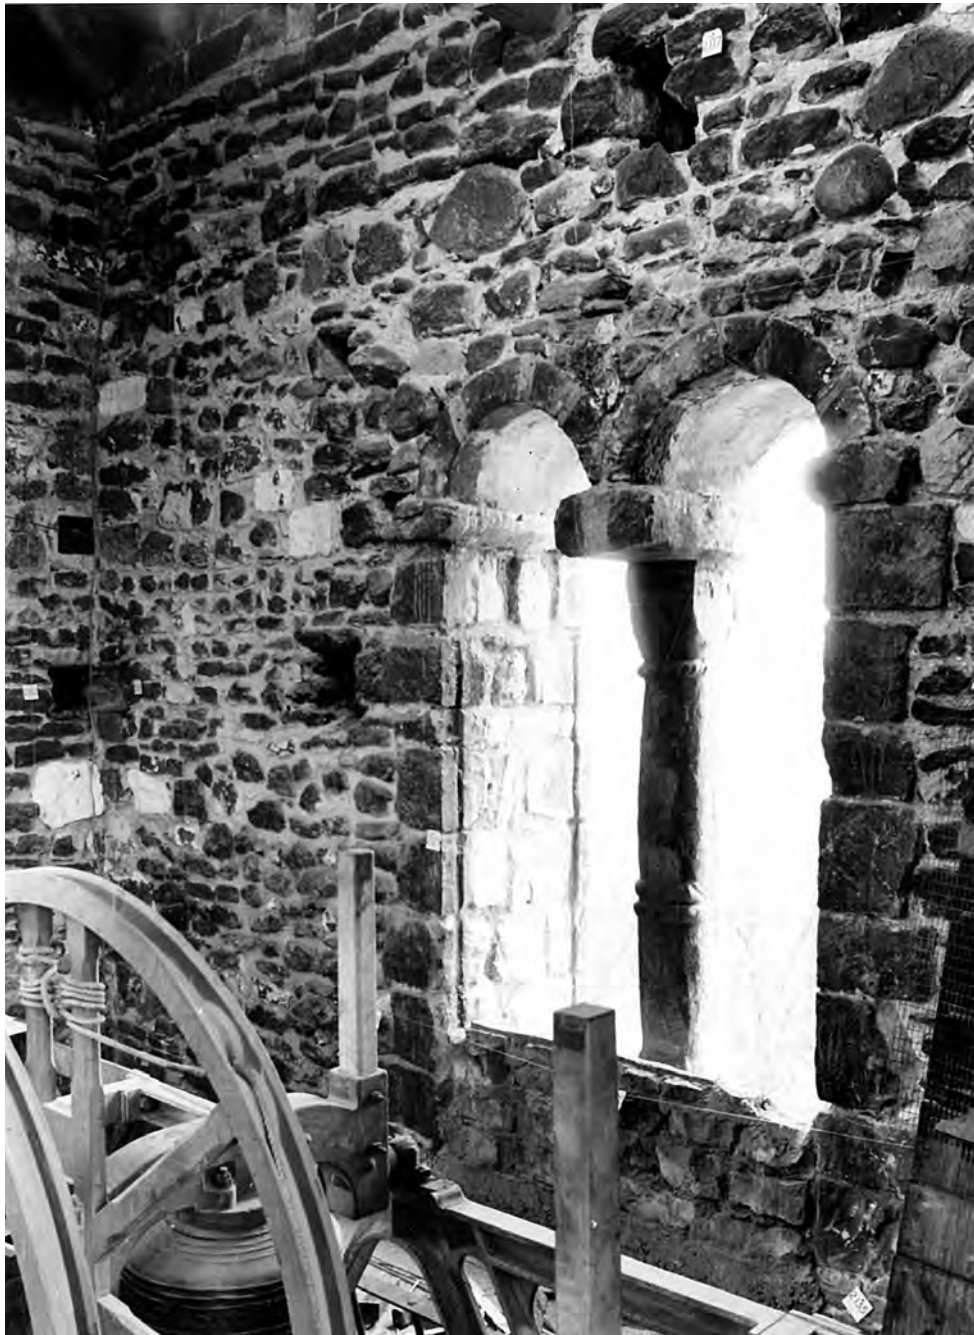
*Fig. 411: Tower: Stage 3, interior. View of the north wall and double belfry-opening (louvres removed), 1980. Photo: Warwick Rodwell*

### **North opening** (Figs. 411 and 412)

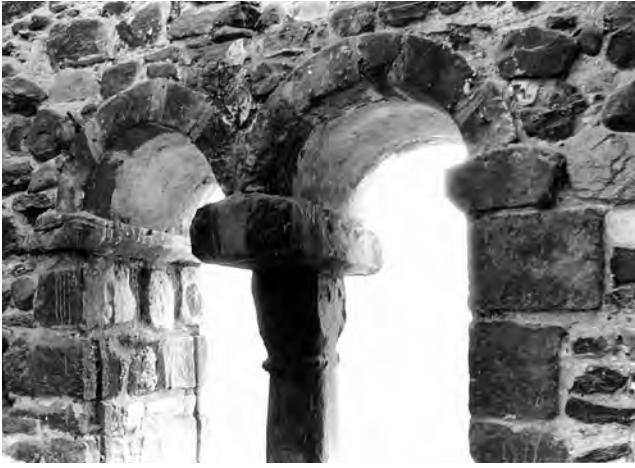
Fig. 412: Tower: Stage 3, interior. Detail of the neatly cut voussoirs in the head of the north belfry opening, 1980. Photo: Warwick Rodwell

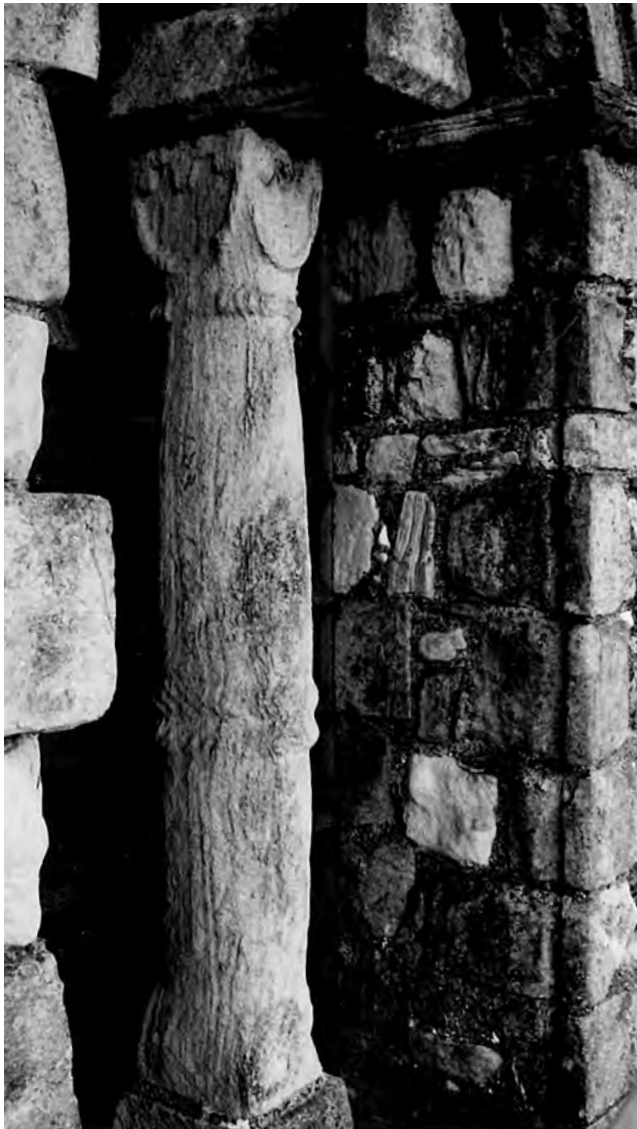
Fig. 413: Tower: Stage 3, north. Mid-wall shaft in the double belfry-opening. View from the north-east, 2005. Photo: Warwick Rodwell

The mid-wall support is distinctly different from the previous two, being a one-piece baluster with integral capital and base (Figs. 413 and 414). It is of soft limestone, and is now too eroded to confirm whether it could have been partially lathe-turned. The double-tapering baluster is decorated with a pair of mid-shaft rings, which now appear to be plain, but close inspection under suitable lighting conditions shows that they were once both decorated with cabling (Fig. 416).<sup>10</sup> There is also a cable-moulded neck-ring (Fig. 415), as occurs at Bracebridge (Lincs.) (Brown 1925, fig. 192), and on the capitals of the columns flanking the chancel arch at Marton (Lincs.) (Brown 1925, fig. 193.3). Stocker and Everson (2006, 44) have compared the Barton baluster with the degraded fragments of one-piece balusters from Grasby and Hagworthingham (Lincs.).<sup>11</sup>

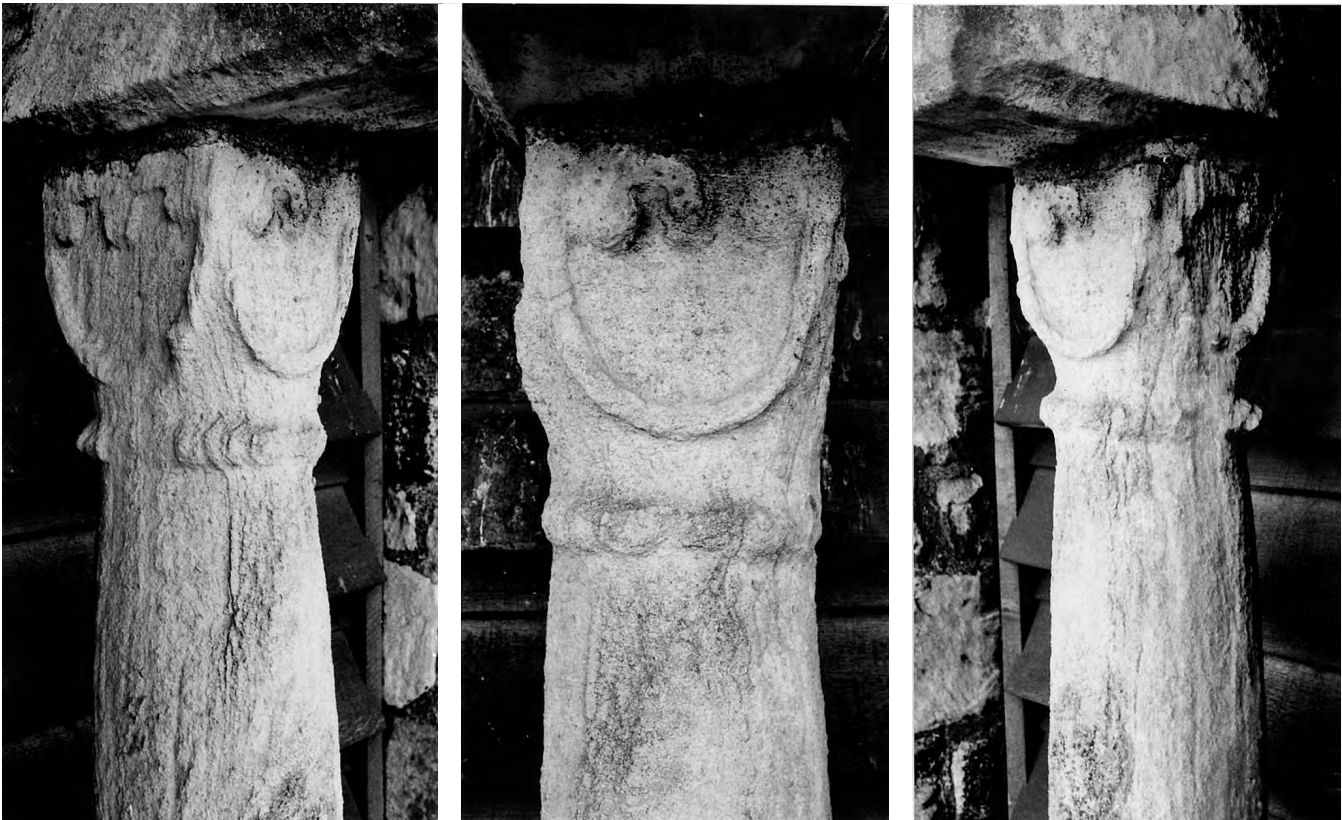
*Fig. 415: Tower: Stage 3, north. Capital and cable-moulded neck-ring of the mid-wall shaft. Left, from the north-east; centre, north face; right, from the north-west. Photos: Warwick Rodwell*

The capital is square-topped and difficult to classify: it is a hybrid cubical and cushion. It has three visible faces, each carrying a simple swag sculpted in relief; also, at the top of the swag, are two pellet-like motifs on the north and west, and three on the east (Fig. 415). The south face of the capital is decorated with a large, inverted triangle, the outline of which is formed by a raised rib (Fig. 416). The lower end of the shaft merges into a cubical base.

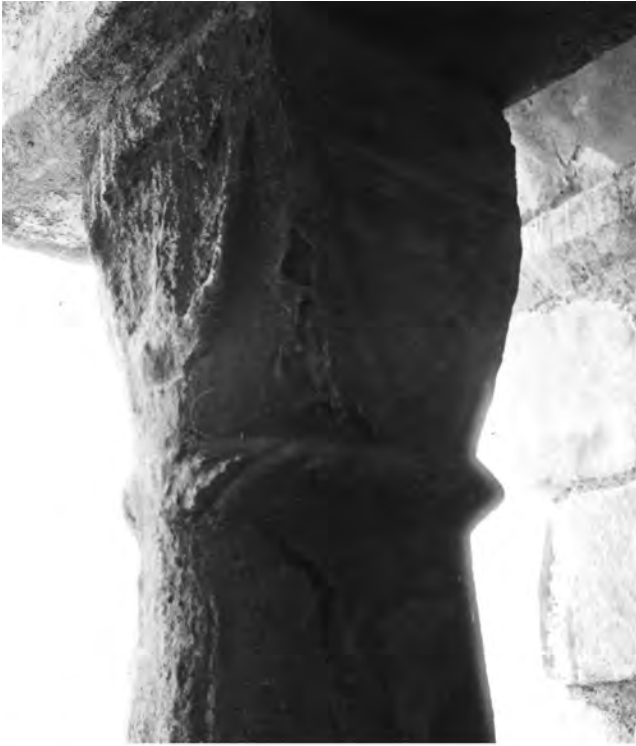
*Fig. 416: Tower: Stage 3, north. Mid-wall shaft. Upper, capital and rope-moulded neck-ring, from the south-west. Lower, eroded cable moulding on the shaft, from the north-east. Photos: Warwick Rodwell*

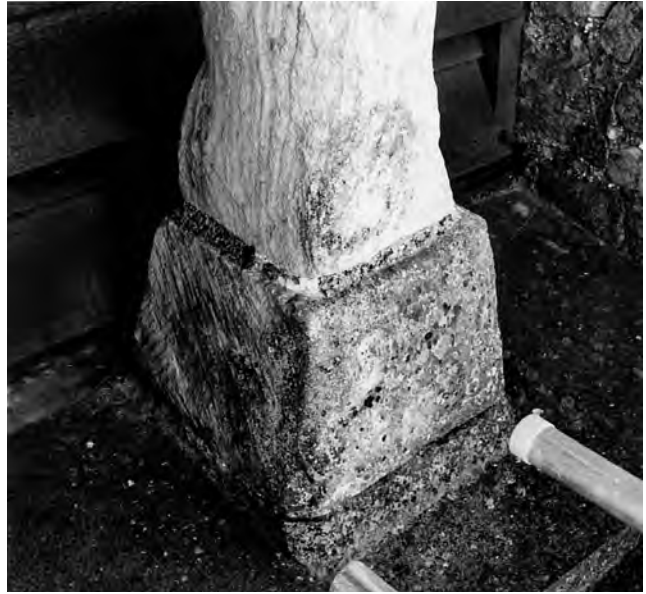
*Fig. 417: Tower: Stage 3, north. Base and sub-base of the mid-wall shaft, from the north-east. Photo: Warwick Rodwell*

The baluster stands on a separate sub-base, a plain cubical block with bevelled sides; the marks left by diagonal axing are still preserved (Fig. 417). The sub-base stands in turn on another square block which is embedded in the sill of the belfry opening. However, only the top of this lower block is visible, being surrounded by a modern concrete capping to the sill.
