# ST PETER'S

## Barton-upon-Humber, Lincolnshire

*A Parish Church and its Community*

HISTORY, ARCHAEOLOGY AND ARCHITECTURE

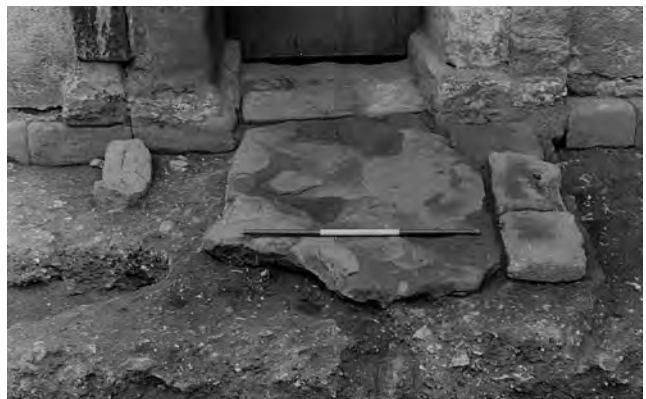
*Fig. 419: Tower: south doorway. Step (F3282) and threshold slab (F3035) lying on the Period 2 churchyard surface. Scale of 75 cm. Photo: Warwick Rodwell*

Another modification to the tower is attributable to Period 3. The raised floor level of the new church was carried through into the tower, and that required the thresholds of the north and south doorways to be raised. On the south, the step down to the churchyard was made from two blocks of salvaged gritstone, set on a mortar bed (F3282). Outside the door, a rectangular threshold slab of coarse limestone was laid (F3035; Figs. 391, 401 and 419).<sup>14</sup> The slab may have been flanked by a pair of postholes, aligned with the strip-work pilasters of the doorway and sited 50 cm forward of them. Only one posthole was present (F3218), the

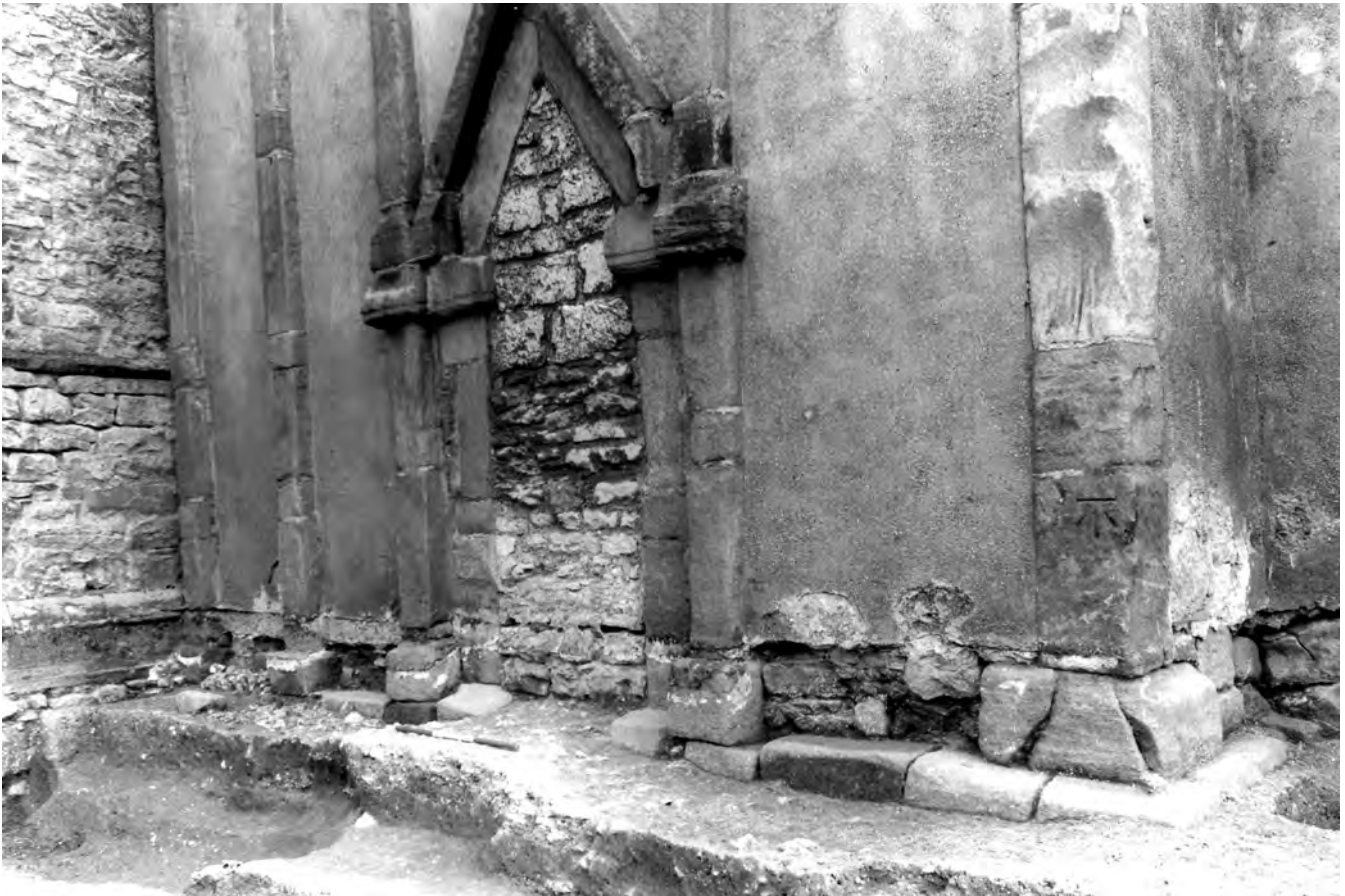
*Fig. 420: Tower: north doorway. Period 3 churchyard surface with masons' debris, alongside the tower plinth. View looking south-east. Scale of 75 cm. Photo: Warwick Rodwell*

On the north side of the tower, contemporary churchyard level was preserved in a narrow strip which had escaped destruction by later grave-digging. Here lay a spread of chalk, apparently forming a metallated surface on which the masons engaged in heightening the tower had worked (F7252). Strewn over the metallating was an accumulation of mortar and masons' waste from dressing limestone (Fig. 420). This activity had slightly raised the ground level alongside the

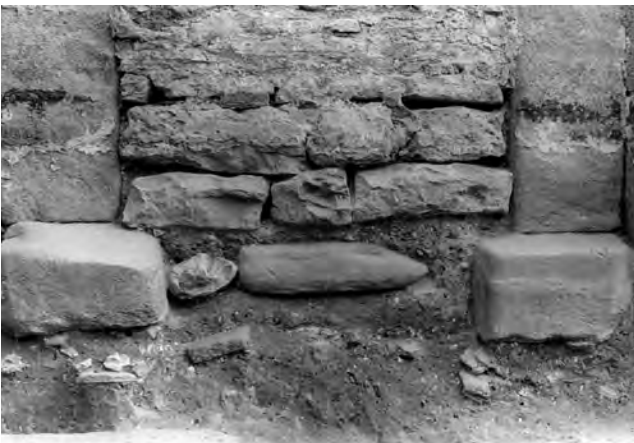
*Fig. 421: Tower: north doorway. Period 3 soil and pebble infill, raising the threshold to the level of the respond bases. Photo: Warwick Rodwell*

tower, so that a step was not needed in the north doorway. Instead, several large pebbles were deposited in the threshold in a soil matrix, and the projecting bases to the door jambs now disappeared from view (Fig. 421).

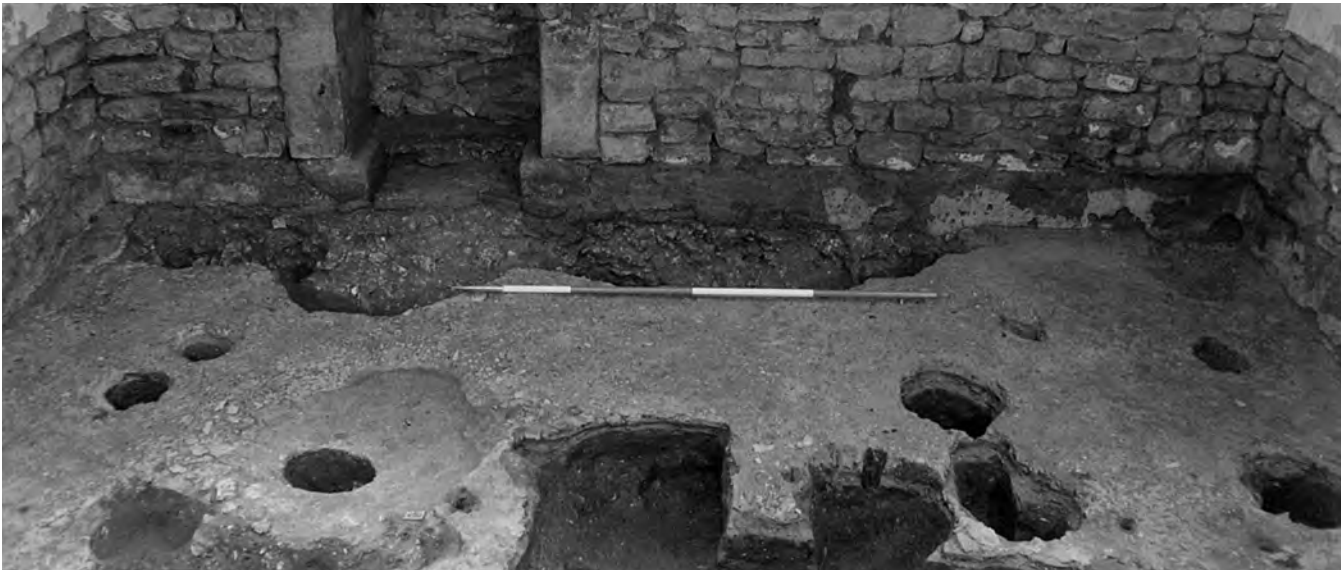
Fig. 422: Tower: interior. Lime concrete floor of Period 3 in the northern half of the tower. View north. Scale of 2 m. Photo: Warwick Rodwell

Within the tower, a new lime-concrete floor was laid over the accumulated material on the primary floor (Fig. 422). In the process, this sealed some of the primary plaster around the base of the walls (Fig. 423).

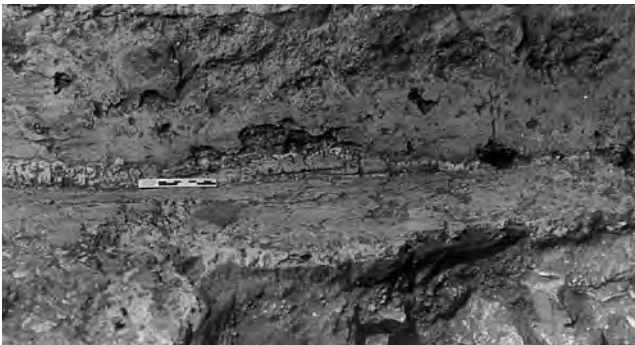
Fig. 423: Tower: interior. Lime concrete floor of Period 3 abutting the west wall. Note how the new floor has been joined into the damaged earlier wallplaster, just above the scale of 8 cm. Photo: Warwick Rodwell

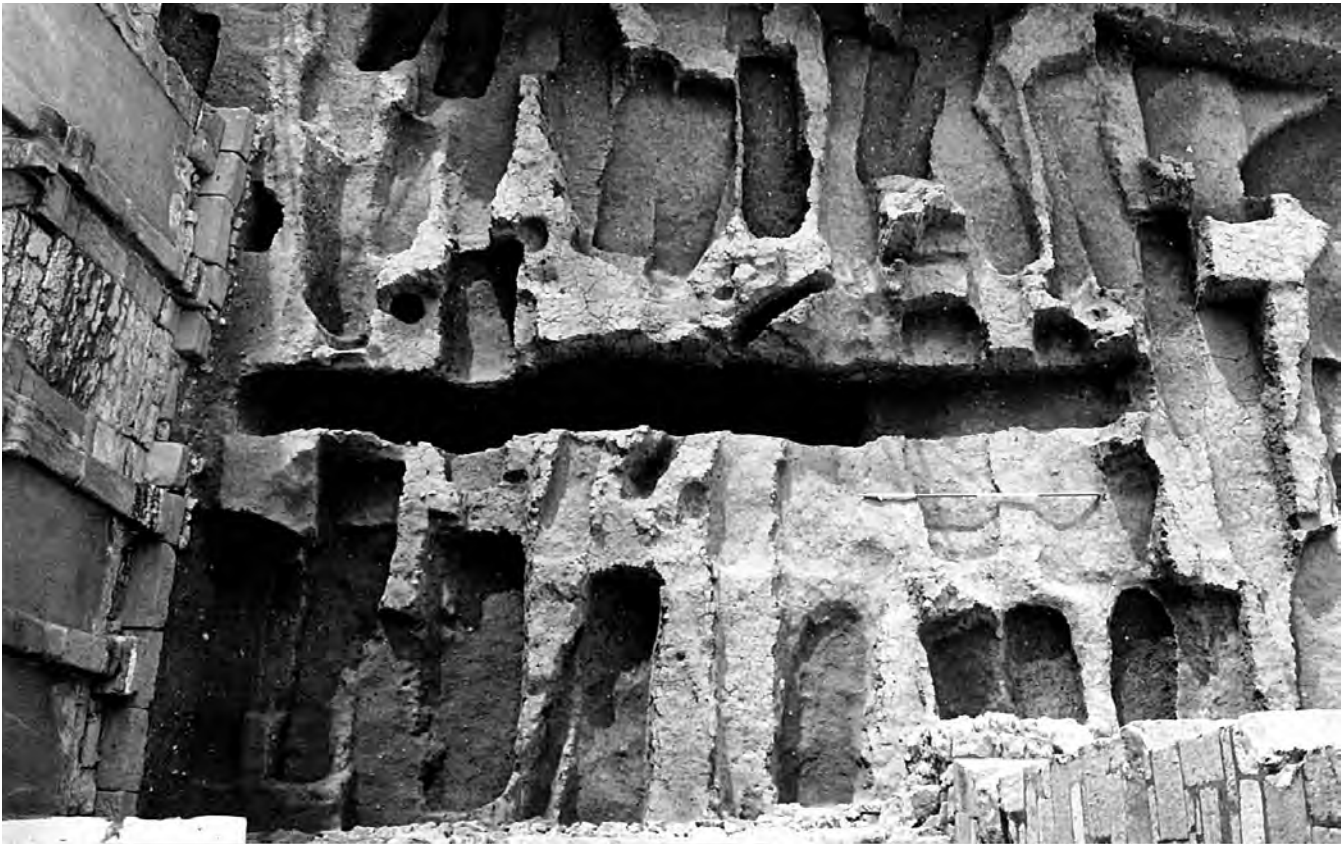
*Fig. 424: Area 14: cemetery after complete excavation. The unused Saxo-Norman foundation trench (F7302, seen at the centre), running north from the tower, was earlier than the majority of the graves. West is at the top. Scale of 2 m. Photo: Warwick Rodwell*

North of the tower, in Area 14, a substantial linear feature was discovered which has defied convincing explanation (F7302). It took the form of a trench 7.4 m long, had an average width of 0.6 m, and had been dug to a depth of *c.* 1.2 m below contemporary ground level (Figs. 391, 424 and 425). The sides were intended to be vertical, but in places the clay had caved. The feature had the appearance of being a foundation trench for a masonry wall. The trench ran north-south and was nearly at right-angles to the axis of the church; it cut through two graves of Phase E (F7382 and

The feature was too precisely cut to be a palisade trench for a timber construction, and the evidence does not convincingly suggest that it was a robbed masonry foundation. Nevertheless, the vertical sides, depth and flat bottom strongly suggest that it was intended to be the foundation trench for a substantial wall, but was abandoned at an early stage of construction. We can only speculate as to the nature of the aborted scheme. The southern end of the wall was clearly intended to abut the tower, the north doorway of which would have been obstructed, and its infilling must have been envisaged (incidentally providing the facility for keying the two elements together). No intended termination towards the north can be suggested, and it is likely that at some point within the next five metres or so (*i.e.* before the break of slope), the wall trench would have turned a right-angle, and run eastwards. The intention may have been to enclose a cemetery or possibly even residential structures, if there were ambitious intentions, for example, to raise the church to collegiate status. However, the project was never completed, the trench was backfilled and a large number of burials of Phases D and E masked its site.

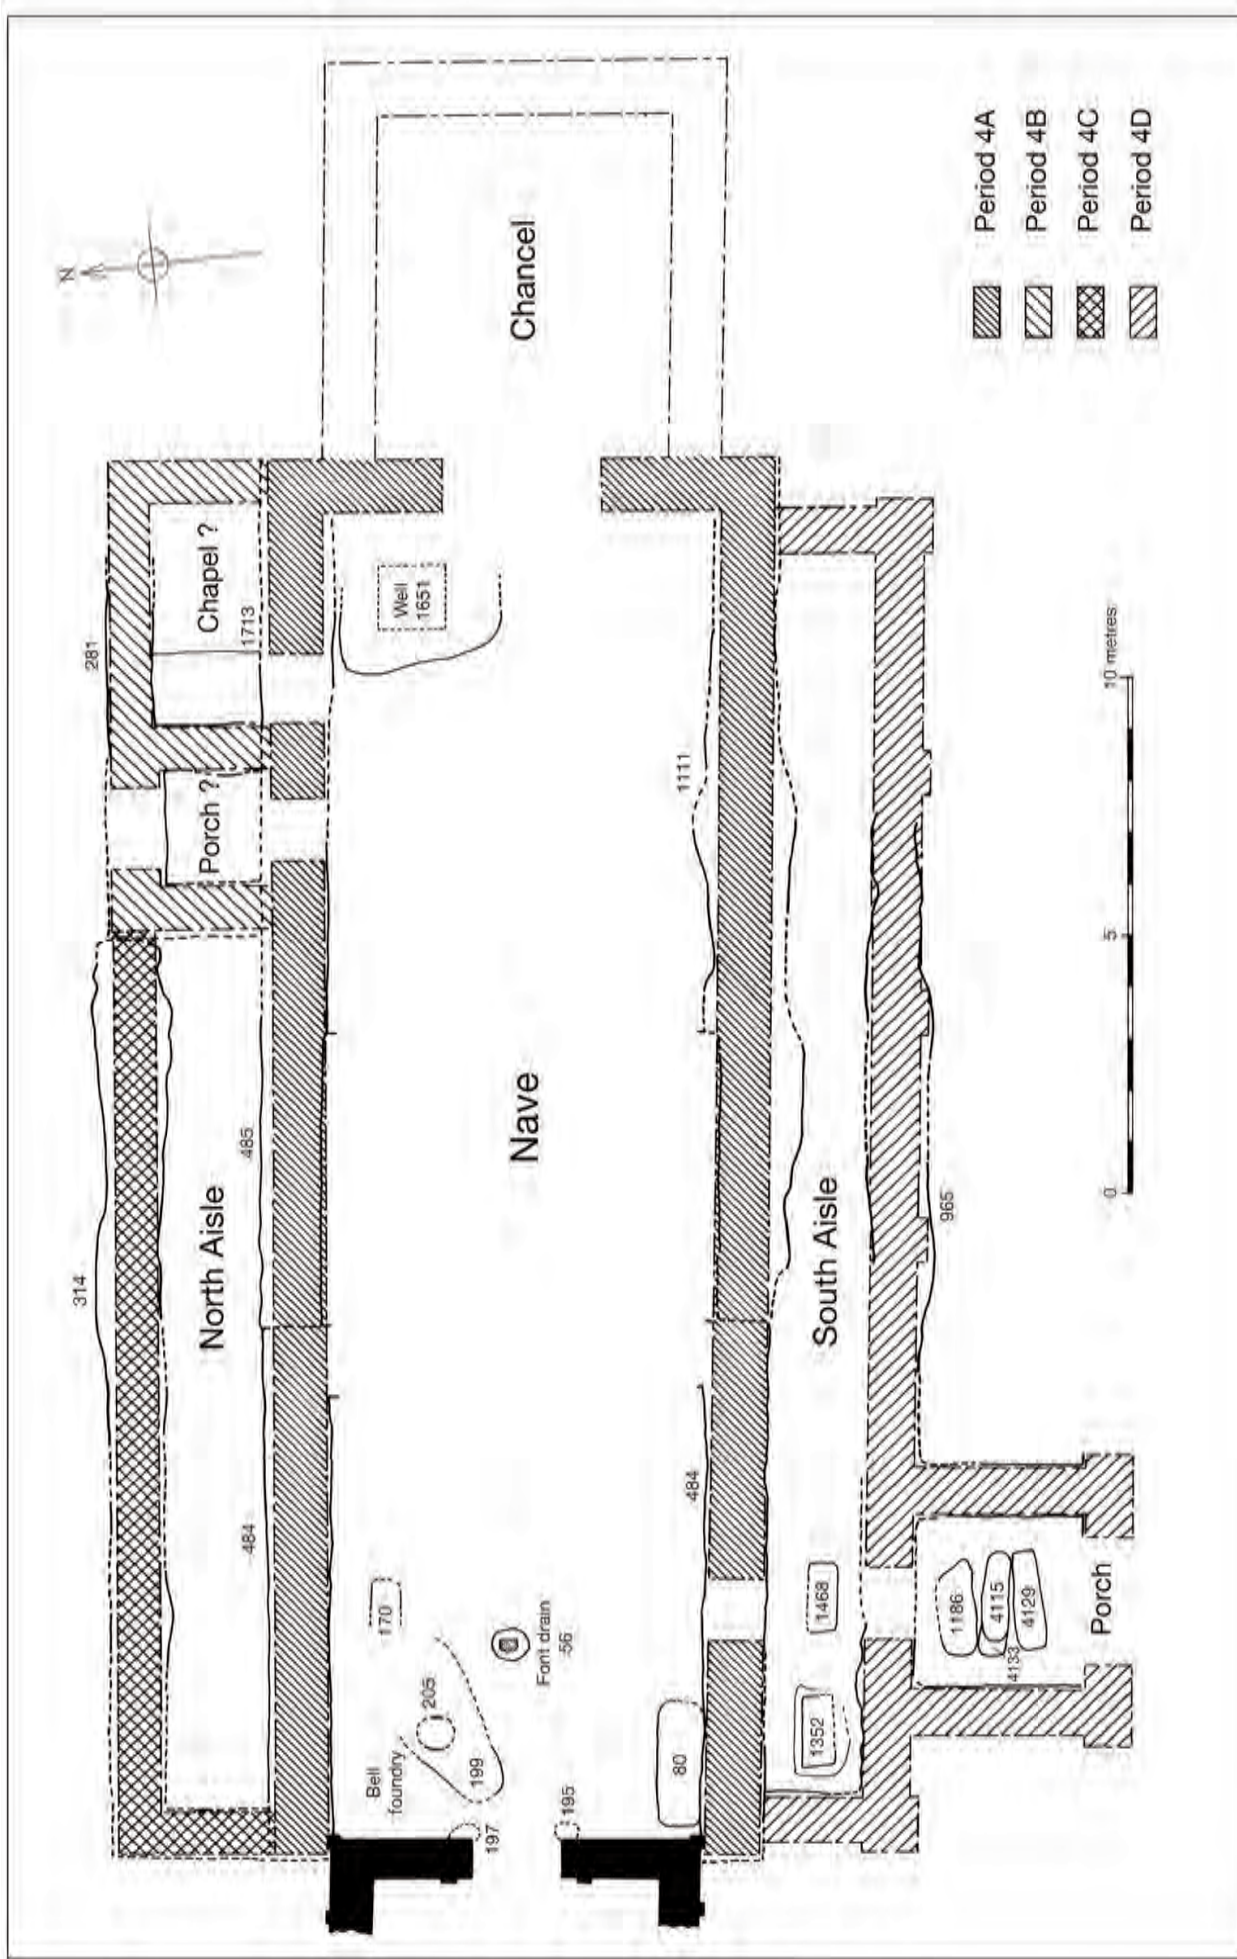
Fig. 426: Foundation plan of the Norman church, Periods 4A–D, based on excavation. Reconstructions of the demolished walls are hatched and openings are schematically shown; the plan of the chancel is entirely hypothetical. Scale 1:150. Drawing: Warwick Rodwell

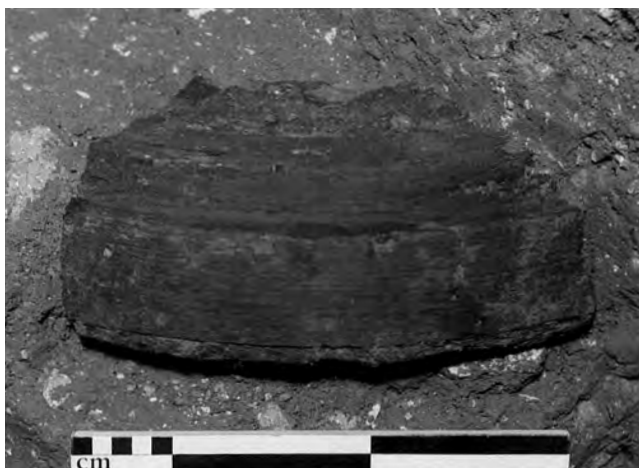
Fig. 427: Nave. Fragment of rim of the inner (core) mould for a bell, in pit F181. Scale of 25 cm. Photo: Warwick Rodwell

Contemporary floor level was not identifiable in the nave, and the only features of significance occurred in the north-west corner. Here, fragmentary remains of an oval pit were encountered, containing burnt earth, charcoal and remnants of bell-mould (F181/199; Fig. 427). Set within the pit was also the damaged base of an *in situ* clay mould for casting a small bell (F205); this was the core-mould for a bell with a diameter of 57 cm (22½ ins) produced by the 'lost-wax' process.<sup>16</sup> Adjacent to the casting pit was a small hearth pit of elongated plan, with a rounded base and burnt sides (F170). Although incomplete, this was too small to be a furnace for melting bell-metal in a crucible. While these features are included here, the possibility should be acknowledged that they could have related to the Saxo-Norman church (Period 3).

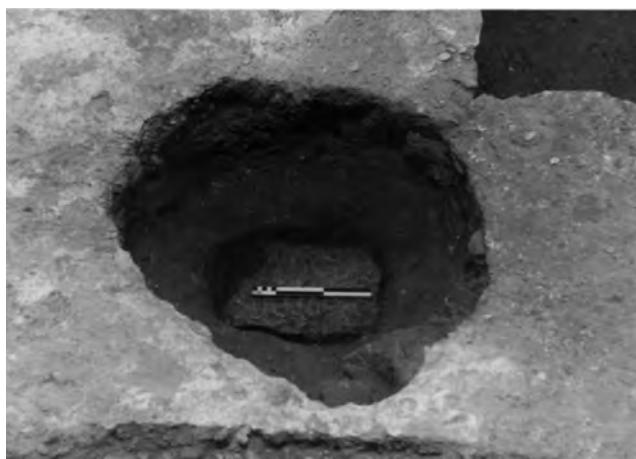
Fig. 428: Nave. Font drain pit (F56). View west. Scale of 25 cm. Photo: Warwick Rodwell

A feature encountered at the west end of the nave, on the central axis, was a circular pit with a slab of limestone in the base and a filling of small rubble above (F56). This was clearly a font drain (Fig. 428).

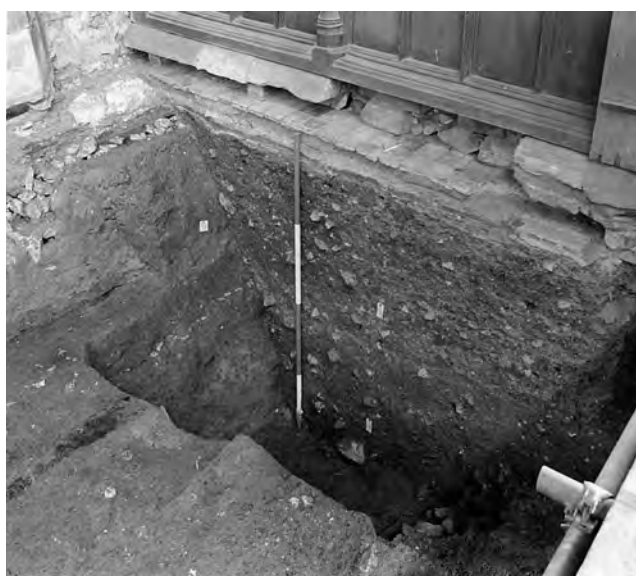
Fig. 429: Collapsed well shaft (F1651) in the north-east corner of the Norman nave. View north-east. Scale of 2 m. Photo: Warwick Rodwell

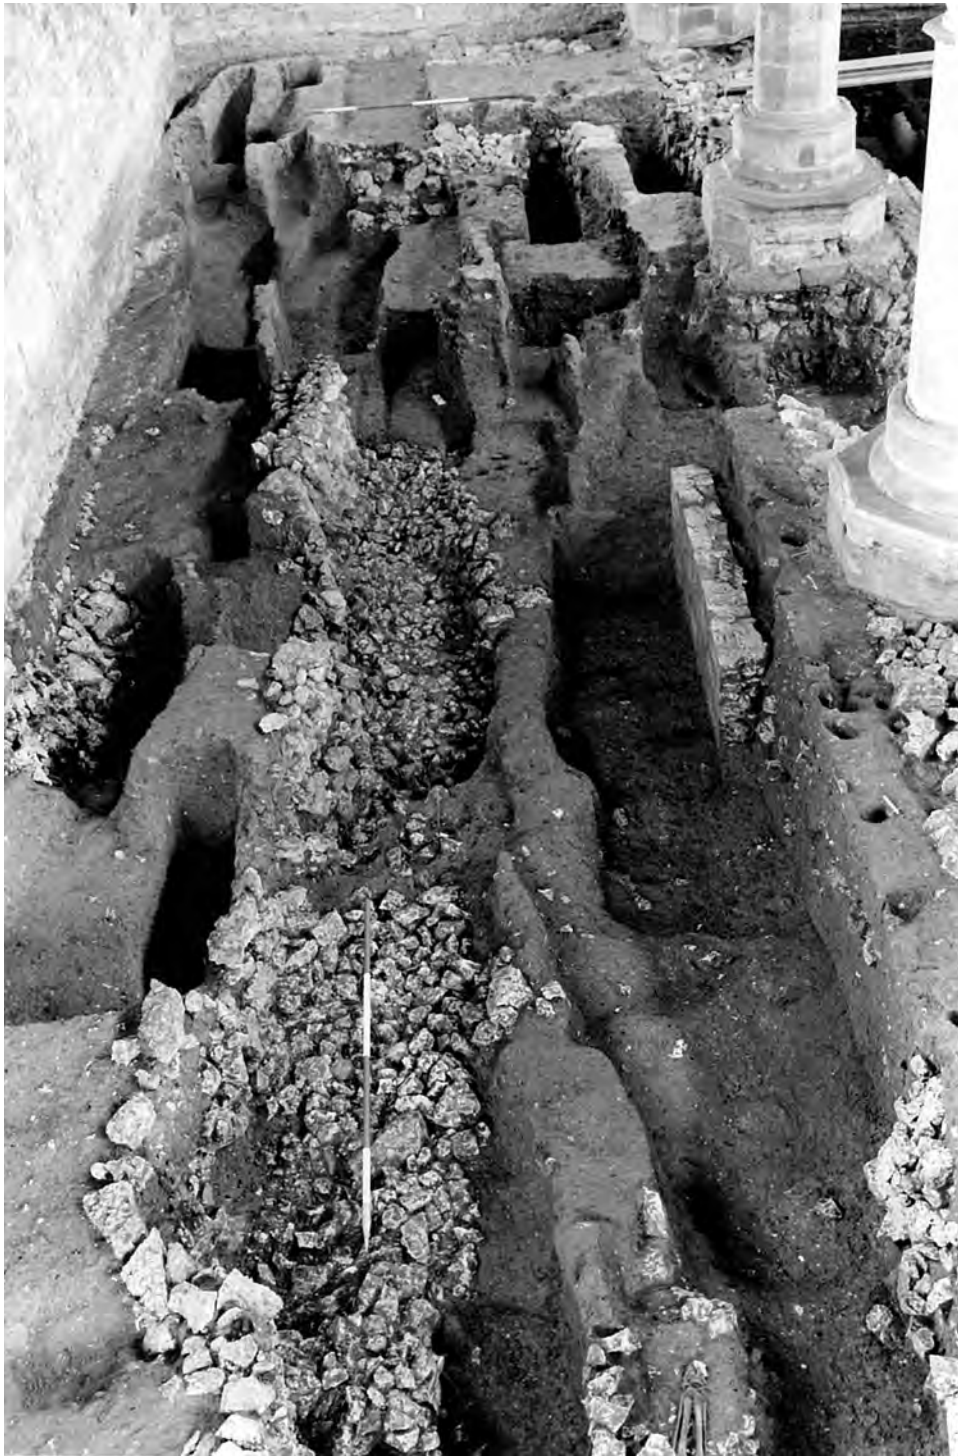
*Fig. 431: North aisle, Period 4C. The fragmentary and irregular chalk rubble foundation of the outer wall of the narrow aisle (F314). View east. Scales of 2 m. Photo: Warwick Rodwell*

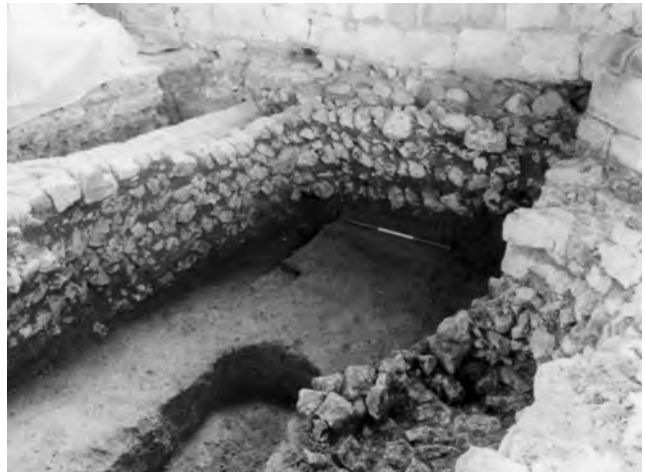
Fig. 432: South aisle, Period 4D. Chalk rubble foundation of part of the south wall (left) and west wall of the narrow aisle (F965). View south-west. Scale of 75 cm. Photo: Warwick Rodwell

The next addition to the nave took the form of a south aisle with an integral porch. Four lengths of rubble foundation (F965) are all that survive; these constitute parts of the south wall, west-end return (Figs. 426 and 432), and the east side of the porch (Fig. 433). A ghosted outline was preserved where the west side of the porch had lain. The edges of the aisle foundation were sinuous as a result of their trenches having been cut through unstable grave fillings.<sup>20</sup> Nowhere was the top of the foundation extant, but the intended width seems to have been *c.* 1.0 m, which points to the walls having been 3 ft (0.92 m) thick. The foundation was *c.* 0.90 m deep and consisted of chalk rubble, flints and occasional pieces of limestone with mortar adhering, set in a matrix of stiff grey clay.

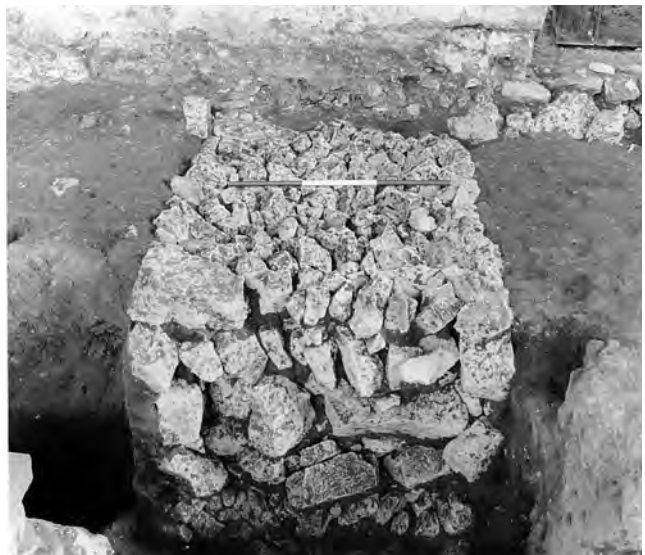
Fig. 433: South porch, Period 4D. Section through the chalk rubble foundation (F965) of the east wall of the porch associated with the narrow aisle. View south. Scale of 75 cm. Photo: Warwick Rodwell

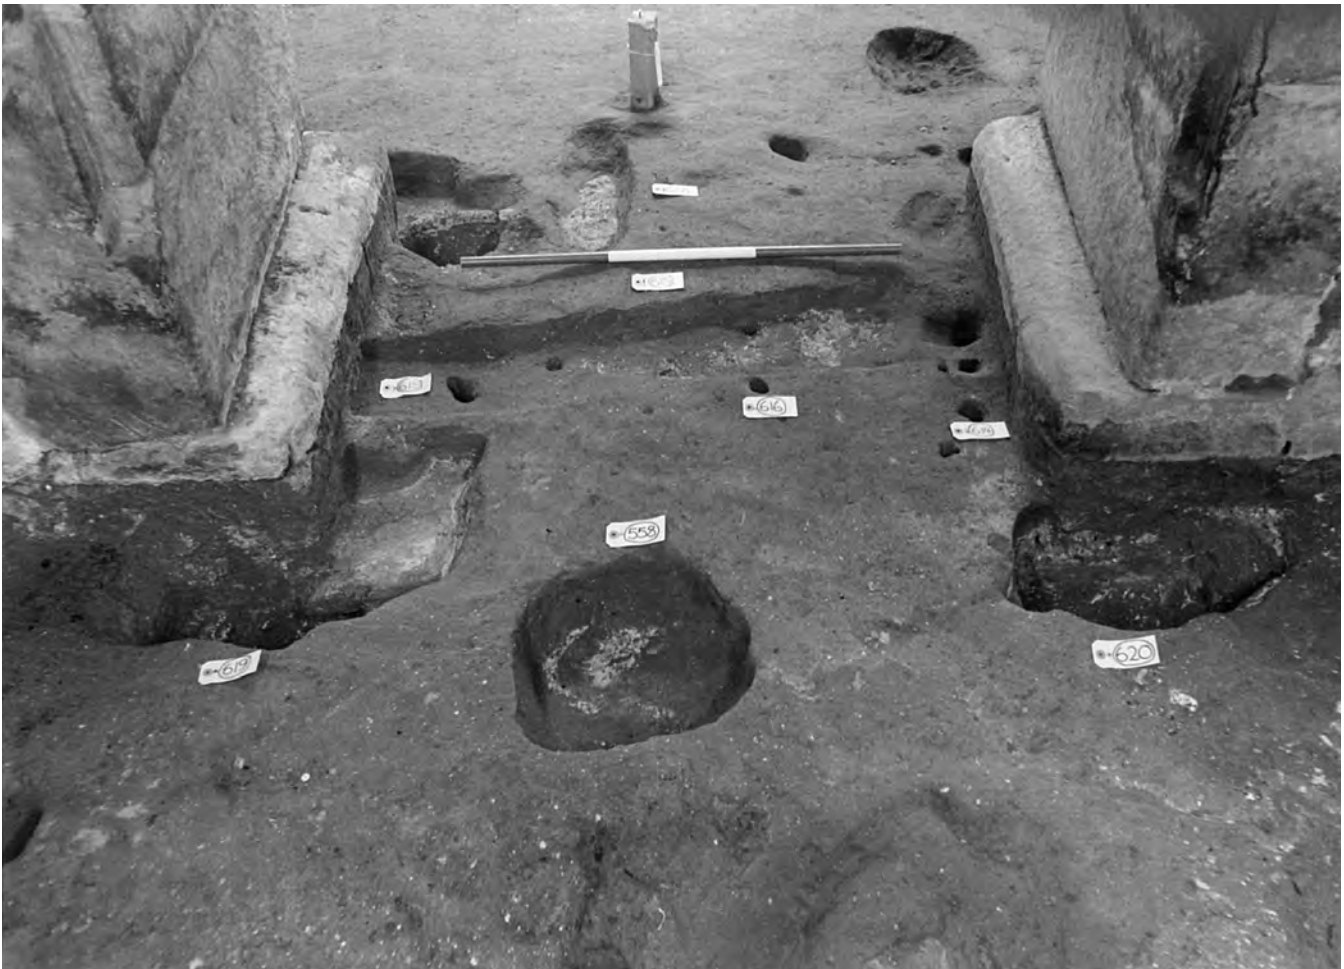
*Fig. 435: Western annexe: base of tower arch. Saxo-Norman earth floors punctured by early medieval features, including a pair of postholes (F619 and F620) for a portal frame and a slot for a threshold timber (F618, in front of the scale). View east. Scale of 75 cm. Photo: Warwick Rodwell*

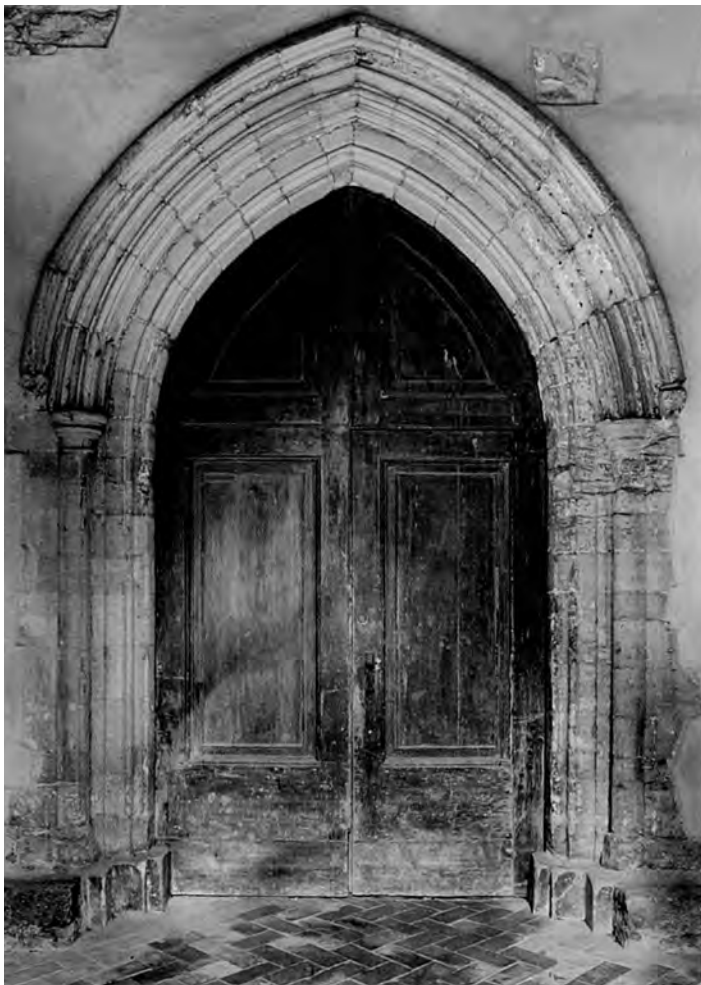
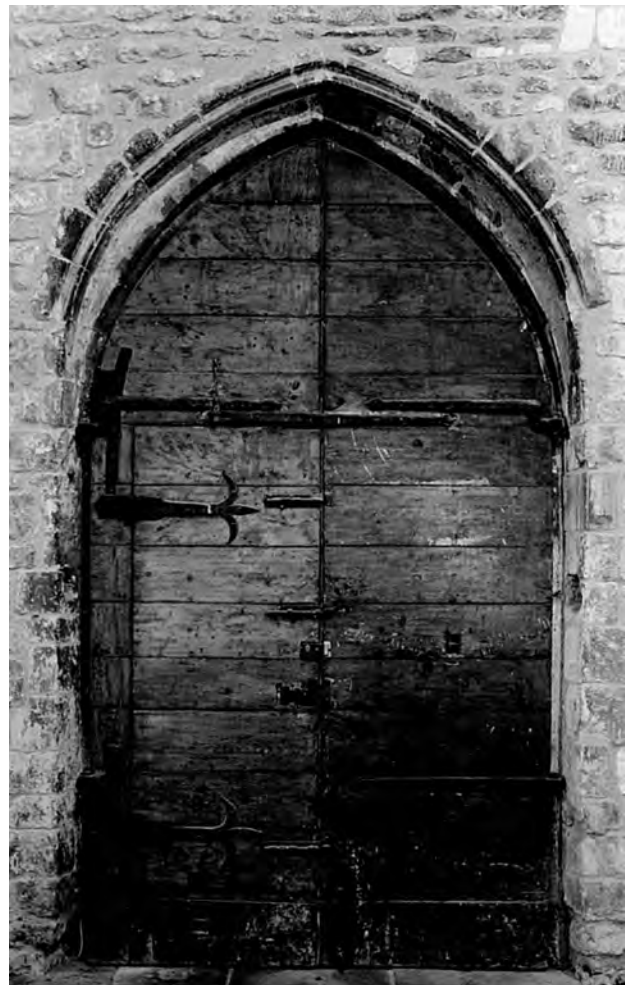
Fig. 438: South aisle doorway, Period 5. Left, exterior. Right, interior. Photos: Warwick Rodwell

The two-centred south doorway opening into the aisle has a well-moulded arch of two orders, with filleted rolls and cavettos; there is also a filleted hood-moulding which terminated in label-stops (Fig. 438). Both stops are now broken and formless.<sup>32</sup> The inner order is continuous with the jambs and the outer order descends onto a pair of recessed and filleted angle-shafts coursed with the jambs. Their bases, which are ten-sided, are seriously decayed and have been partly renewed. The moulded capitals of the flanking shafts have integral abaci and neck-rings: they have been heavily scraped with a claw-chisel and the mouldings clumsily recut.<sup>33</sup> Given that the doorway has always been protected by the porch, its masonry is in remarkably poor condition. Part of the outer order of the arch has been lost and was 'restored', probably in the late eighteenth century, by driving nails into the masonry and modelling the missing moulding in stucco; this too is now lost.<sup>34</sup> There is a good deal of dark red paint on the damaged masonry of the doorway, also of late date (Pls. 49 and 50).

The opening is large and the door must have comprised two leaves that were secured from the interior by a draw-bar, the sockets for which remain in the walling to either side.<sup>35</sup> The two-centred rear-arch has a filleted roll-moulding, which dies into the plain reveals (Fig. 438). It is likely that the original door leaves survived until the beginning of the nineteenth century; and the reused fleur-de-lys terminals on the present hinges of the wicket may have come from the medieval door (Pl. 52A, but see also p. 513).

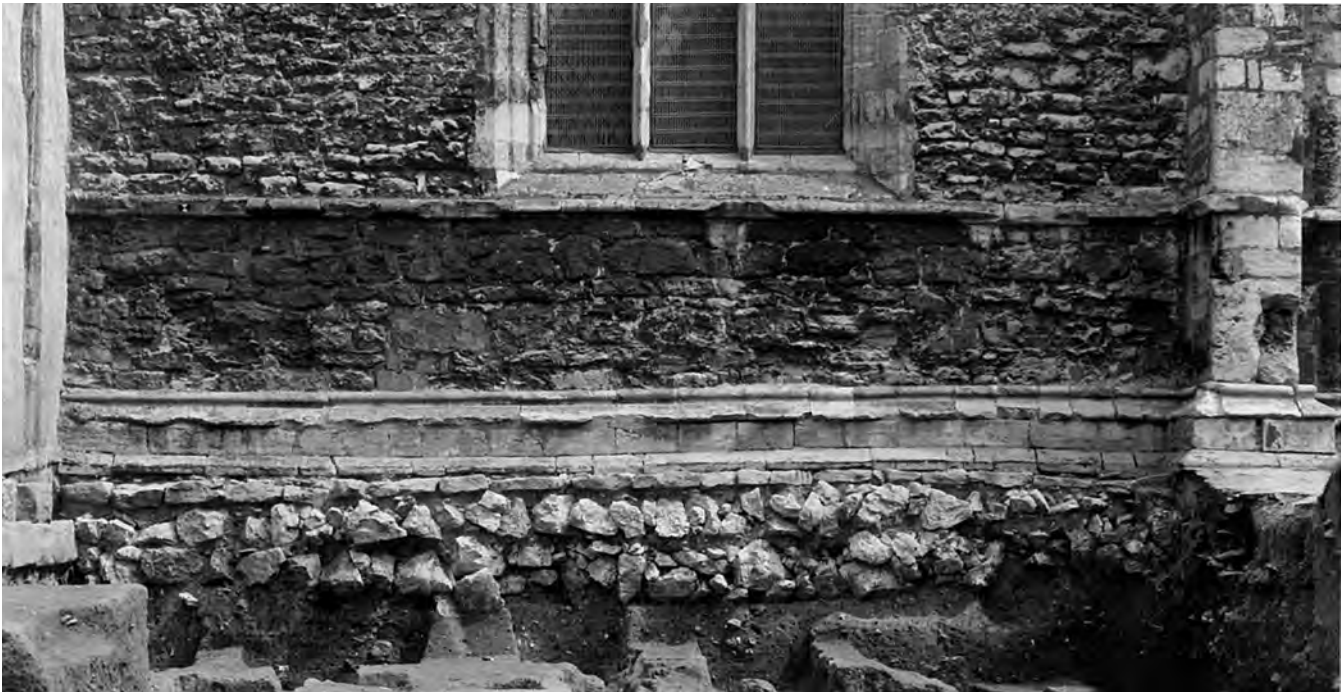
*Fig. 440: South aisle, Period 5: west wall. Thirteenth-century chalk rubble foundation, encasing and extending the foundation of the Norman narrow aisle. Note the slightly undulating profile of the plinth, resulting from subsidence. Photo: Warwick Rodwell*

extended southwards. Slight subsidence in the plinth is visible at the south-west corner of the aisle (Fig. 440). Only the jambs of the three-light Early English west window survive, the traceried head being a later replacement. It is of the same width as the south windows and may well have been *en suite*, although the external mouldings of the jambs are more elaborate,<sup>38</sup> and the sill is of two chamfered courses, both internally and externally. The rear-arch is more widely splayed and its present pointed head comprises thin, flat voussoirs of limestone without a chamfer on the arris.

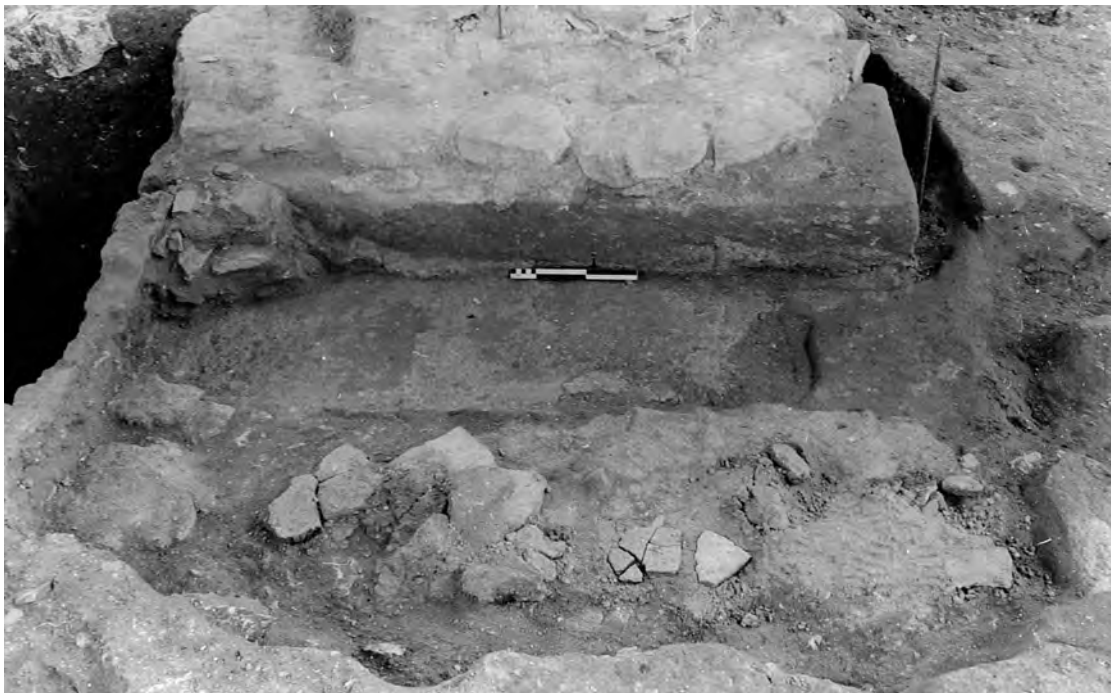
Fig. 443: South arcade. Remains of a base (F1306), apparently made from three reused grave-covers, which carried the late thirteenth-century pier between bays 4 and 5. In the foreground is the robber pit where one slab has been removed; in the middle is the mortar bed for the second (the scale lying on it); and beyond is the third slab, still in situ and largely concealed beneath the later arcade pier. View west. Scale of 25 cm. Photo: Warwick Rodwell

was a robber pit where a third slab had apparently once been (Fig. 443). Together, the three slabs would have constituted a squarish footing to carry an arcade pier.

The three footings just described cannot have been those created for the early thirteenth-century narrow aisle, for two reasons. First, their positions synchronize with the bay divisions of the late thirteenth-century wide aisle and, second, all three decorated grave-slabs that have survived here are themselves datable to that century. It is thus inescapable that there have been two arcades on this site prior to the present fourteenth-century one. Moreover, the dogtooth capitals and other elements must have been salvaged and reused twice.

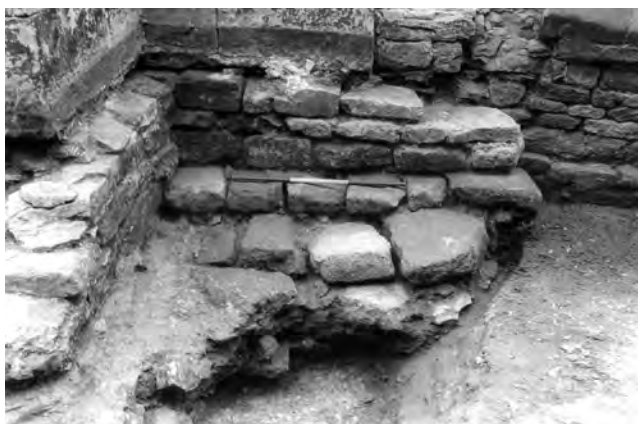
*Fig. 446: Chancel: north-east corner. Foundation for a thirteenth-century north-facing buttress, oversailed (top right) by the fourteenth-century east wall of the vestry. View west. Scale of 75 cm. Photo: Warwick Rodwell*

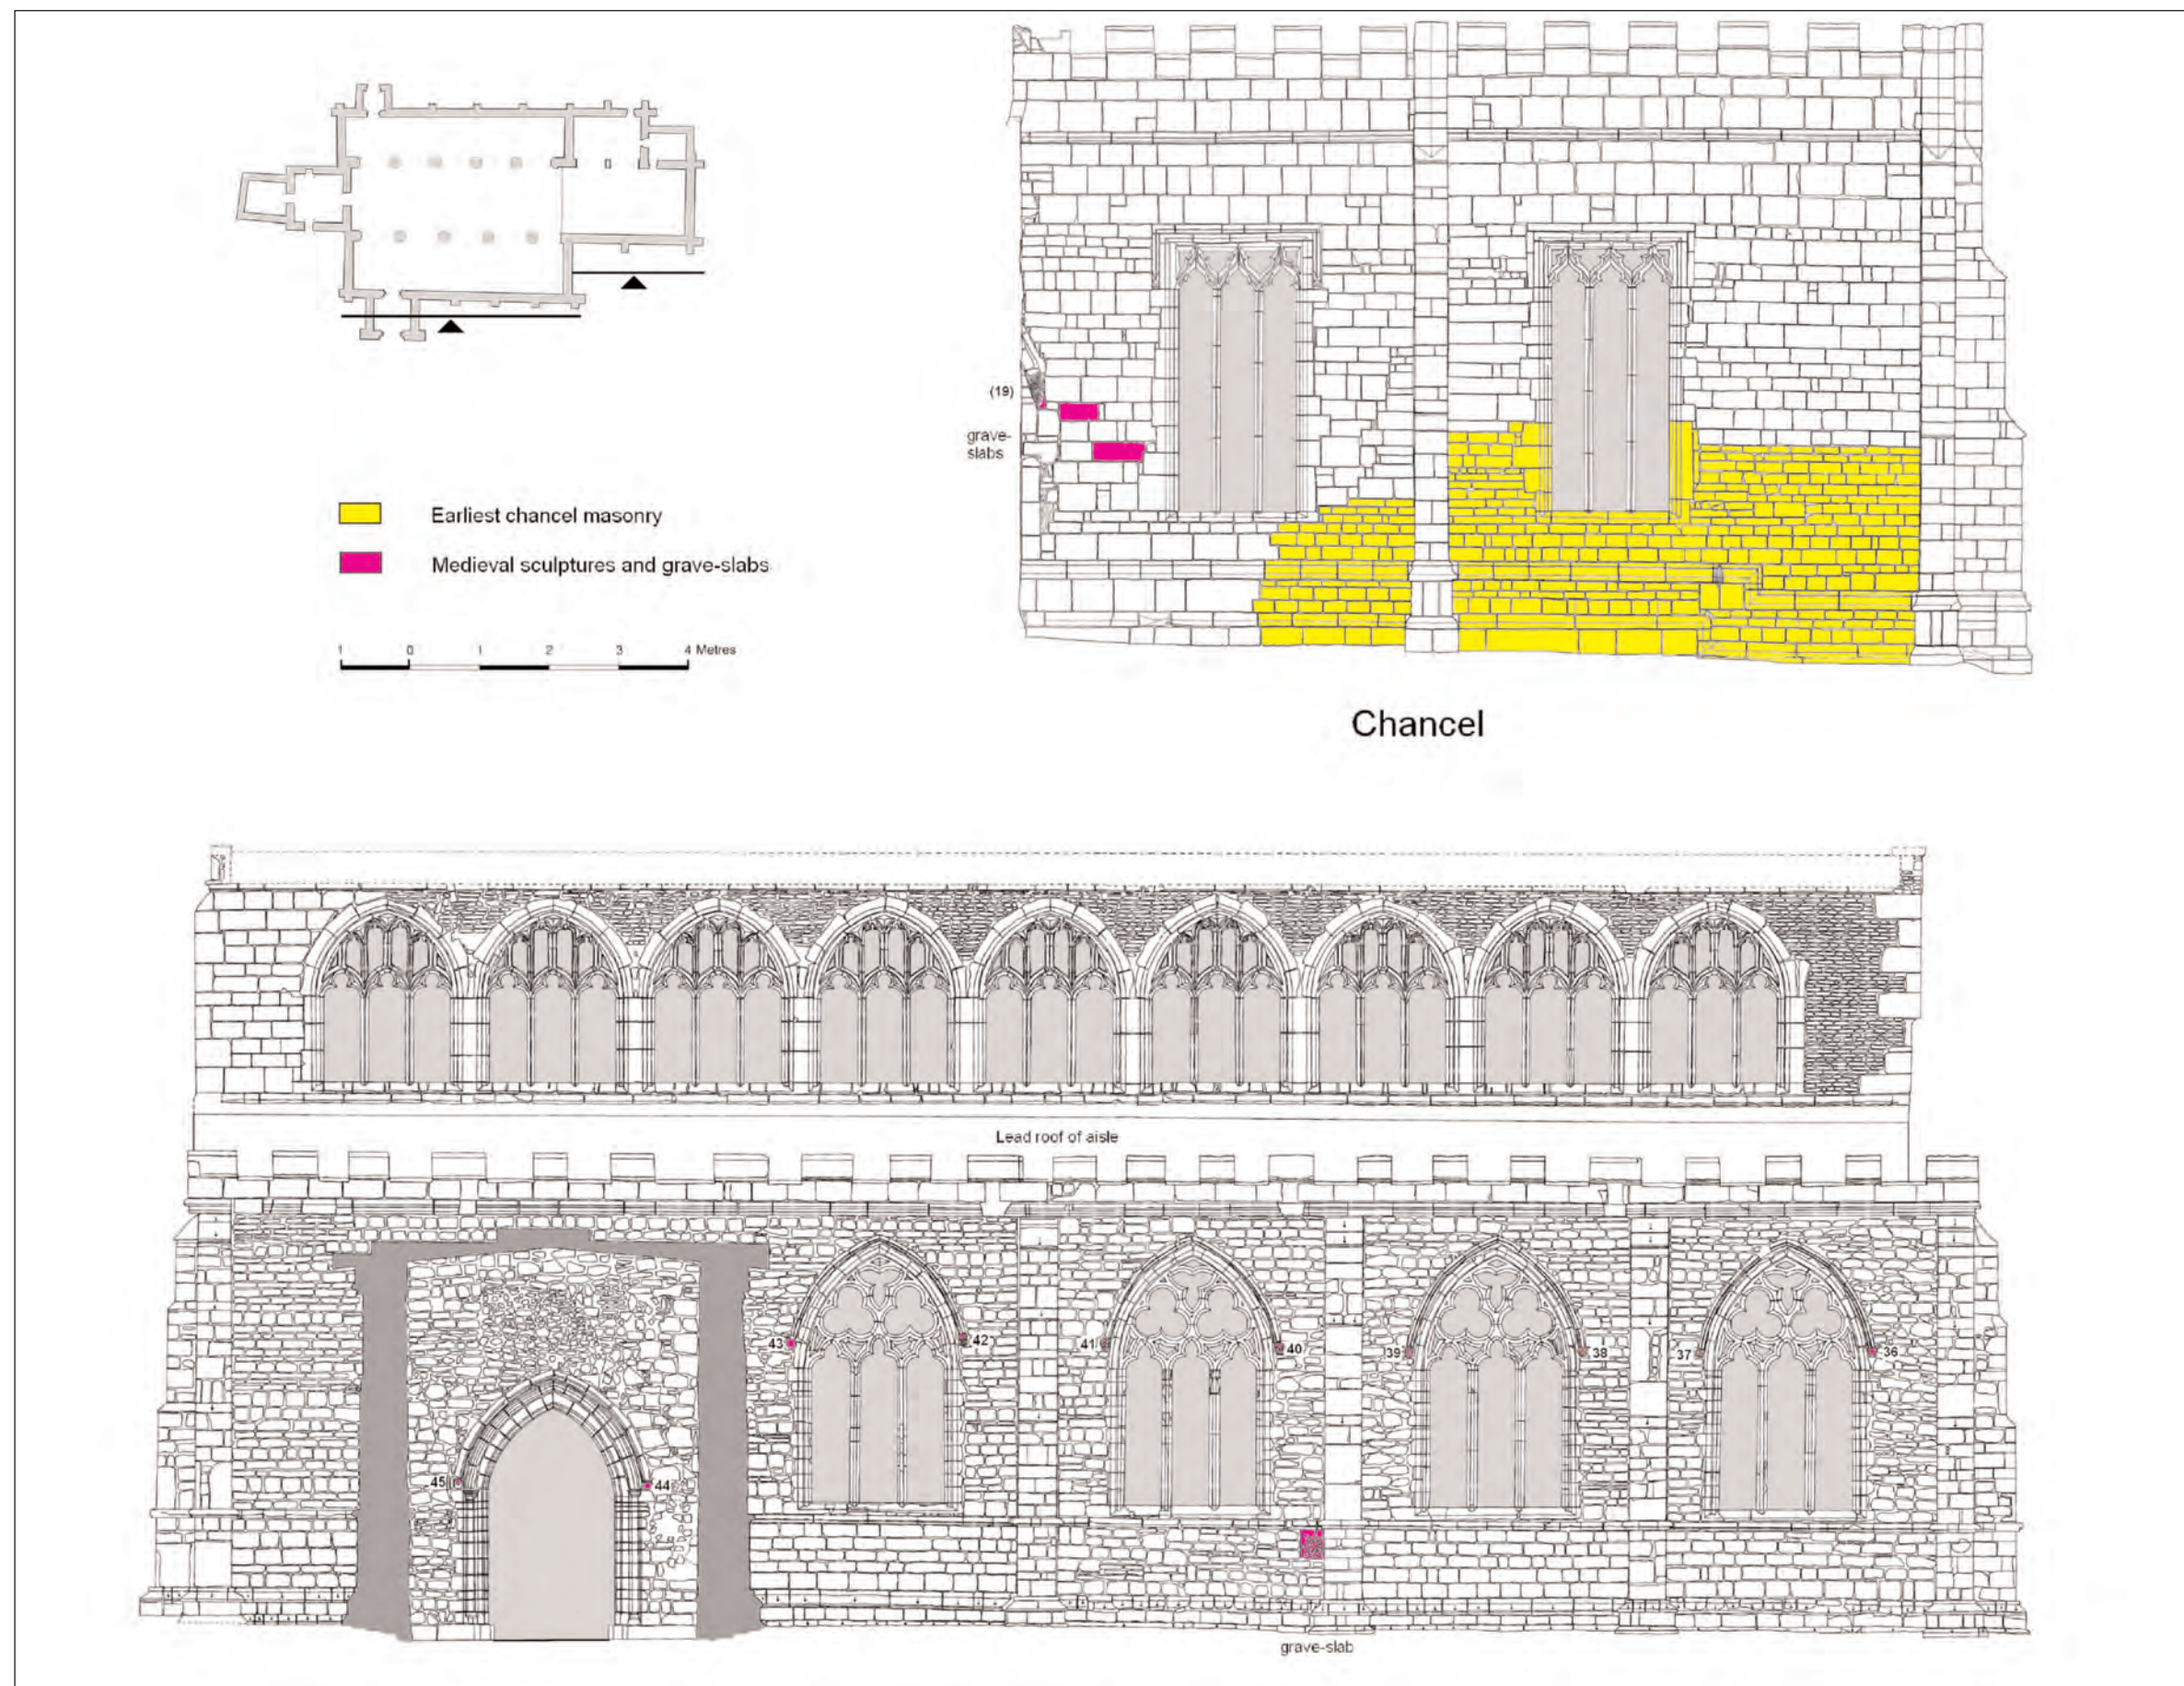
Fig. 452: South aisle (omitting the porch), clerestory and chancel. External elevations (south), 1984. For the tower and annexe, see Figs. 259 and 324. Scale 1:100. Drawing: Simon Hayfield
