# ST PETER'S

## Barton-upon-Humber, Lincolnshire

*A Parish Church and its Community*

HISTORY, ARCHAEOLOGY AND ARCHITECTURE

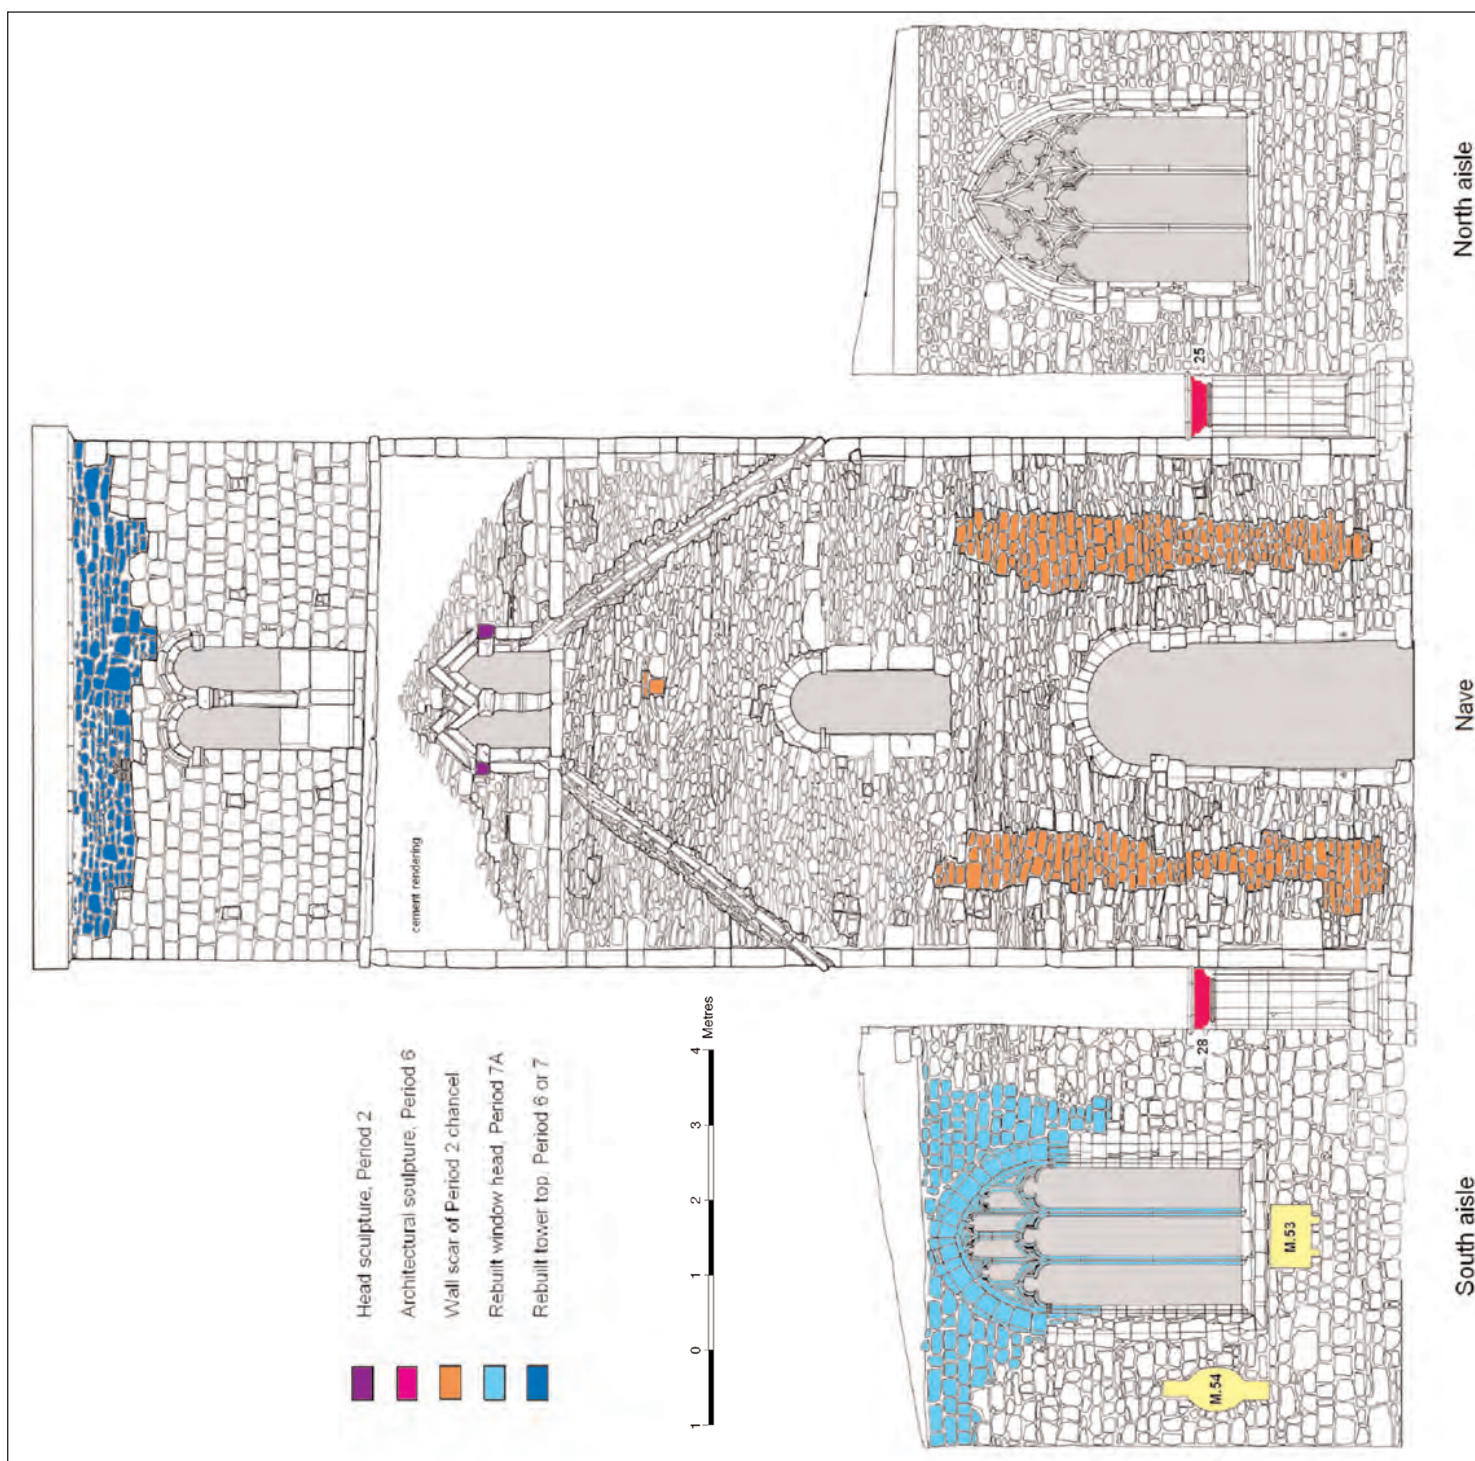
Fig. 462: Nave and aisles. Internal sectional elevation, looking west, 1984. The external east face of the tower above the nave is also shown. Scale 1:100. Drawing: Simon Hayfield

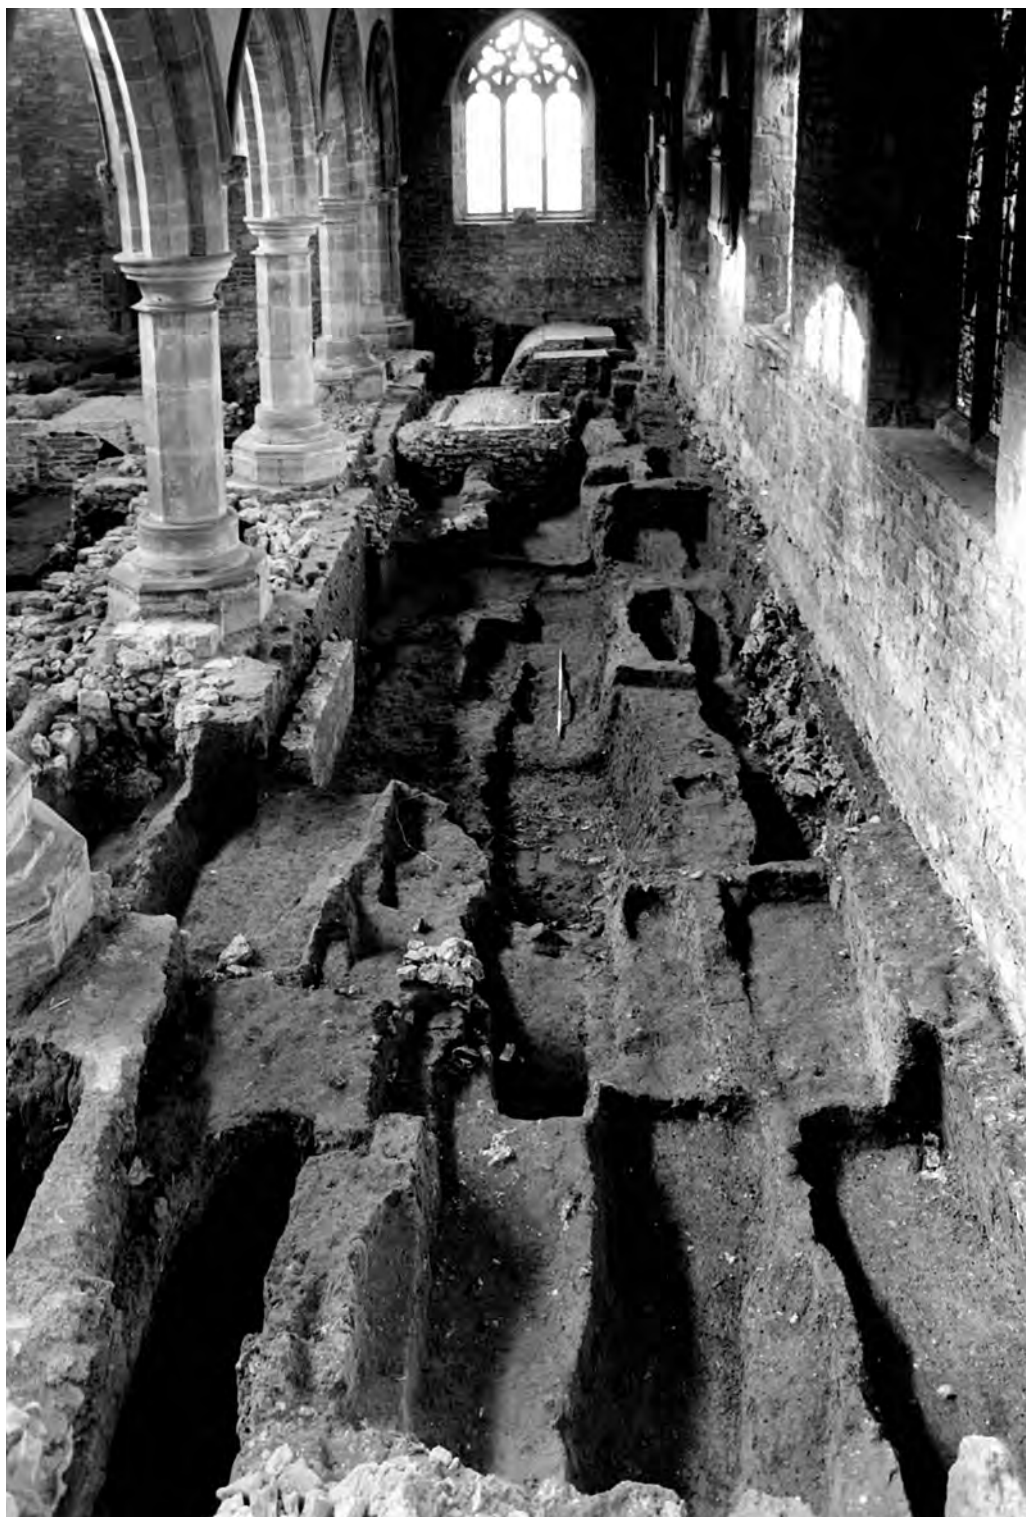
*Fig. 465: North aisle: view west, after excavation, 1980. The foundation for the wall-bench appears on the right. The 2 m ranging pole rests in the base of the robbed foundation trench for the preceding narrow aisle. At the far end are the Scrivener/Tomblason and Branston burial vaults. Photo: Warwick Rodwell*

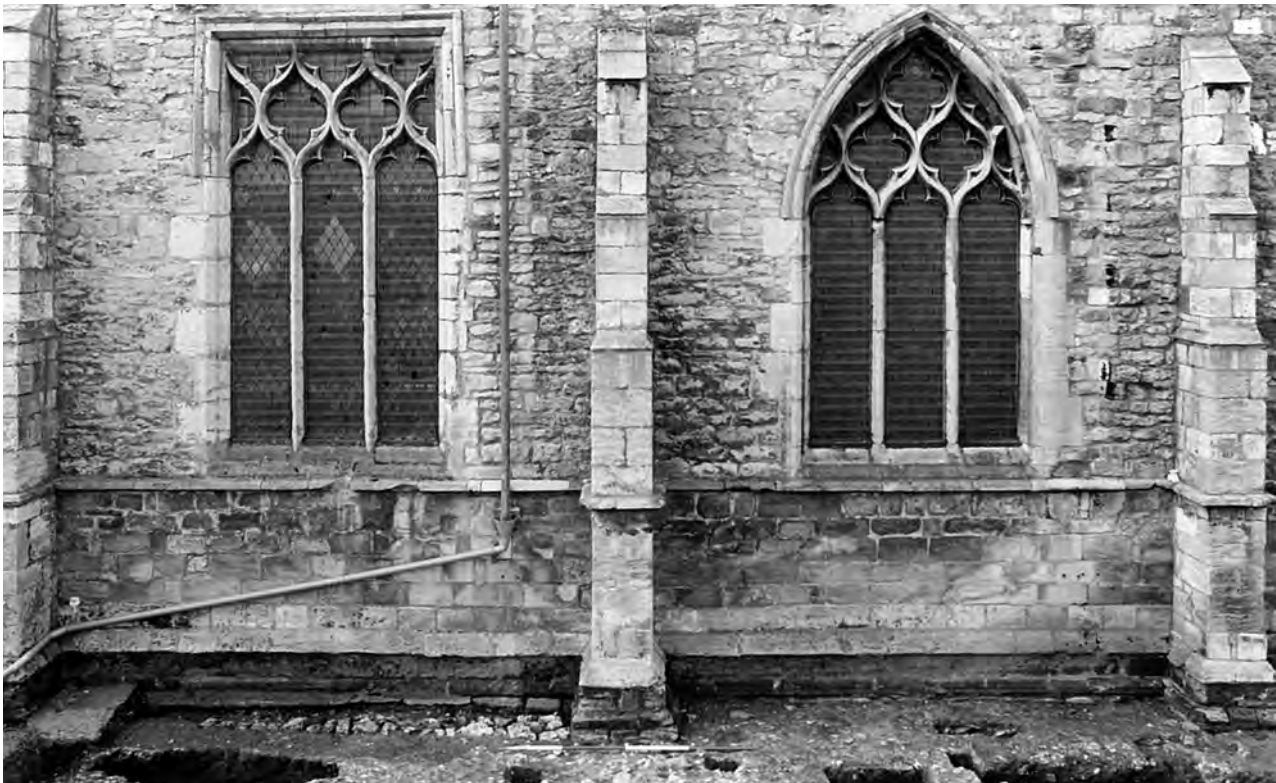
*Fig. 468: North aisle windows, bays 1 and 2. The windows have reticulated tracery, and are alternately square-headed and pointed. Contemporary construction level for the aisle has been exposed by excavation externally, 1982. Scale of 2 m. Photo: Warwick Rodwell*

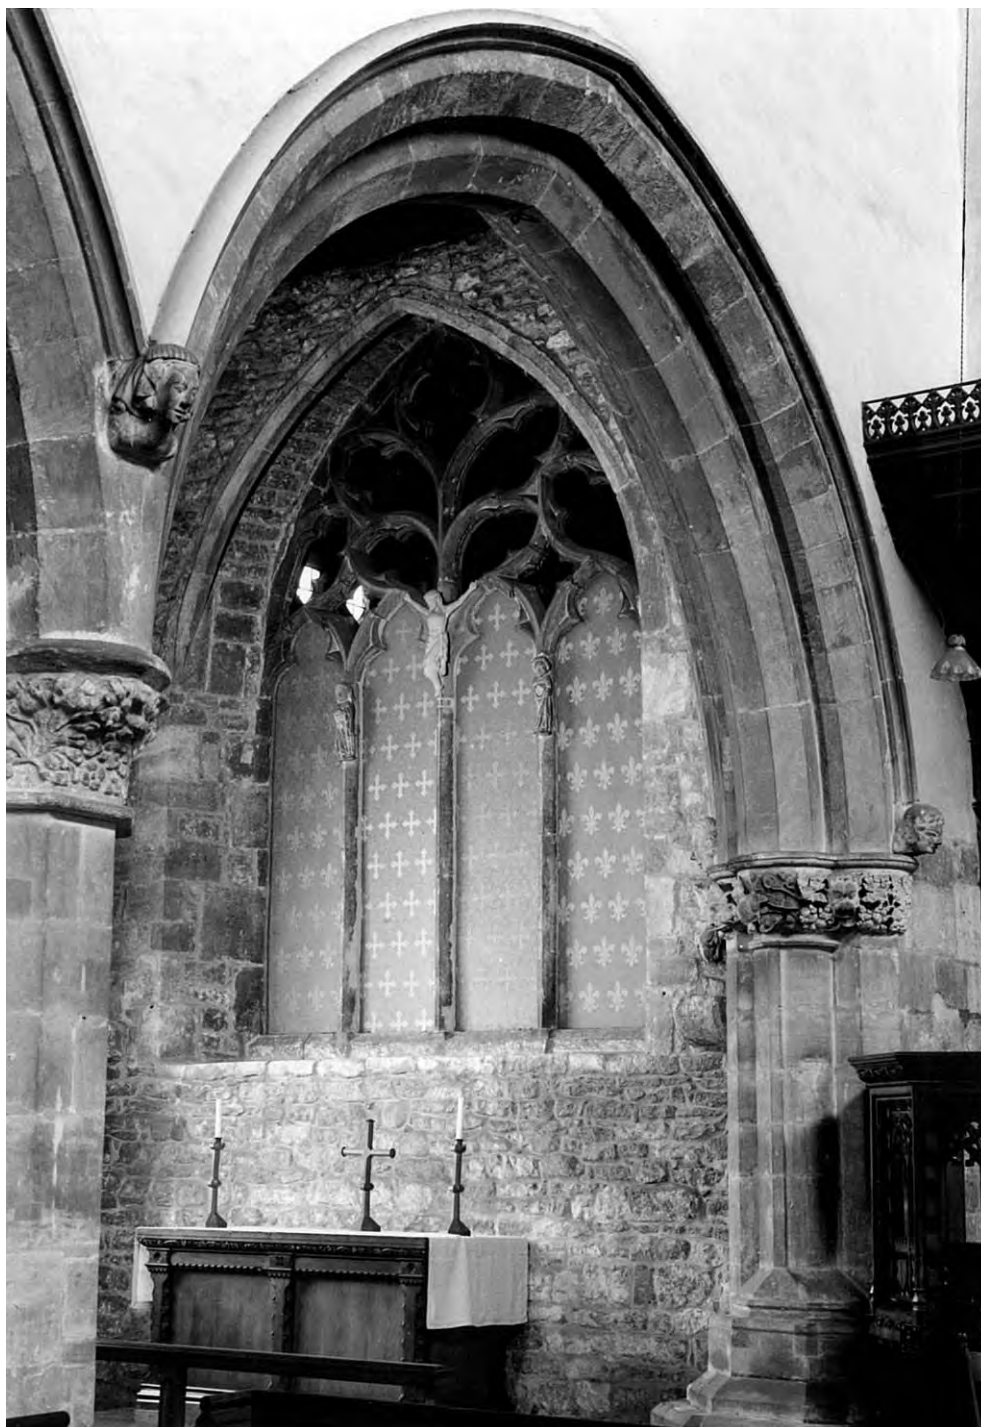
*Fig. 469: North aisle: east window, mid-1960s. The glazing was removed in 1898, the figure of Christ was renewed in c. 1924, and the painted boards were inserted in the main lights soon after. Photo: David Lee Photography*

The east and west windows in the aisle have flowing tracery of good quality, but the two are not closely related (Fig. 49, 12 and 13). The four-light east window is of unusual elaboration (Figs. 469 and 470). It has trefoil-headed lights arranged in two pairs under ogival sub-arches with central quatrefoils. Rising from the central mullion is a flowing tracery pattern having the appearance of a five-lobed leaf. Its components are a quatrefoil and four *mouchettes*. Thus far, the design is unexceptional, but is elaborated in a unique fashion by the *en suite* incorporation of a rood composition. The three figures are sculpted on the mullions: St Mary the Virgin on the north and St John on the south occupy the uppermost stones of their respective mullions (Figs. 471, 473 and 474). The figure of the crucified Christ is sculpted on the central springer-mullion, the beginnings of the ogival tracery to either side notionally forming the arms of the cross. The window was clearly a representation in stone of the Tree of the Cross (p. 489).

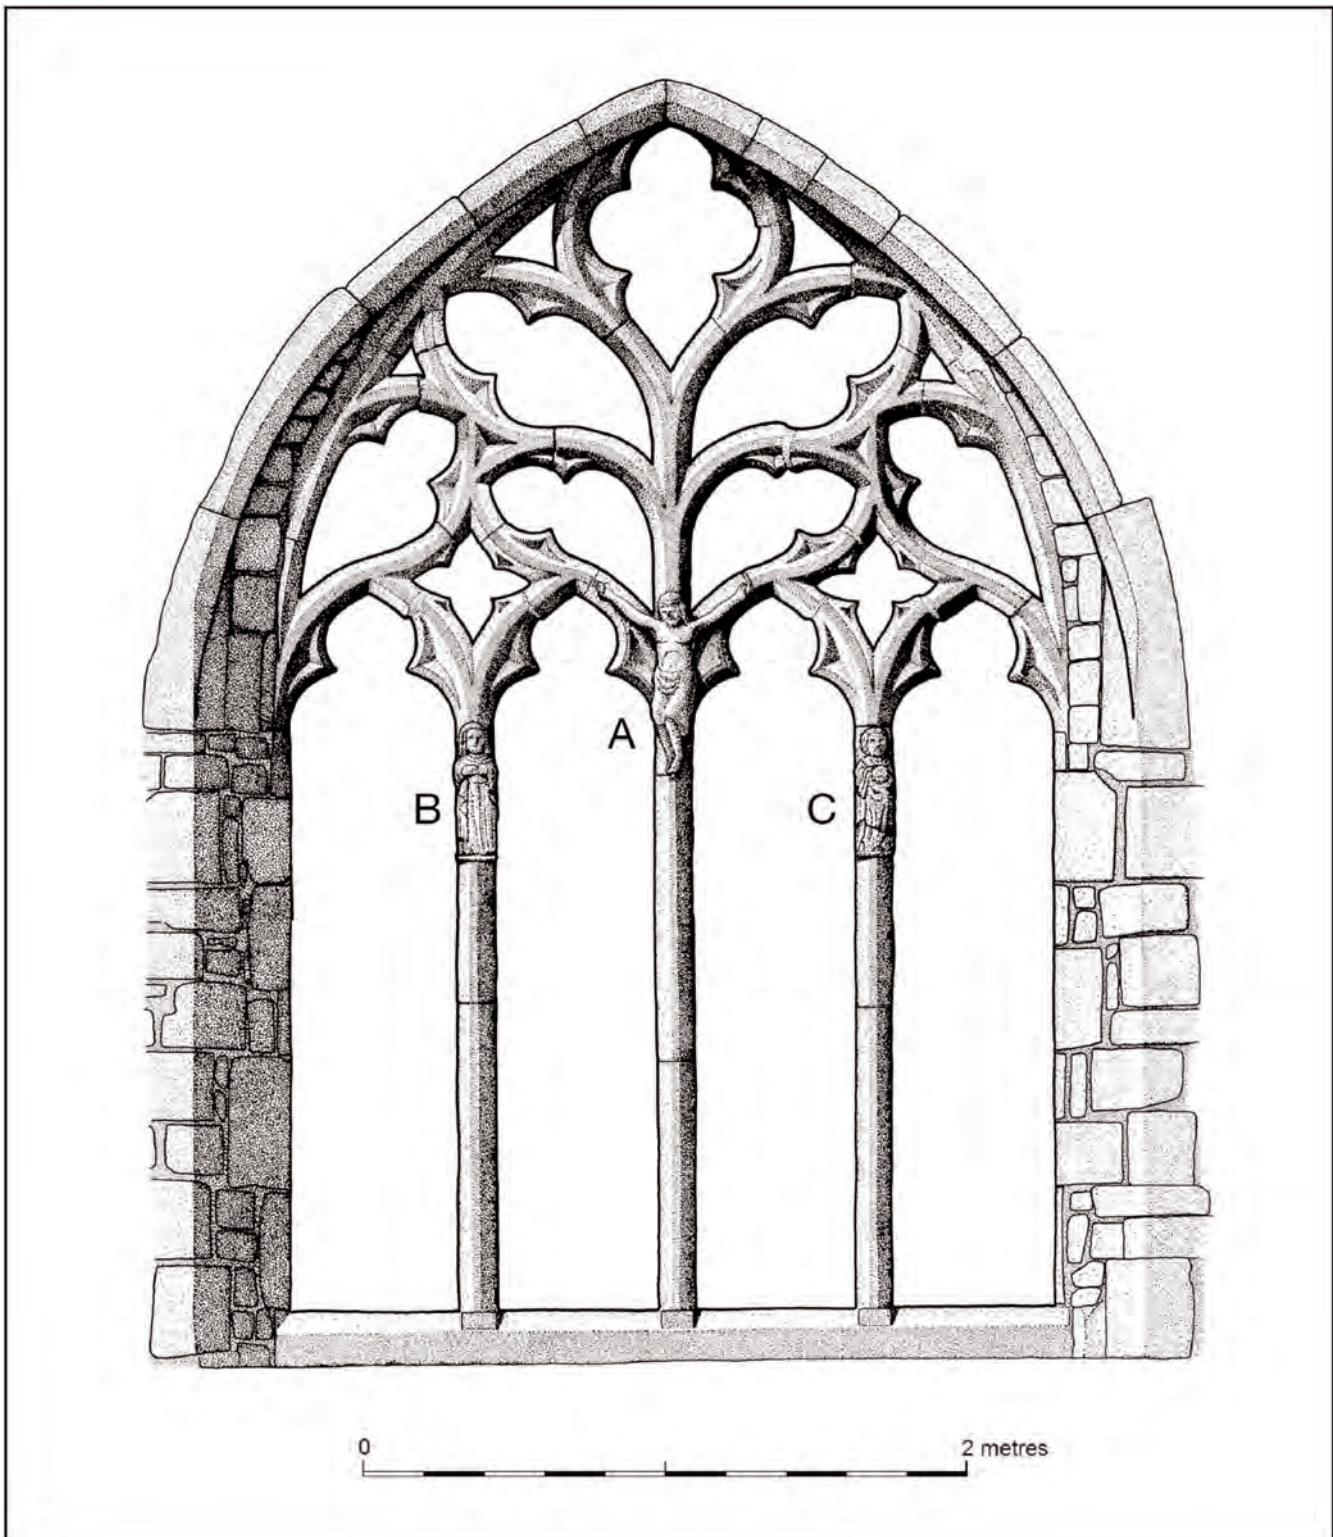
Fig. 470: North aisle: east window. Internal elevation of the masonry. A, Christ (replacement figure); B, St Mary the Virgin; C, St John. Scale 1:25. Drawing: Simon Hayfield

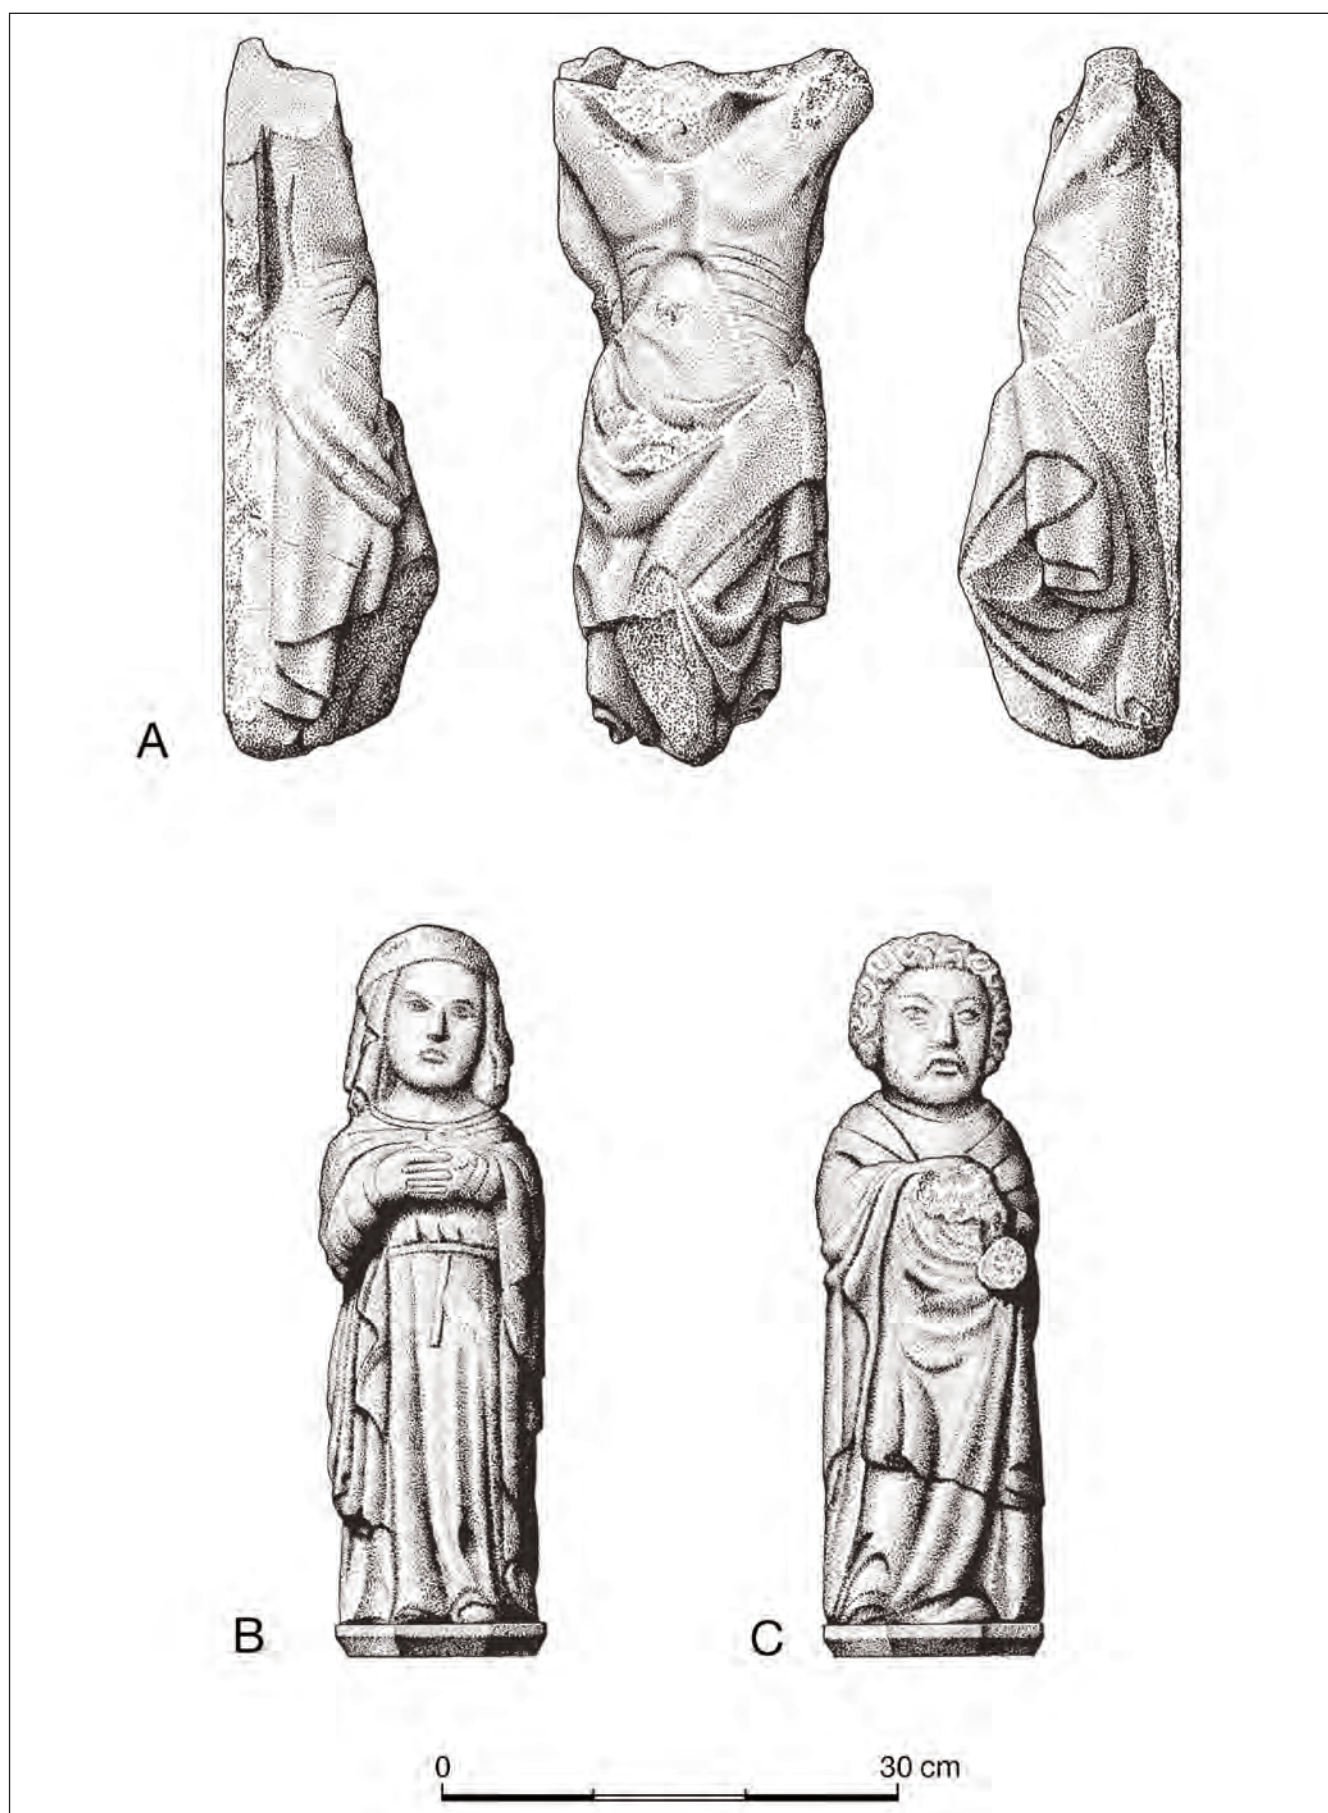
Fig. 471: North aisle: east window. A, Torso of the mutilated medieval figure of Christ (now ex situ); B, Mullion figure of St Mary the Virgin; C, Mullion figure of St John. Scale 1:5. Drawing: Simon Hayfield

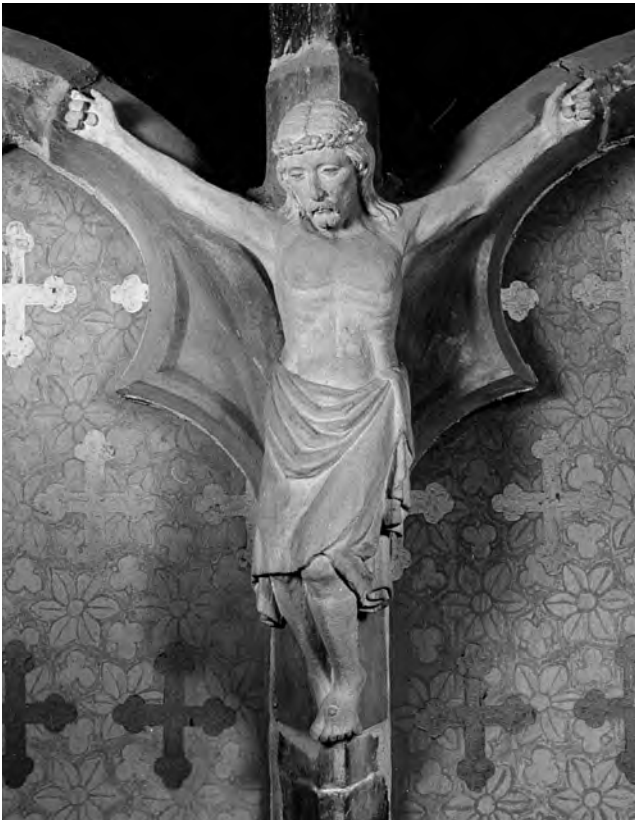
*Fig. 472: North aisle: east window. Replacement limestone figure of Christ (c. 1924) on the central mullion (sculpture no. 33), 1982. Photo: Warwick Rodwell*

mullion in c. 1924, and the stumps of tracery bearing the remains of the arms to either side were hacked away. A newly carved section of tracery bearing the figure, conjecturally completed, was then fitted (Fig. 472). The old fragment of torso was mounted as an exhibit on the southern flank of the window (Pl. 48).<sup>8</sup> Pockets in the mullions, jambs and sill show that the

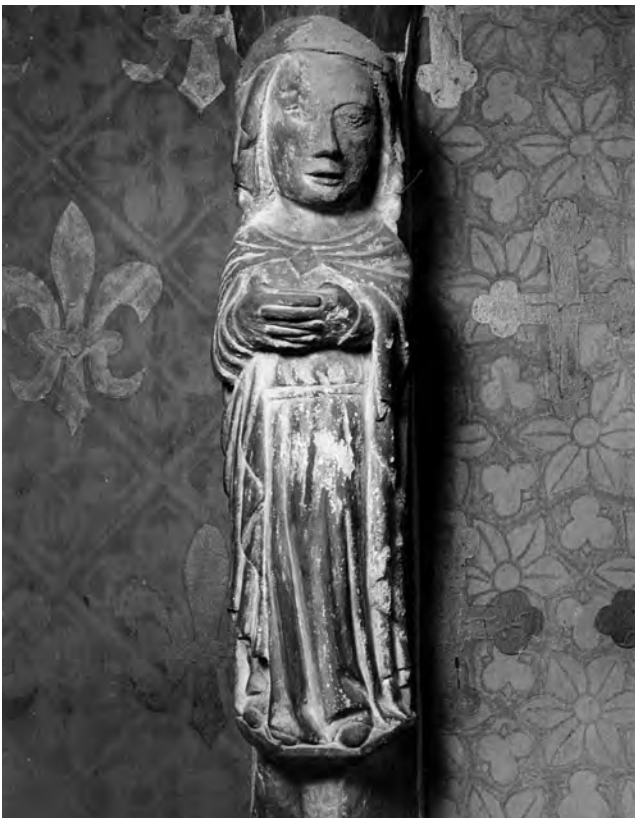
*Fig. 473: North aisle: east window. Limestone figure of St Mary the Virgin on the northern mullion (sculpture no. 32). Photo: Warwick Rodwell*

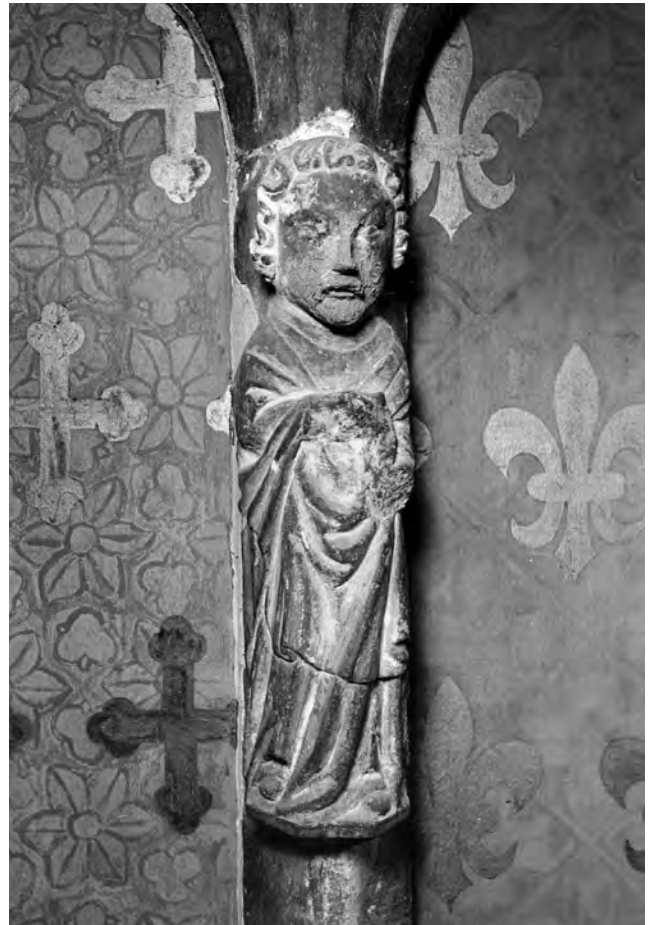
*Fig. 474: North aisle: east window. Limestone figure of St John on the southern mullion (sculpture no. 34). Photo: Warwick Rodwell*

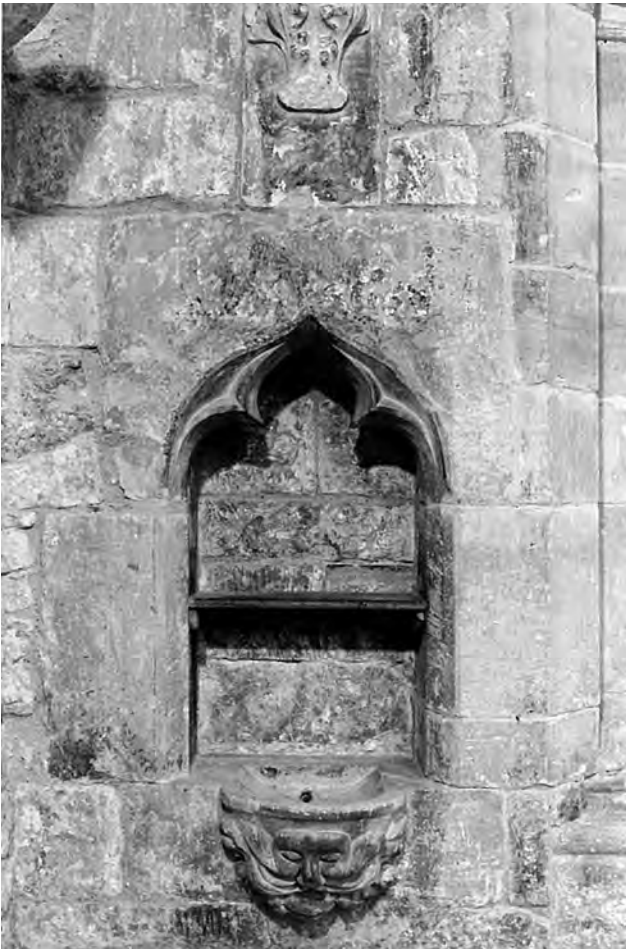
*Fig. 476: North aisle. Mutilated piscina in the south-east corner, with sculpture nos. 30 and 31. Photo: Warwick Rodwell*

bearing the damaged remains of a poppy-head finial, which seems to have been detached from the hood-moulding (sculpture no. 31; Fig. 477). The original bowl of the piscina had been hacked off nearly flush with the wall face, but a new projecting section was made and fixed in the 1920s (sculpture no. 30; Fig. 478). It is corbel-like and decorated with a head in the form of a 'green man'. Although the face is new, the lower lip and foliage issuing to either side are original. The basin is internally scalloped.

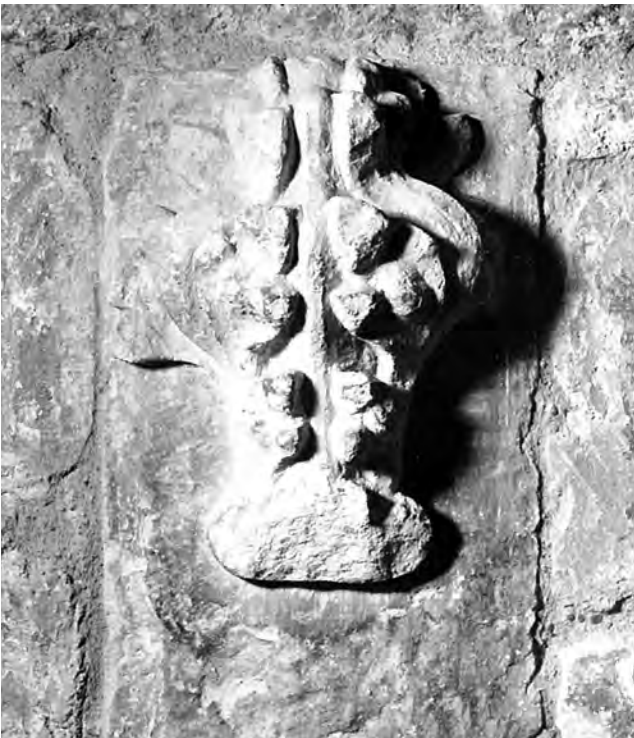
*Fig. 477: North aisle: poppyhead finial of piscina (sculpture no. 31). Photo: Warwick Rodwell*

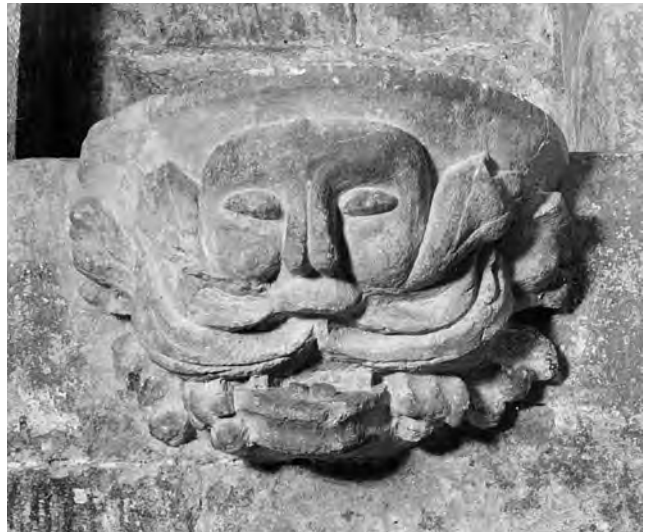
*Fig. 478: North aisle piscina: restored bowl with 'green man' (sculpture no. 30). Photo: Warwick Rodwell*

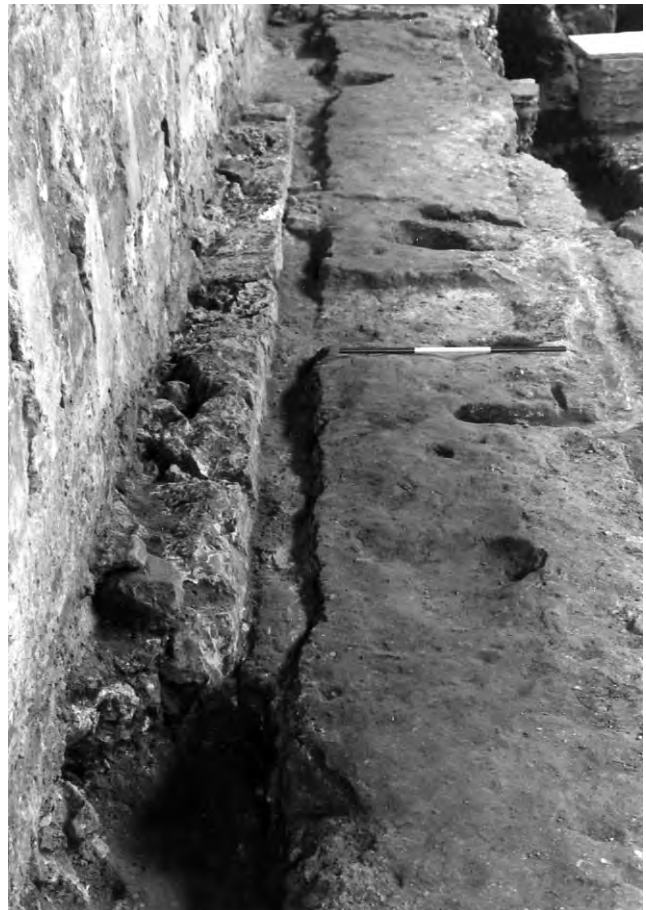
*Fig. 479: North aisle. View east along the surviving remains of the masonry bench adjoining the north wall, 1980. Scale of 75 cm. Photo: Warwick Rodwell*

Finally, the aisle had a stone wall-bench along the north and west sides, the footings of which were found. In part, the lowest ashlar course survived and was abutted by floor layers; there were also scars on the walls resulting from the removal of these benches (Figs. 479 and 480).

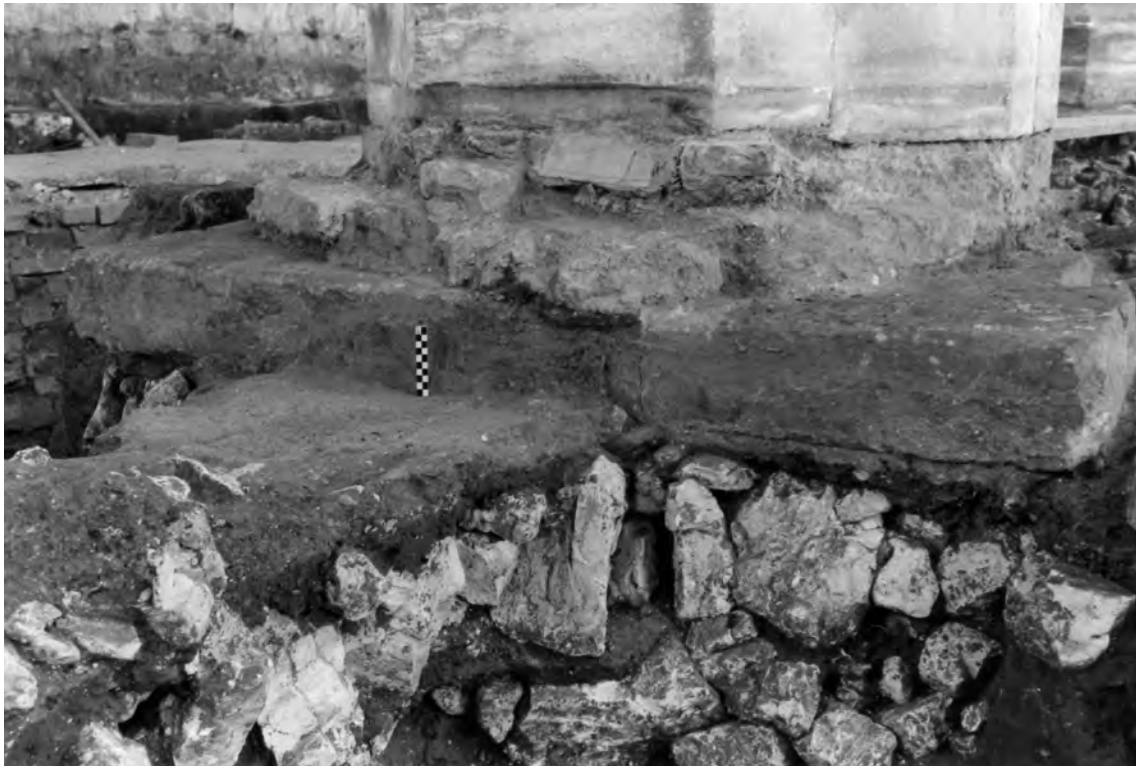
*Fig. 480: North aisle. Lowest ashlar course of the wall bench. View north, 1980. Scale of 2 m. Photo: Warwick Rodwell*

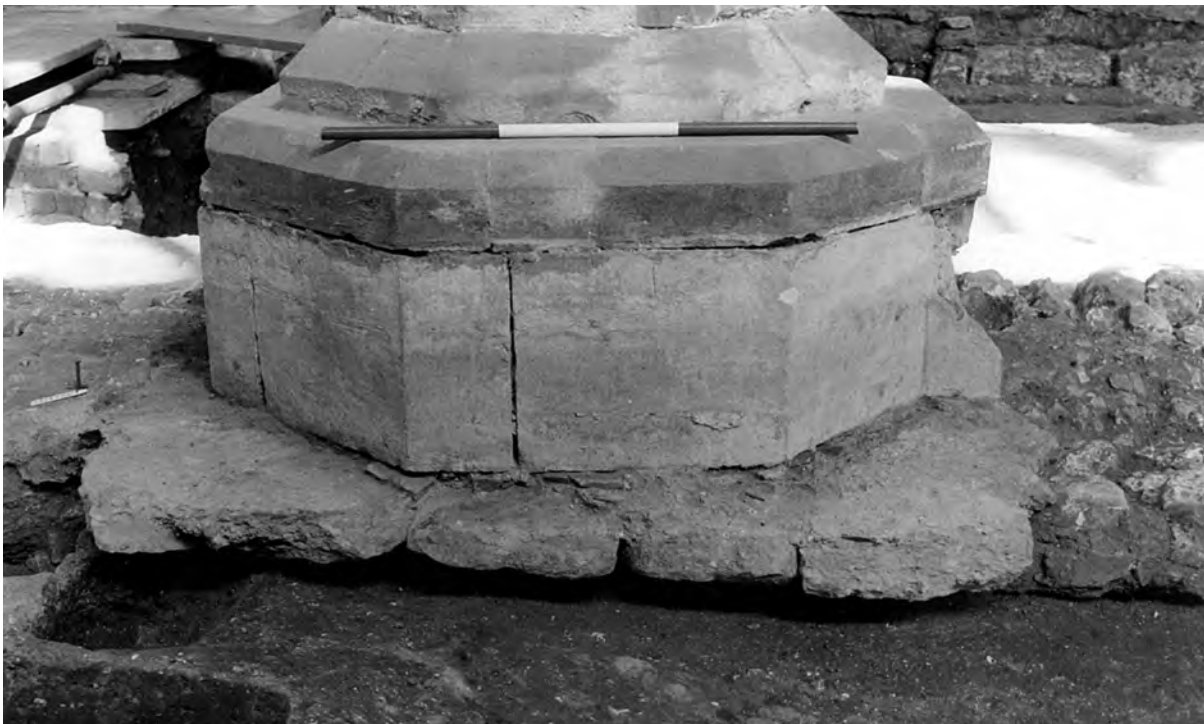
Fig. 482: North arcade. Pier base 4/5 with its shallow footing resting on the Saxo-Norman nave foundation. View north. Scale of 75 cm. Photo: Warwick Rodwell

The piers supporting both arcades were reconstructed using some old materials and some new; in particular, chamfered octagonal plinths were provided under each pier. The Norman nave foundations continued to act as sleeper walls, but the dimensions of the new plinths slightly exceeded their widths. Consequently, foundation pads were laid over the old walls, to provide secure bases for the piers. In the north arcade, these pads comprised flat pieces of rough limestone laid in mortar (Fig. 482). In the south arcade, however, there were two instances where the footings

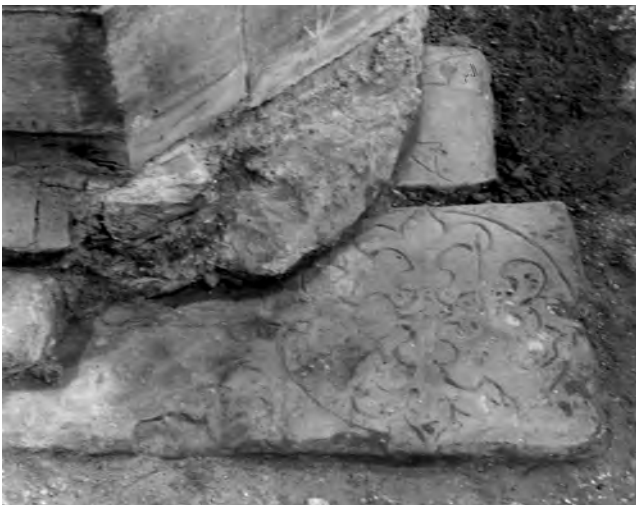
*Fig. 484: South arcade. Pier base 2/3, showing the upper end of a grave-cover (F4199) reused in the footing; beyond is glimpsed the lower end of a second grave-cover (F4198). View west. Photo: Warwick Rodwell*

incorporated thirteenth-century decorated grave-covers: the slabs were laid side by side, transversely over the old foundations (Fig. 483). Excavation revealed most of an incised slab (F4199), and the extreme ends of a second laid alongside it (F4198), projecting from beneath the eastern edge of pier 2/3 (Figs. 484 and 711, nos. 8 and 9). Similarly revealed, beside pier 4/5, was most of another slab (F4197; Figs. 485 and 711, no. 7). That had, however, been laid originally as part of a pier base for the early thirteenth-century arcade (p. 393).

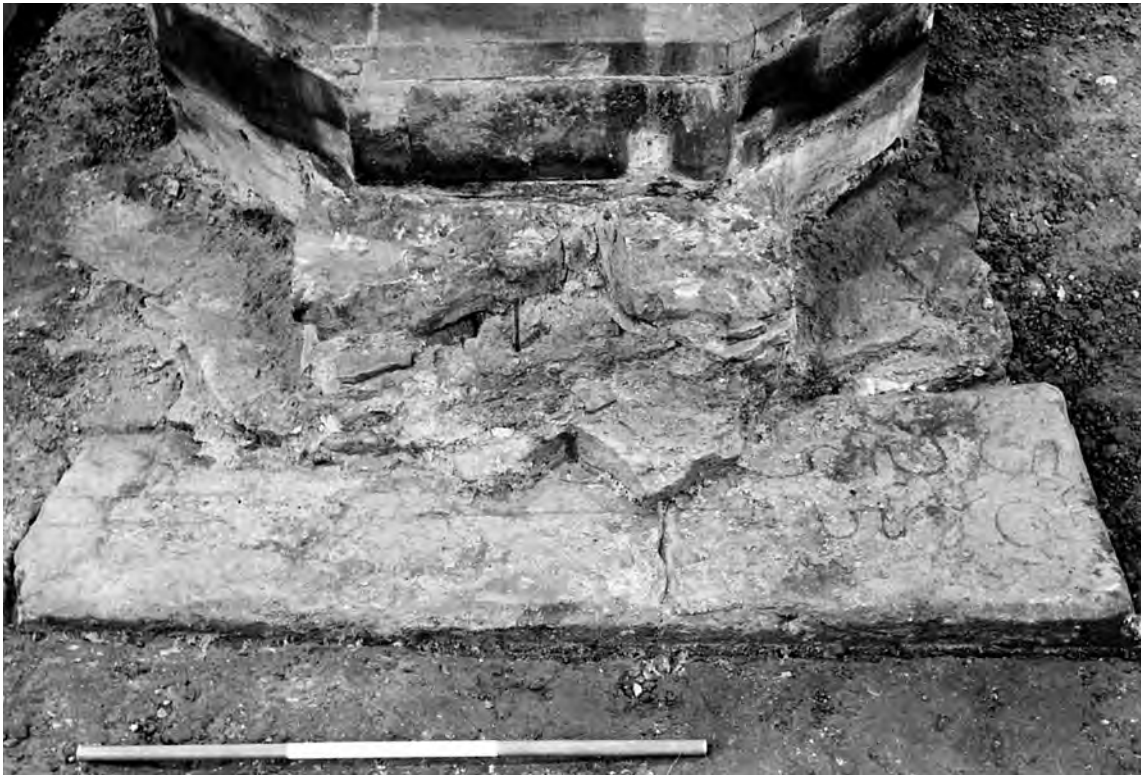
*Fig. 485: South arcade, bay 4. Stub of the destroyed arcade bench adjoining pier 4/5. Note the thirteenth-century decorated grave-cover (F4197) reused as a footing for the pier. View west. Scale of 75 cm. Photo: Warwick Rodwell*

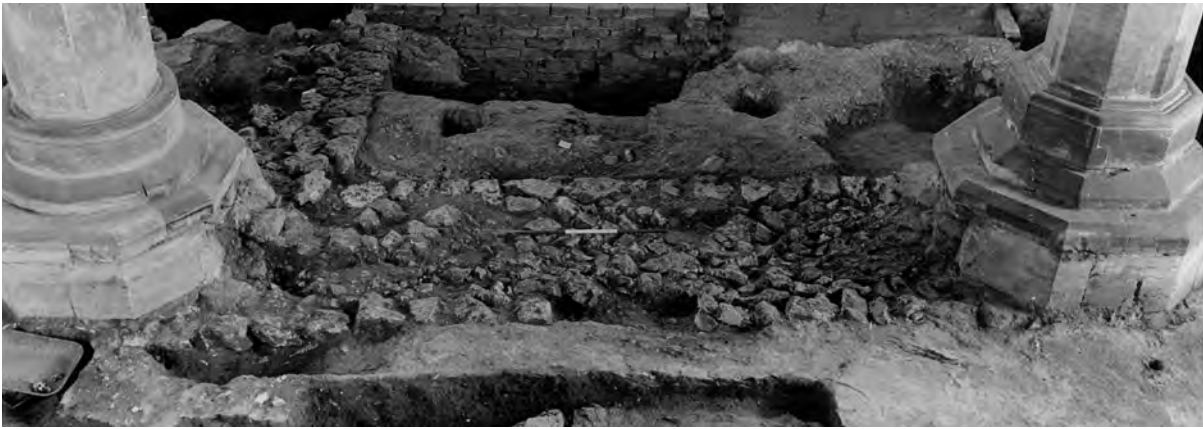
*Fig. 487: North arcade, bay 4. The top of the Norman sleeper-wall upon which an arcade bench had been constructed; the latter now entirely destroyed except for scarring on the faces of the plinths of piers 3/4 and 4/5. View south. Scale of 75 cm. Photo: Warwick Rodwell*

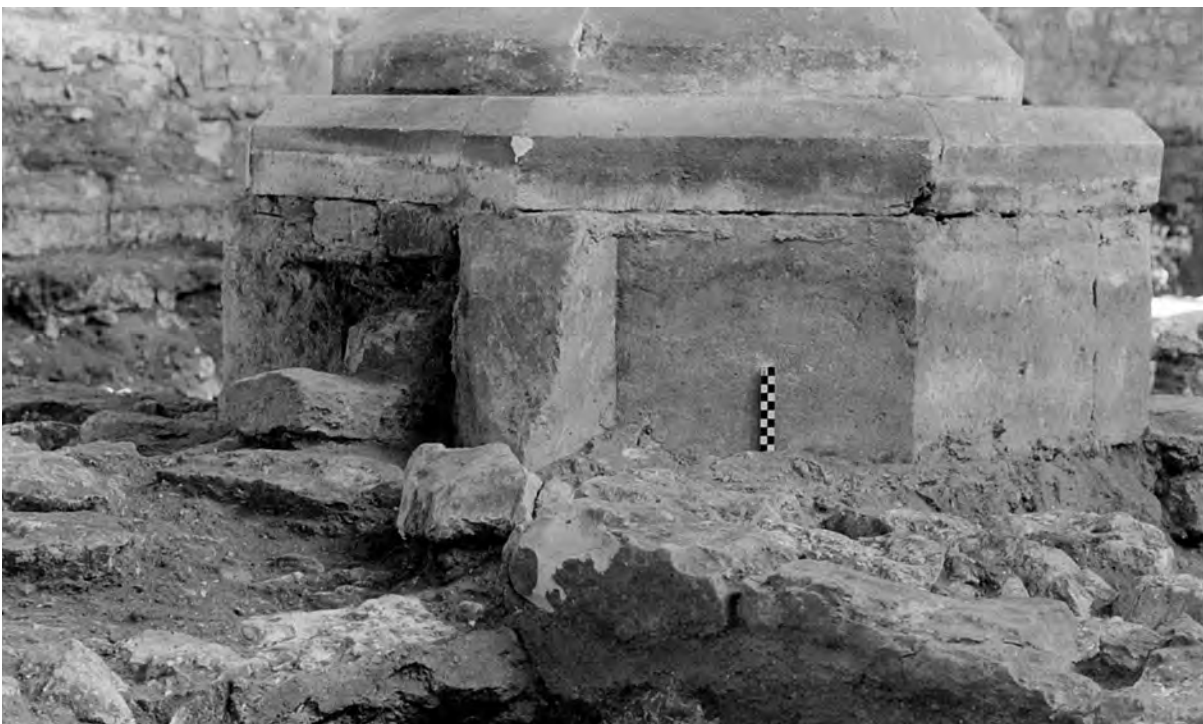
*Fig. 488: North arcade. Stub of broken ashlar indicating where the arcade bench in bay 2 was bonded to the plinth of pier 1/2. View north-east. Scale of 10 cm. Photo: Warwick Rodwell*

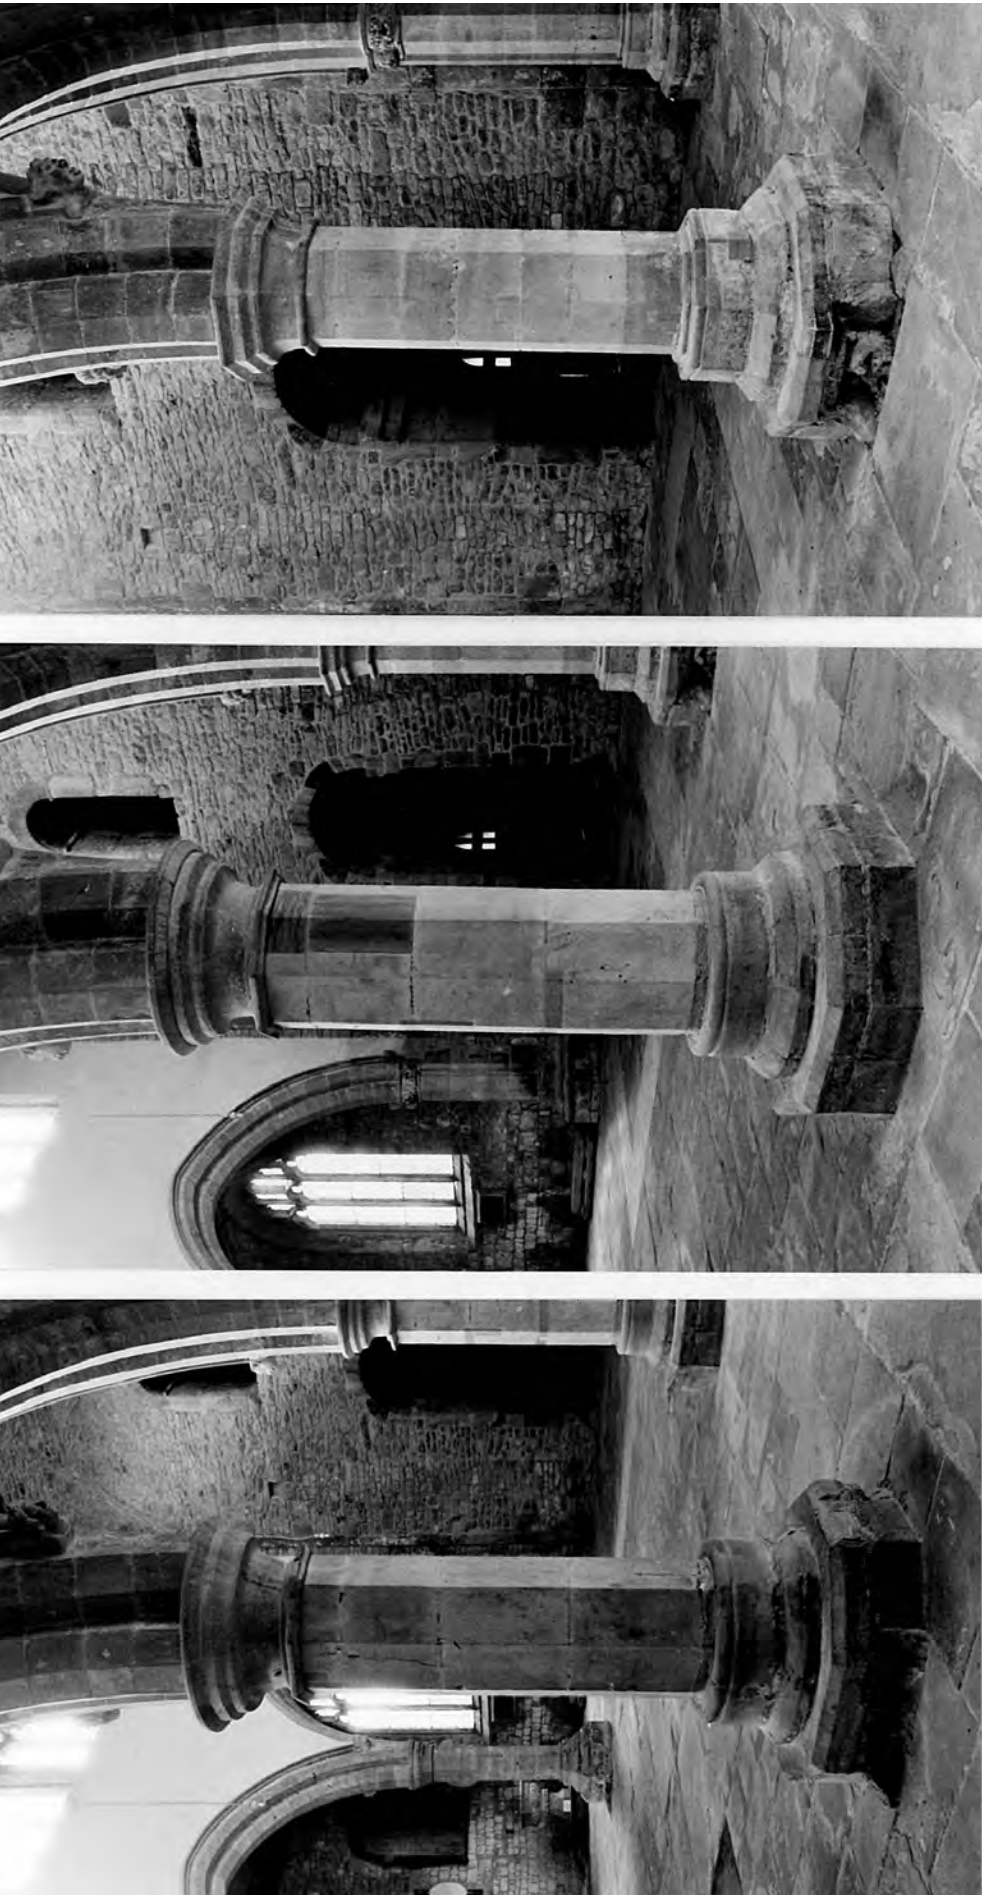
Fig. 489: North arcade piers. A, Bay 2/3; B, Bay 3/4; C, Bay 4/5. Viewed from the north-east, 2005. Photo: Warwick Rodwell

Two of the capitals are circular and have matching bases (on piers 2/3 and 3/4), and one capital is octagonal (pier 4/5) with the same moulding profile; these were clearly derived from a late twelfth-century arcade with alternating circular and octagonal piers (p. 384; Fig. 489). The capital of pier 1/2 has also been recycled and, in this instance, reworked as well (Fig. 490). Apart from the two circular bases, the remainder are

**Pier, bay 2/3** (Fig. 489, A)

The octagonal shaft, which leans slightly to the north, is composed of tall sections which were inserted into an existing pier in the fifteenth century. Most likely, the circular twelfth-century shaft was still in use down to that time, but was replaced with an octagonal one for

visual uniformity (p. 468). The circular capital has its own integral neck-ring, and there is a second ring of octagonal plan immediately beneath it. This is formed on a separate slip of stone, and sits very uneasily with the capital. The deep sections of shaft are each cut from single blocks of stone.<sup>20</sup> The base with its heavy arris roll and the chamfered sub-base are both circular and date from the late twelfth century. They too were not designed to be surmounted by an octagonal shaft. The capital, abacus and hood-moulding of the arch are all damaged and have been repaired; this was doubtless caused by the attachment of the three-decker pulpit to this pier before 1806 (p. 502).

#### **Pier, bay 3/4 (Fig. 489, B)**

The shaft, capital and base are all similar to the last, and the pier also leans towards the north. Again, the shaft was replaced in the fifteenth century. In both piers, the tall sections of shaft carry four masons' marks that are not found elsewhere on fourteenth-century masonry, but are prolific on work of the following century (Fig. 825).
