# ST PETER'S

## Barton-upon-Humber, Lincolnshire

*A Parish Church and its Community*

HISTORY, ARCHAEOLOGY AND ARCHITECTURE

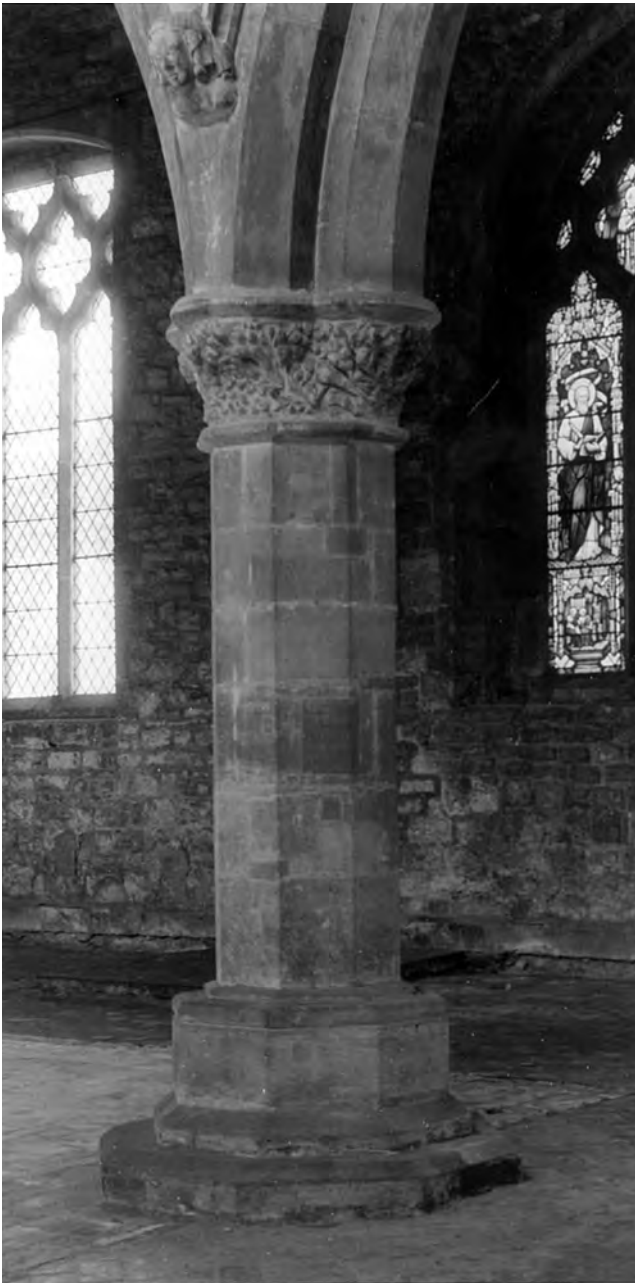
*Fig. 490: North arcade pier, bay 1/2. Viewed from the south-east, 1979. Note the Victorian brick floor which conceals the lower part of the plinth. Photo: Warwick Rodwell*

Two of the capitals are circular and have matching bases (on piers 2/3 and 3/4), and one capital is octagonal (pier 4/5) with the same moulding profile; these were clearly derived from a late twelfth-century arcade with alternating circular and octagonal piers (p. 384; Fig. 489). The capital of pier 1/2 has also been recycled and, in this instance, reworked as well (Fig. 490). Apart from the two circular bases, the remainder are

**Pier, bay 1/2** (Fig. 490)

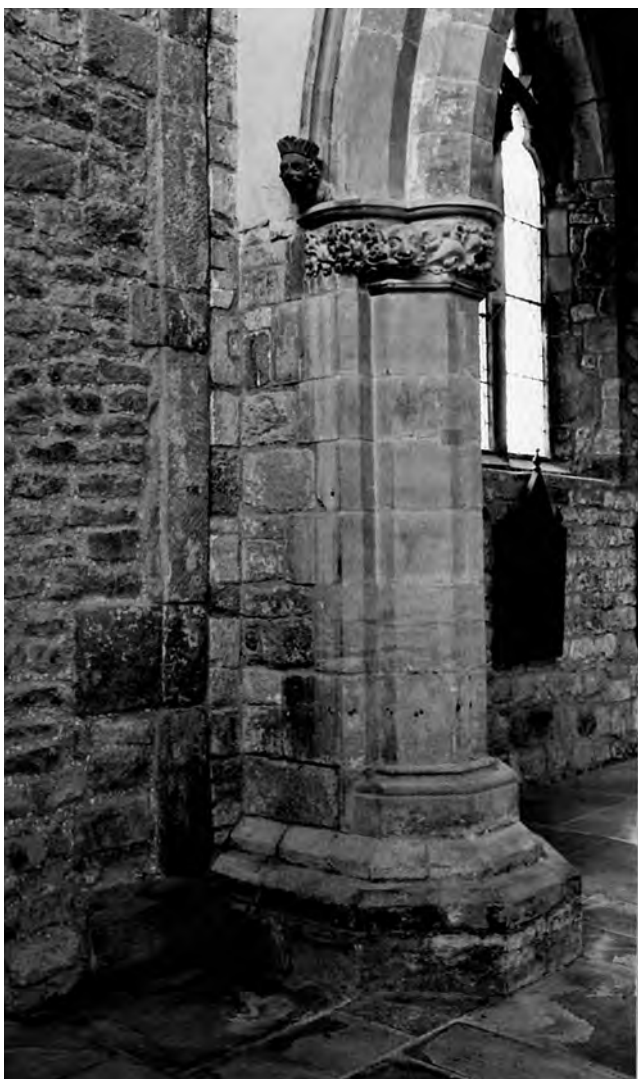
*Fig. 492: North arcade. West respond, from the south-east, showing also the abutment of the arcade to the long-and-short quoin of the late Saxon tower. Photo: Warwick Rodwell*

#### **West respond (Fig. 492)**

The respond is chamfered and carries an attached semi-octagonal shaft, coursed with the adjoining masonry. One mason's mark (a pentacle) occurs ten times on the shaft, another twice (six-armed cross: Fig. 825).<sup>21</sup> The impost is carved with knobbly foliage and 'green men' (sculpture no. 25). The trefoil-plan abacus

is separate from the impost, but the neck-ring is integral; both are ogivally beaked rolls. The base is semi-octagonal and finished with a cavetto and roll moulding.

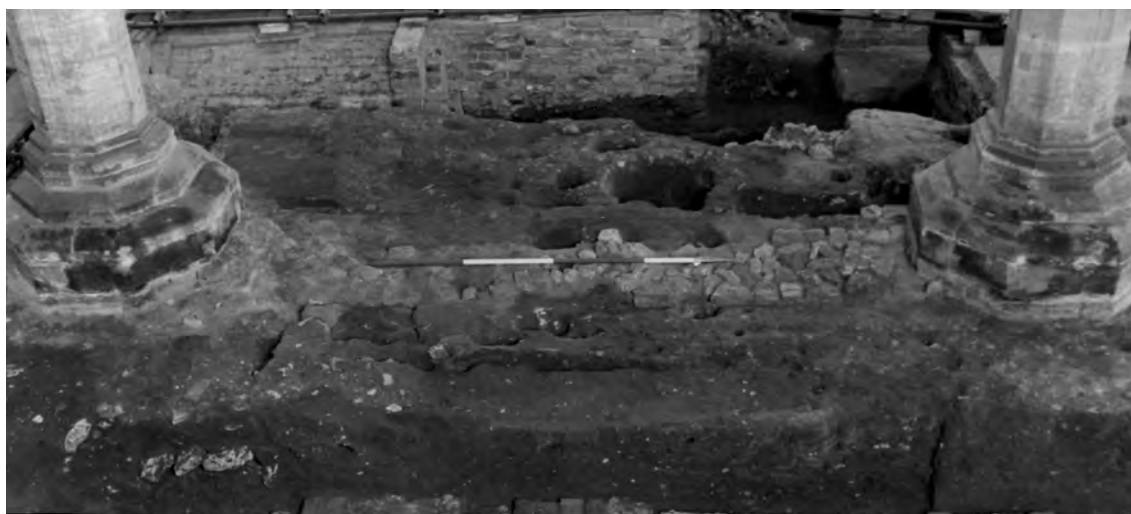
*Fig. 493: South arcade. Remains of the rubble foundation of the arcade bench in bay 4. View north. Scale of 2 m. Photo: Warwick Rodwell*

The bay pitch is 4.9 m (16 ft) and, as with the north arcade, stone benches were incorporated in bays 2 and 4, but these too have been destroyed. In places, the last course of foundation rubble associated with the bench remained on top of the Norman sleeper wall (Fig. 493), and tell-tale scarring occurs on the sides of the plinths. However, the chamfered tops of the latter have been modified, as in the north arcade, to give the appearance of being complete octagons (*e.g.* Fig. 494).

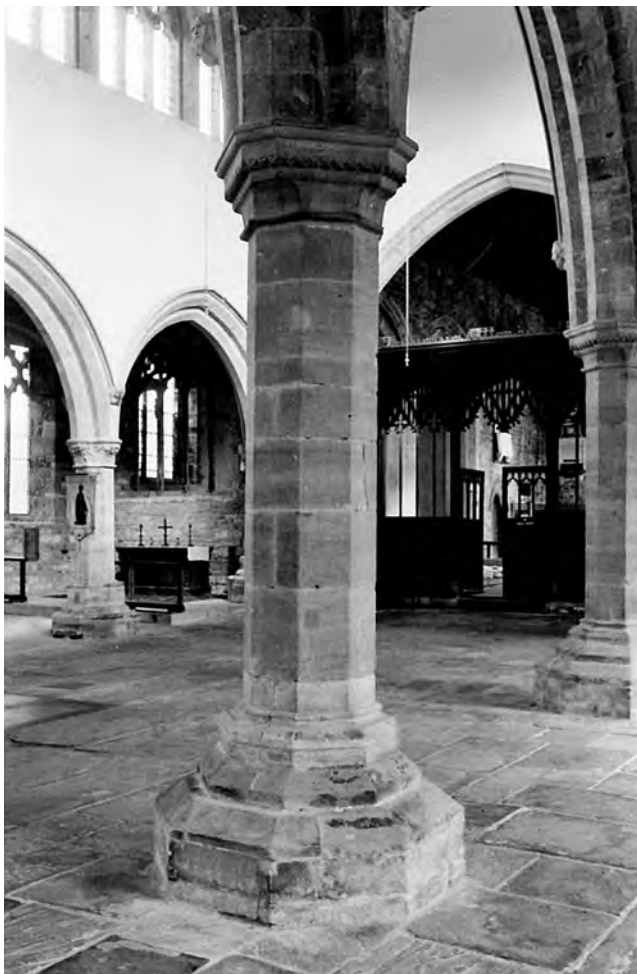
*Fig. 494: South arcade. Pier 3/4 from the south-west, 2005. Photo: Warwick Rodwell*

#### **Pier, bay 3/4 (Fig. 494)**

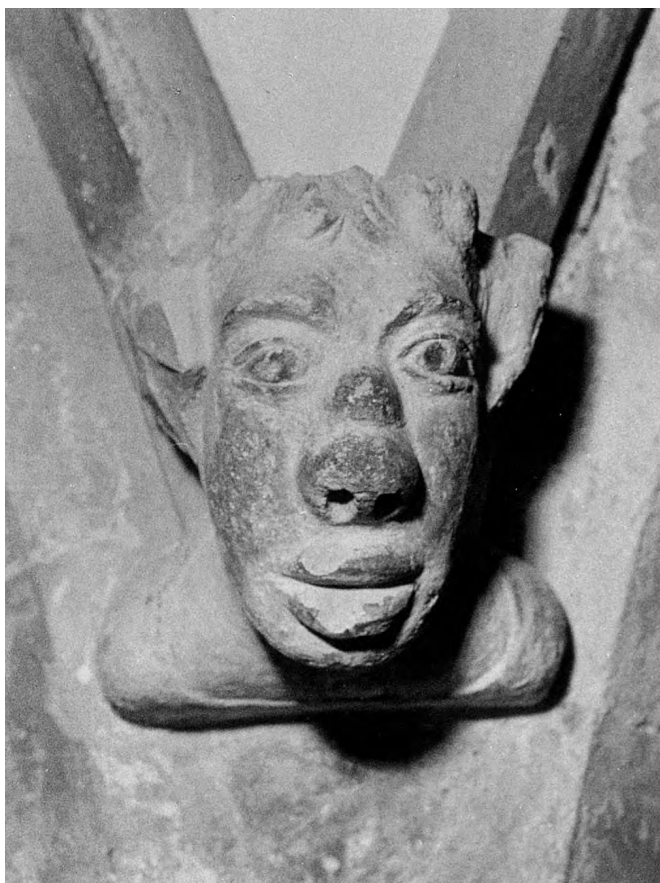
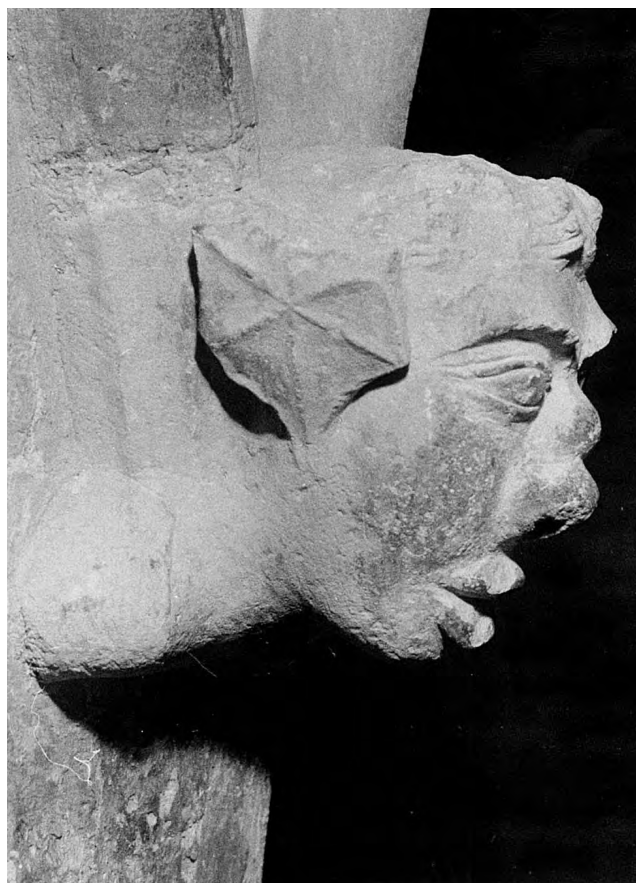
*Fig. 499: North aisle, arcade. Label-stop no. 2. Photos: Warwick Rodwell*

2. Head of a negroid male (Fig. 499).

The face is clearly negroid, with a bulbous nose, pronounced brow-ridges and thick lips. The head has, however, been turned into a grotesque by adding angular ears, somewhat akin to bats' wings. The head was finely finished, but the top is rough and unfinished. The tufts of hair on the forehead are partly damaged, and there is an indication of the neck-line of a garment.

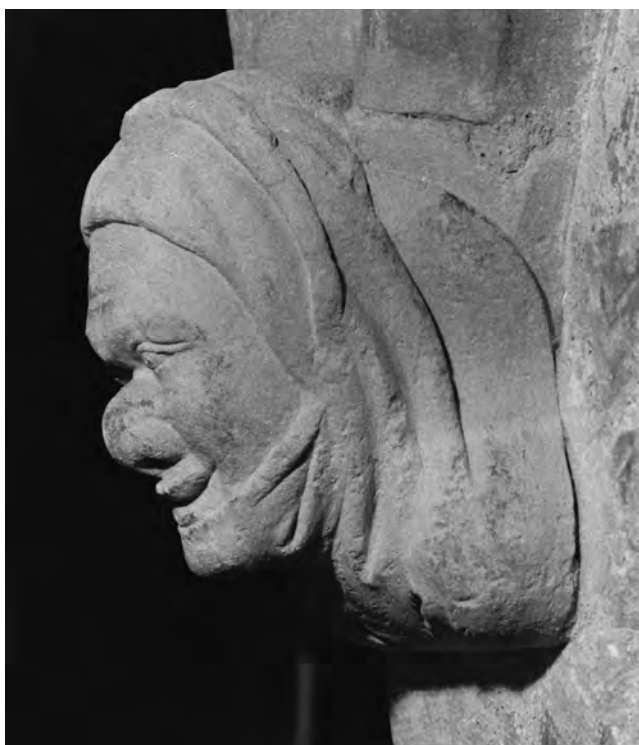
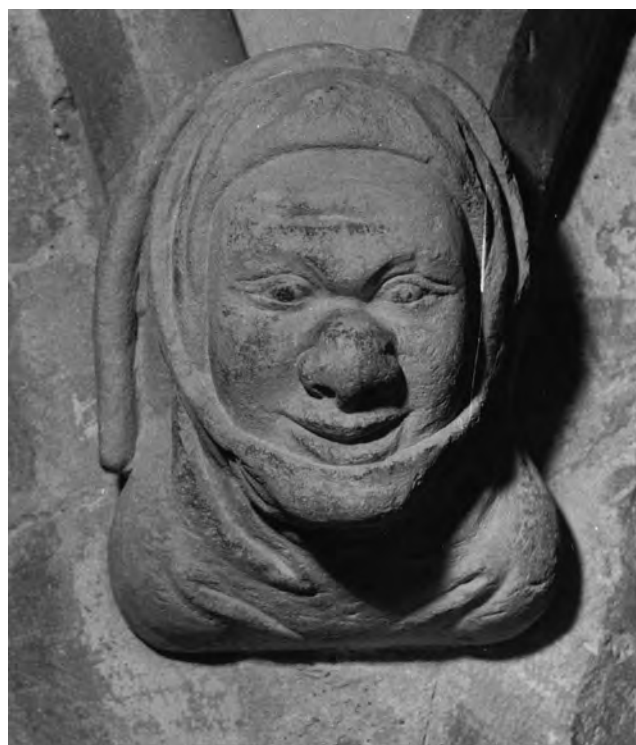
*Fig. 500: North aisle, arcade. Label-stop no. 3. Photos: Warwick Rodwell*

3. Head of a ?negroid lady (Fig. 500).

This figure has a furrowed brow and bulbous nose, but the lips are not pronounced (*cf.* no. 2). She wears a garment wrapped around her head and under the chin, and there is a V-shaped neck-line to her dress. Slight traces remain of a rasped finish, presumably associated with Victorian scraping. The irises of the eyes are painted purplish-black, the nose dark grey; again, this may be original colouring. Elsewhere, are remains of yellow ochre, over white limewash.

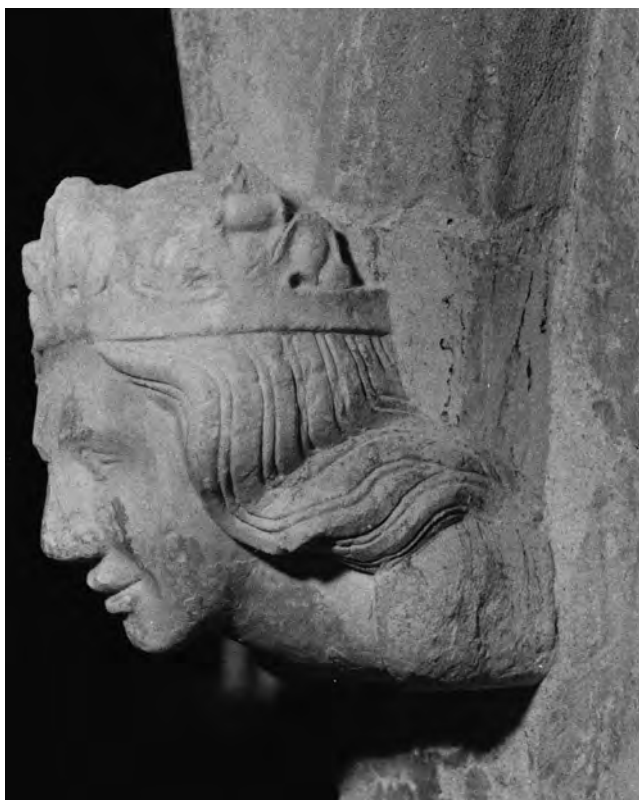
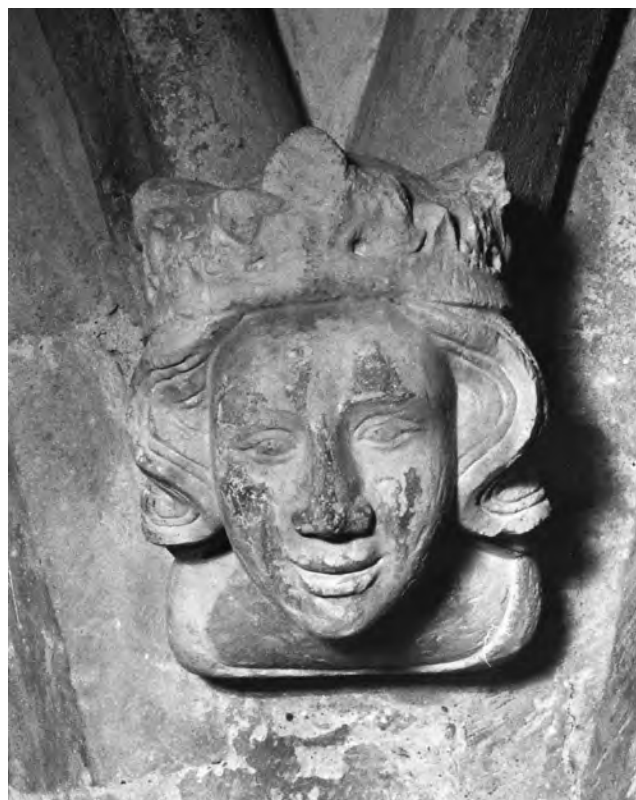
*Fig. 501: North aisle, arcade. Label-stop no. 4. Photos: Warwick Rodwell*

4. Head of a prince (Fig. 501).

Crowned, with long wavy hair and a low-necked gown. Delicately executed and in fine condition. The trefoil points of the crown are in the form of knobbly foliage. A fine rasp has been used on the plainer parts of the

bust, particularly the neck. The chin and neck have a polished appearance and there are hints of a thin application of a terracotta-coloured pigment, probably original. A speck of pinkish-red paint was noted on the dexter side of the neck, at the junction with the hair-line; much yellow ochre limewash is in the hair.

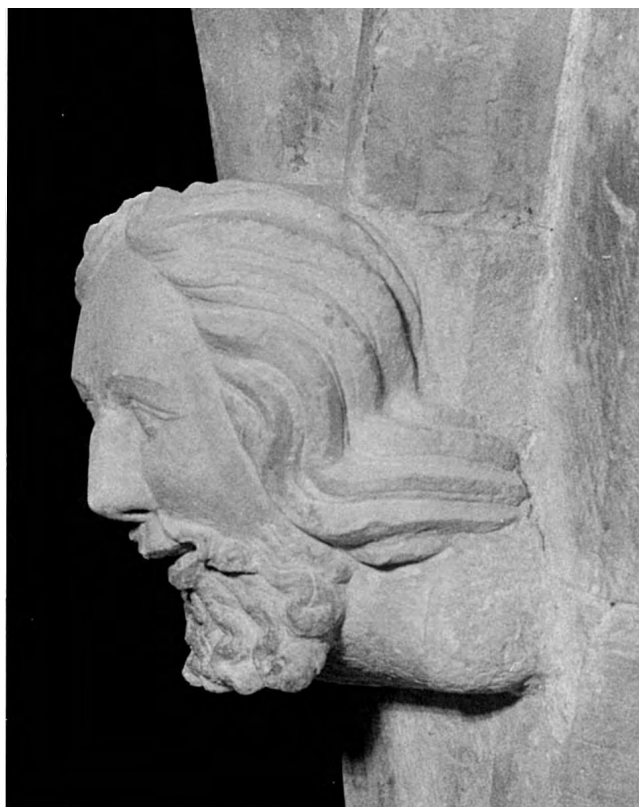
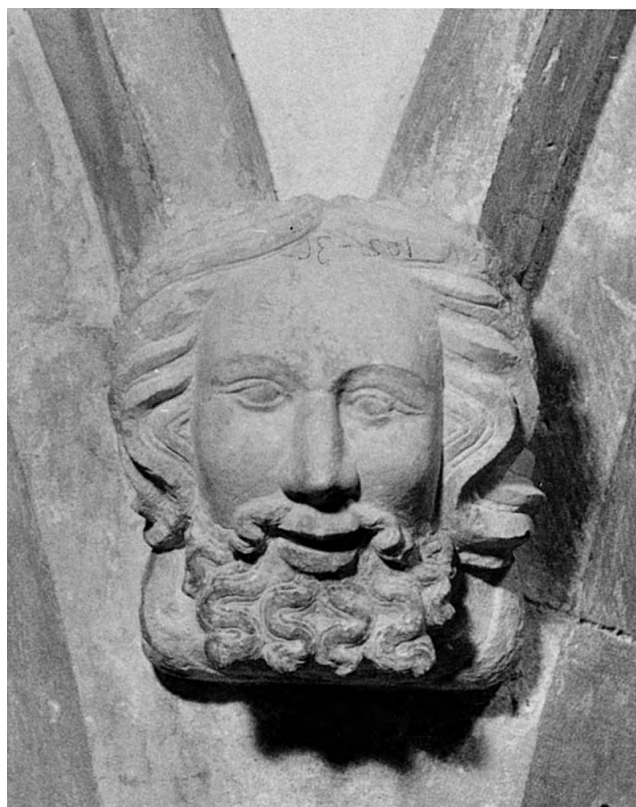
*Fig. 502: North aisle, arcade. Label-stop no. 5. Photos: Warwick Rodwell*

5. Head of a young male (Fig. 502).

A powerful head with a beard, moustache and wavy hair; the lips are parted to show the teeth. He wears a low-necked garment, similar to no. 4 (*cf.* also no. 11). Faint traces of rasping and slight hints of a smooth terracotta-coloured finish. The irises are painted purplish-black<sup>30</sup> and there is much white and yellow ochre limewash over the neck and shoulders.

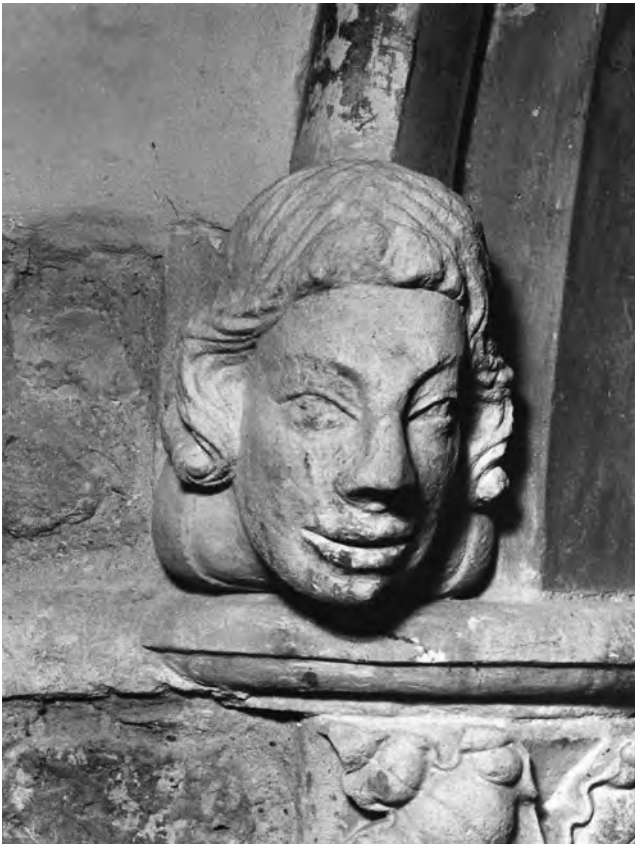
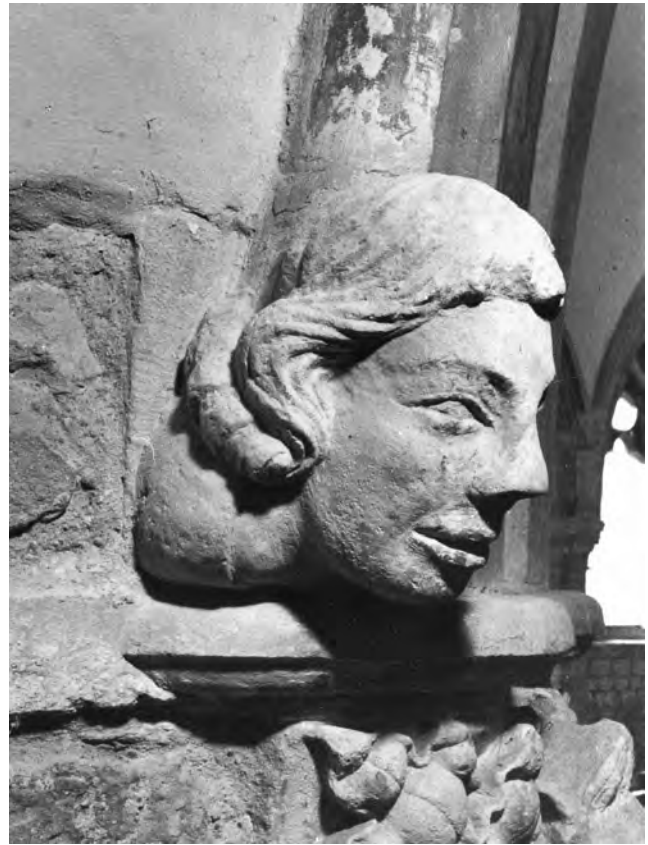
*Fig. 503: North aisle, arcade. Label-stop no. 6. Photos: Warwick Rodwell*

6. Head of a youth (Fig. 503).

This has arched eyebrows and wavy hair. The head is turned slightly to sinister, reflecting its position at the end of the arcade. The neck-line of a garment is indicated. Extensive use has been made of a rasp, especially under the chin, and the nose has been renewed in grey cement. The dexter eye has had the iris sharply outlined in black, the sinister eye less clearly so. Tinges of pinkish-buff colour in the hair appear to be late lime-washing, which is also found on the adjoining hood-moulding.

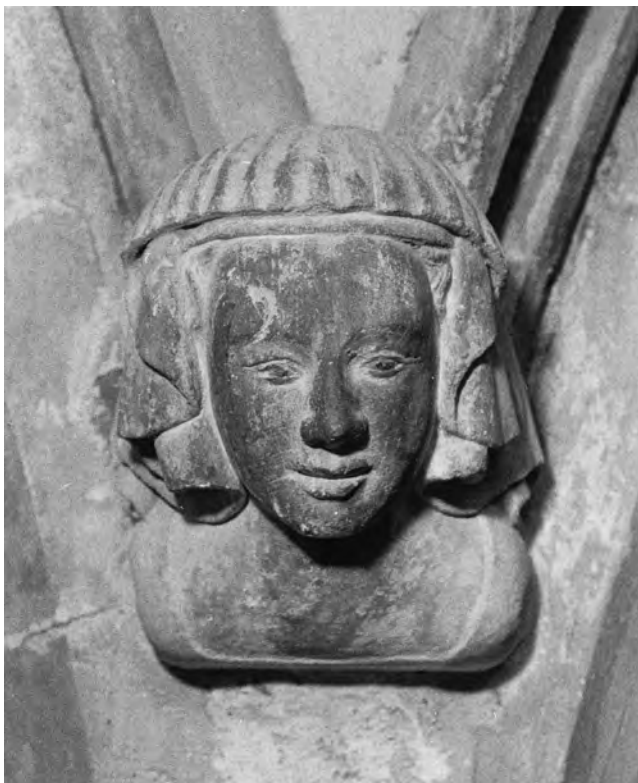
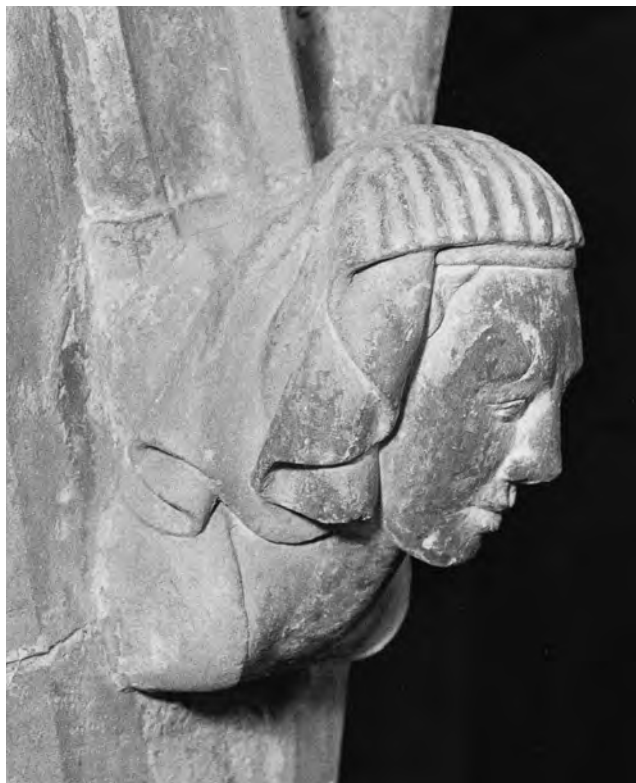
*Fig. 505: Nave, north arcade. Label-stop no. 8. Photos: Warwick Rodwell*

8. Head of a lady (Fig. 505).

Wearing a headdress; finely executed features; low neckline to her garment. The eyes appear to have had the

irises blackened, and there is crimson paint in both nostrils; also remnants of limewash. Bright red paint occurs on the adjacent arches and hood-mouldings of bays 1 and 2.

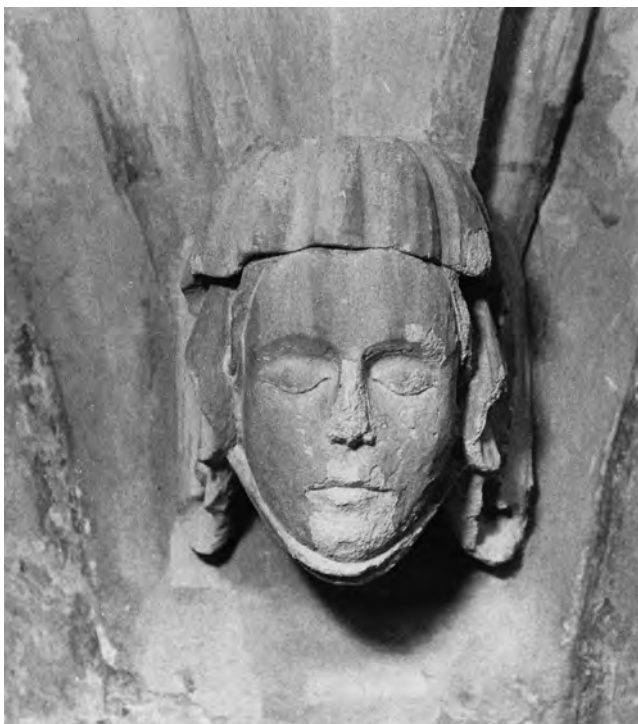
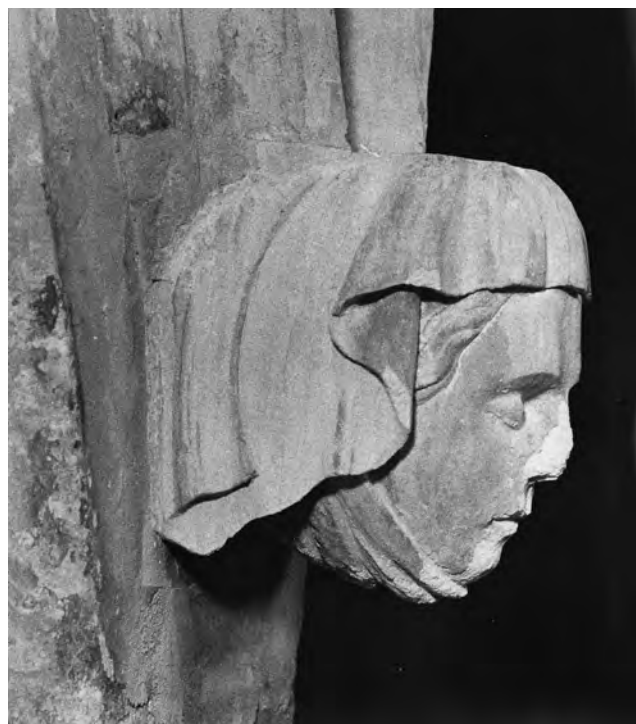
*Fig. 506: Nave, north arcade. Label-stop no. 9. Photos: Warwick Rodwell*

## 9. Head of a lady (Fig. 506).

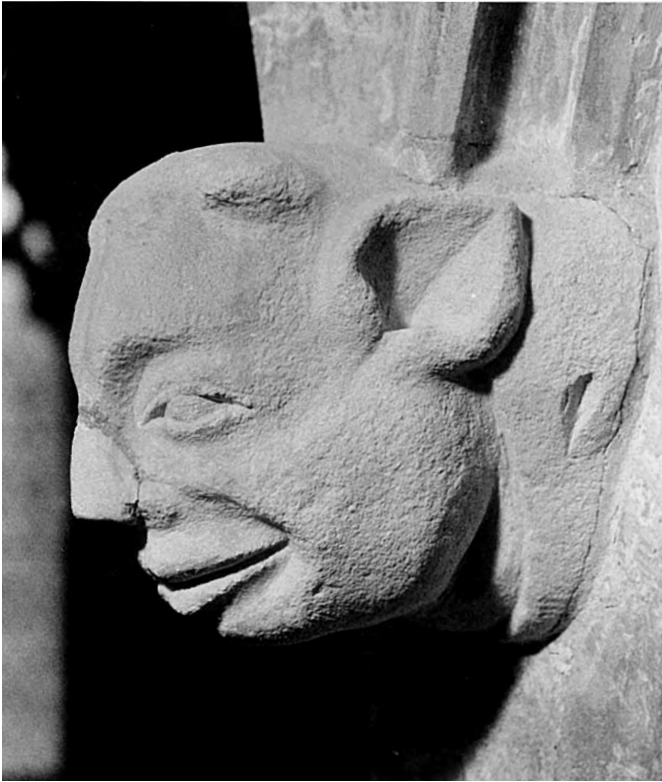
*Fig. 507: Nave, north arcade. Label-stop no. 10. Photos: Warwick Rodwell*

## 10. Grotesque male head (Fig. 507).

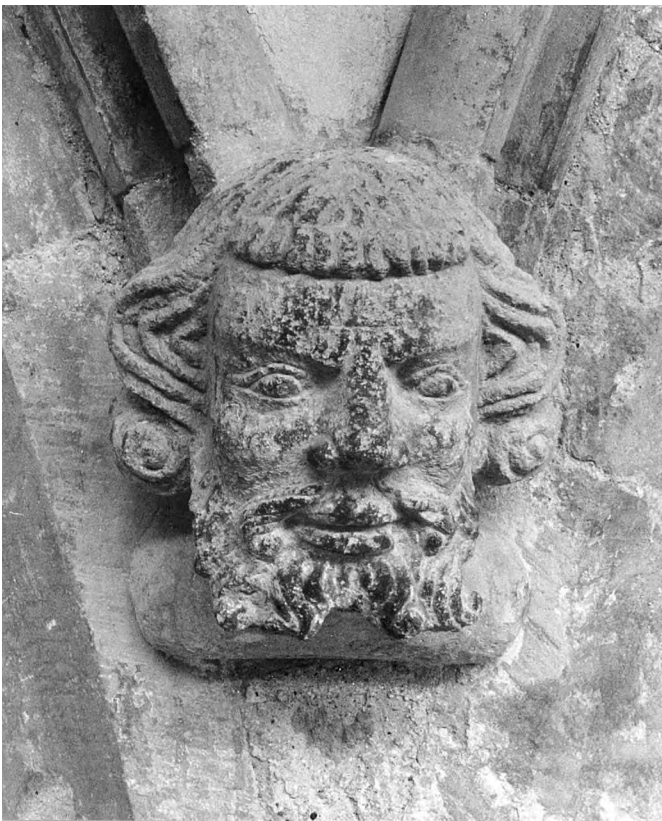
*Fig. 508: Nave, north arcade. Label-stop no. 11. Photos: Warwick Rodwell*

## 11. Male head (Fig. 508).

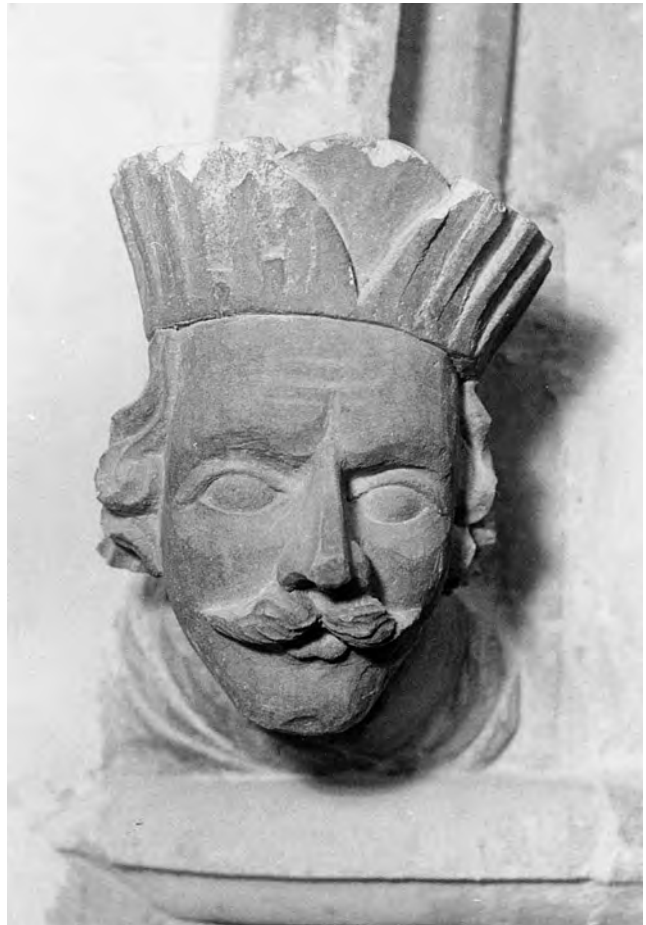
Fig. 509: Nave, north arcade. Label-stop no. 12. Photos: Warwick Rodwell

## 12. Royal male head (Fig. 509).

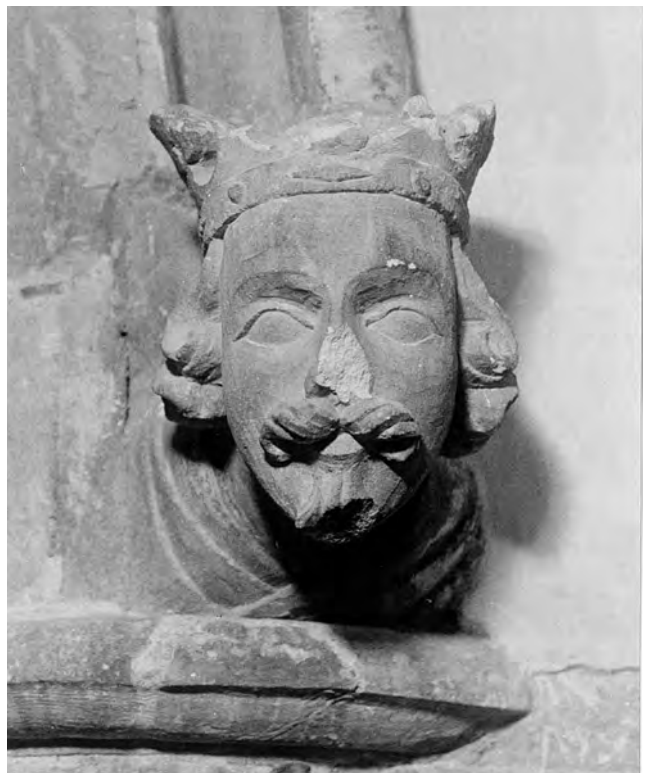
Fig. 510: Nave, south arcade. Label-stop no. 13. Photos: Warwick Rodwell

Moustache and diminutive beard.<sup>33</sup> Another crudely carved, slightly comic Victorian figure, reminiscent of Tenniel's 'White King'. Head turned to dexter. It is a pair with no. 12, and again replaces a head that was lost when the western gallery was erected.

and label-stop no. 13 has been renewed. This damage was all caused by the insertion of a west gallery in the nave.

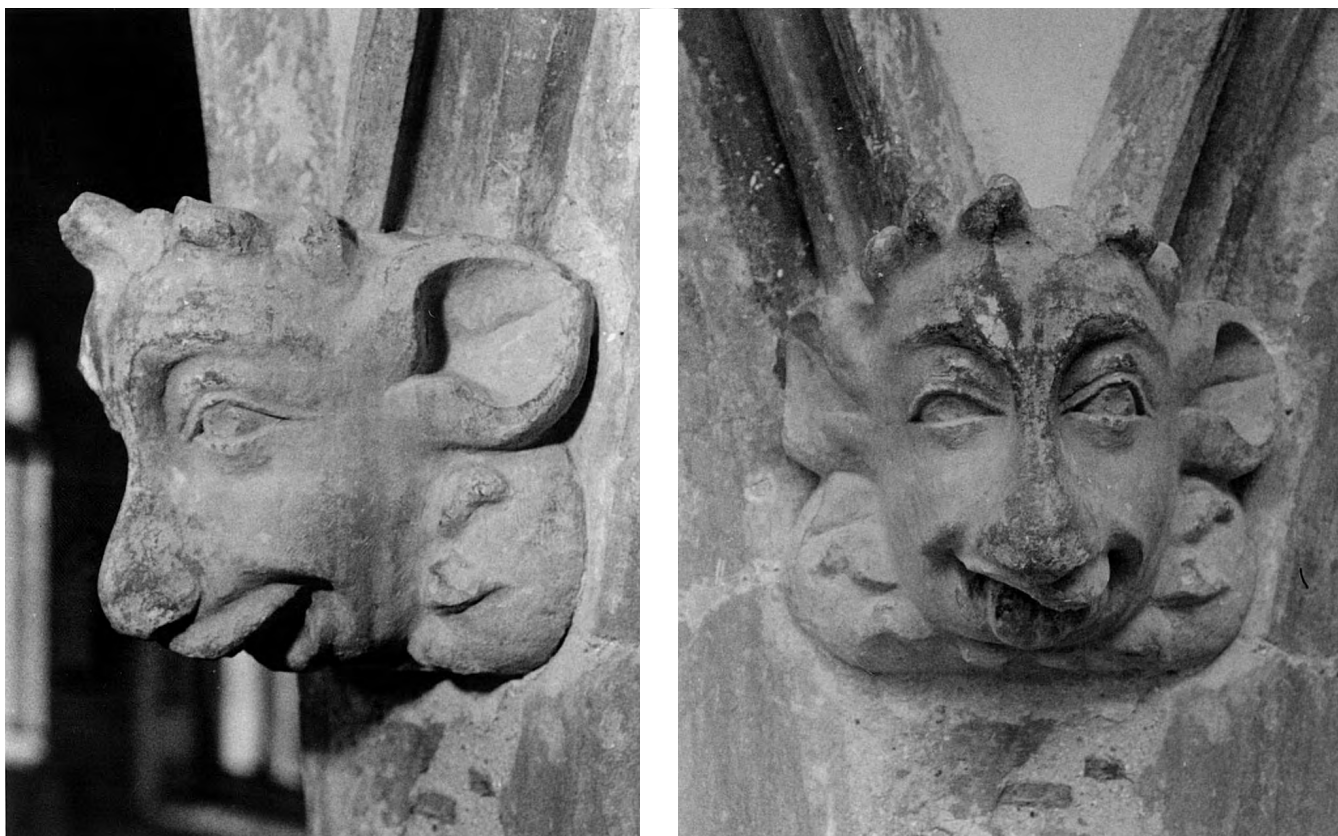
*Fig. 511: Nave, south arcade. Label-stop no. 14. Photos: Warwick Rodwell*

A large, lion-like head, powerful in appearance and crude in execution. The animal has prominent ears (identical to those on no. 10) and a protruding tongue. There are no stoolings for the hood-mouldings. Some repairs, and one curl is missing from the forehead; part of the upper jaw is broken away on the dexter side.

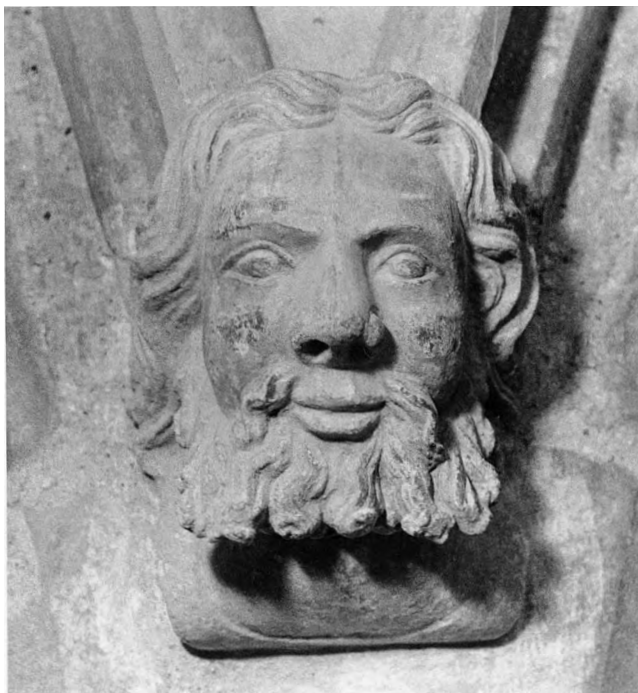
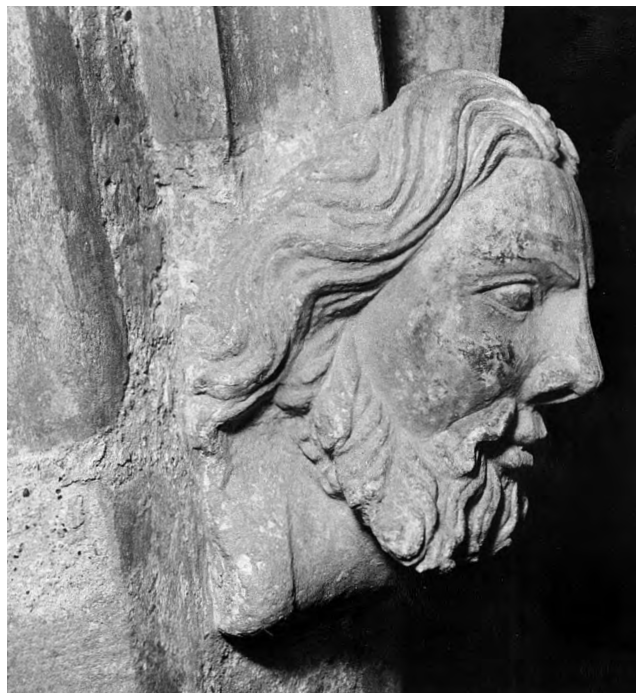
*Fig. 513: Nave, south arcade. Label-stop no. 16. Photos: Warwick Rodwell*

A finely executed head in good condition, distinguished in appearance, and probably representing a nobleman. The hair is carefully finished on the top of the head. Black paint in the irises of the eyes.

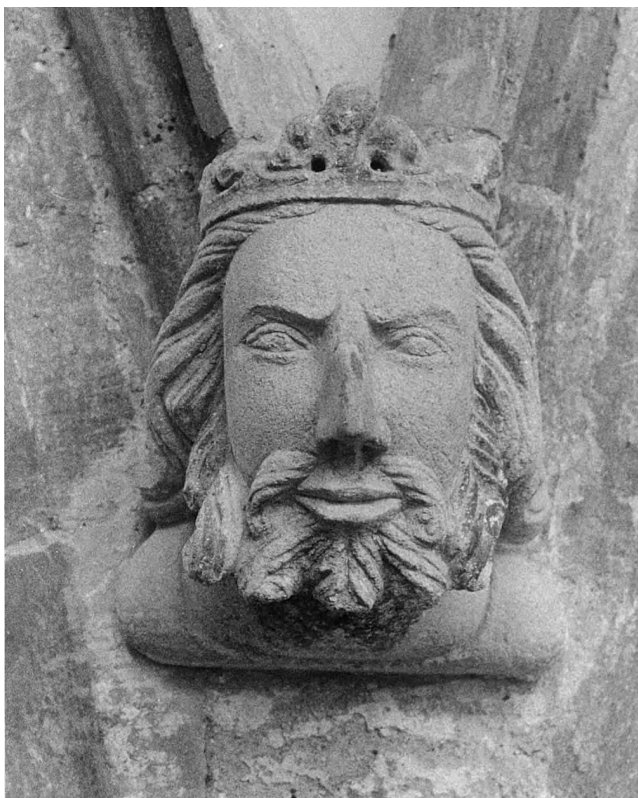
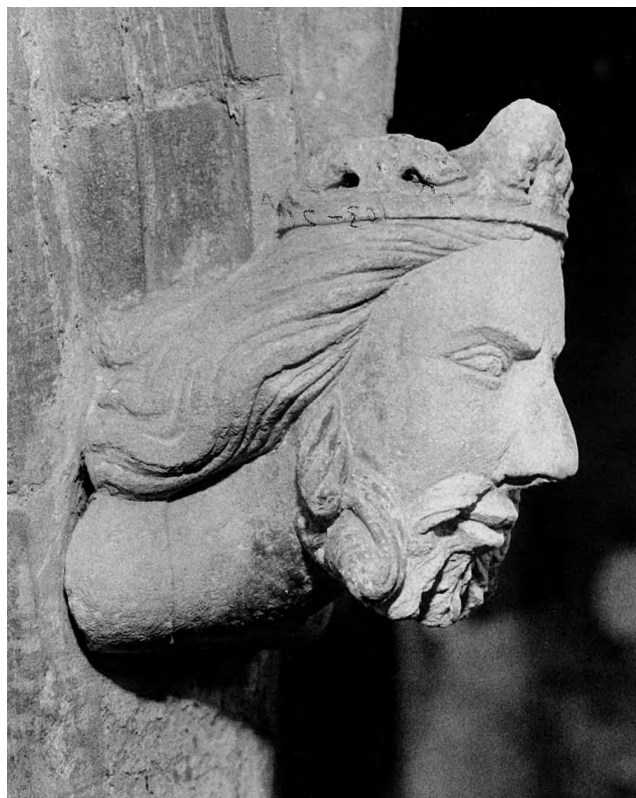
*Fig. 514: Nave, south arcade. Label-stop no. 17. Photos: Warwick Rodwell*

Moustache, beard and long flowing hair; nose replaced in cement. Two points are broken off the crown, which also exhibits original drill holes.

Identified by Brown (1908, 134) as a portrait bust of Edward II.

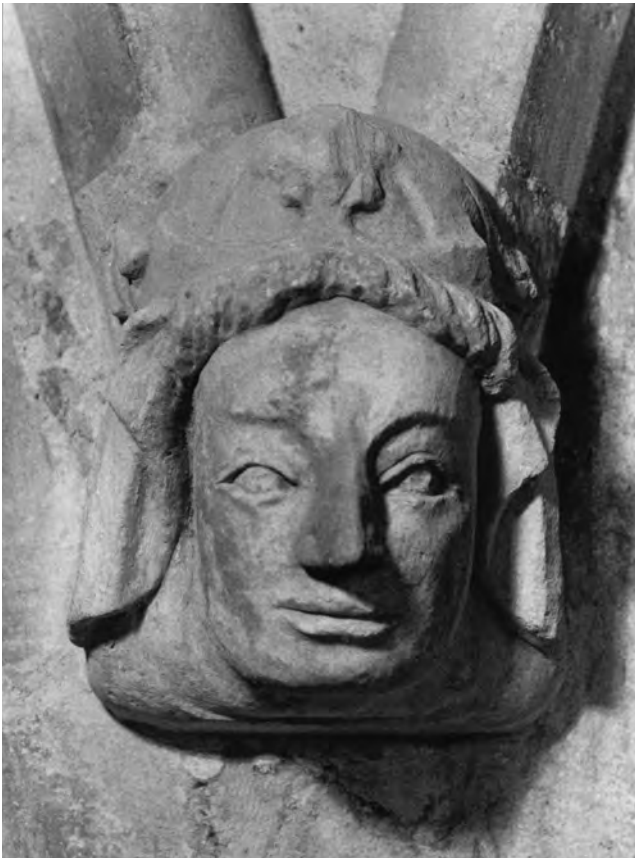
Fig. 515: South aisle, arcade. Label-stop no. 20. Photos: Warwick Rodwell

19. Missing, probably removed in the fifteenth century. No evidence visible to prove the existence of a head-stop, but one would be expected.
20. Head of a queen (Fig. 515).  
She wears a crown and headdress, and has a high neckline to her garment. The front of the crown is damaged and the nose has been replaced in cement. Prominent traces of red paint on the hair; ochre and pink on the jewels of the crown. The original plaster skim survives on the small spandrel below this head.  
Brown (1908, 138) wondered whether this might represent Isabella of France, wife of Edward II, partly on the basis that it is addorsed on the same pier as the head which he confidently identified as that king's (no. 17).

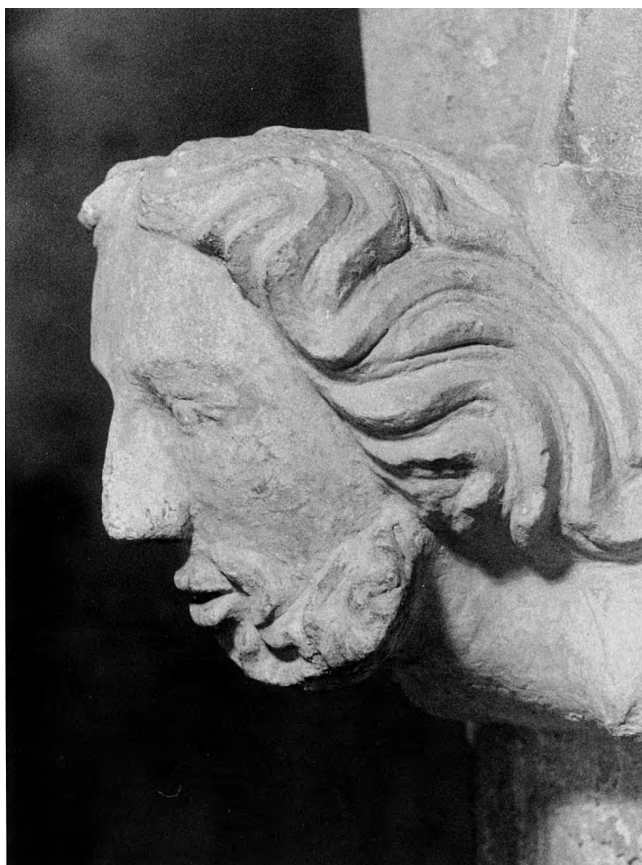
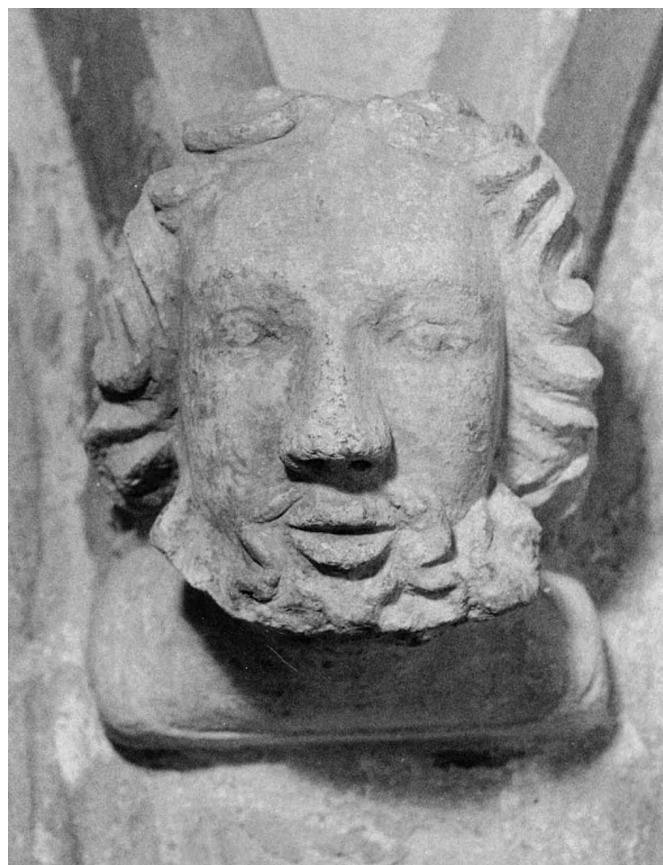
*Fig. 516: South aisle, arcade. Label-stop no. 21. Photos: Warwick Rodwell*

21. Bearded male head (Fig. 516).  
A well-carved head, distinguished in appearance, and probably representing a nobleman. The hair is carefully finished on the top of the head in a chevron pattern. Much red paint of doubtful age is present on the hair. The beard is broken away under the chin and has lost some of its length.

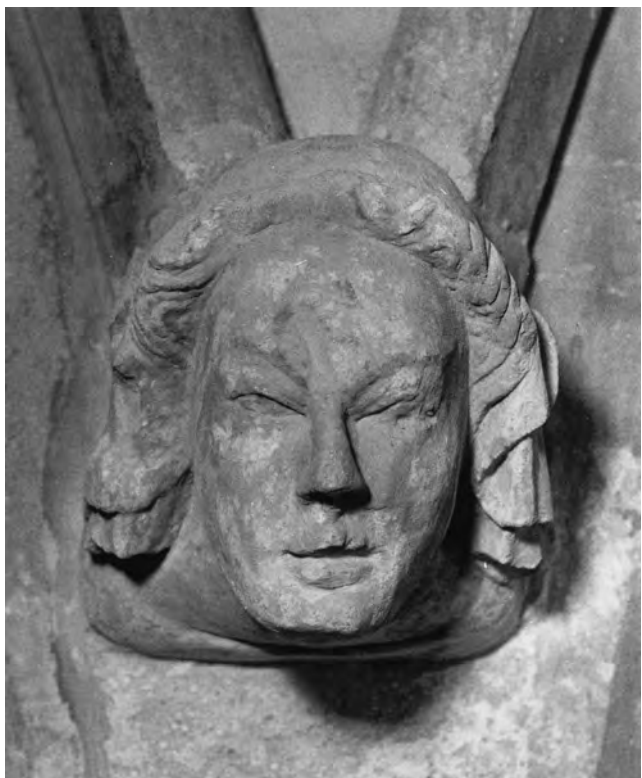
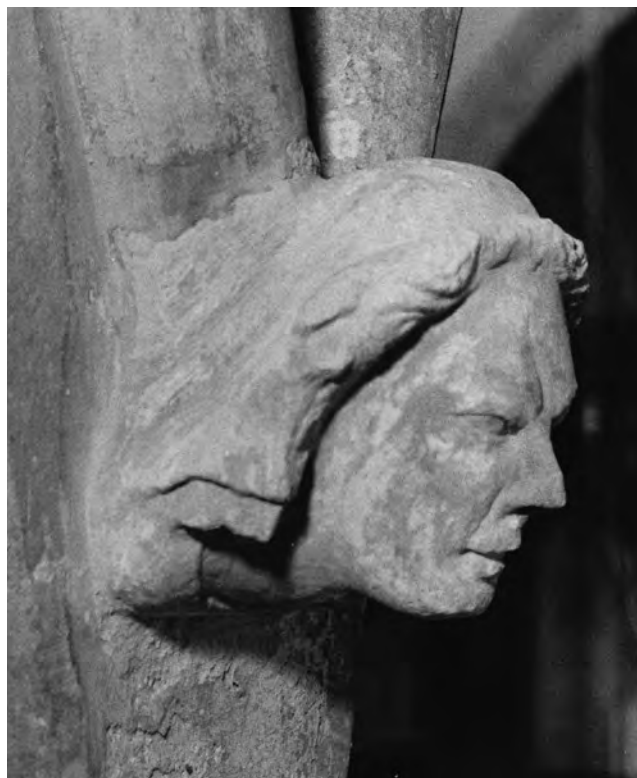
*Fig. 517: South aisle, arcade. Label-stop no. 22. Photos: Warwick Rodwell*

22. Head of a lady (Fig. 517).  
The lady wears a veil which is drawn back. The nose has been replaced; also there is damage to the sinister eye and cheek, which have been reconstructed in cement.

- The hair and veil have also been damaged and partially reconstructed in a clumsy manner. The hair-style is similar to that of no. 20.
23. Head of a youthful male (Fig. 518).  
Clean-shaven face with a long, pointed nose; hair with curls on the forehead and neatly finished on top of the head. Spots of blue paint on the eyes are modern. The head is slightly angled to dexter, suggesting that it was intended for a respond. There is a stooling for the hood-moulding on the dexter side, and not on the sinister. In its present position, the stooling carries the hood-moulding of bay 5, while the hood of bay 4 is simply bedded on the hair with a thick mortar joint. This head-stop could have been made for the east respond in the south aisle (*i.e.* position no. 19), with the intention that it would look down upon the altar below; examples of this attitude are well attested.

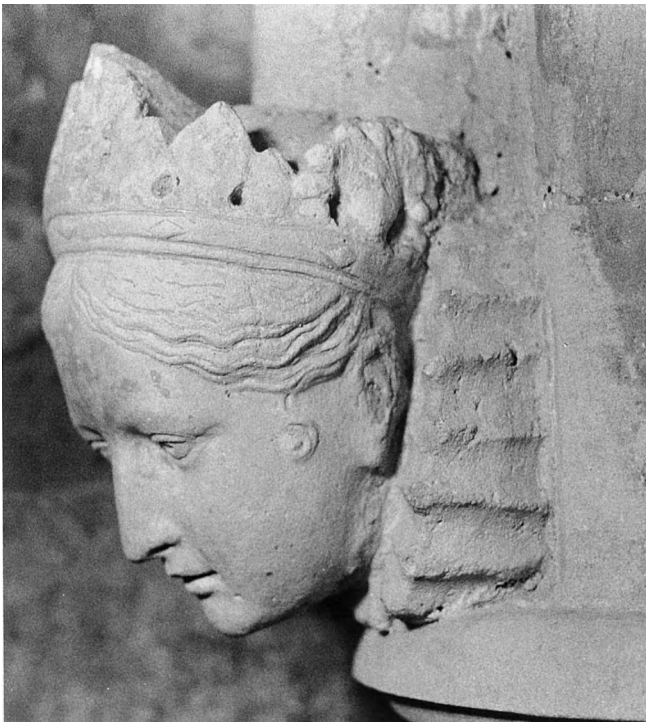
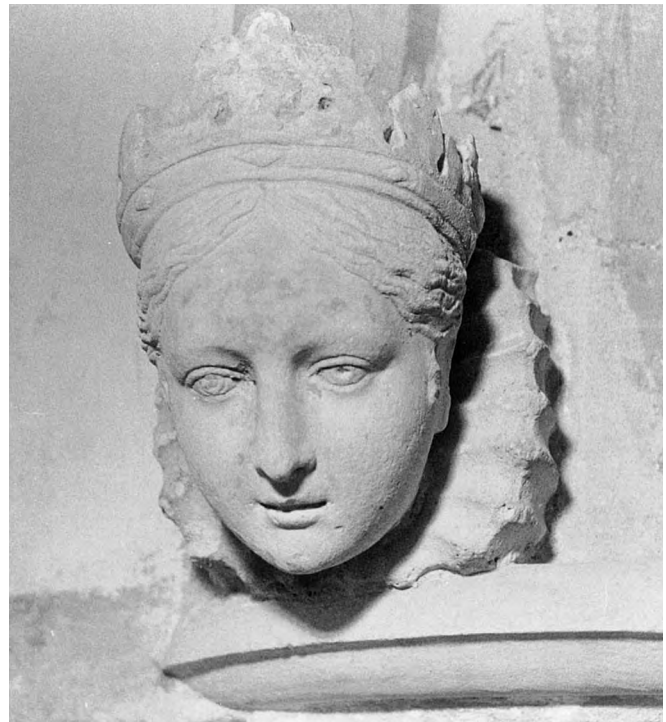
*Fig. 519: South aisle, arcade. Label-stop no. 24. Photos: Warwick Rodwell*

24. Head of a queen (Fig. 519).  
This is not one of the original set of label-stops, but a much later addition. It is sculpted in soft, white limestone and the quality is far superior to that of any of the other replacement work. It was not made as a label-stop, and the head has been attached via the neck (perhaps with a dowel?); the joint was then masked by surrounding it with a ruff, modelled in coarse pinkish-buff mortar of uncertain age.<sup>34</sup> The head may originally derive from a different kind of sculpture, possibly a small statue.  
The facial features are finely executed, and a delicate curl of hair descends on to each temple. The crown seems to have been less well sculpted, is damaged at the front and has had a new section, carved in chalk, fitted on the sinister side.

The location of this head is particularly conspicuous, catching the eye as one enters the church by the main door. Determining its age is, however, problematical. Brown (1908, 137) unquestioningly accepted that it was medieval, and sought to identify it with Eleanor of Castile. He explained the appearance of the ruff as an Elizabethan addition. Varah, on the other hand, claimed

that the head itself represented Queen Elizabeth I.<sup>35</sup> Most recently, Pamela Tudor-Craig wondered whether it might not be a depiction of the 'young head' of Queen Victoria. However, it bears no resemblance in stone type, style or quality to the other nineteenth-century replacement heads, adding force to the suggestion that it is reused.
