# ST PETER'S

## Barton-upon-Humber, Lincolnshire

*A Parish Church and its Community*

HISTORY, ARCHAEOLOGY AND ARCHITECTURE

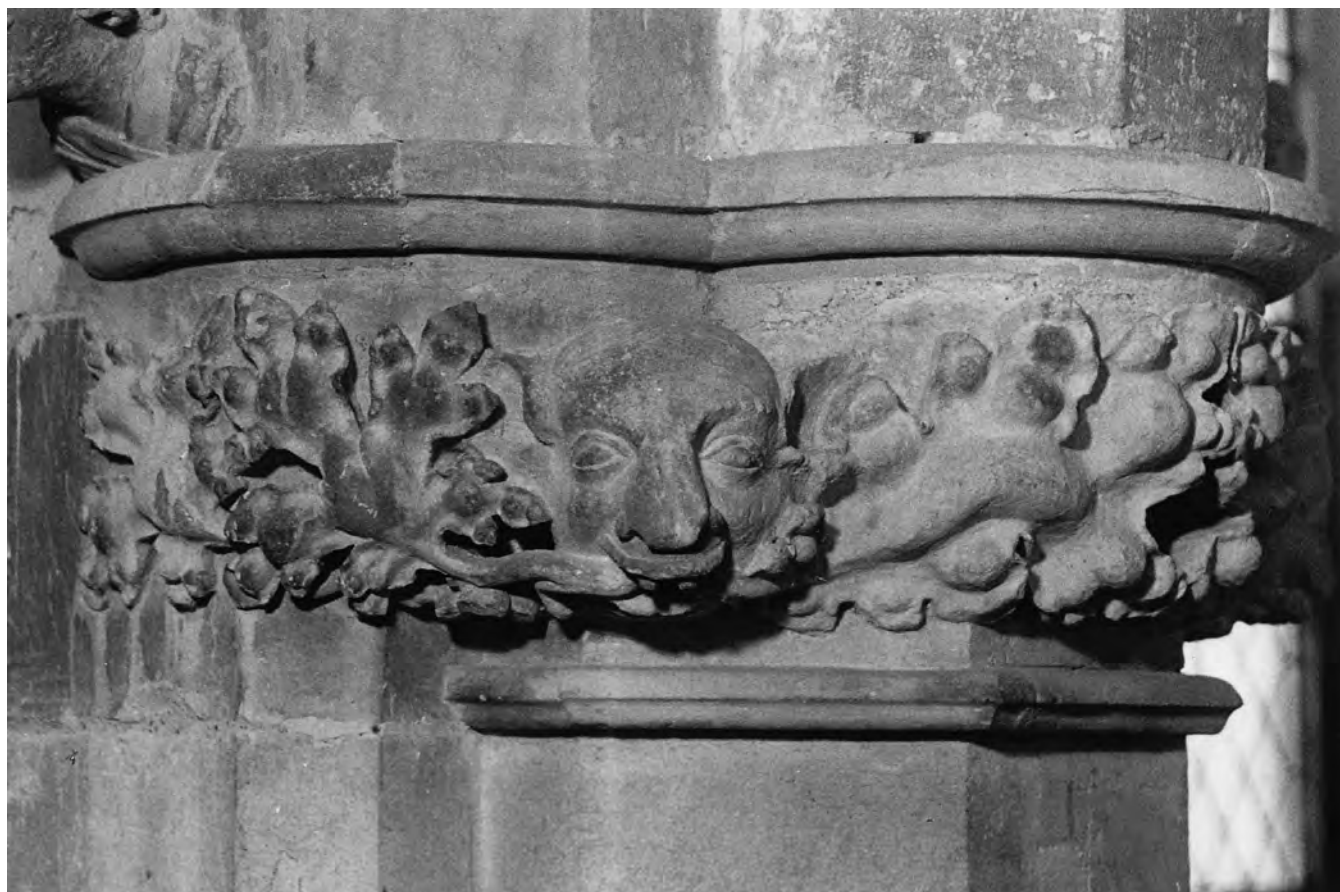
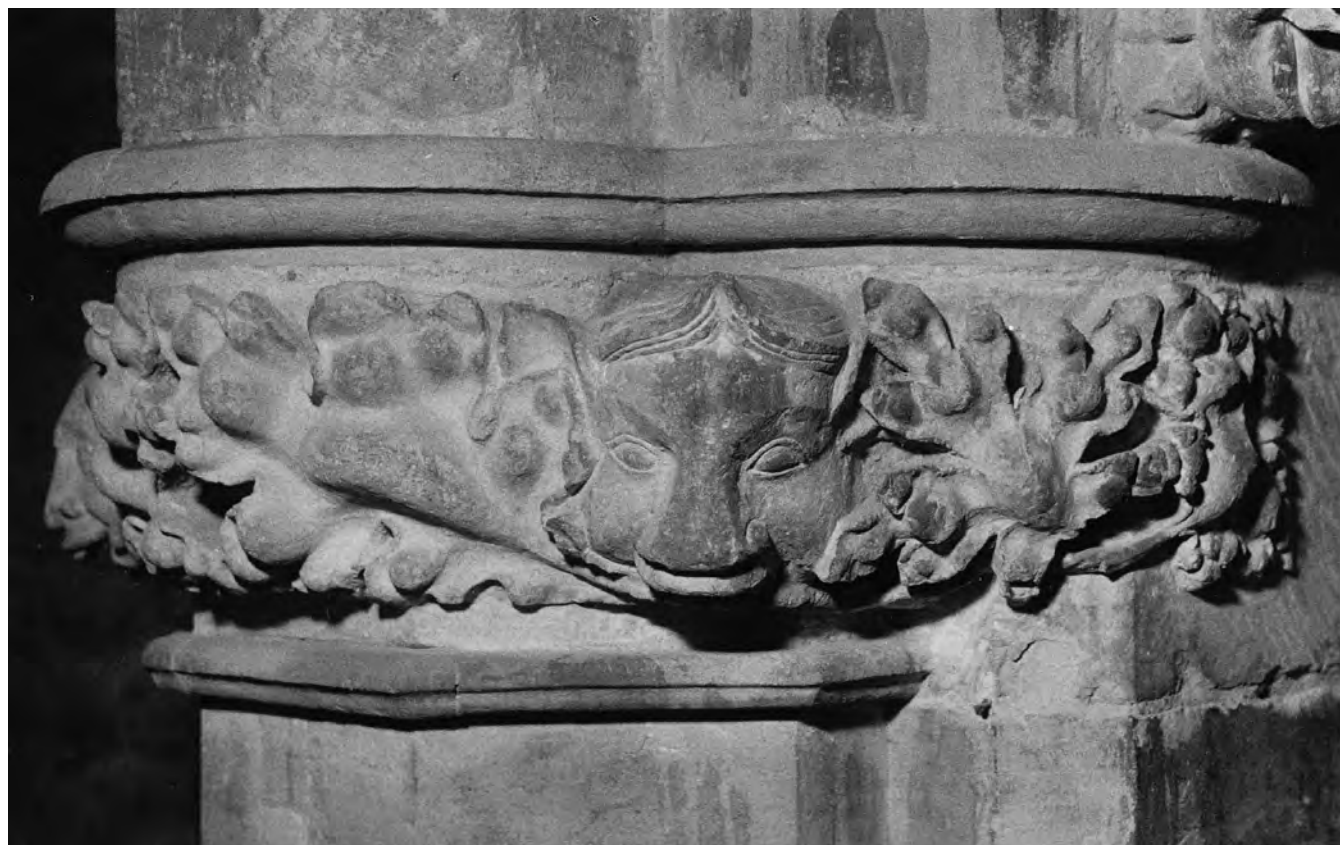
*Fig. 520: North arcade, west respond. Sculpture no. 25. Photos: Warwick Rodwell*

**North and south arcades: responds and capital****25. North arcade: west respond (Figs. 492 and 520)**

The impost is carved with two grotesque lion-like heads facing south-east and north-east, respectively; the latter is wearing a headdress or crown. Both heads have broad noses and pointed ears, and knobbly foliage issues from their mouths, wrapping round on to the faces of the arcade. The teeth have been broken from the upper jaw of the north-east head. Incorporated among the foliage on the south side, and facing vertically downwards, is a small rose (*cf.* capital, no. 26). Dark red paint survives on the background in many places; this extends on to the abacus and the neck-ring.

The respond sustained a little damage when the west gallery was inserted in the nave. Parts of the abacus and hood-moulding on the south face of the arcade were renewed in 1858–59, when the gallery was removed.

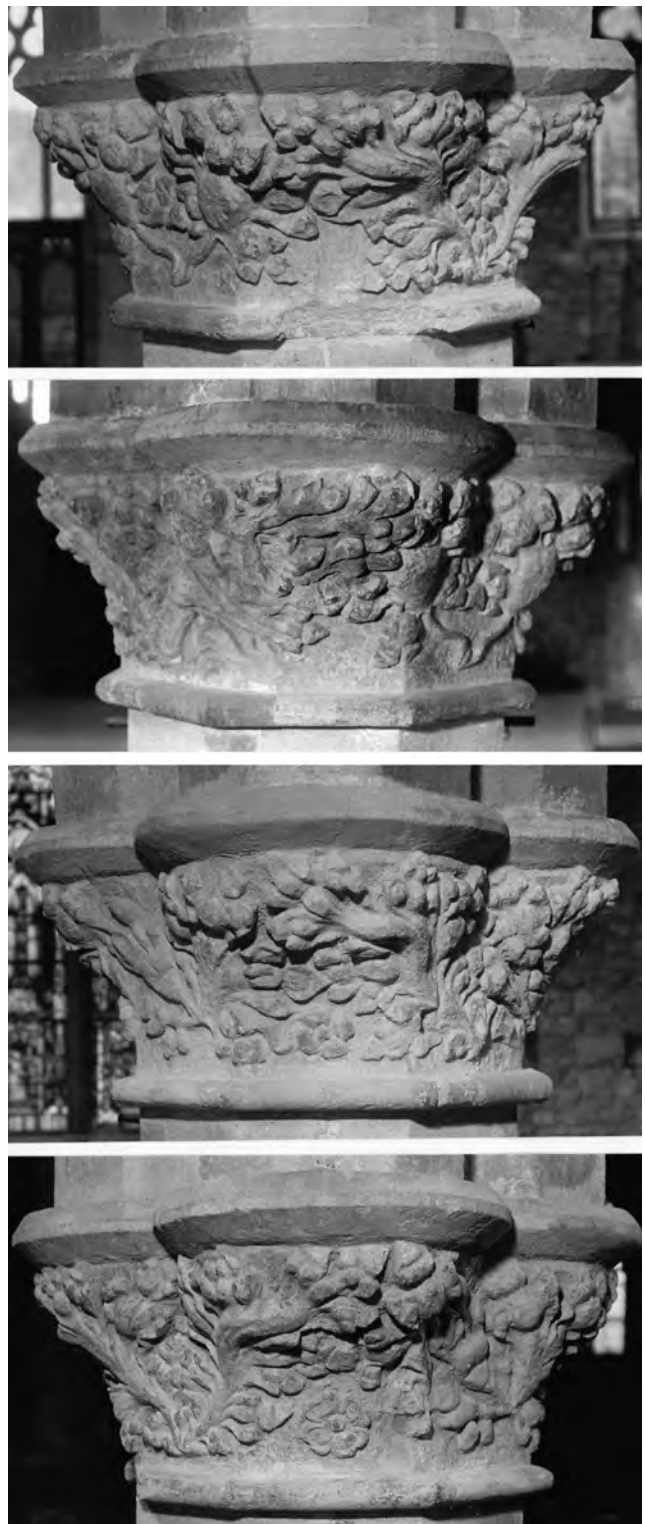
*Fig. 521: North arcade, capital pier 1/2. Sculpture no. 26. The four cardinal faces. Photos: Warwick Rodwell*

The trefoiled abacus is separate from the impost, but the semi-octagonal neck-ring is integral. The impost is decorated with two male heads wearing caps and facing north-east and south-east, respectively. Knobbly foliage issues from the mouths of both. The north-east head has prominent teeth; the nose and part of the face have been repaired. The south-east head has a wide-open mouth and no teeth.

Repairs to the foliage have taken place, especially where it runs on to the north face of the arcade; there, the abacus and hood-moulding have also been repaired,

and label-stop no. 13 has been renewed. This damage was all caused by the insertion of a west gallery in the nave.

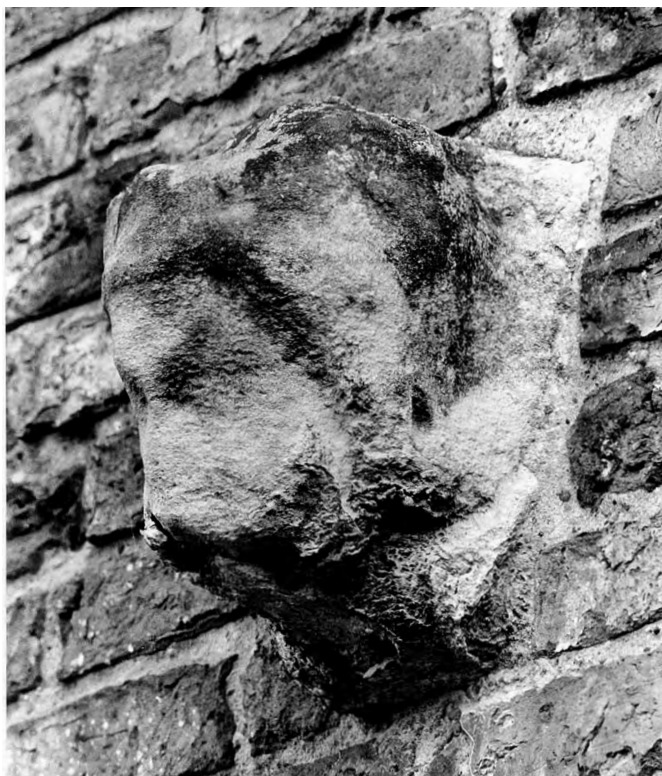
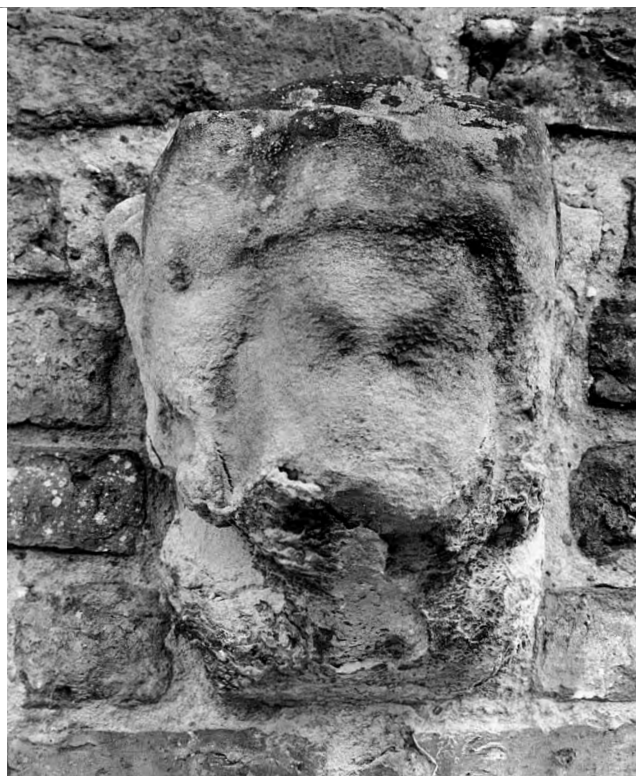
Fig. 524: North porch, exterior. Reset head sculpture, no. 35. Photos: Warwick Rodwell

35. Head of a male, wearing a hat (Fig. 524).  
Now outdoors and heavily weathered, having been built into the brick gable of the north porch in the eighteenth century. This was formerly a head-stop from an arcade and retains the stoolings for the two hood-mouldings that sprung from it; very likely that it was the original no. 9, in the north arcade.

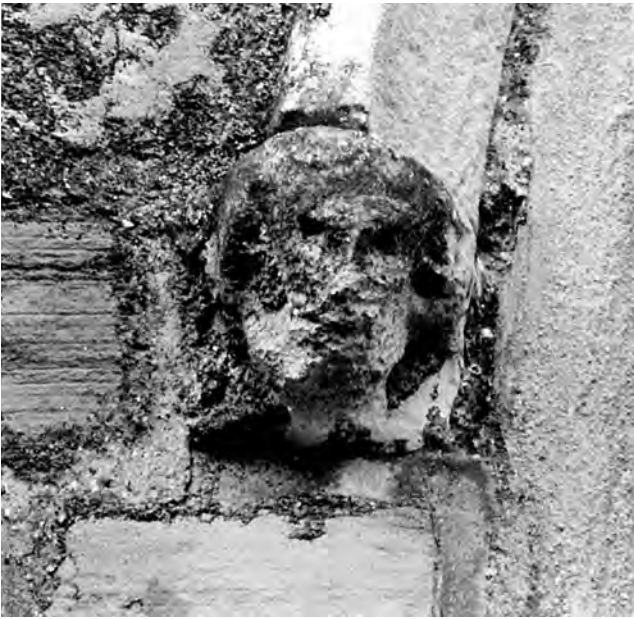
*Fig. 525: South aisle window, bay 1. West label-stop, no. 37. Photo: Warwick Rodwell*

36. Bay 1 (E). Young ?male head. Almost lost through weathering.
37. Bay 1 (W). Male bearded head with drilled eyes. Heavily weathered (Fig. 525).
38. Bay 2 (E). Head wearing a hood, meeting under the chin. Almost lost (Fig. 526).
39. Bay 2 (W). Torso of a beast with forepaws and drilled eyes (Fig. 527).
40. Bay 3 (E). Female head, veiled (Fig. 528).
41. Bay 3 (W). Head of young male wearing a turned-up cap (Fig. 529).

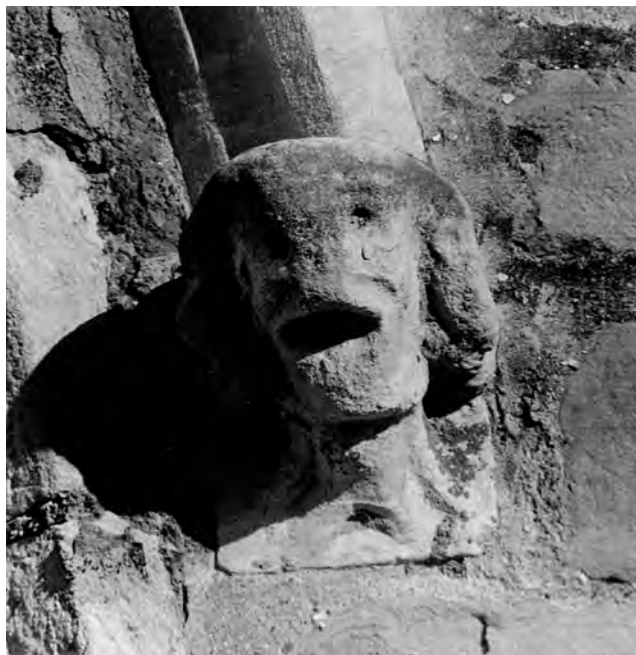
*Fig. 530: South aisle window, bay 4. East label-stop, no. 42. Photo: Warwick Rodwell*

- 42. Bay 4 (E). Distressed male head with drilled eyes and open mouth (Fig. 530).
- 43. Bay 4 (W). Head missing, broken off at the neck.
- 44. Bay 5 doorway (E). Destroyed: a formless lump.
- 45. Bay 5 doorway (W). Destroyed: a formless lump.
- 46. Bay 5 porch (E). Male head. Heavily weathered; no features visible except hair.
- 47. Bay 5 porch (W). Female head. Heavily weathered; no features visible except hair and veil.

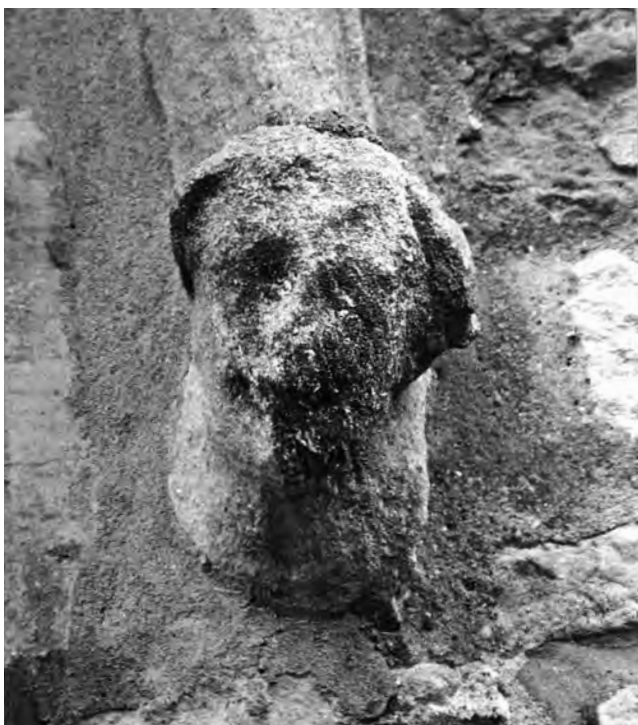
*Fig. 531: North aisle window, bay 4. East label-stop, no. 48. Photo: Warwick Rodwell*

- 48. Bay 4 (E). Round smiling face of a fool. Nineteenth or early twentieth century (Fig. 531).
- 49. Bay 4 (W). Head of young woman, turning in towards the window, her veil flying away behind her (cf. south porch) (Fig. 532). Thirteenth or fourteenth century, but potentially a secondary insertion.

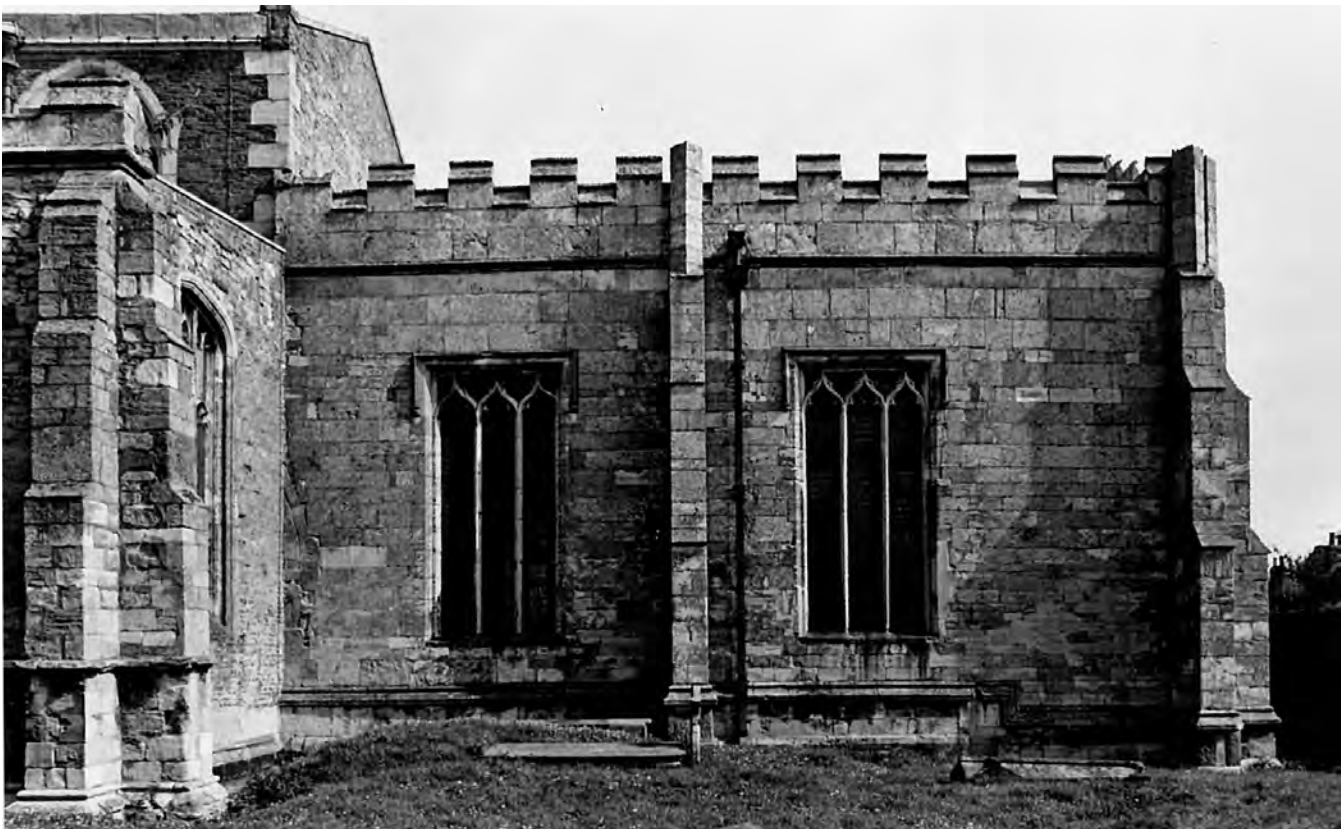
Externally, the chancel is entirely faced with medium-to-large blocks of Lower Magnesian Limestone ashlar,<sup>43</sup> standing above a deep plinth which has a plain chamfer at the base and is topped by a heavy bolection moulding (Fig. 533). On the east wall alone, between the buttresses, is a cavetto-moulded string-course beneath the window sill (Fig. 534). There are clasping buttresses at the eastern angles, and a single medial buttress marking the division between the bays on the south. The bays are of markedly unequal widths and the positioning of the windows is noticeably unbalanced in relation to the south elevation (Fig. 452).<sup>44</sup> Internally, however, the south wall and its fenestration presents a uniform aspect. The north side, by contrast, was divided into three bays, with a similar buttress between bays one and two (Figs. 556 and 698), and the vestry abutting the third. However, this side was substantially rebuilt when the organ chamber was added (p. 529).

Fig. 533: Chancel. South view, 1999. Photo: Warwick Rodwell

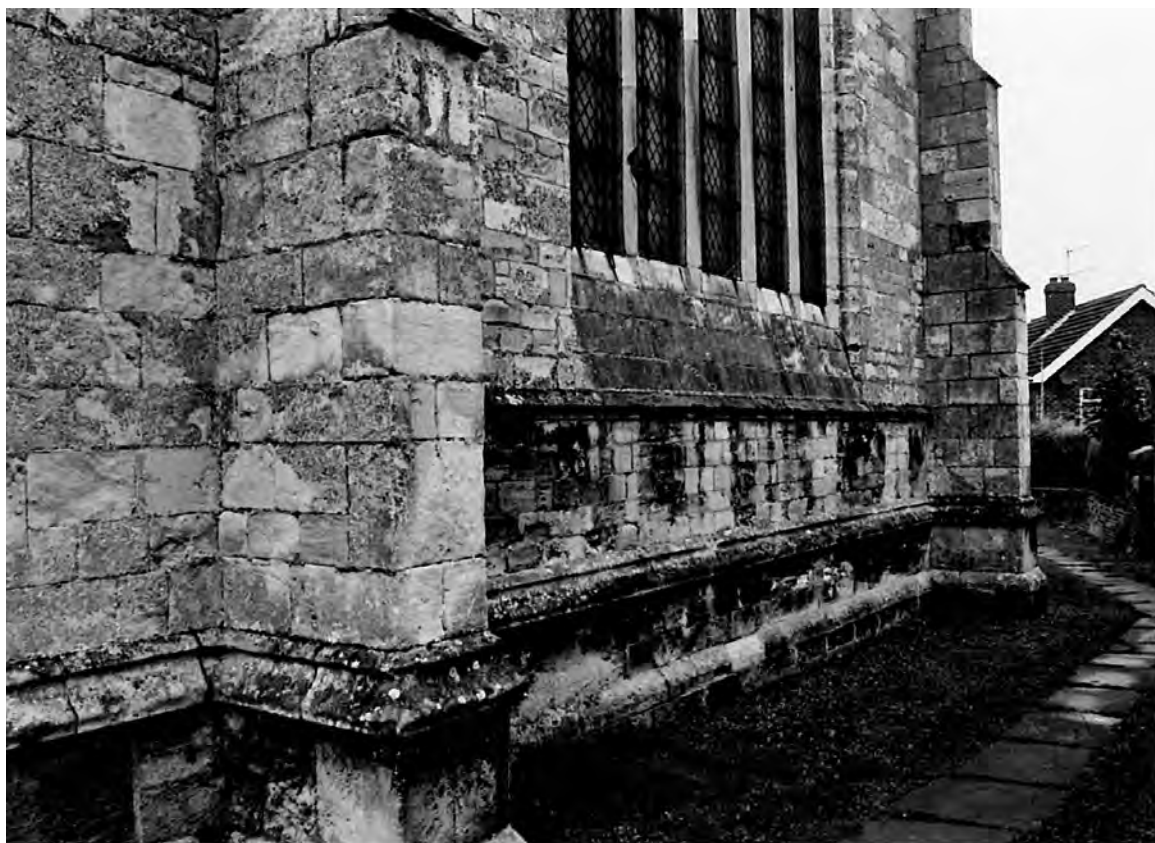
*Fig. 534: Chancel. Lower part of the east wall, showing details of the plinth, string-course and raised window sill, 2005. Photo: Warwick Rodwell*

The large east window, now of five wide lights, has been substantially modified. Only the chamfered and rebated jambs, to about three-quarters of their present height, are original: the head and tracery are later (Figs. 50 and 535). Also, the sill once rested directly on the string-course, but has subsequently been raised by three masonry courses (p. 518; Fig. 534). This is the

constructed (Figs. 50, 21 and 559). The window has five cinquefoil-headed lights that are wider than all the others in the church, and the chamfered mullions are acutely angled. The original sill has gone, and four bevelled courses of masonry (the uppermost being the new sill) have been inserted in the opening, between the jambs (Fig. 534). The head is three-centred and has a hollowed hood-moulding with short returns, but no label-stops.

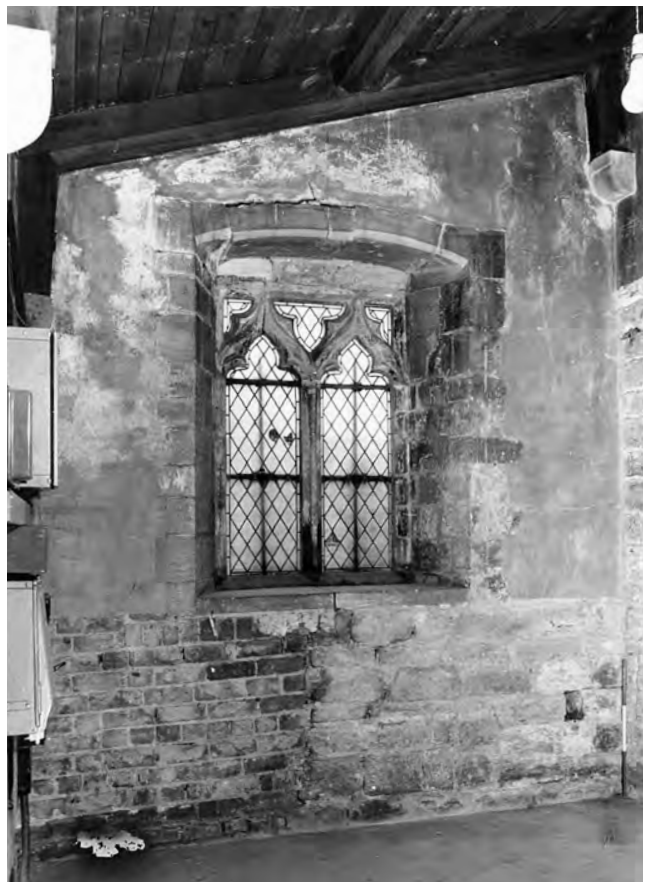
The four lateral windows of the chancel are all square-topped, and have three trefoil-headed main lights and half-quatrefoils in the tracery. Superficially, they resemble truncated versions of the reticulated fenestration of the north aisle. However, they are not derived from the same templates: the lights in the chancel are a little narrower and the cusping of their trefoiled heads is slightly different. The window sills (including those now resited in the organ chamber) are broad and have low-angled chamfers, and the mullions are bevelled, with acute angles.<sup>50</sup> There are hollow-chamfered hood-mouldings with diminutive label-stops in the form of a small pyramid between two horizontal bars.<sup>51</sup> The two-light east window of the vestry is a diminutive version of those in the chancel (Fig. 537).

Fig. 537: Vestry. Interior showing the east wall which was partly rebuilt in brick in 1897. Photo: Warwick Rodwell

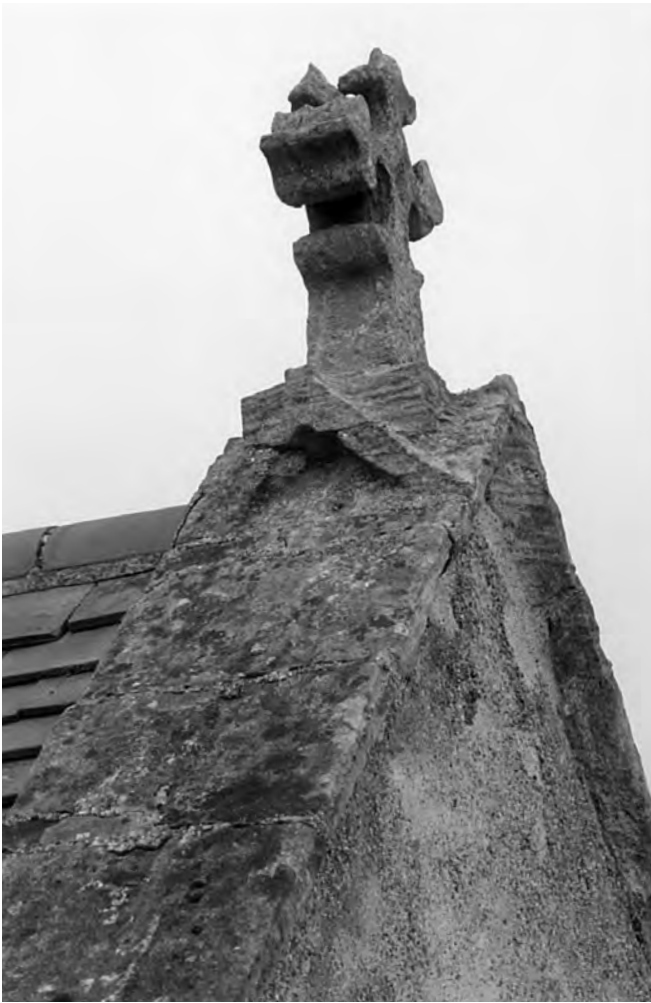
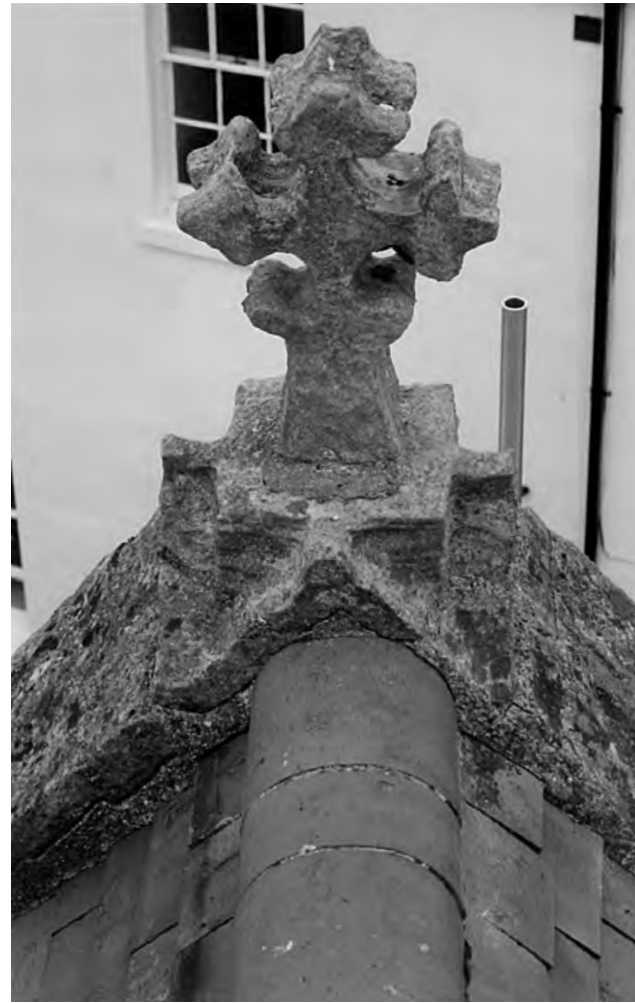
Fig. 539: Western annexe. Two views of the gable cross. Photos: Warwick Rodwell

It is likely that the western annexe was reroofed at the same time as work was undertaken on the tower. No roof timbers survive, but the chamfered limestone gable-coping and its floriated finial cross are fourteenth century. The latter was mentioned in 1832 by Loft.<sup>56</sup> The cross, which has fleur-de-lys terminals to the arms, has a square stem and rises from a block with four-way gablets (Fig. 539). The west-facing gablet is integrated with the adjacent chamfered coping, while the other gablets are finished with apex-rolls.

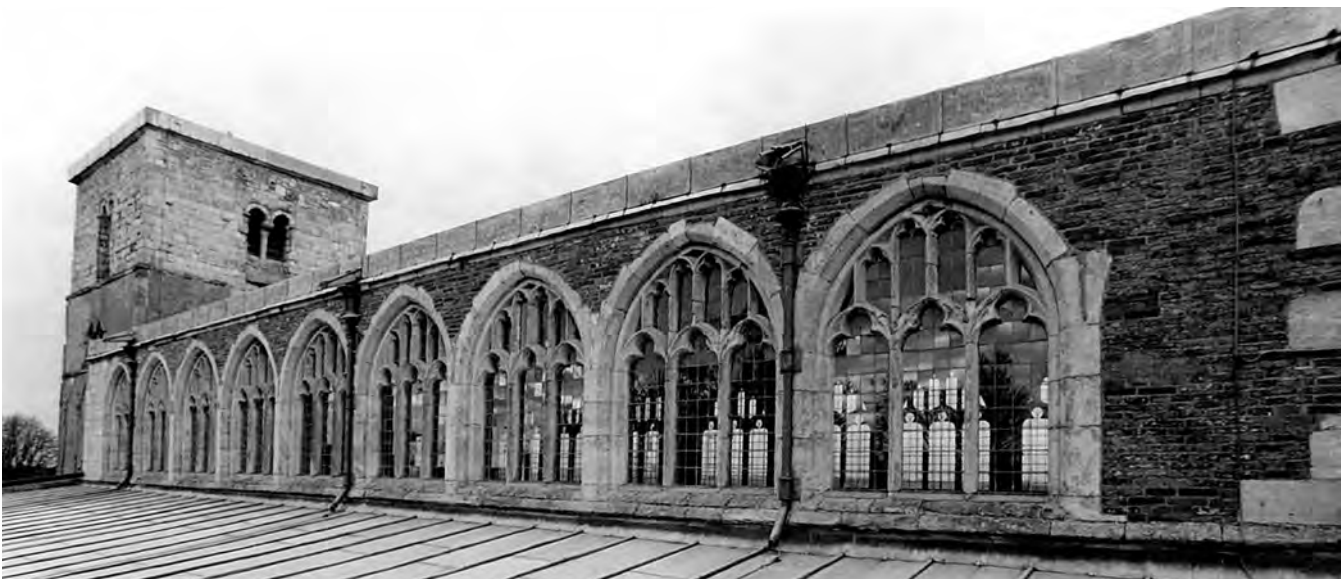
Fig. 541: South clerestory. View from the south-east, 2000. Photo: Warwick Rodwell

The most substantial work, certainly since the building of the Norman nave, was the raising of an elegantly fenestrated clerestory of nine bays (Fig. 541). In order to facilitate this, the nave and aisles were all unroofed, and construction proceeded as a single operation. After the tie-beams and wall-plates had been removed, the tops of the fourteenth-century nave walls were reduced to the apex-levels of their respective arcades: c. 50 cm higher on the south than on the north (p. 453). Scaffolding was erected, using rectangular, through-putlogs which were built into the tops of the arcade walls. In the case of the south arcade, the putlogs were laid in the bottoms of the largely destroyed pockets that formerly held the tie-beams.

Again, the remainder of the wall up to sill level was raised in brick, and it incorporated a more regularly spaced line of putlogs. Both clerestories have a limestone chamfered weathering-course on the external face, immediately below window-sill level, to house the lead-flashing of the aisle roof (Fig. 541).

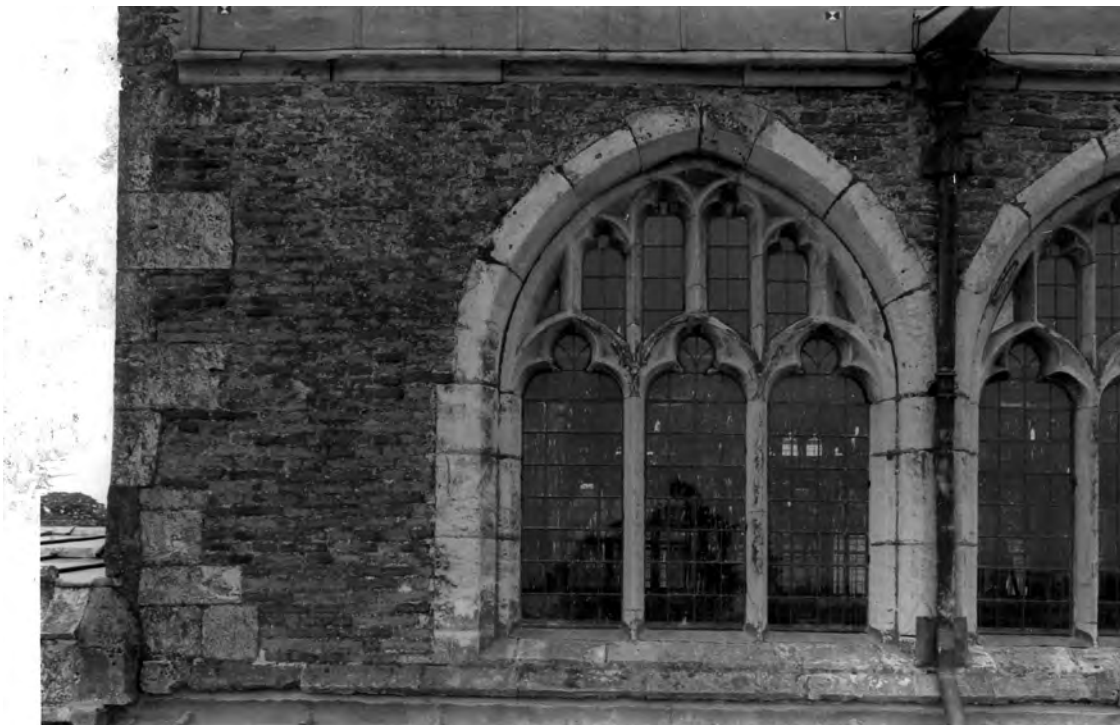
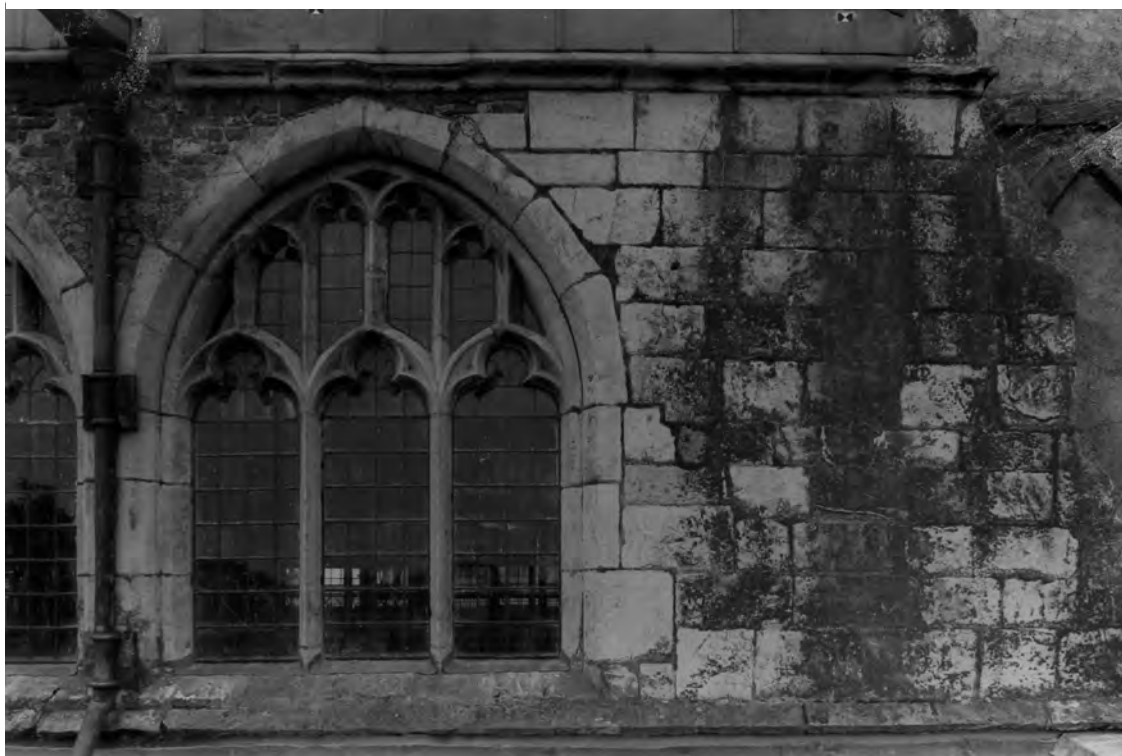
*Fig. 542: North clerestory. A, Bay 1 (east); B, Bay 9 (west); showing windows and adjoining nibs of brickwork and ashlar masonry, 1983. Photos: Warwick Rodwell*

angles were raised in limestone ashlar to the new clerestory eaves level, 11 m (36 ft) above the floor, and then nine identical window bays were formed, north and south being in register (Figs. 50, 16, 542B and 543A). One or more courses of clay roof tile were used as levelling material under the sills. The windows are of three trefoil-headed lights under a pointed arch, framed by a simple chamfered order without a hood-moulding; the tracery is filled with four small trefoil-headed lights. The bays are punctuated by simple piers upon which are carved the mouldings of the jambs. It might have been expected that the piers would support double springer-blocks, but all are single, and a small putlog was seated on top of each pier, sandwiched between the springers of adjacent windows.<sup>59</sup>

Unlike at the west end, the nib of wall between the easternmost (ninth) window and the corner was not built of limestone ashlar: brick was used instead, with ashlar reserved for the quoins alone (Figs. 542A and 543B). Even then, brick was employed at a low level in the quoins, where they were abutted and concealed by the parapets of the chancel and aisles.<sup>61</sup> The clerestory is closed on the east by a plain brick gable-wall, which is carried by the chancel arch and rises well above the chancel roof (Figs. 457 and 590).

The abutment of the aisle leads to the clerestory was sealed by a continuous limestone weathering-course, immediately below the window sills (Fig. 542).

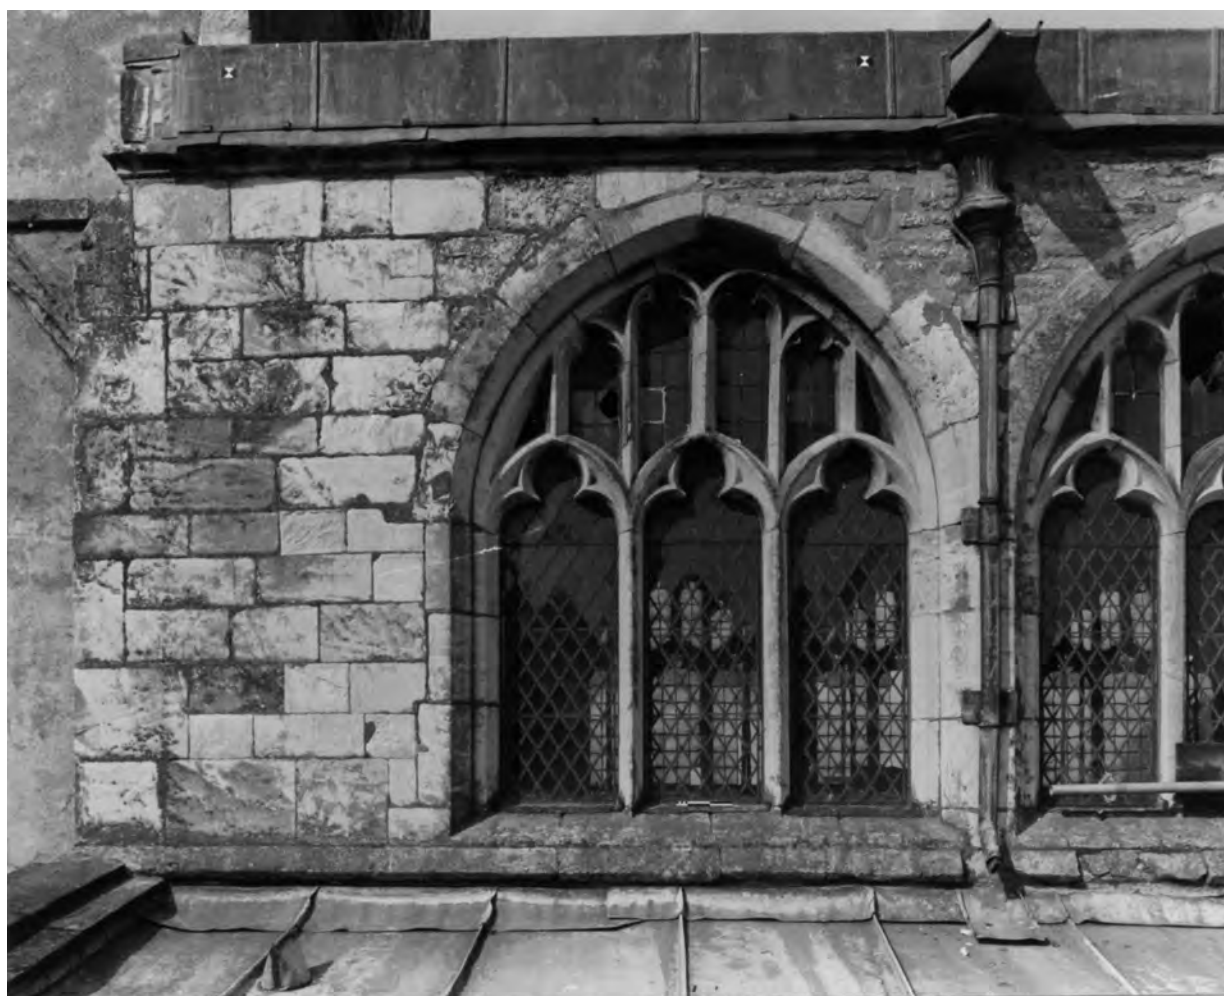
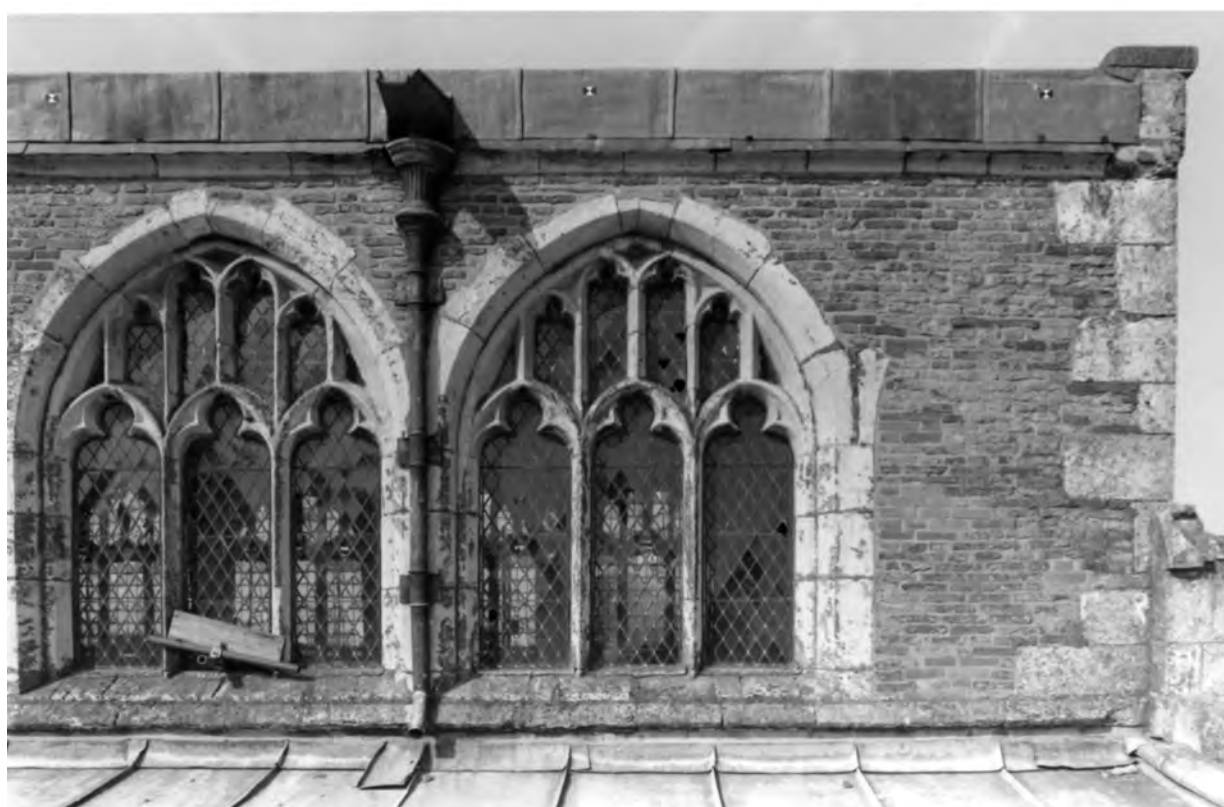
*Fig. 543: South clerestory. A, Bay 9 (west); B, Bay 1 (east); showing windows and adjoining nibs of brickwork and ashlar masonry, 1980. Note also the springing for an unbuilt tenth bay to the east. Photos: Warwick Rodwell*

The evidence is unambiguous: on both the north and south clerestories the easternmost window does not have a conventional jamb on its east flank, but a double-moulded pier of the same kind as would separate two adjacent bays. Although the abutting brickwork has been carefully cut to hide the unwanted jamb mouldings, the toe of the sill remains visible. Also, on the south, the springer for the tenth window had already been set in place, but not on the north (Fig. 543B). Whether the final south window had even been erected, and was taken down, is impossible to determine. Anyway, the moment of change is clearly fossilized in the fabric.

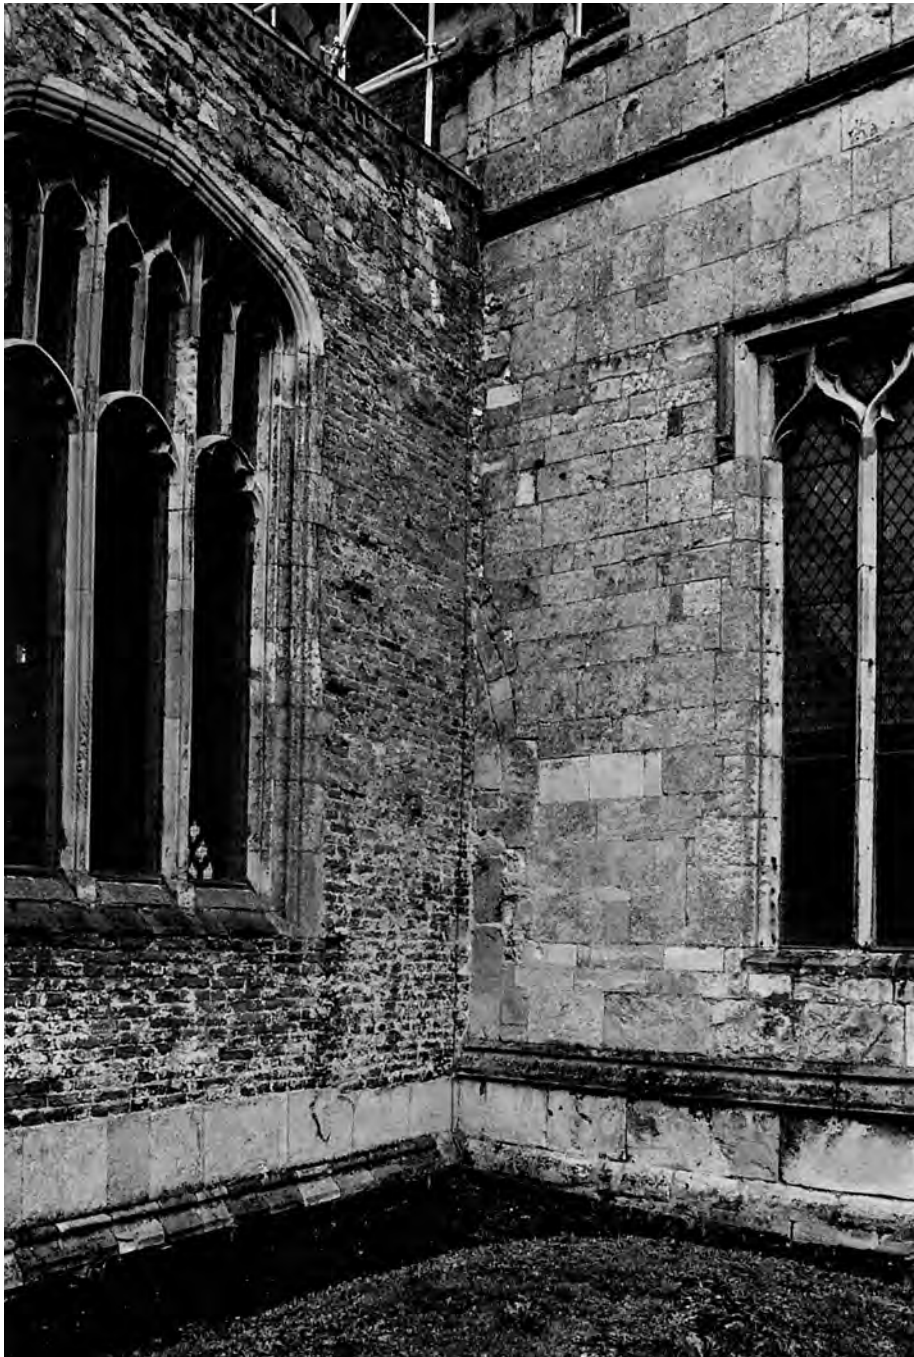
*Fig. 544: South aisle. View into the external angle between the aisle (left) and the chancel, showing the cut-back remains of the east respond and hood-moulding of the fourteenth-century arcade, bay 1. Photo: Warwick Rodwell*

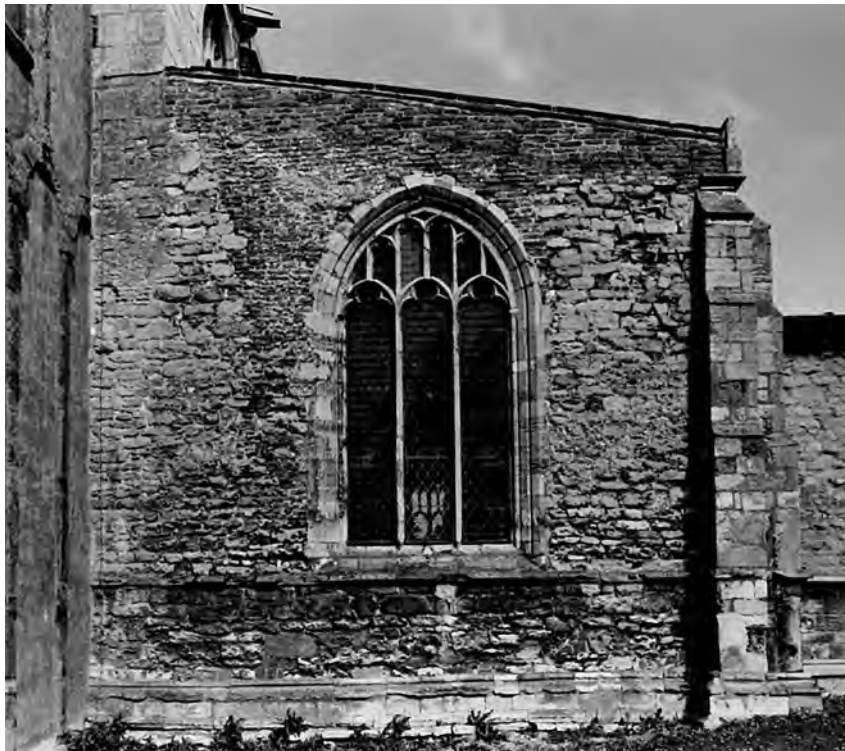
Fig. 545: South aisle. Modified west window, with partial rebuilding of the wall above in brick; unrestored, 1999. Photo: Warwick Rodwell

The upper part of the west wall was taken down and rebuilt, including the head and one jamb of the three-light window (Figs. 456 and 545). It is not apparent why this rebuilding occurred, except that there was obviously a problem relating to the window. It may simply have been a desire to increase the height of the main lights, and thus provide better proportions for painted figures in the glazing, the thirteenth-century lights being decidedly stumpy.

Externally, medieval brick was used in the rebuild, while internally the new work was of limestone rubble, almost certainly recycling the original masonry (Fig. 462). The double chamfered sill and most of the south jamb remain from the thirteenth-century window, but the jamb and internal reveal on the north were completely reconstructed, although resetting some of the earlier stones (p. 390).<sup>76</sup> The chamfered outer reveal is continuous and there is now no hood-moulding.

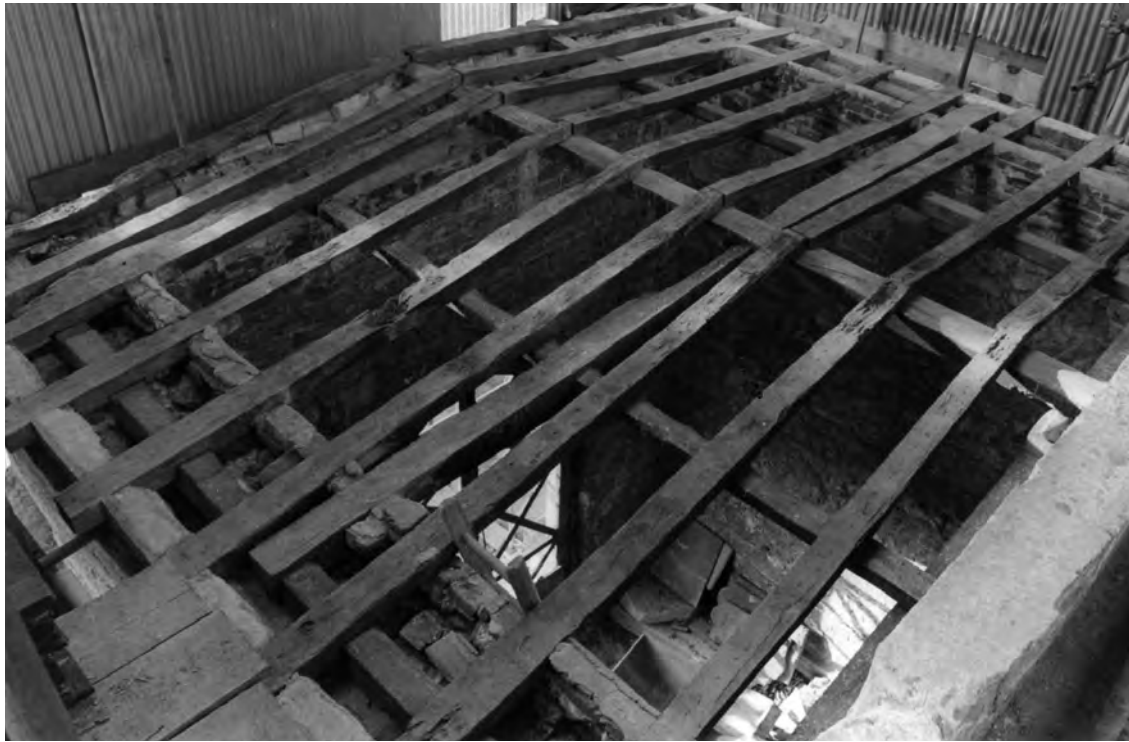
*Fig. 546: South porch. View of the roof, from the north-east, after stripping the lead and boarding, 1983. Photo: Warwick Rodwell*

the ends of six rafters oversailing the west wall (Fig. 11). The structure was studied when the lead and boarding were stripped in 1983 (Fig. 546).

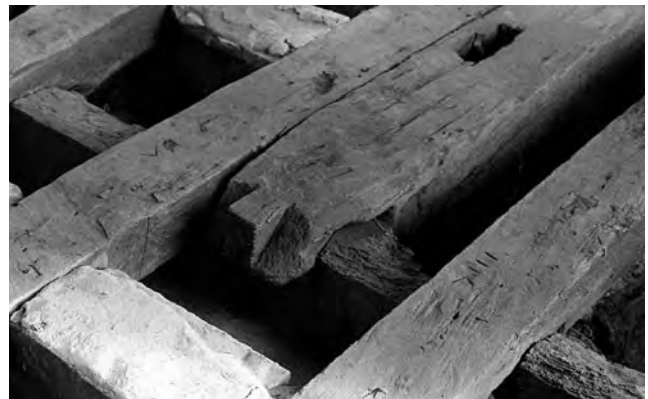
*Fig. 547: South porch roof. Detail of reused timber (with mortice on the upper side) at the south-west corner of the roof; view looking north-east. Photo: Warwick Rodwell*

into open-sided housings. Loose oak filling-pieces were then placed into the open tops of the housings: the result was a false mortice-and-tenon joint.

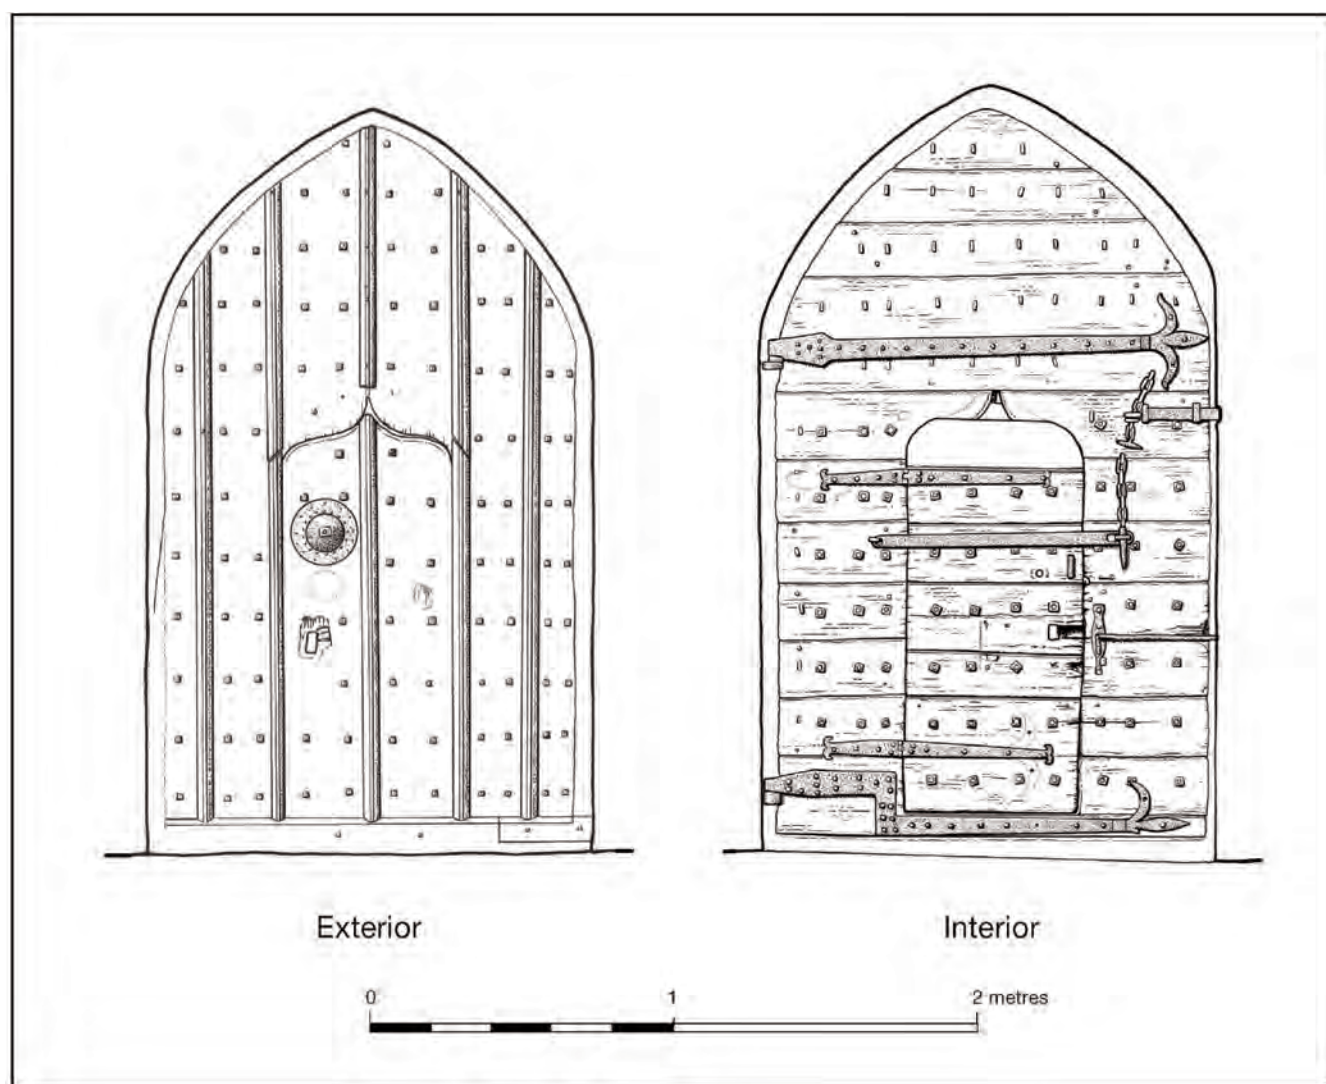
Fig. 548: North door. External and internal elevations. Scale 1:25. Drawing: Simon Hayfield

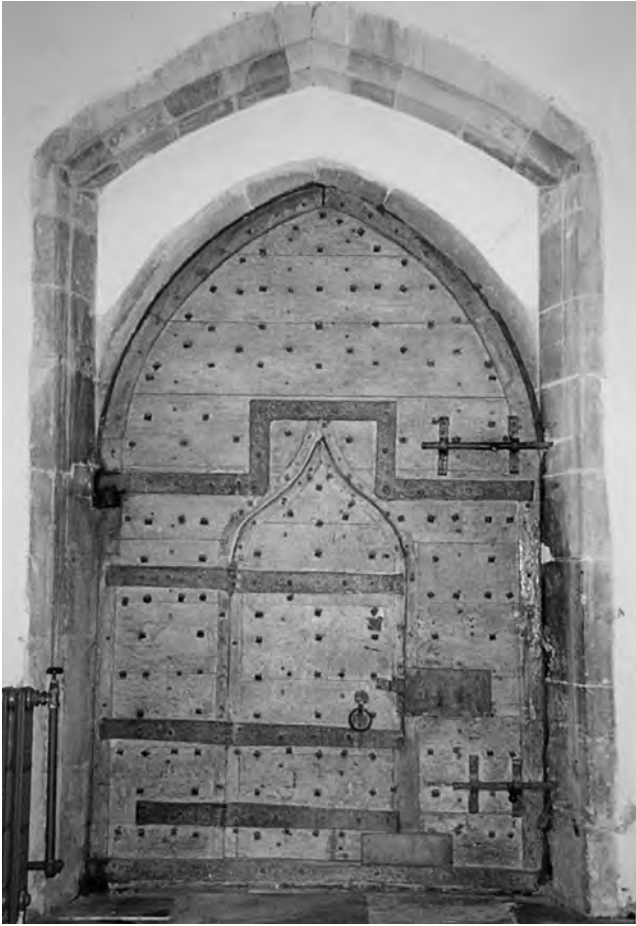
Fig. 550: *St Mary, West Walton (Norf.). Interior of a door of similar construction to that in the north aisle at St Peter's. Photo: Warwick Rodwell*
