# ST PETER'S

## Barton-upon-Humber, Lincolnshire

*A Parish Church and its Community*

HISTORY, ARCHAEOLOGY AND ARCHITECTURE

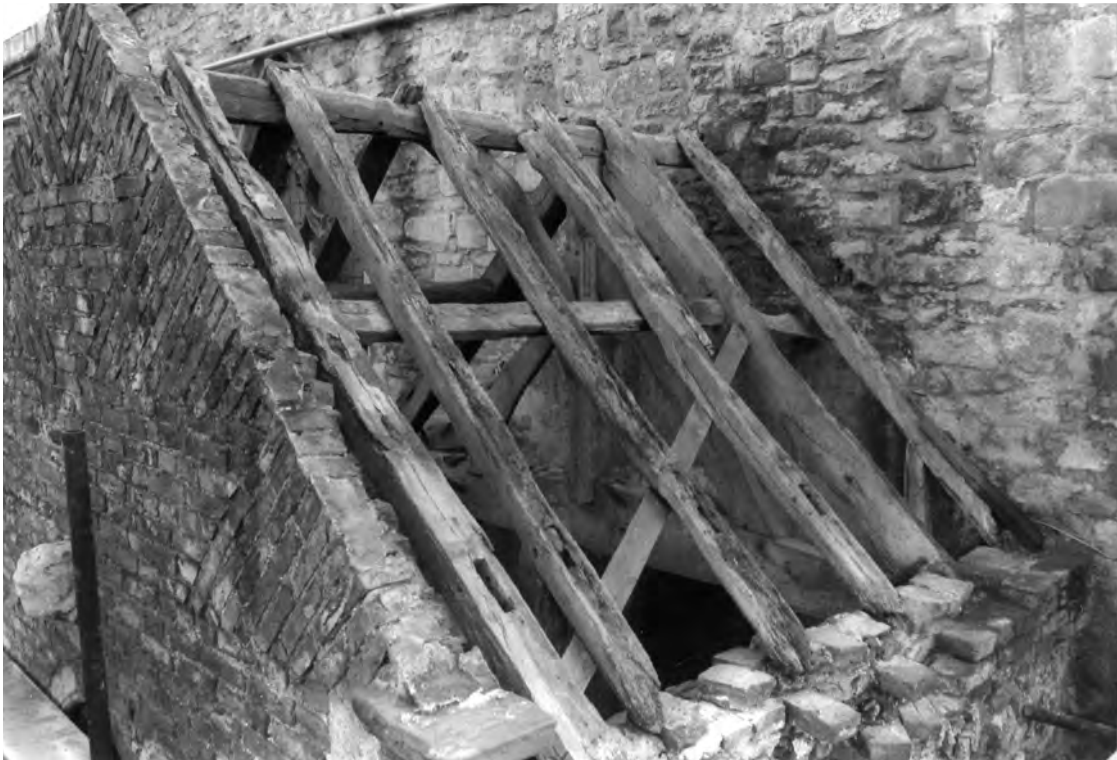
*Fig. 553: North porch roof. Viewed from the north-west during repair, 1983. Photo: Warwick Rodwell*

The oak roof is of crude construction but is nevertheless medieval, and is undoubtedly original to the porch; unfortunately, the timbers are flimsy, knotty and contain too few rings to permit dating by dendrochronology (Tyers 2001b). The roof is a structure of one bay, but there is a single crown-post truss placed a short distance away from the north wall of the aisle (Fig. 554),<sup>93</sup> and there was formerly a complementary gable-truss over the outer entrance, now superseded by the thin brick gable. The crown-post is tenoned directly into the ridge, which is also clasped by the principals. A brace links the crown-post to the ridge on its north side, and there was also a corresponding brace

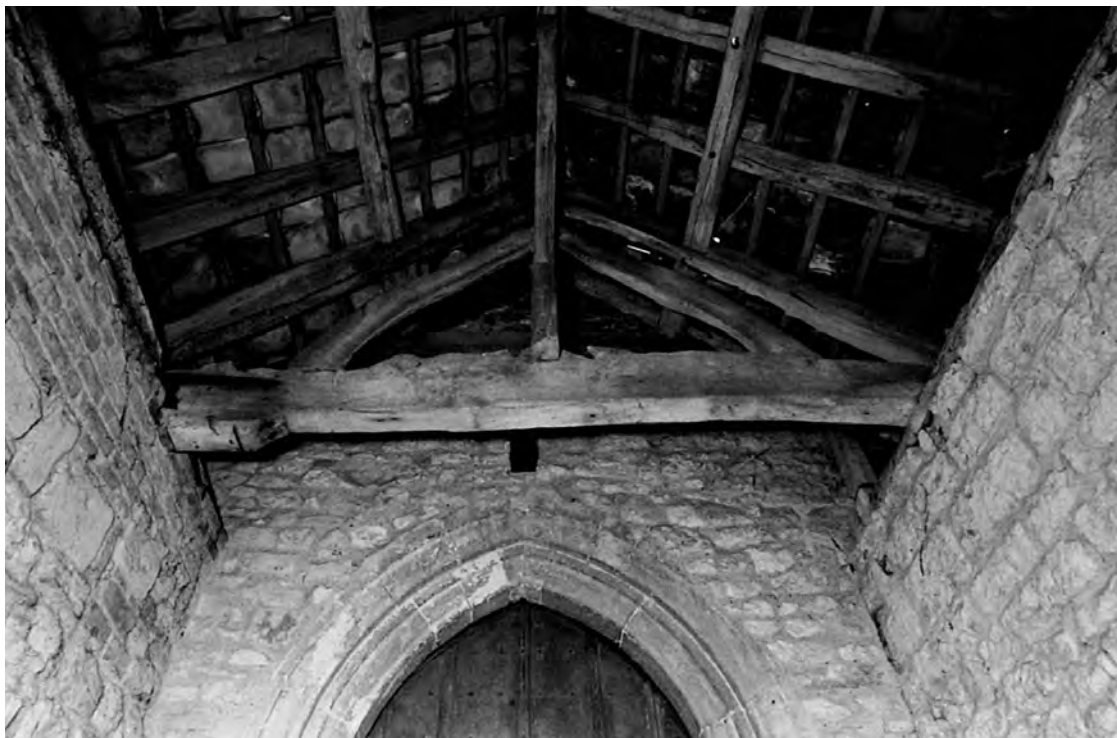
*Fig. 554: North porch roof. View of the underside, 2000. Photo: Warwick Rodwell*

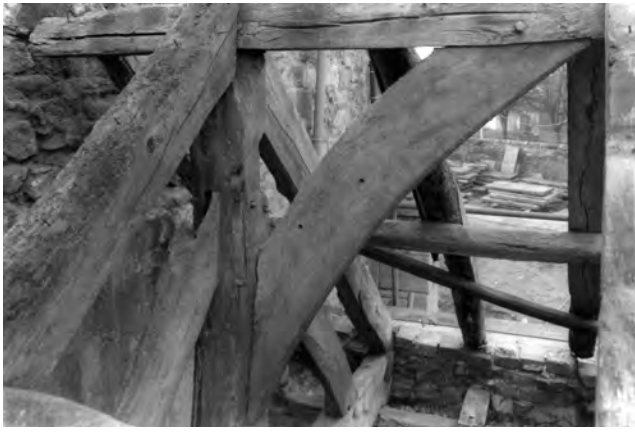
*Fig. 555: North porch roof. Detail of the crown-post truss, from the north-east. Photo: Warwick Rodwell*

rising from the gable truss to the ridge (Fig. 555). The plain rectangular crown-post sits awkwardly on the tie-beam (which has a narrow, rectangular cross-section) and is braced by two struts.<sup>94</sup> Butt-purlins run between the main and gable trusses, and short lengths of purlin span the gap between the main truss and the aisle wall.<sup>95</sup> There were pairs of wallplates on each side, with sole-pieces connecting them: only the inner plates survive, and short ashlar-pieces rise from these to the undersides of the rafters. The latter are face-pegged to the purlins.<sup>96</sup> The east end of the tie-beam decayed and an oak knee was inserted to provide support, most likely in the seventeenth century; it has an ogee moulding on its end and is nailed to the tie-beam.

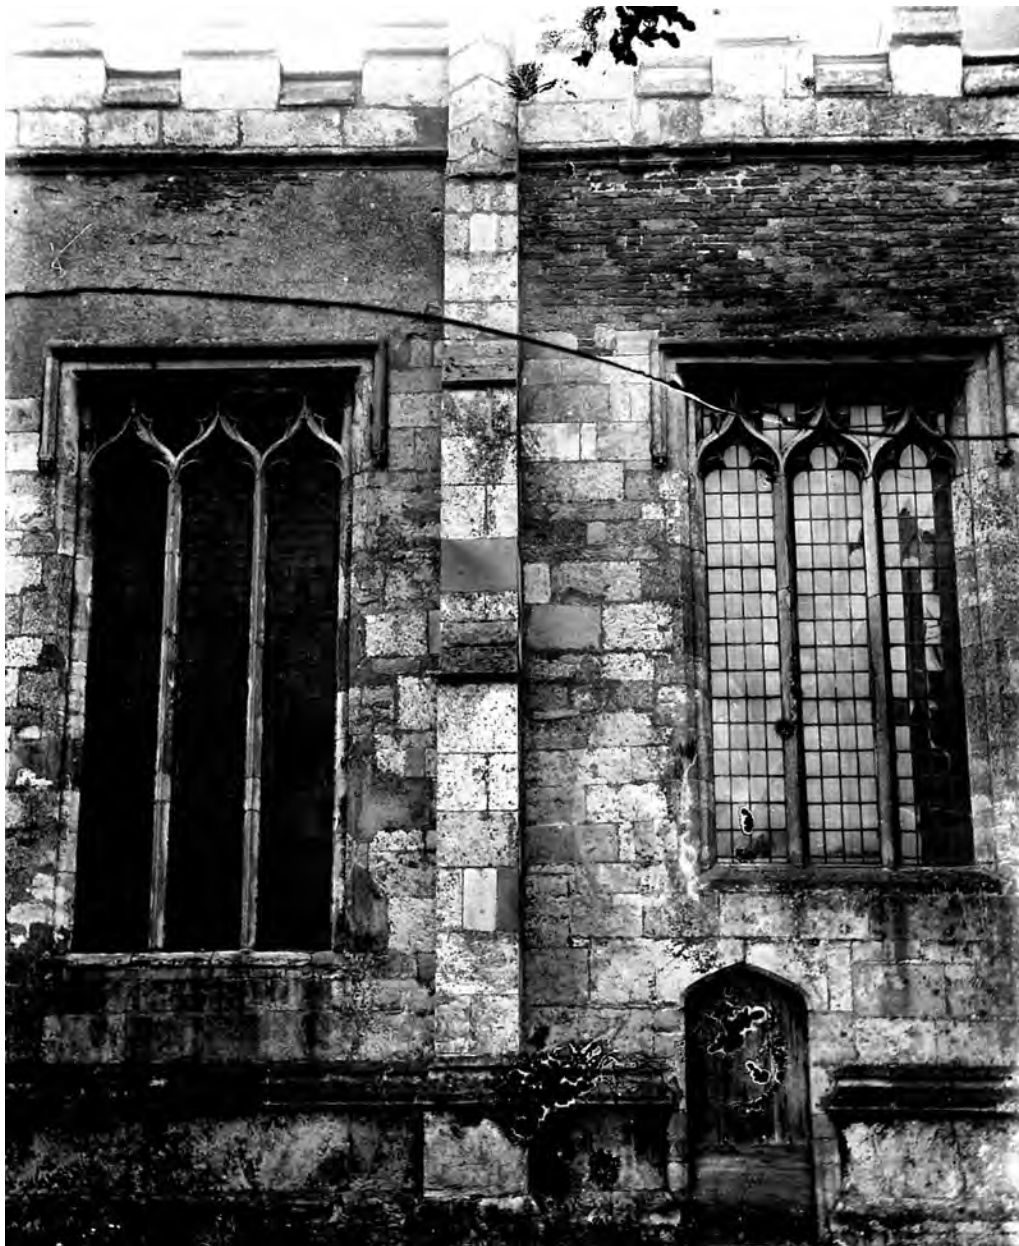
*Fig. 556: Chancel, north wall. The masonry of bays 2 and 1 before the organ chamber was built in 1897. Note the Tudor heightening of the wall in rendered brickwork, and the original position of the priest's door in bay 1. Photo: Arthur Brummitt, courtesy of John French*

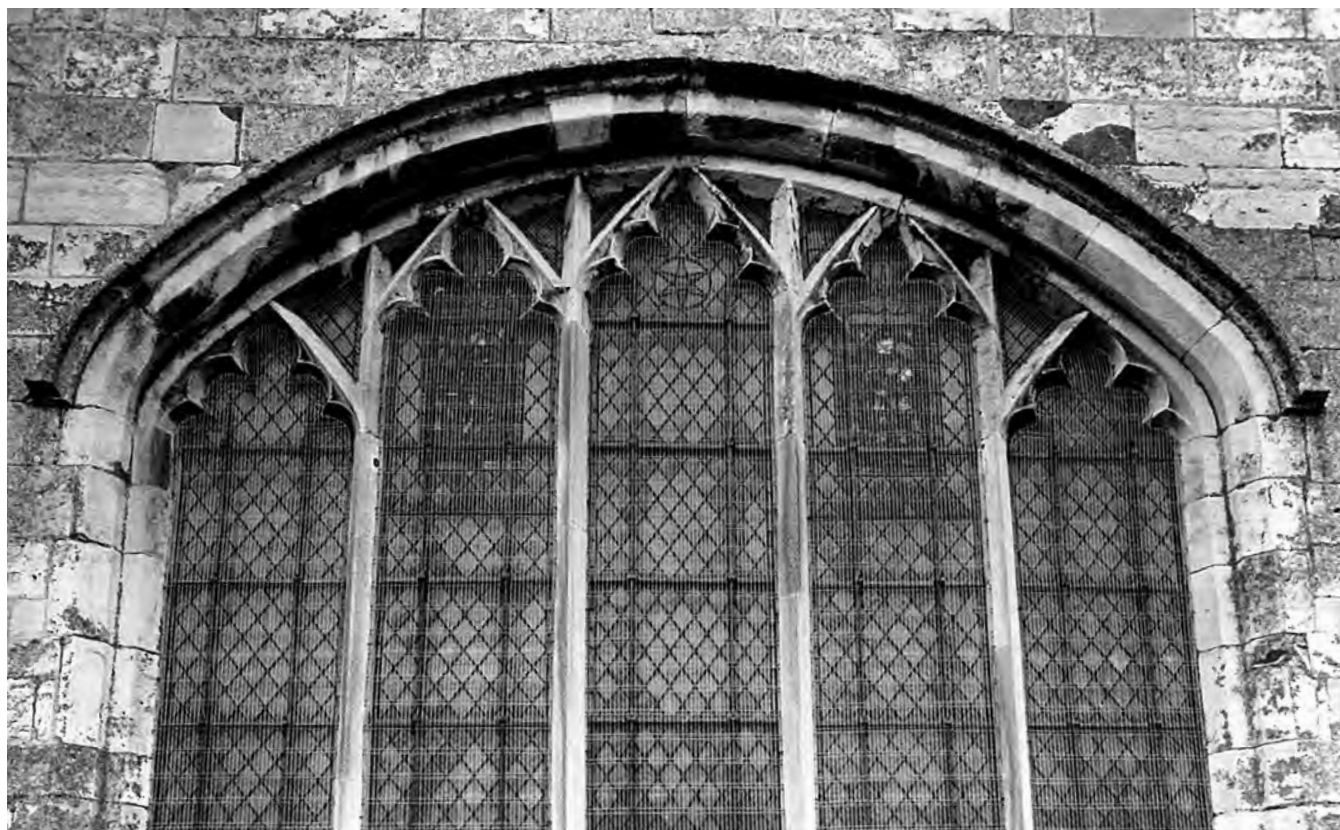
Fig. 559: Chancel east window. Late Perpendicular head and tracery, replacing Decorated tracery. Photo: Warwick Rodwell

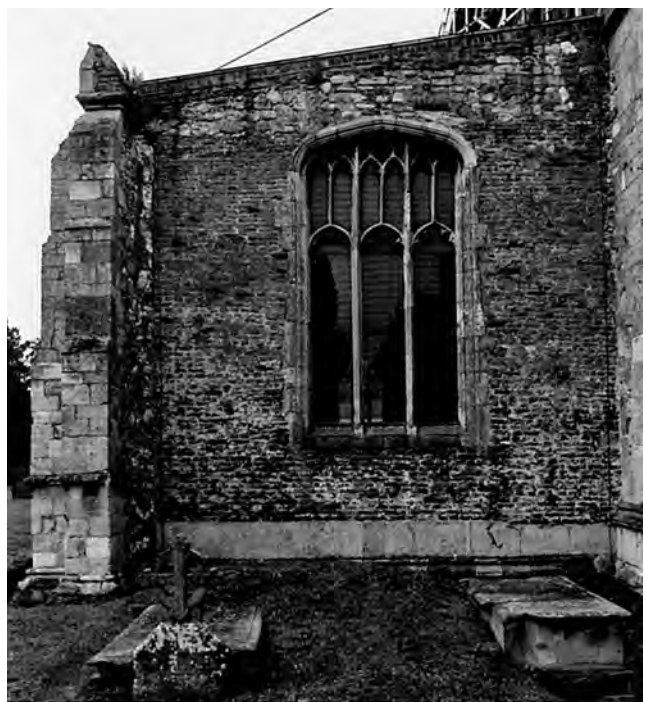
Fig. 561: South aisle. East wall unrestored, 1999. Photo: Warwick Rodwell

The thirteenth-century east wall of the south aisle was completely taken down and rebuilt 80 cm to the west of its original position. The south-east corner of the aisle, with its clasping buttresses was, however, left intact (Figs. 561 and 562). The reason for repositioning the

Externally, the wall is largely faced with Tudor brick, laid to English bond (Fig. 561),<sup>105</sup> while internally it is mainly constructed of small, roughly squared blocks of limestone with about a ten per cent inclusion of chalk blocks (Fig. 459);<sup>106</sup> three tiers of putlog holes are present. The wall was clearly intended for plastering on both faces. The new east wall rests on the thirteenth-century moulded limestone plinth, which was reclaimed from the old wall; the plinth is surmounted by a single course of large limestone ashlar (Fig. 563). The top of the wall, above the window head, is a later rebuild in mixed rubble and brick, and now has a plain modern parapet, but was previously finished with the same roll-topped stone coping as the south wall of the aisle.<sup>107</sup>

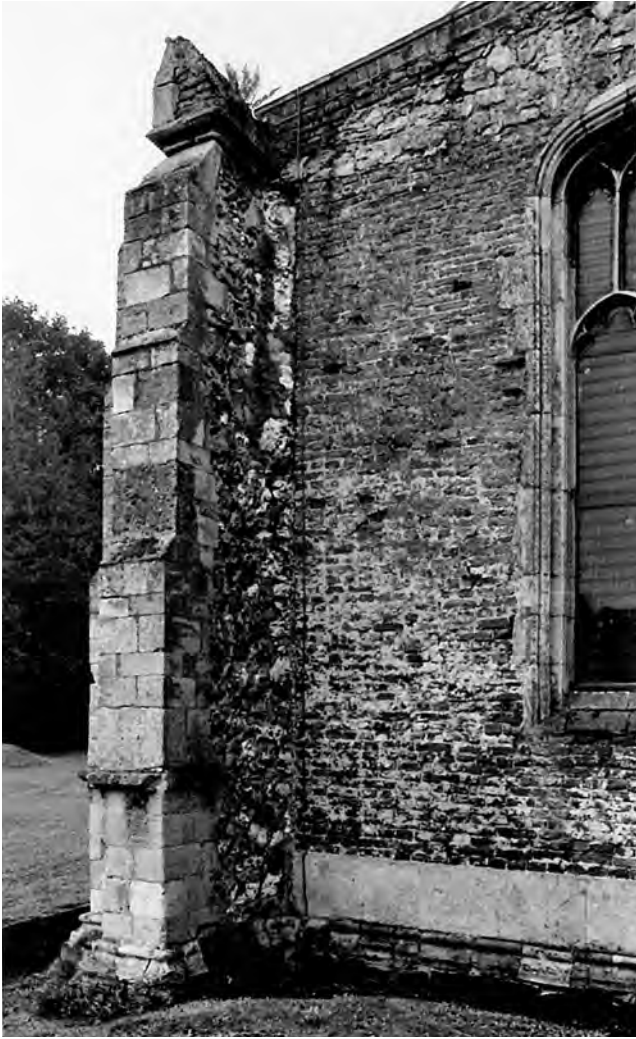
*Fig. 562: South aisle. Detail of the south-east clasping buttress, showing how the Tudor east wall was set further west than its predecessor, leaving a rubble scar on the side of the buttress. Photo: Warwick Rodwell*

east end of the aisle was to provide support for the lateral thrust of the relatively new chancel arch, which was apparently showing signs of structural failure. Its southern end was sinking into the soft filling of one of the underlying Anglo-Saxon ditches, probably the same one that caused distortion in the east end of the north aisle (p. 474).

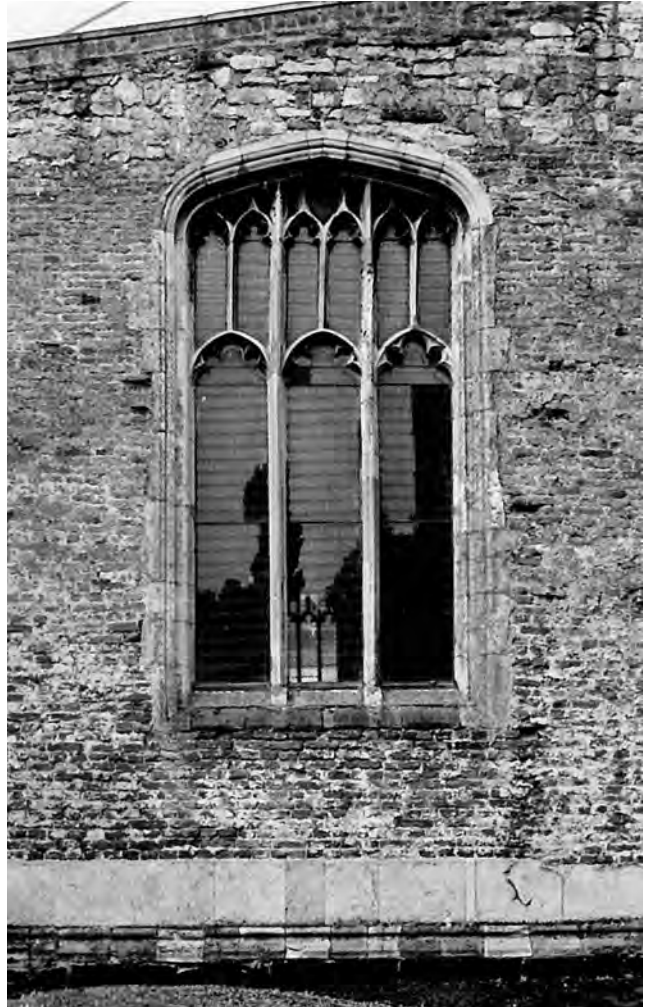
*Fig. 563: South aisle. Detail of the east window, 1999. Photo: Warwick Rodwell*

The thirteenth-century east window was discarded and a new one incorporated in the rebuild; the glazing is set at the mid-point of the wall's thickness, and the complex mouldings extend symmetrically to both faces (Figs. 50, 19, and 563). The same distinctive, fine-grained, yellow limestone was used as occurs in the clerestory and chancel arch. The window has three cinquefoil-headed main lights and six small ones in the tracery. The four-centred arch, jambs and principal mullions are all moulded, but there is no label. The mullions rise from sill to head without interruption; they have thin, filleted frontal rolls. The sill has two chamfered orders and the block-stoolings are very prominent.

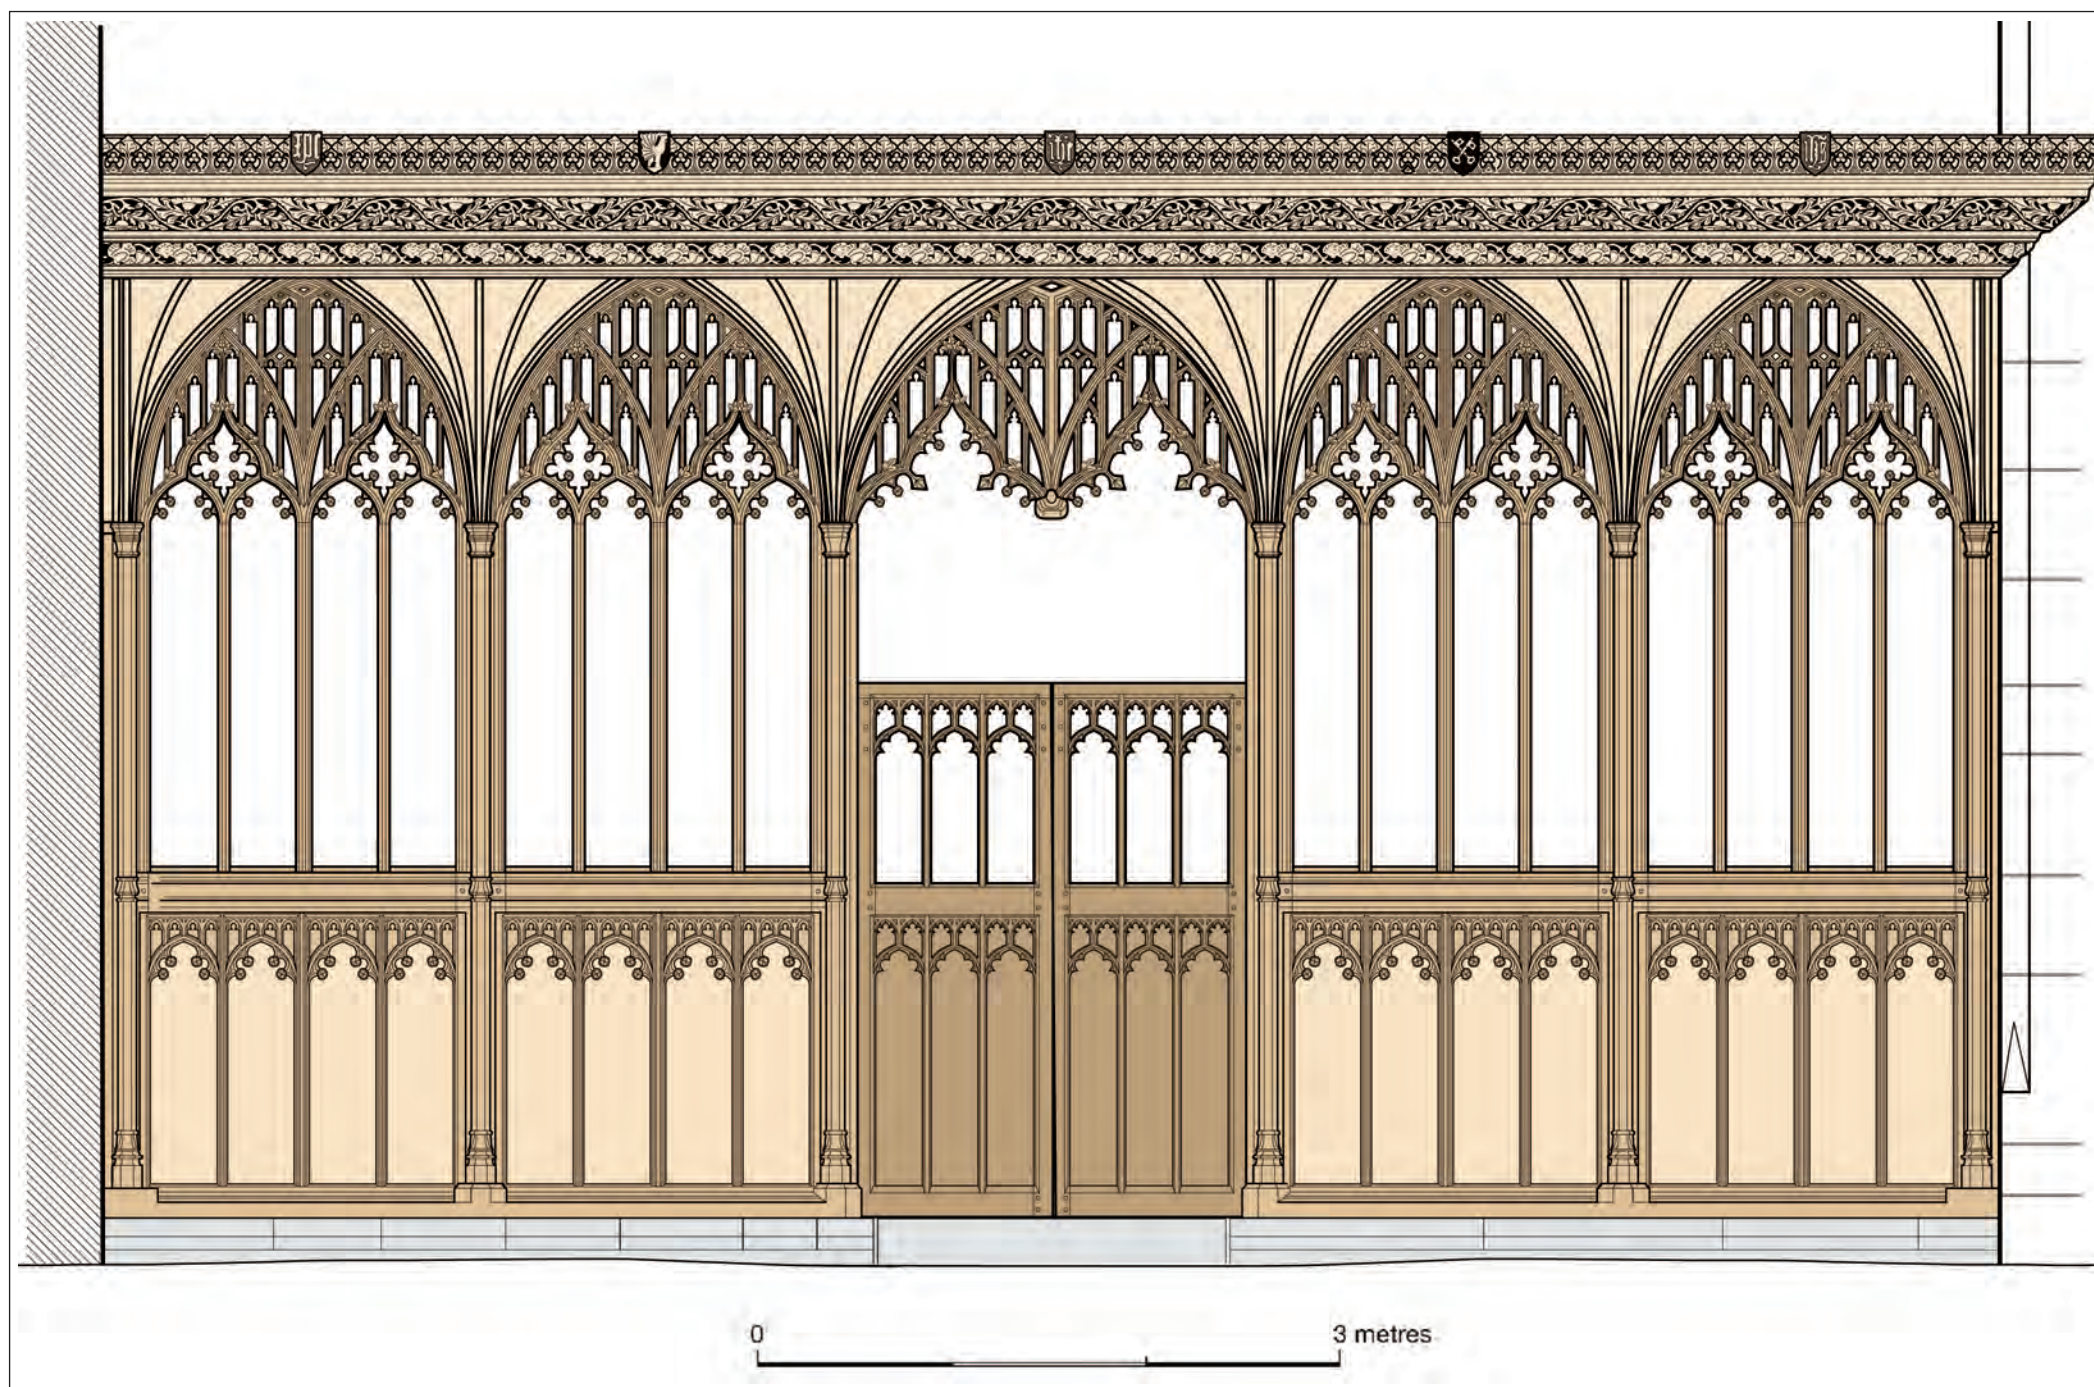
*Fig. 564: Chancel screen. Elevation of the west face. Scale 1:40. Drawing: Simon Hayfield*

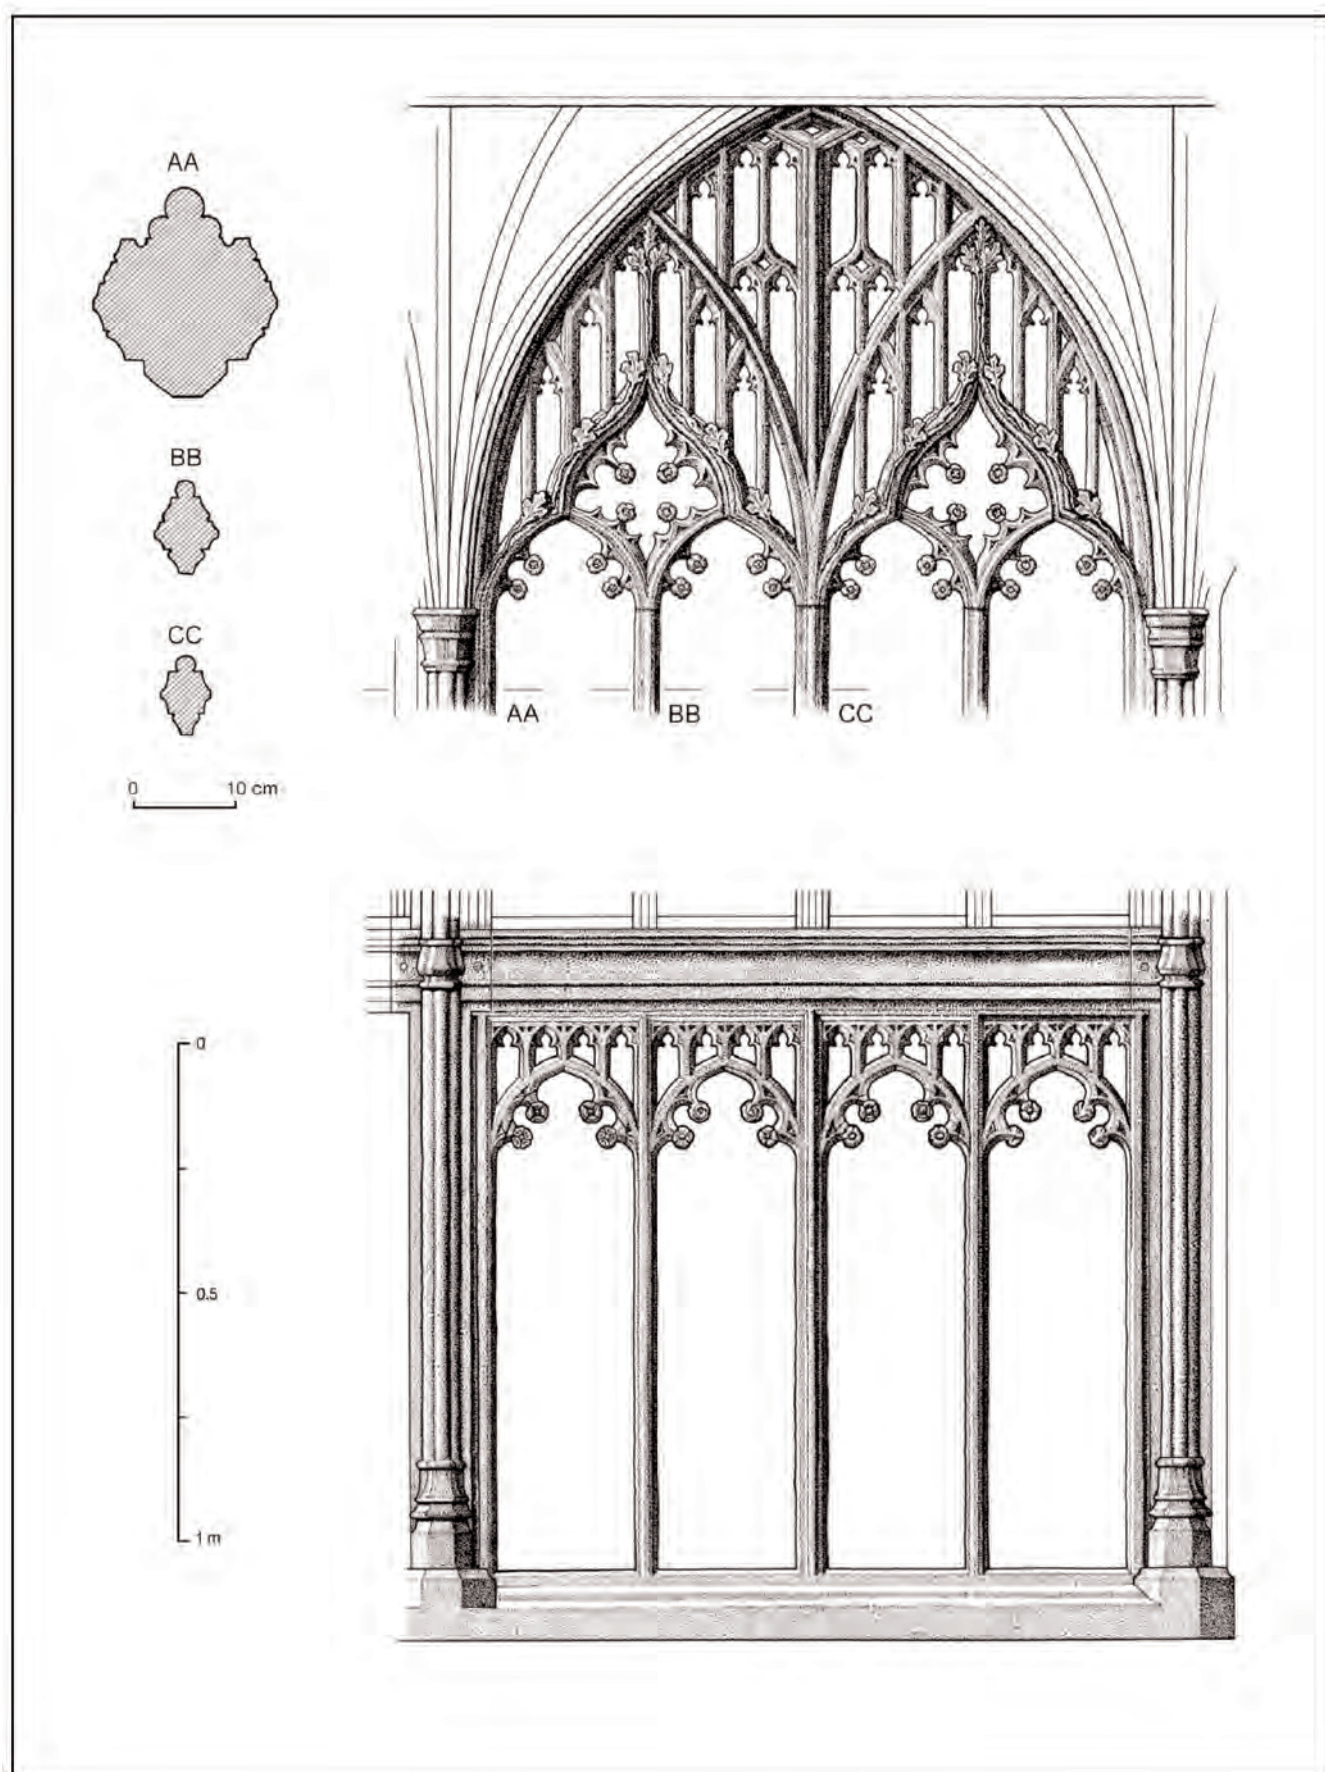
Fig. 565: Chancel screen. Detail of the traceried upper and lower registers of one bay (west face). Scale 1:15; moulding profiles 1:7.5. Drawing: Simon Hayfield

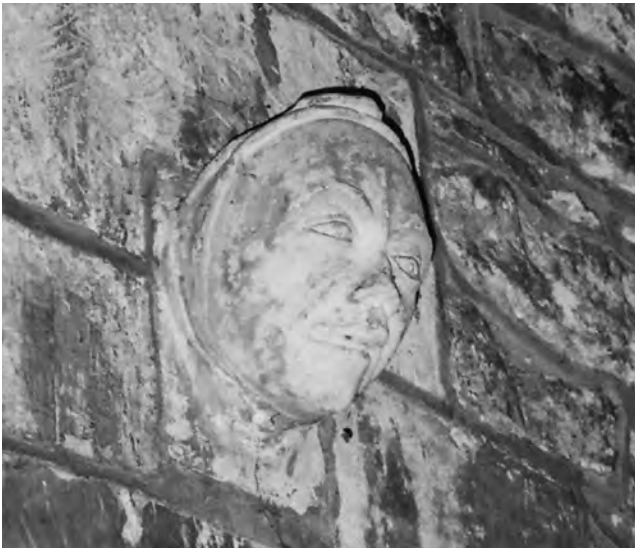
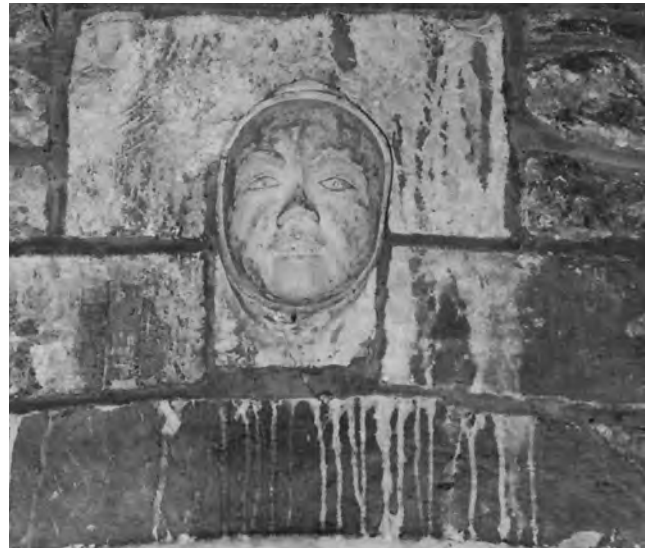
Fig. 567: *All Saints, Goxhill (Lincs.)*. Limestone head of a cowed monk, set internally over the north aisle doorway. Photos: Warwick Rodwell

It is possible to argue that the different facial types grouped in this way do not represent as many sculptors, but the number of models in the same workshop, on which any of the craftsmen could have worked interchangeably. There is, however, one head that could not be explained in this way: no. 11, the rectangular head blocked out without any understanding of depth: it is different in scale and skill from any of the others in this church. On the other hand, the Goxhill head (Fig. 567) is strikingly similar to it.

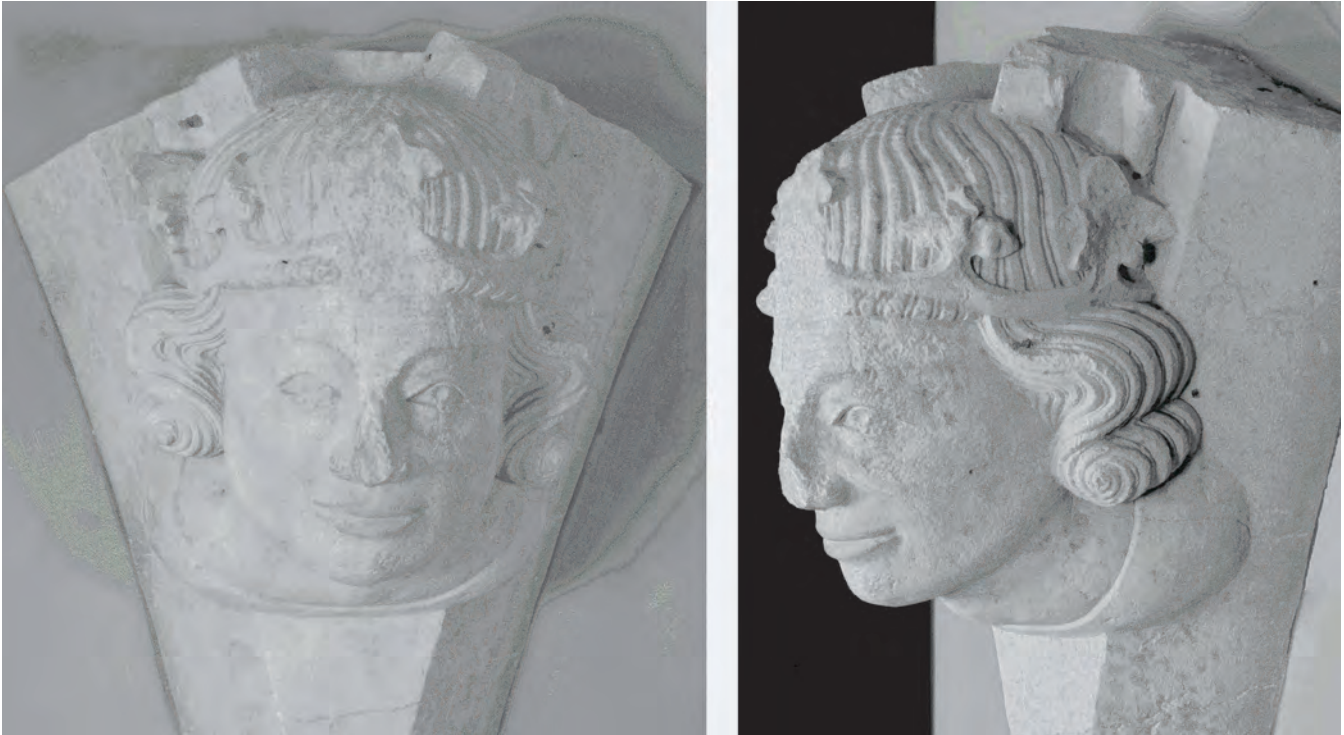
Fig. 568: Thornton Abbey (Lincs.). Arcade label-stop: king's head. Photos: English Heritage

Thornton include the pointed and slightly receding chins of the Barton males, and in particular their full and somewhat pouting lips. The more subtle carving at Thornton is exaggerated at Barton into a definite local characteristic.

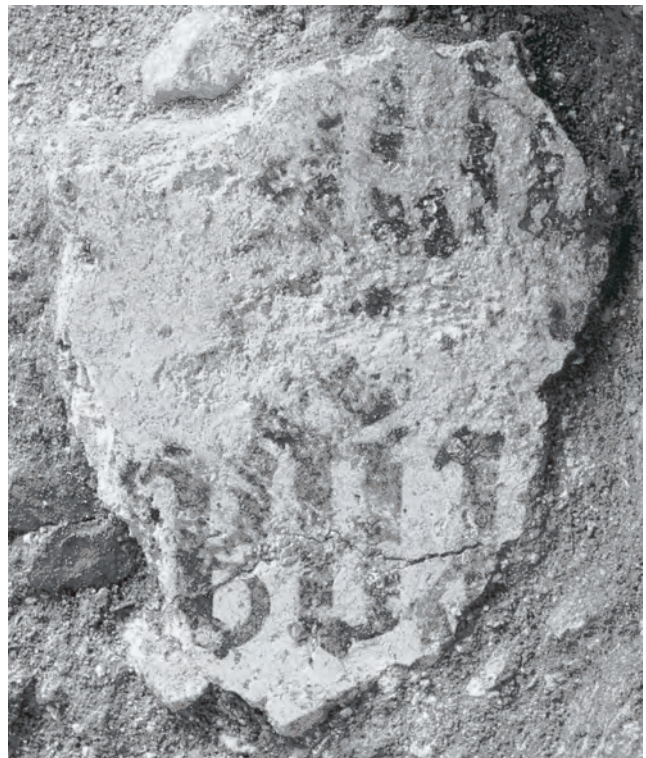
Fig. 575: North porch. Fragment of wallplaster with two lines of a painted black-letter inscription; found under the floor (F3672). Max. width 16.5 cm. Photo: Warwick Rodwell

While there are vestigial traces of medieval polychromy in both St Peter's and St Mary's, nothing is known of decorative schemes in these churches. The sole evidence for post-Reformation texts is provided by a detached piece of wallplaster bearing a few black painted letters, on two lines: it was found in rubble under the floor of the north porch of St Peter's (F3672; Fig. 575).

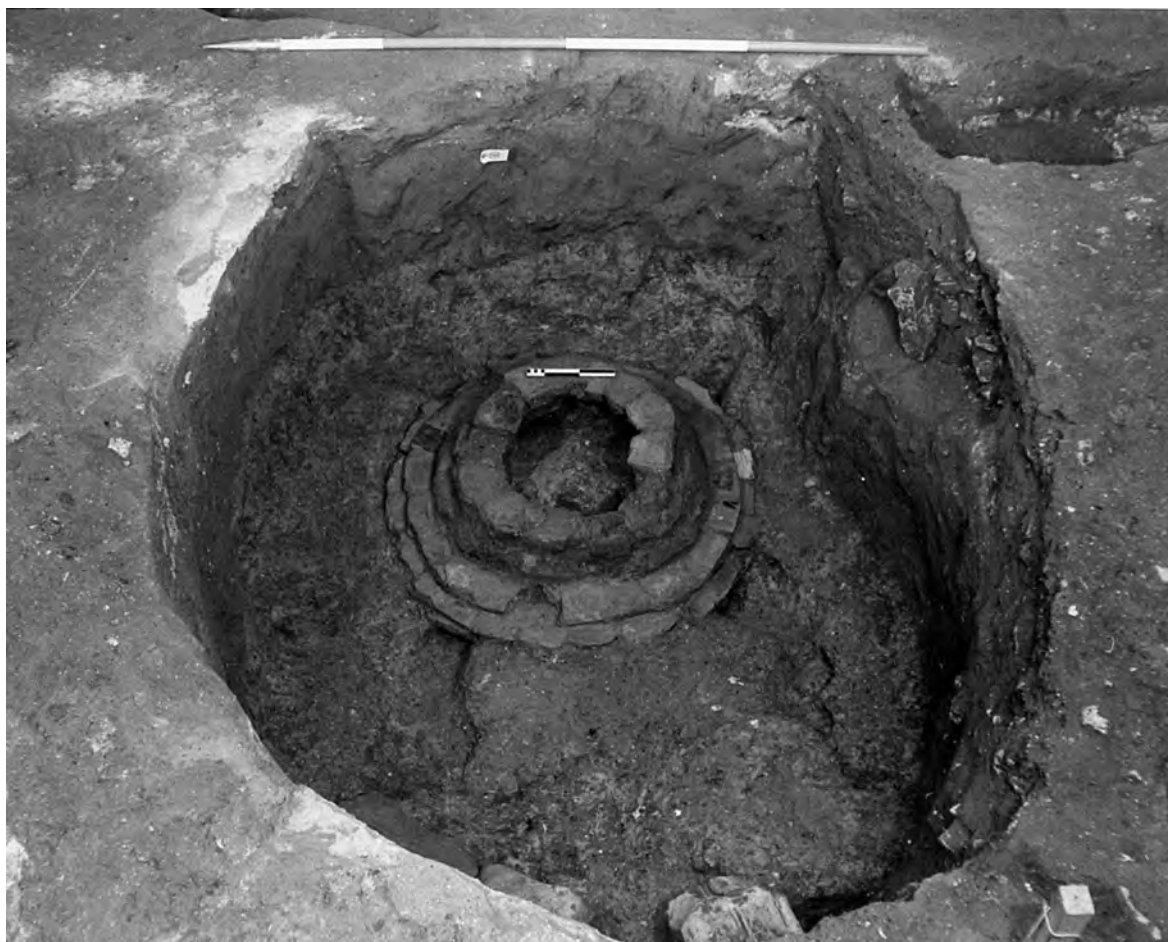
*Fig. 577: Tower. Bell-casting pit (F511) with part of the inner core of the bell-mould remaining in situ. View west. Scales of 2 m and 25 cm. Photo: Warwick Rodwell*

Excavation revealed a slightly elongated, sub-circular pit, dug into the natural clay close to the centre of the tower floor (F511; Fig. 577). It had near-vertical sides and a flat bottom, and averaged 2.2 m (7¼ ft) in diameter by c. 1.0 m (3¼ ft) deep. In the base of the pit (towards the west side) a cone was constructed, reusing broken bricks and fragments of floor tiles, set in a matrix of stiff brown clay (F553) and laid to courses (Fig. 578). Only the lowest five courses of the cone survived intact, and debris from the destruction of the remainder of the feature littered the bottom of the pit. The interior of the cone was hollow and at its centre, in the clay floor of the pit, was a stake-hole 2 cm in diameter by 10 cm deep. Also, dug radially under the base of the cone, from the outside to the hollow interior, were four channels. The tiles, all well worn, were of the fourteenth-century glazed type found in the nave and aisles (p. 459); the bricks were Tudor.

The conical structure was clearly identifiable as the inner core of a clay mould for casting a large bell by the *cire perdue* or 'lost wax' process. There were several different ways of making and handling medieval and later bell-moulds,<sup>3</sup> but the relevant particulars in this instance are as follows. The hollow core, which was strengthened by the inclusion of brick and tile rubble, would have been built up to the full internal height of the bell, then coated with a layer of fine clay. The central stake-hole contained an upright stick, acting as an arbor, around which was rotated a wooden template to smooth the clay into the required internal profile of the bell. Next, a thick layer of wax was built up on the core, and another template used to mould and scribe

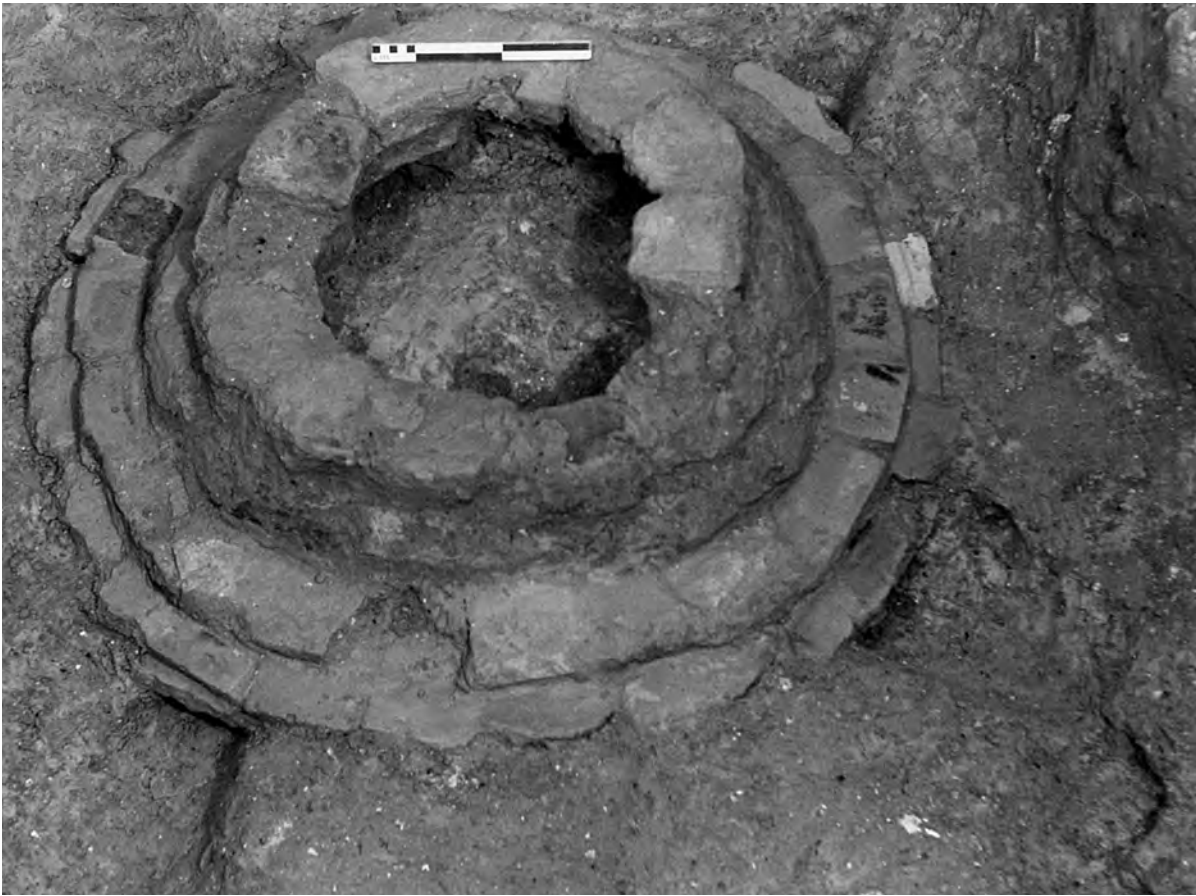
*Fig. 578: Tower. Detail of the surviving inner core of the bell-mould, made of reused medieval bricks and floor tiles. Note the radiating channels emerging from beneath the core. View west. Scale of 25 cm. Photo: Warwick Rodwell*

Following excavation and dismantling of the core, it was discovered that partly underlying it and extending to the east was evidence of another, earlier bell-mould in the base of the pit. It was approximately the same diameter as the later mould, but the evidence does not admit of a precise dimension: all that survived was a circular indentation in the base of the pit, a central stake-hole and four radial channels. Hence, two bells had been cast in the same pit. However, that does not necessarily establish that two bells were successfully produced and hung in the tower. Mishaps in casting were not uncommon, and it could be that the second mould represented the recasting of a bell that failed on the first attempt. On the other hand, it is perhaps no coincidence that St Peter's tower contains a second bell by Henry Oldfield which is only 7.5 cm (3 ins) smaller in diameter. This could have been cast first, in the same pit.

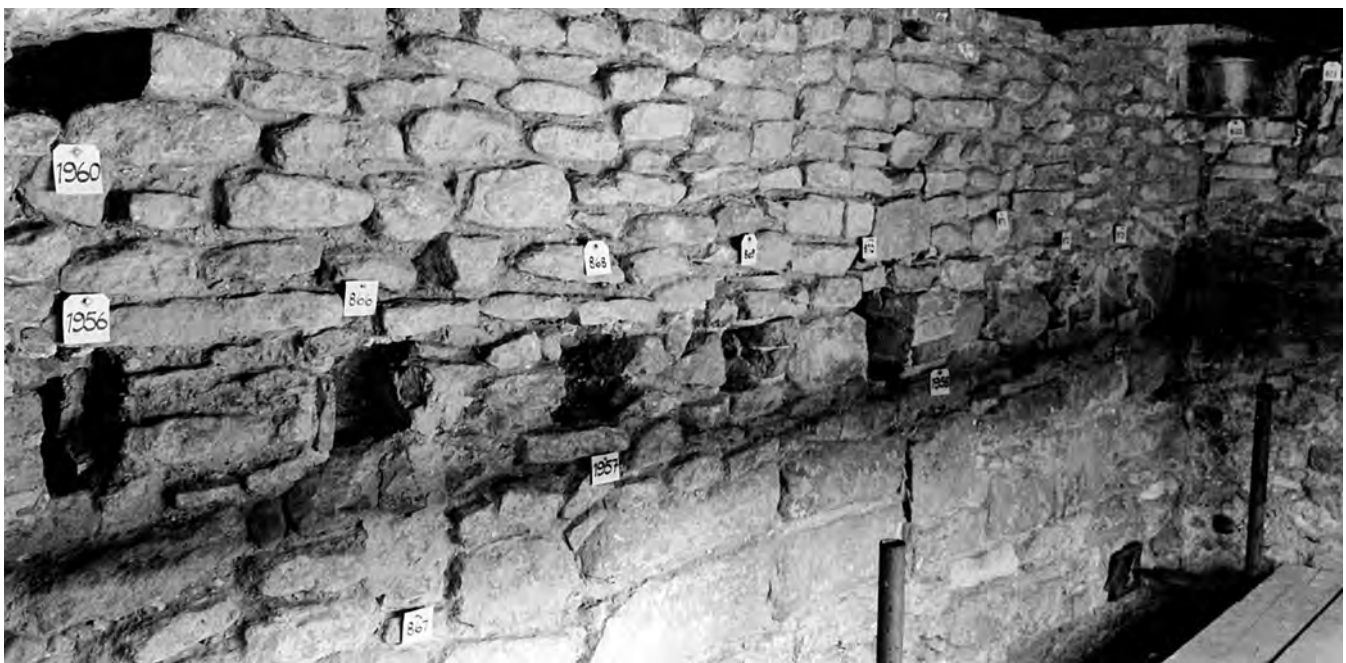
Fig. 579: Tower, south wall. A series of pockets cut to receive the joists for a post-medieval ringing-chamber floor which was removed again in 1858. Note the stone corner-bowl at top right (see Fig. 580). View south-west, 1980. Photo: Warwick Rodwell

Until 1858, an old floor existed in the first stage of the tower: it was not at the same level as the former Anglo-Saxon gallery, but lay 90 cm below it. The floor was carried on twelve closely spaced joists, running north-south (Fig. 579); pockets for these had been cut into the Anglo-Saxon masonry. When the floor was inserted, an integral staircase was constructed against the north wall: it rose from the ground at the north-east corner of the tower, to first-floor level at the north-west corner. It seems to have been seventeenth or early eighteenth century.<sup>15</sup> The floor had doubtless been lowered in order to provide more manoeuvring space in the ringing-chamber.

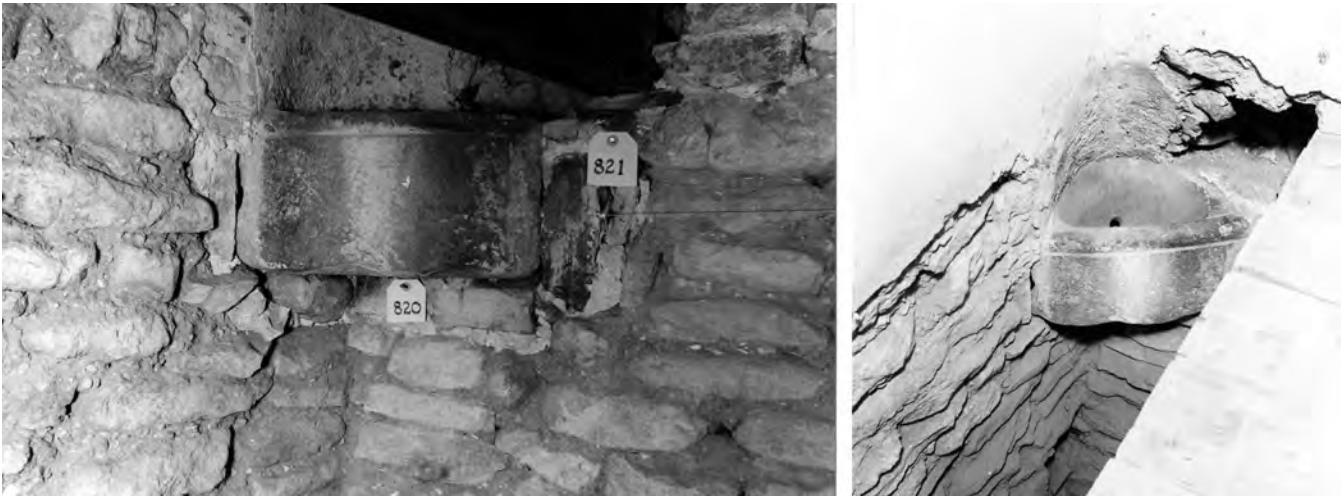
Fig. 580: Tower. Two views of the quadrant-shaped limestone bowl, probably originally a stoup, reset in the south-west corner of the ringing-chamber for use as a bellringers' urinal. Photos: Warwick Rodwell

Related to the lowered floor was the installation of a segmentally shaped limestone bowl in the south-west corner of the ringing-chamber (Figs. 579 and 580). The bowl, which is 23 cm deep overall and was designed to fit in a corner, has a curved front with a plain roll-moulded rim. Originally, it is likely to have been a holy water stoup, but is difficult to date: it could be later twelfth or thirteenth century. However, the bowl cannot have been placed in its present position until the post-medieval period, when the floor was lowered. Since the rim of the bowl is only 65 cm above floor level, it is too low to have been used as a lavabo, but was ideal as a urinal for the bellringers. There is a drilled hole in the base of the bowl, which presumably drained to the outside, via a channel in the wall core. The hole must be secondary, since stoups did not have drains. A simple recess with a plastered soffit was formed in the masonry at the corner of the tower, creating a partial hood over the basin.

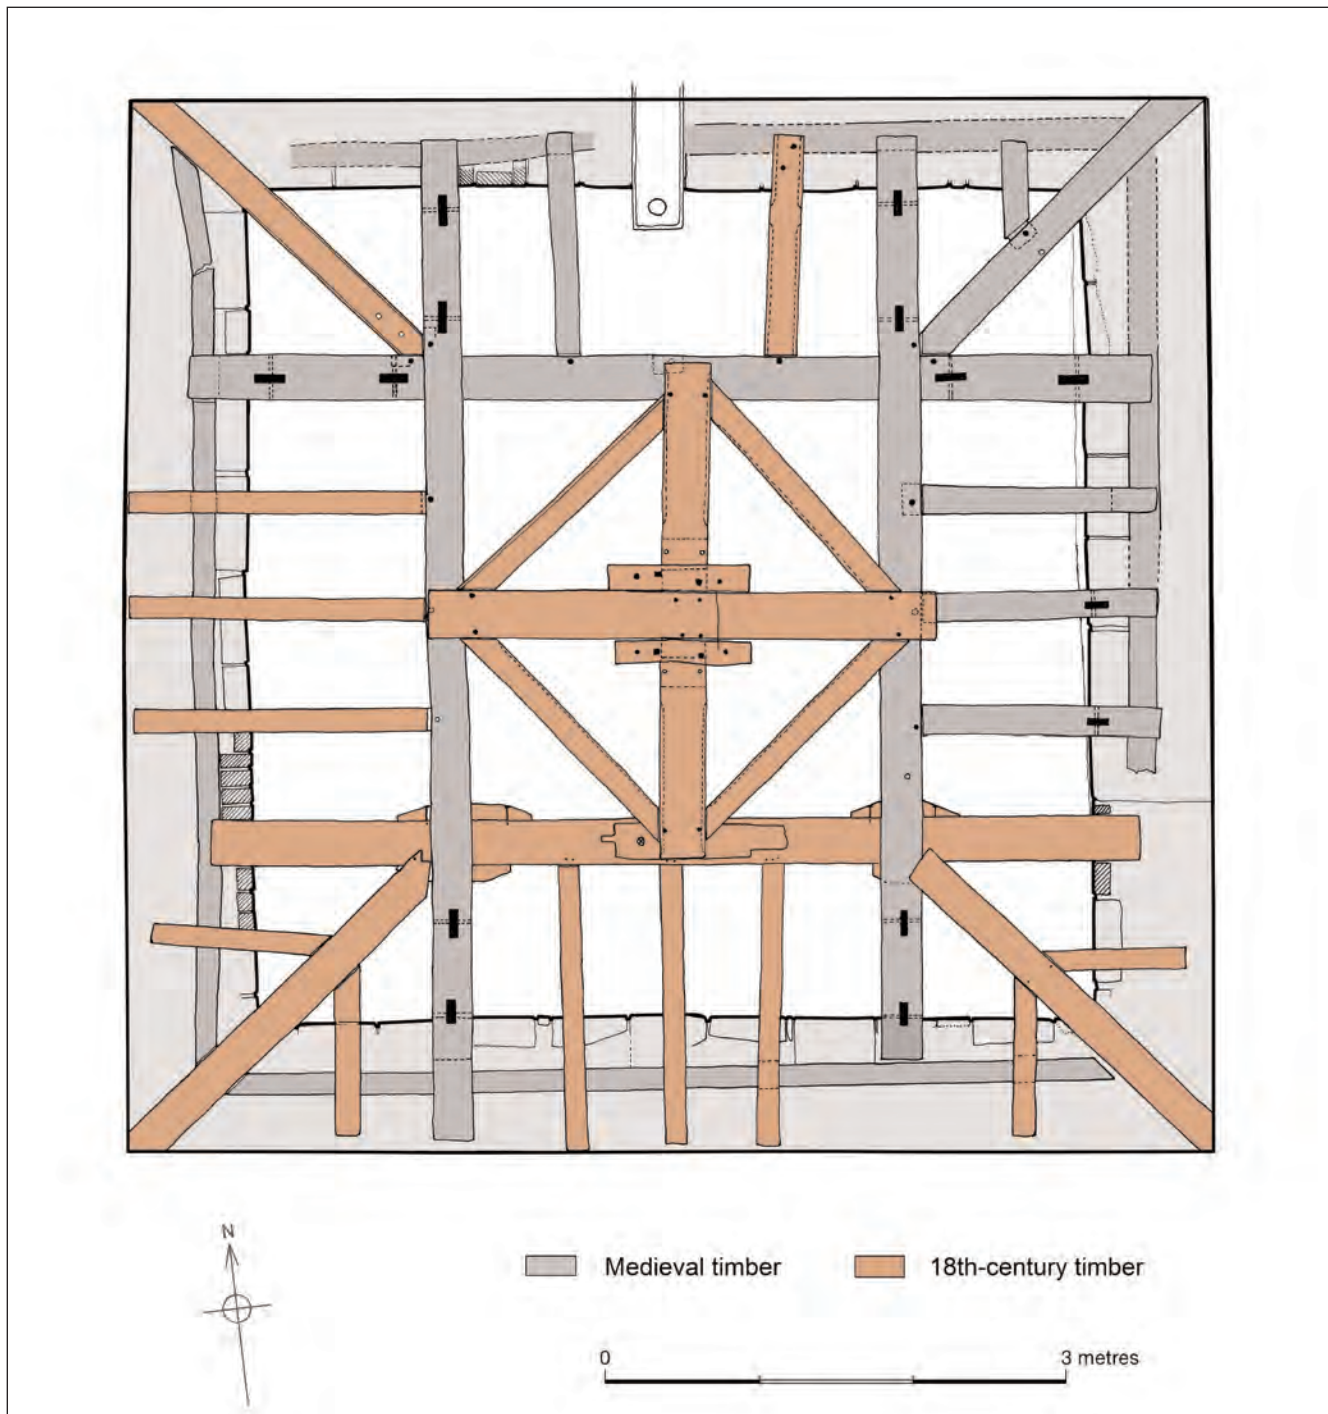
*Fig. 581: Tower. Plan of the existing roof structure. Post-medieval timbers are shown in outline. For a detailed drawing of the surviving medieval components (grey-toned), see Fig. 538. Scale 1:50. Drawing: Stephen Coll*
