# ST PETER'S

## Barton-upon-Humber, Lincolnshire

*A Parish Church and its Community*

HISTORY, ARCHAEOLOGY AND ARCHITECTURE

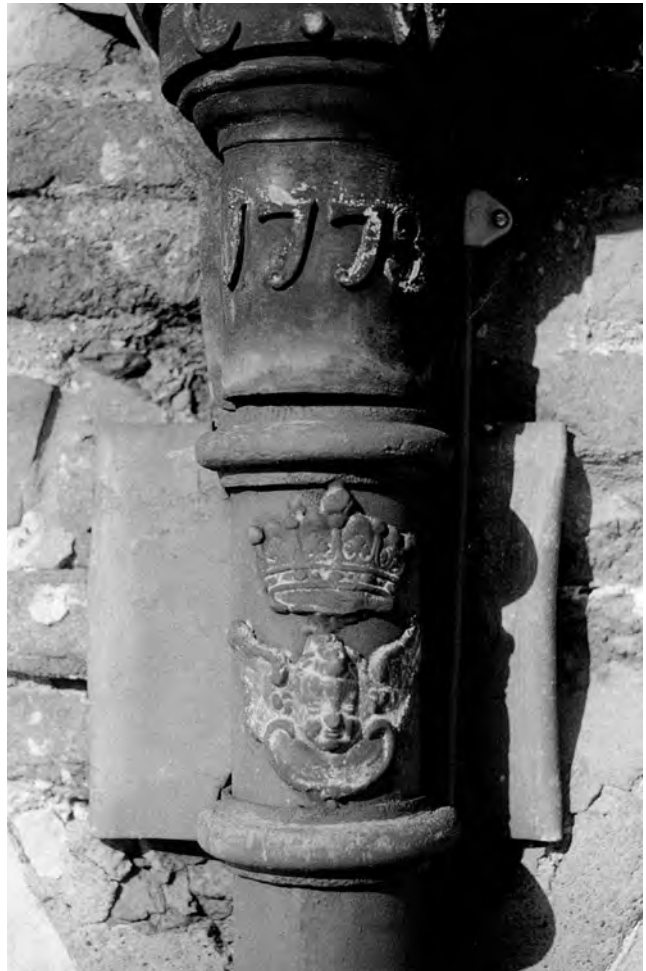
Fig. 584: South clerestory, central rainwater pipe. Detail of the dated hopper-head and cast lead plaques on the uppermost collar of the downpipe. Photo: Warwick Rodwell

Dates and initials are frequently found on lead rainwater goods, and it is not uncommon for the pipe-collars and their flanges to bear cast decoration, such as rosettes, fleurs-de-lys, lions' heads and human masks. Neo-classical figures appear more rarely, but there is also an example from St Mary's church (p. 127). Winged cherubs sometimes occur, as on the hopper-heads of 1707 at Westminster Abbey. Coronets are generally found on domestic leadwork associated with noble families, and the appearance of a coronet at St Peter's must surely indicate that Lord Nelthorpe paid for the work. The Nelthorpes were the only titled family in Barton in the eighteenth century (p. 50).

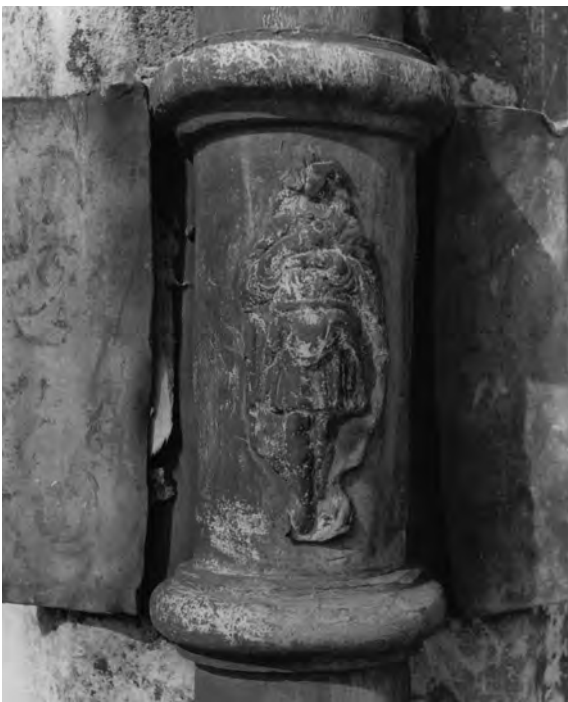
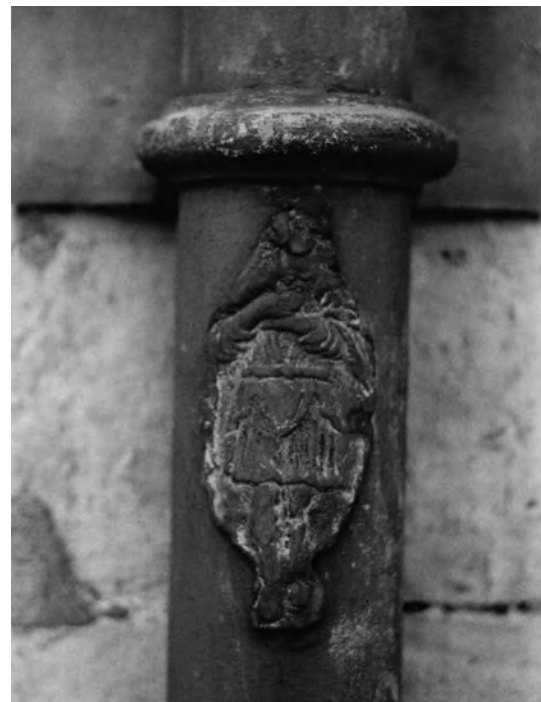
*Fig. 586: South clerestory. Neo-classical cast lead figure of a Lar. A, in its original location (1980) on the medial collar of the central downpipe; B, in its present location, below the medial collar of the renewed western downpipe. Photos: Warwick Rodwell*

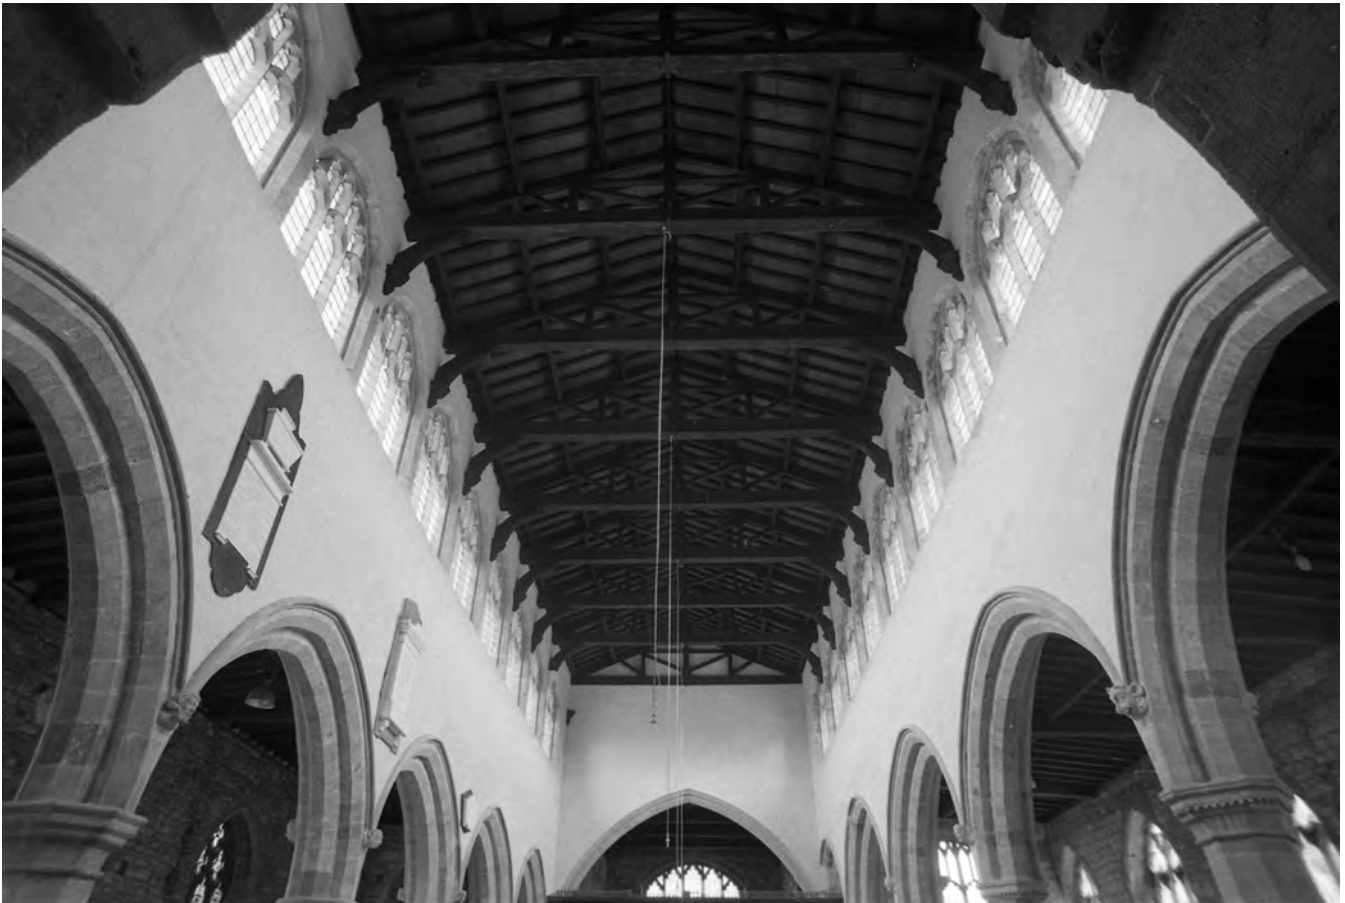
*Fig. 589: Nave roof, looking east, 2005. Photo: Warwick Rodwell*

erected over the nave of the church, which is under drawn and divided into compartments, forming cross elliptical arches, that spring from neatly executed brackets between each of the upper windows'. The present oak corbels (1858) occupy the sites of those brackets (Figs. 589 and 591).<sup>45</sup>

While the king-post trusses with their queen struts date from 1805 (Fig. 591), the extant ornamental brackets and timber corbels beneath the tie-beams were clearly designed to be seen from below, and thus cannot be earlier than 1858: they must have been added to the existing structure, after the removal of the ceiling and the brackets that supported it (Fig. 589).

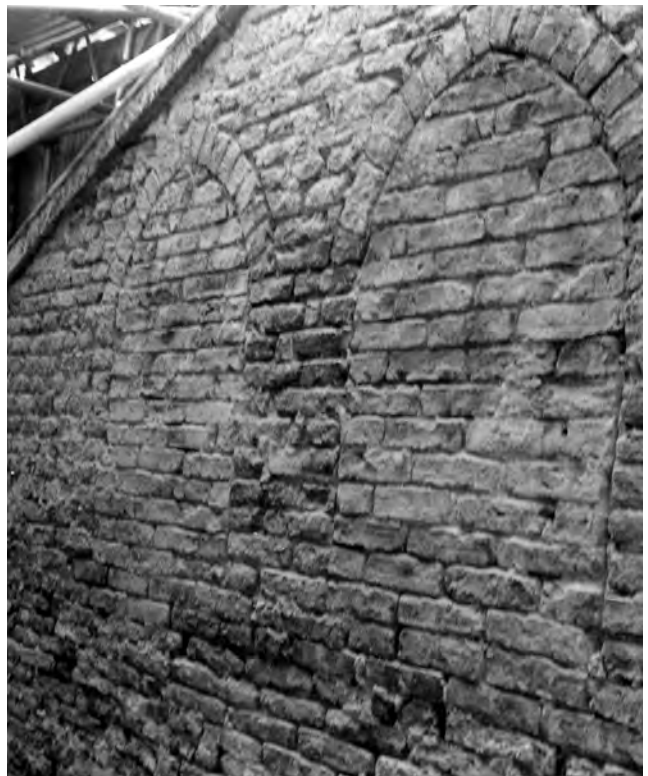
*Fig. 590: Nave, exterior of the east gable, 1984. Two blocked openings which formerly ventilated the space between the roof and the ceiling. Photo: Warwick Rodwell*

adequately ventilating a ceiling of this kind, to prevent condensation on the underside of the lead, and the possible outbreak of dry rot, was appreciated and consequently two arched openings into the roof void were provided at the east end (Fig. 590), and on the west the conveniently situated lower double belfry-opening in the tower was unblocked.<sup>49</sup> A through-draught was thereby created. Iron railings were installed in the belfry openings, to prevent bellringers and others from gaining access to the void above the nave ceiling (glimpsed in Fig. 289).

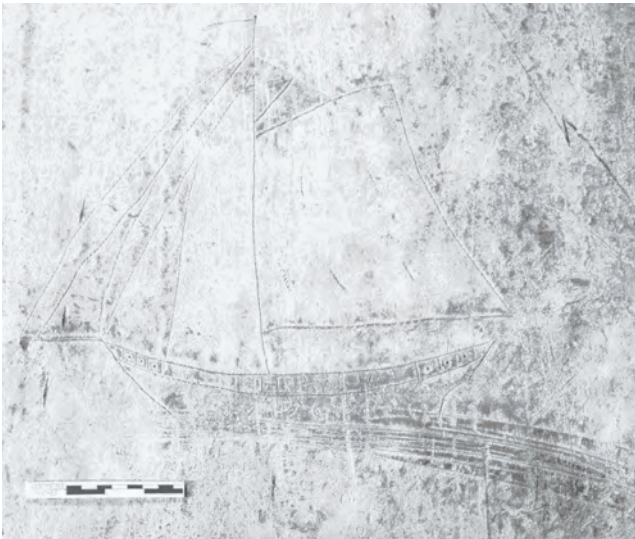
Fig. 592: Nave roof, 1978. Graffiti on lead. A, Sailing ship, inscribed by H. Porter, 1806. Photo: Warwick Rodwell

- Punched outline of a sailing ship, bearing the inscription on the side of the hull, *H. Porter / 18/0/6*<sup>50</sup>  
Incised lines below the ship represent the sea (Fig. 592, A).

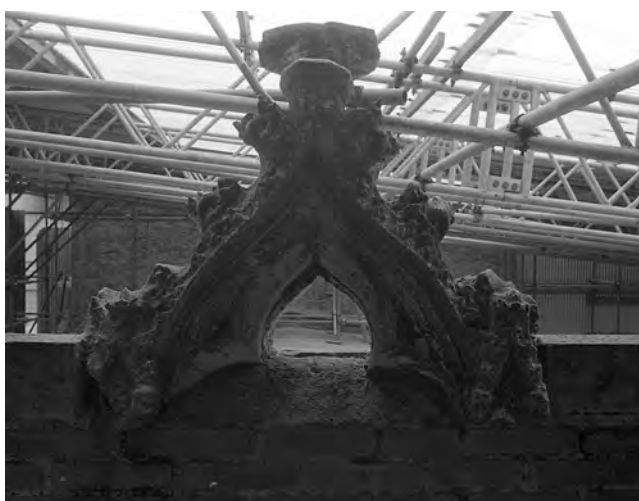
Fig. 598: Chancel, east wall. Fourteenth-century ogival canopy, reused as a central ornament to the crow-stepped gable; removed 1984. View west. Photo: Warwick Rodwell

and when a woodcut was made in the early 1830s (Fig. 15). Other evidence confirms that the gables were all intact in *c.* 1830 (Pl. 10), but had gone before the clock was installed in the tower in 1852. The most plausible context for the removal of the stepped gables is the reroofing of the aisles in 1830s. Whether the east gable of the chancel was rebuilt at the same time, with a lower pitch, is uncertain. Nattes shows a moderately high-pitched, crow-stepped gable, but by the early 1860s it was certainly lower and a fragment of fourteenth-century ogival canopywork had been set on the apex as an antiquarian embellishment (p. 798; Fig. 598). The gable was again rebuilt in *c.* 1903.

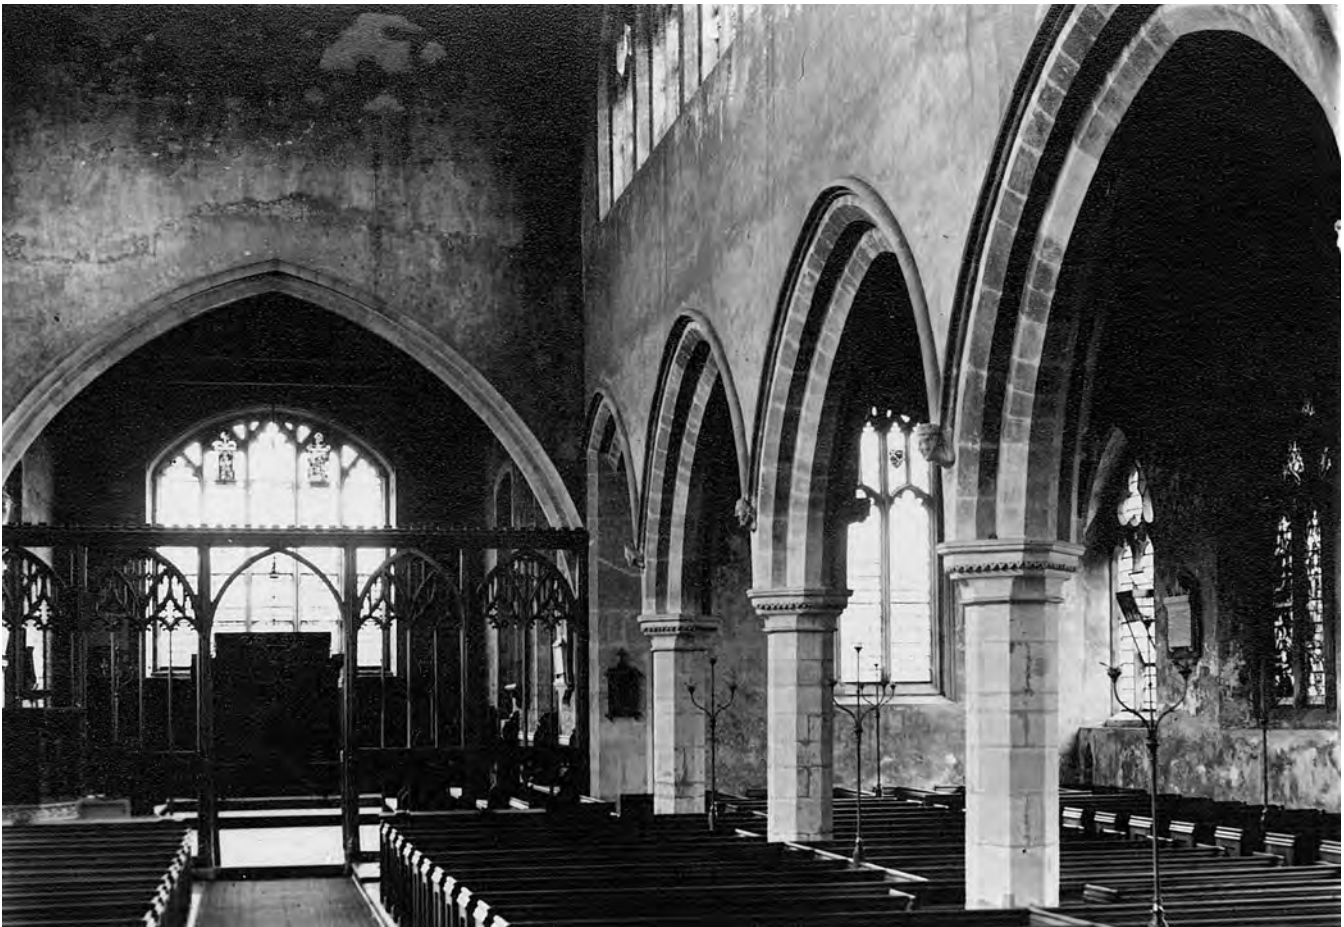
Fig. 601: View of the nave, chancel and south aisle, c. 1890, showing the internal arrangement created by the restoration of 1858–59. Photo: ex. Varah Coll., Lincolnshire Archives

There was no mention in Brodrick's specification of the stained pine choir stalls (although they appear on the plan), restoration of the chancel screen, wall-tiling in the sanctuary, the reredos, ornamental brackets for the nave roof and other works that must have taken place at this time. Nor is a new font mentioned, or the breaking of a pseudo-Saxon doorway through the west wall of the annexe. Regrettably, only one internal photograph of the church is known, ante-dating the restoration of 1897<sup>69</sup> (Fig. 601).

Gas lighting was installed, and early photographs show standards with triple burners attached to pews in the nave (Figs. 601 and 607).<sup>82</sup> Hanging in the centre

The chancel screen, instead of being skilfully restored, was patched up with deal, given a coat of paint and then varnished, to impart uniformity of appearance. Moreover, the solid panels in the lower register were entirely removed<sup>84</sup> (Fig. 601). The restored church was reopened on 1 June 1859,<sup>85</sup> the total cost of the work having far exceeded the estimate. A printed report, with a list of subscribers and statement of accounts, was issued in 1861.<sup>86</sup>

6. The altar was raised on two limestone steps, in substitution for a timber dais. The steps (15 cm) were returned along the north and south, and the enclosed dais was stone-paved. This structure visibly overlies the earlier tile floor and also abuts the wall-tiling on the east (Fig. 601).

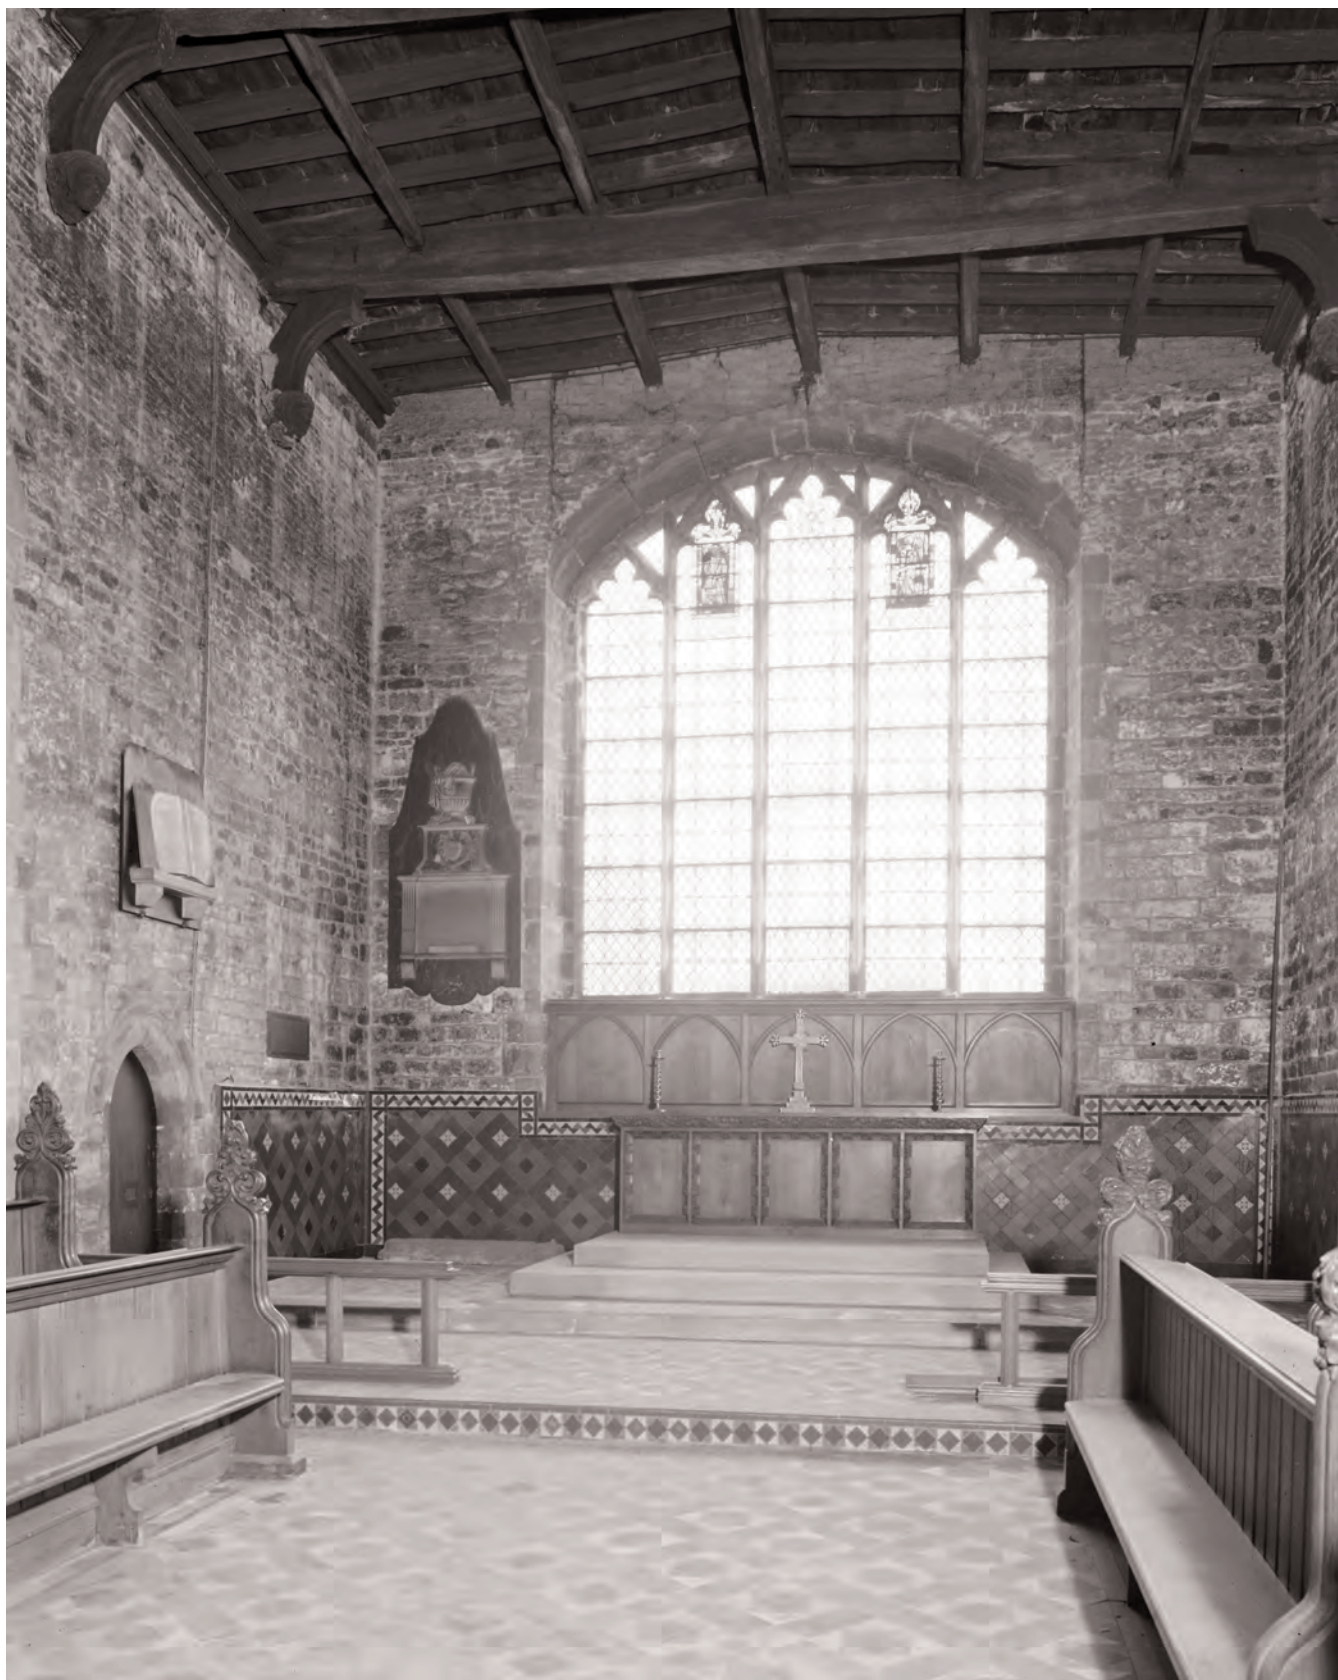
*Fig. 602: Chancel. Interior, looking east, 1972. Photo: English Heritage, RCHME*

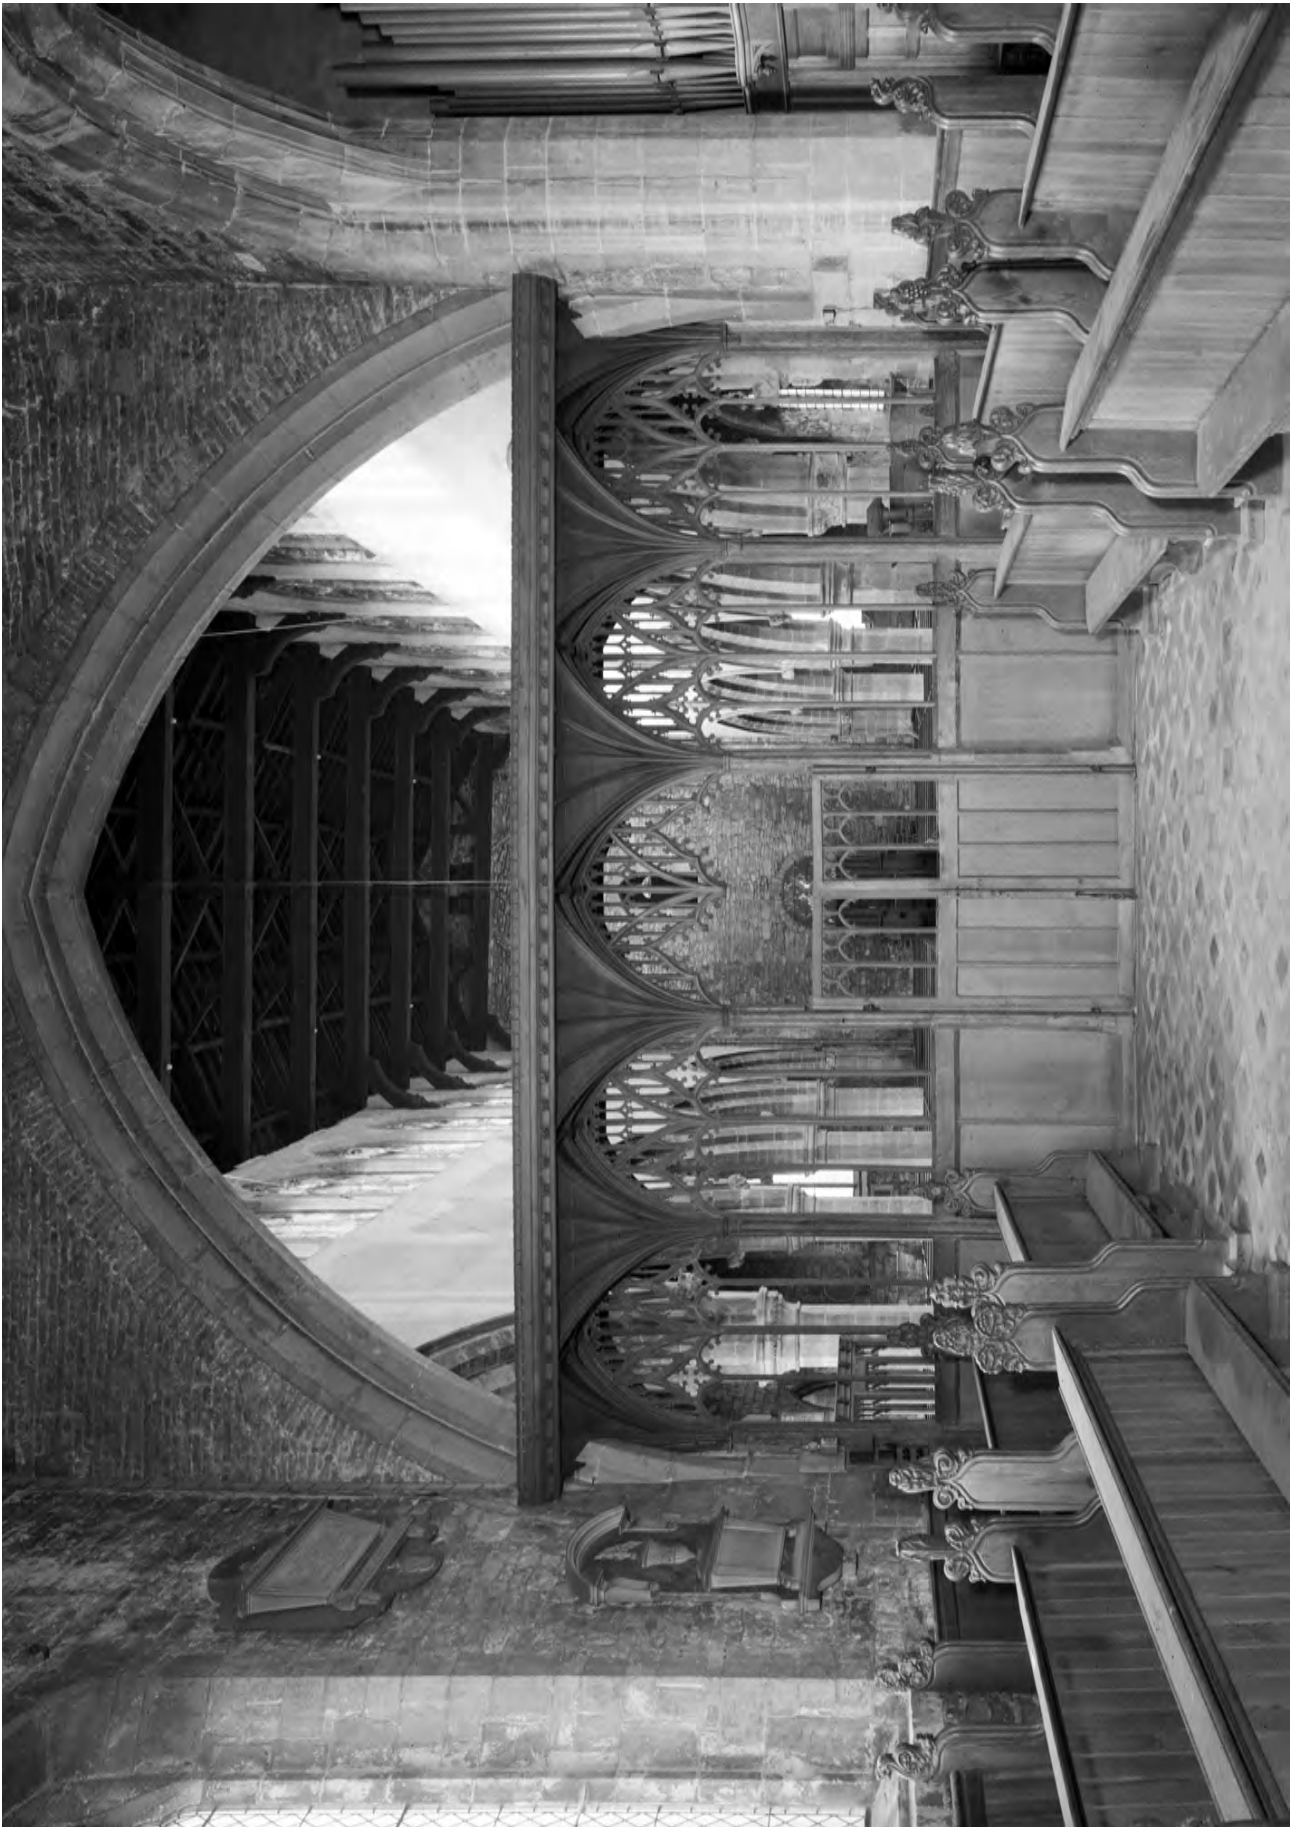
Fig. 603: Chancel: choir stalls and screen. View west, 1972. Photo: English Heritage, RCHME

The chancel was comprehensively refloored with unglazed Staffordshire (Maw's) tiles in subdued colours, laid diagonally and having inset squares forming a simple pattern (Pls. 63 and 67; Fig. 603).<sup>71</sup> Two rows of pine choir stalls were placed against the north and south walls, raised on timber platforms with sub-floor air spaces (Figs. 602 and 603). The ends of the stalls were decorated with poppy-head carvings (Fig. 604). The sixteenth-century chequered floor of tile pavements, and all the ledger-slabs in it, was swept away.

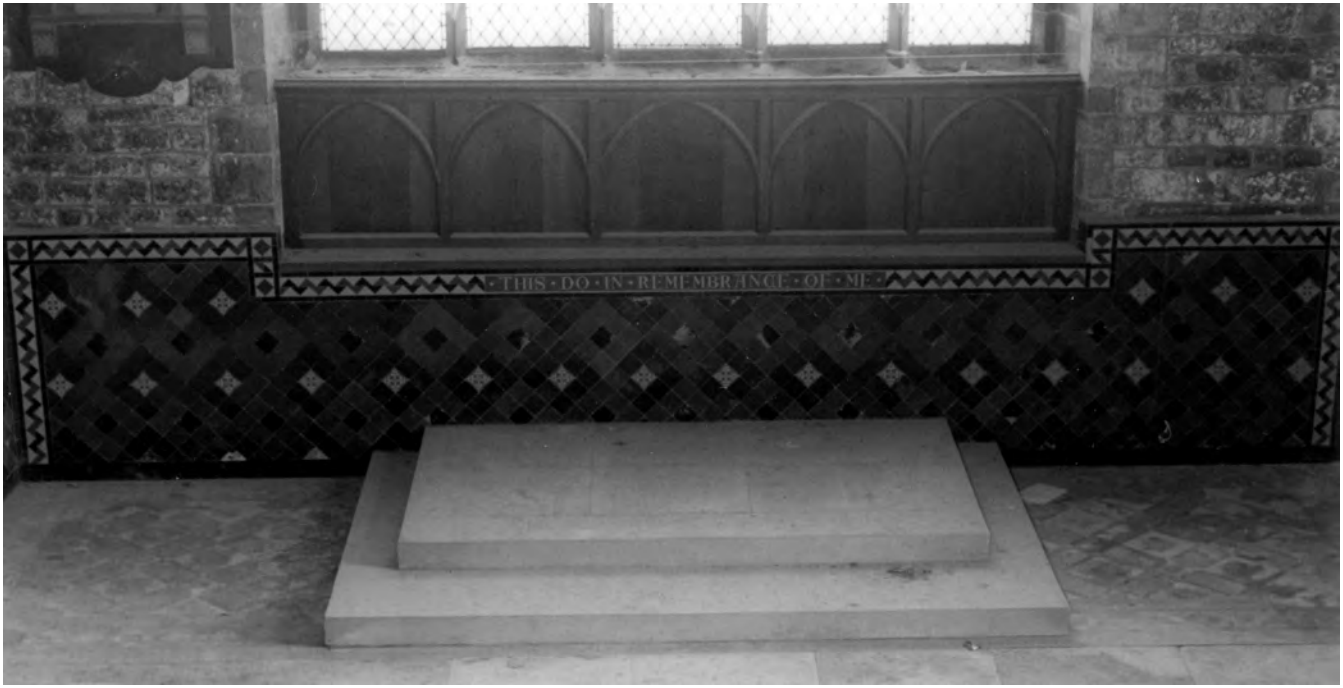
*Fig. 605: Sanctuary, showing the tile pavement and wall tiling of 1858–59; also the later dais and reredos. View east. Photo: Warwick Rodwell*

The eastern part of the chancel was raised by one step (17 cm) and given a Staffordshire tile floor similar to the rest.<sup>72</sup> The sanctuary was raised by a further step (15 cm), placed immediately east of the doorway to the vestry (Fig. 605). This is of cream limestone<sup>73</sup> and bears six scars where iron standards supporting the altar rails were formerly fixed. The sanctuary floor was tiled, but with slightly more elaboration than the chancel. The altar stood on a timber dais, and behind was a retablo painted on slate: it had a central panel with a sacred monogram, flanked by two pairs of panels inscribed with the Commandments<sup>74</sup> (p. 551; Pl. 105).

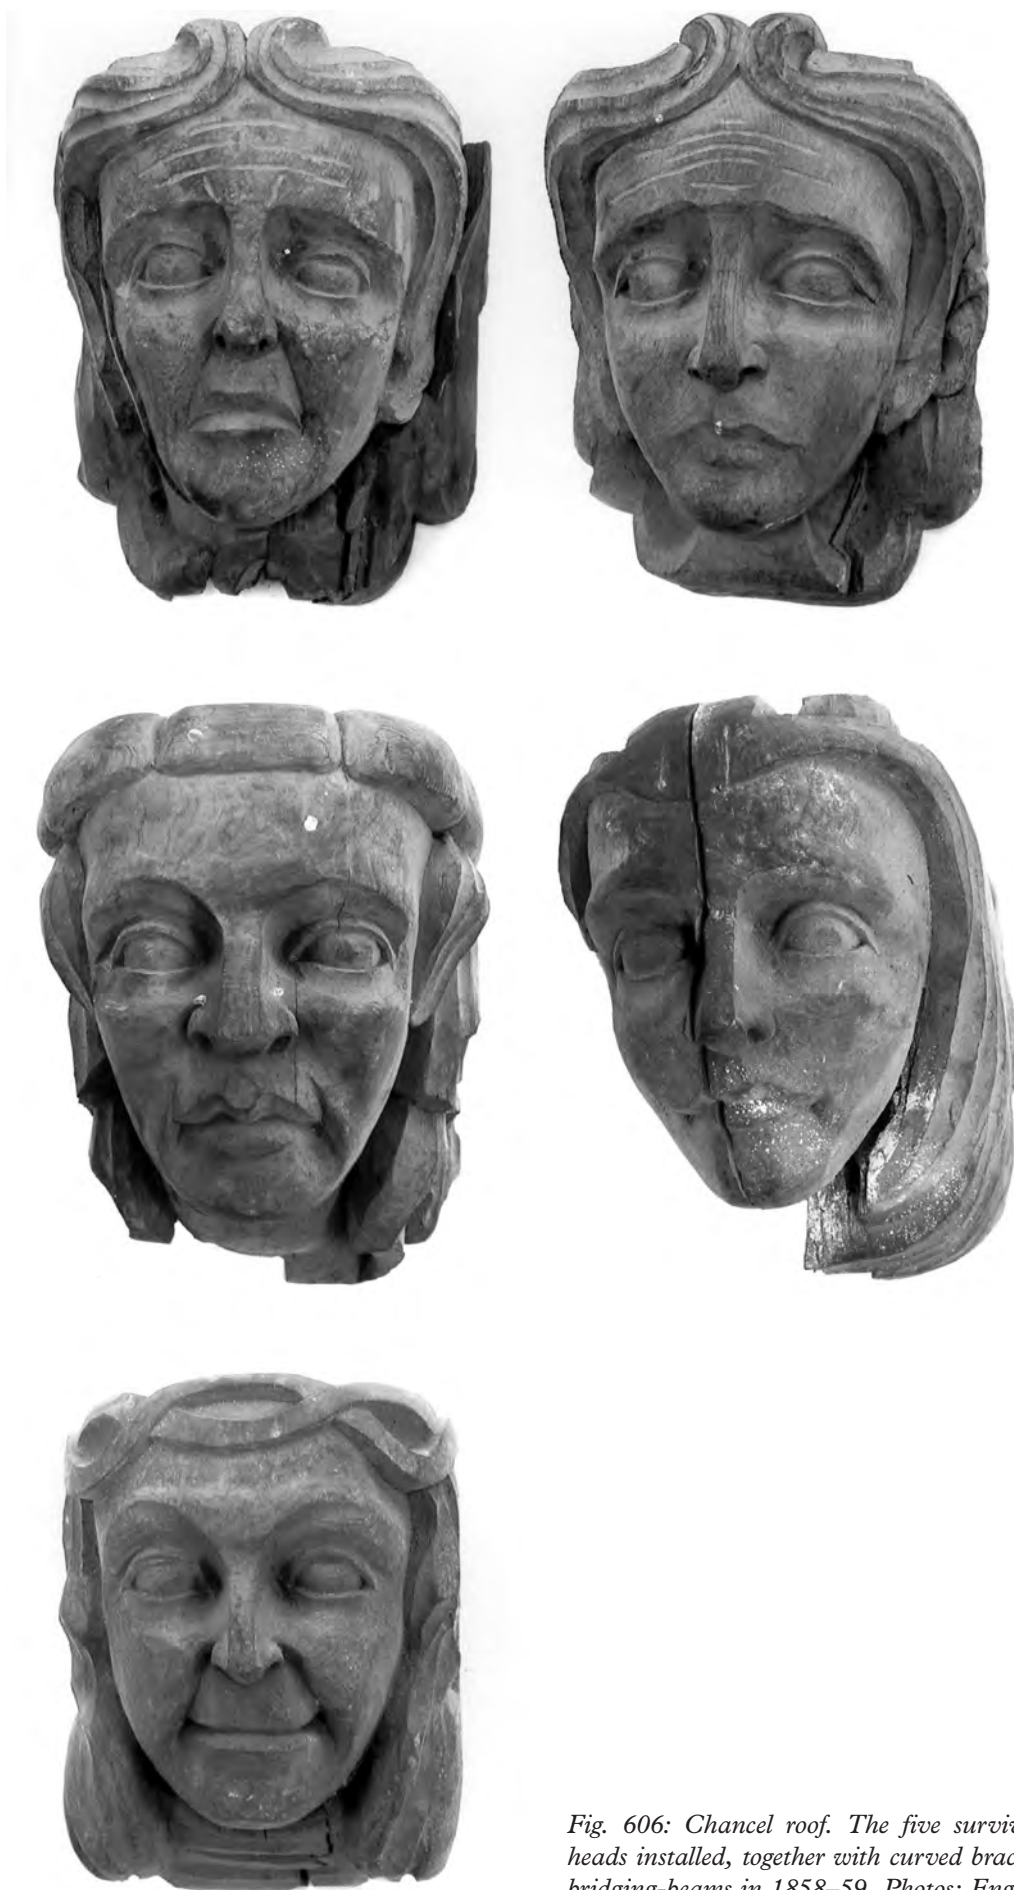
*Fig. 606: Chancel roof. The five surviving pine corbel-heads installed, together with curved brackets, beneath the bridging-beams in 1858–59. Photos: English Heritage*

The cosmetic work carried out to the chancel roof, after the ceiling was taken down, is apparent. The bridging-beams were given simple stopped chamfers, and mortices were cut in the soffit face, near to the ends; curved wall-brackets were fitted, descending on to timber corbels enlivened with boldly carved heads. Lengths of moulded timber cornice were fitted on the wall-tops, between the beams. The eight corbels and brackets, which were purely decorative, were partly consumed by dry rot in the mid-twentieth century.<sup>78</sup> Five of the heads have survived more-or-less complete, and there is a fragment of a sixth; these and the brackets were all taken down in 1981 (Fig. 606). The other two heads were lost at an earlier date. The features are bold and crudely carved, but nevertheless pay homage to the fourteenth century: two of the survivors are female.<sup>79</sup>

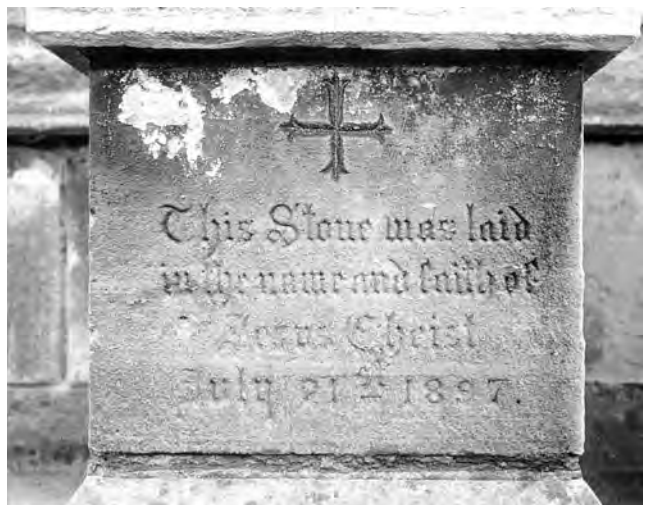
Fig. 612: Organ chamber. Foundation stone in the north-eastern buttress, 1897. Photo: Warwick Rodwell

Before the end of 1896, the gift of £1,000 by Mrs Holt, widow of the vicar who had instigated the last great restoration, was used to set up a new fund. She also gave the £250 required to restore the chancel screen in accordance with a scheme prepared by Fowler. It was estimated that £1,800–£2,000 would be required to: rebuild the vestry, construct an organ chamber on the north side of the chancel, restore the screen and renovate the internal walls.<sup>119</sup> This restoration is well documented.<sup>120</sup> Within a few months J.W. Briggs of Barton had been given the contract for the building work, the old organ was sold for £40, and Bowman and Sons of Stamford were entrusted with the restoration of the screen.<sup>121</sup> Services were transferred to St Mary's, to allow work to proceed unhindered. A stone-laying ceremony for the organ chamber took place on 21 July 1897, which was carried out by Canon Moor, the former vicar of Barton. The limestone plaque, now eroded, is built into the north-eastern buttress (Fig. 612).<sup>122</sup> The inscription reads:

+ / This Stone was laid / in the name and faith of / Jesus Christ / July 21<sup>st</sup> 1897.

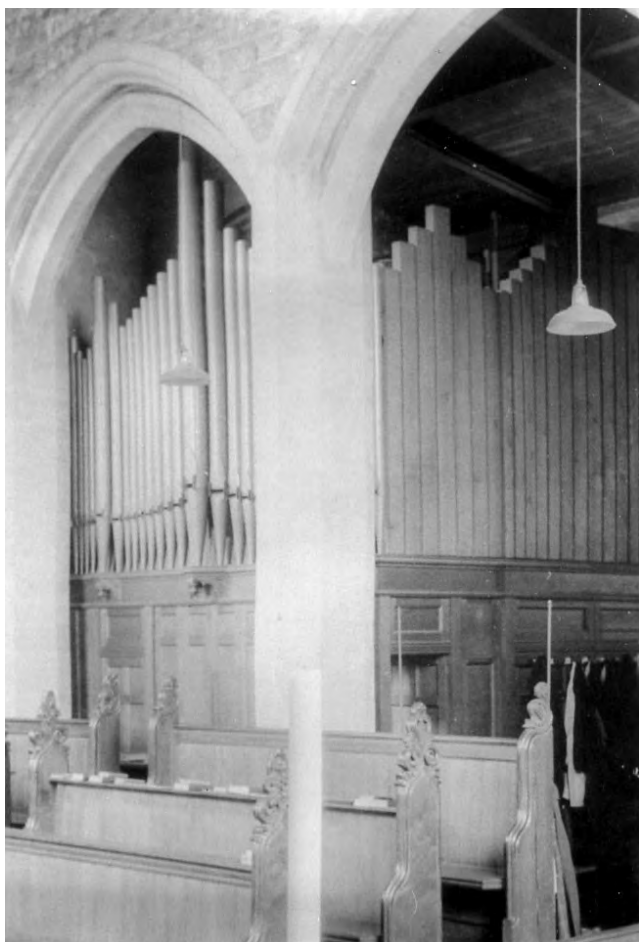
Fig. 618: Chancel and organ chamber, 1945. Arcade of two bays in the north wall of the chancel, with the organ beyond. Photo: Courtesy of the Church Buildings Council (F. Huntley Woodcock Coll.)

The new limestone arcade in the chancel wall was made as lofty as possible, with plain jambs and low, two-centred arches with hollow-chamfered mouldings (Fig. 618). The lower part was meant to be filled with a traceried oak screen, but that was never constructed, and the eventual disposition of the organ differed from

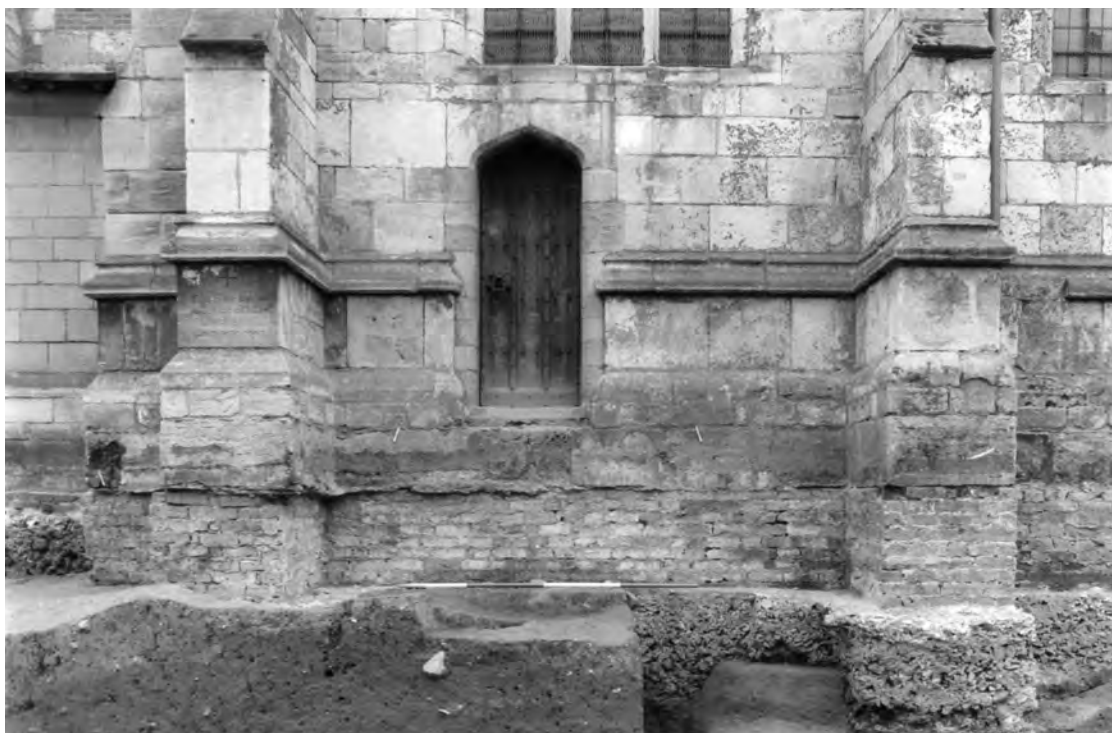
Fig. 619: Organ chamber. Foundations of the north wall (bay 2) during excavation. Scale of 2 m. Photo: Warwick Rodwell

The rebuilt north wall stands on a brick footing, with a poured concrete foundation (Fig. 619). The wall carries the deep bolection-moulded plinth salvaged from the medieval chancel. The central buttress is of reused masonry, but the clasping buttresses at the north-east angle (including the plinth mouldings) were new in 1897. The plain parapet with a coping-roll, and the chamfered eaves-course supporting it, are of similar date. The east wall, which was partly abutted by the vestry, was completely rebuilt and faced with new limestone ashlar. Internally, the chamber is plastered.

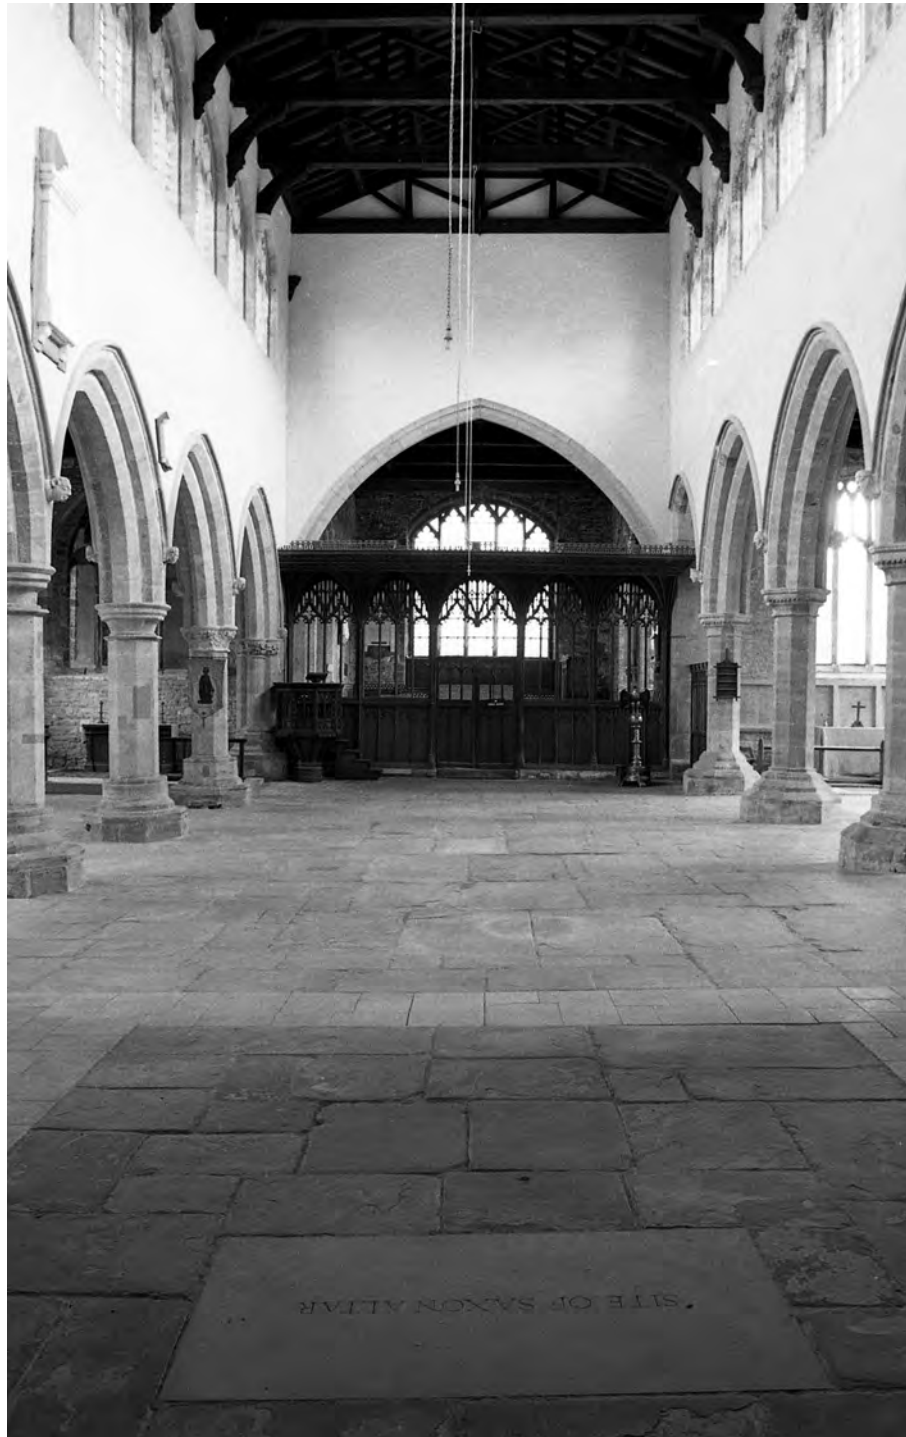
Fig. 626: Nave, looking east, 2005. Photo: Warwick Rodwell

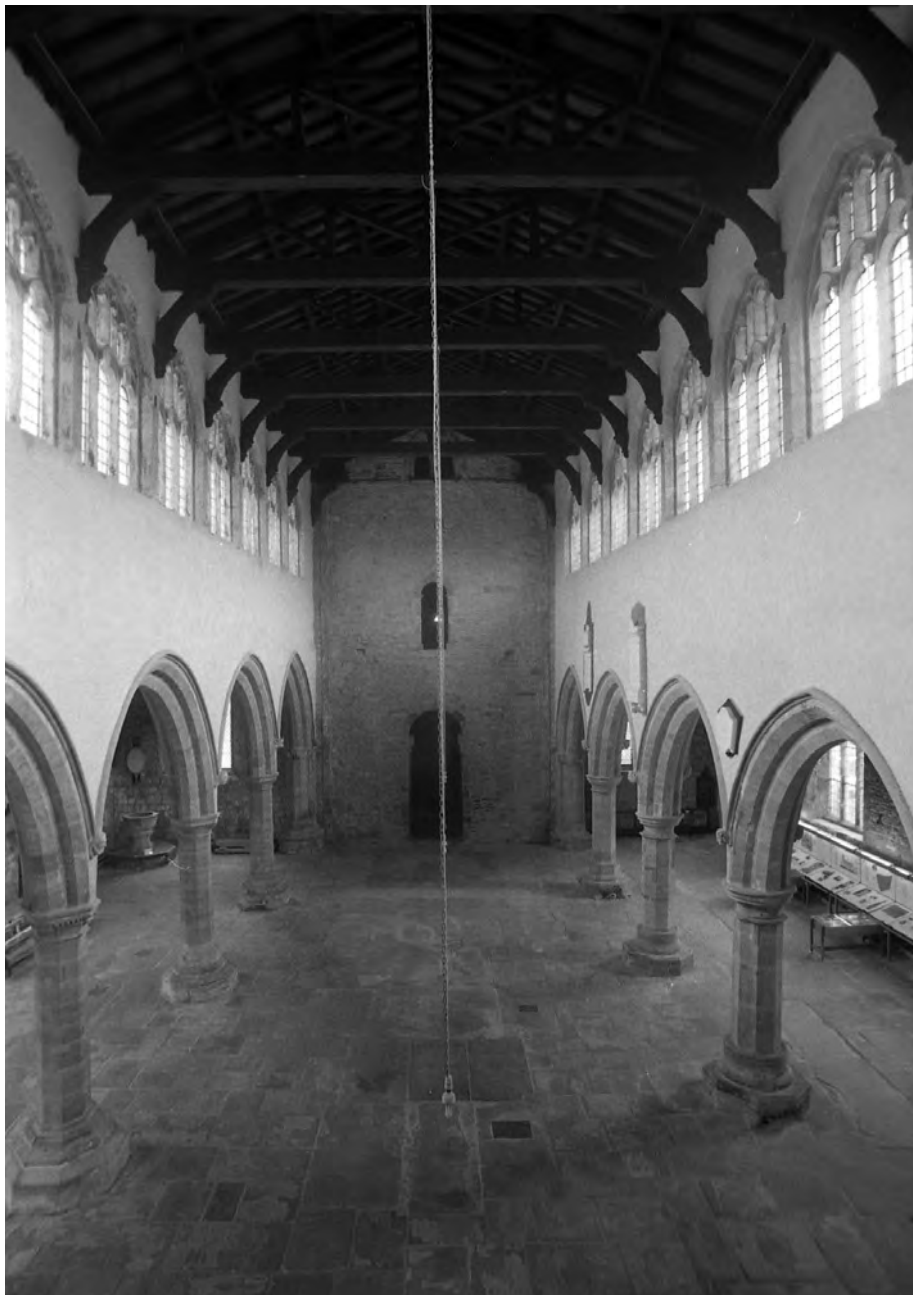
*Fig. 627: Nave, looking west, 2005. Photo: Warwick Rodwell*

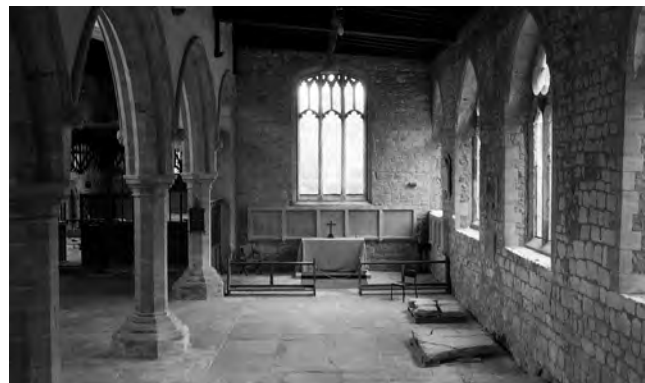
Fig. 629: South aisle, looking east, 2005. Photo: Warwick Rodwell

paviours, laid as a chequer pattern. These sixteenth-century Flemish tiles were recovered from under the 1858–59 pew platforms and were previously from the chancel (Pl. 62). Inset into the south-west corner of the dais is a small patch of medieval glazed tiles, yellow and black, laid as a chequer pattern (Pl. 61).<sup>180</sup> The chapel in the south aisle remains as a war memorial (Figs. 629, 630 and 631). Herringbone paving in red

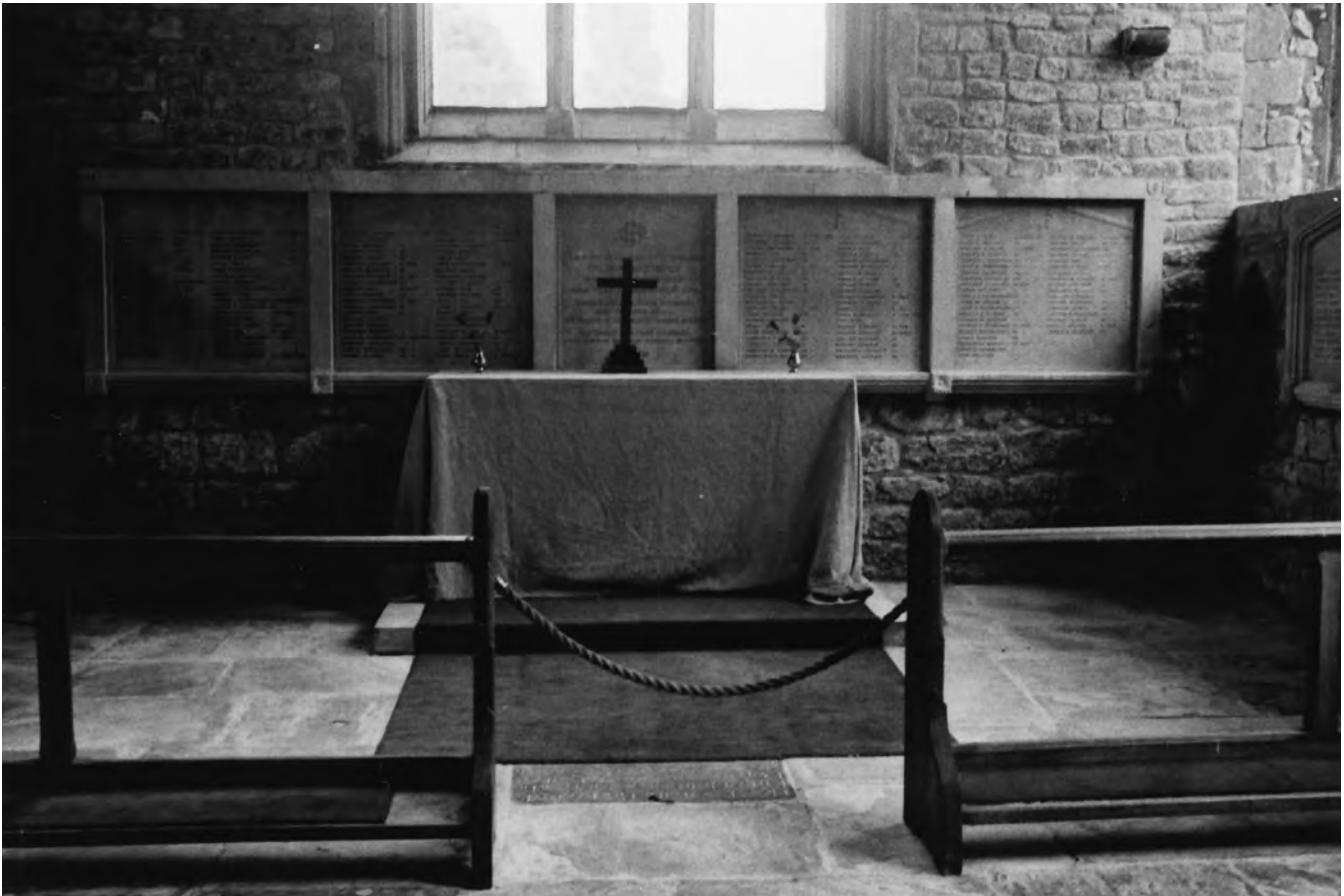
Fig. 630: South aisle chapel and inscribed memorial to the First World War, 2005. Photo: Warwick Rodwell

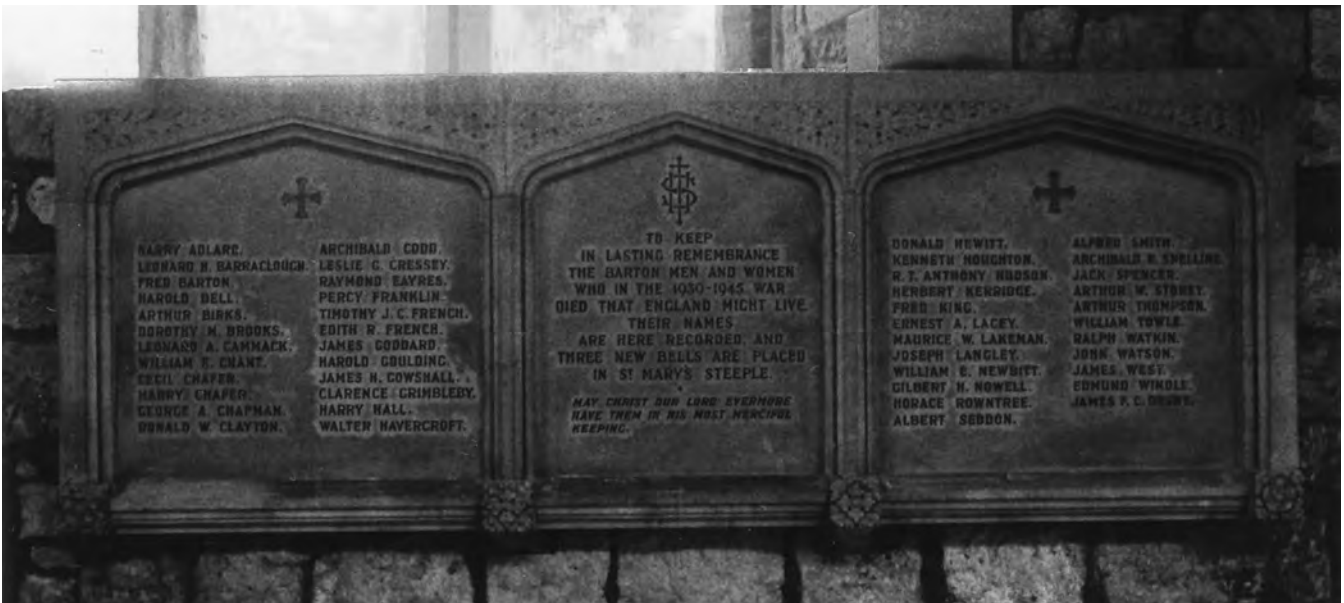
Fig. 631: South aisle chapel. Inscribed memorial to the Second World War on the south wall, 2005. Photo: Warwick Rodwell

In the late 1940s a second war memorial was installed in St George's chapel, on the south wall (Fig. 631). At an uncertain date in the 1960s, and without a faculty, the roofs of the chancel, aisles and south porch were stripped of lead and re-covered with sheet copper (*cf.* St Mary's). Similarly, piecemeal repairs to external masonry led to fundamental changes in the character of some of the walls, when rubblework was replaced with quasi-ashlar. The introduction of reclaimed grit-stone ashlar in the aisles is regrettable from an archaeological point of view; the same occurred at St Mary's. Most of the mouldings in the outer arch of the south porch were renewed, and sundry reglazing was carried out, particularly in the clerestory.
